1. Operator:	Hilcorp Energy (	Company			OGRI	D #:	372171	
-	382 Road 3100							
Facility or well na	ame: <u>Canyo</u>	n 1						
API Number:	30-045-21247			OCD Permit N	umber:			
U/L or Qtr/Qtr _	O Sectio	n <u>10</u>	_ Township	25N Rang	ge <u>11W</u>	<u>County: S</u>	San Juan	
Center of Propose	ed Design: Latitude	2 <u>36.41125</u>	5	Longitude	-107.98	8788	NAD83	
Surface Owner:	] Federal 📃 State	Private	🔀 Tribal Trust	or Indian Allotment				
Temporary: Permanent Lined Ur String-Reinfo Liner Seams: <u>Below-grade</u>	lined Liner type: rced Welded 🗌 Factor tank: Subsection	ver avitation Thickness _ ry Other J of 19.15.1	P&A milmil		PE [] PVC	C Other _	nloride Drilling Fluid	-
Tank Constructio	n material:	Metal						
Secondary co	ontainment with leal	k detection	Visible side	ewalls, liner, 6-inch l	ft and auton	natic overflow	w shut-off	
□ Visible sidewalls and liner □ Visible sidewalls only □ Other

### Hilcorp Energy Company San Juan Basin Below Grade Tank Closure Report

### Lease Name: Canyon 1 API No.: 30-45-21247

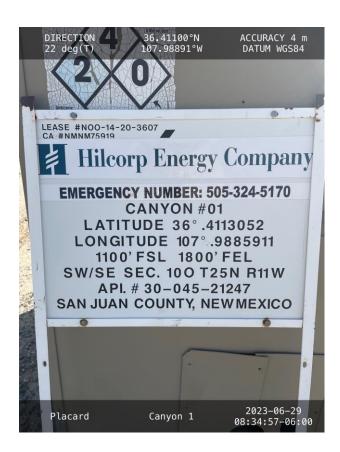
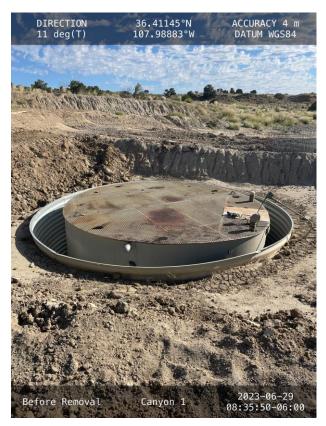
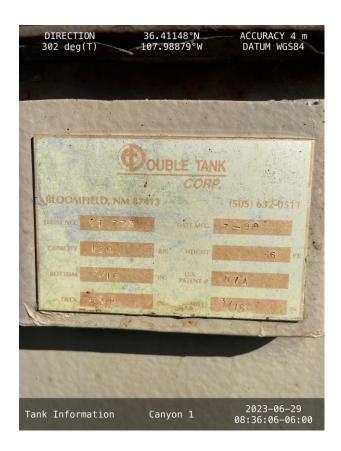
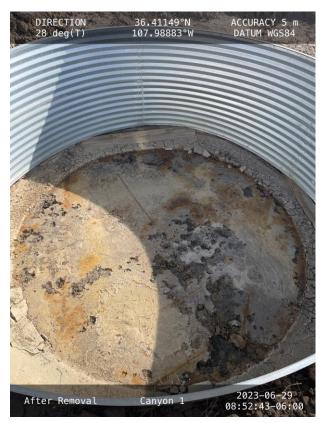
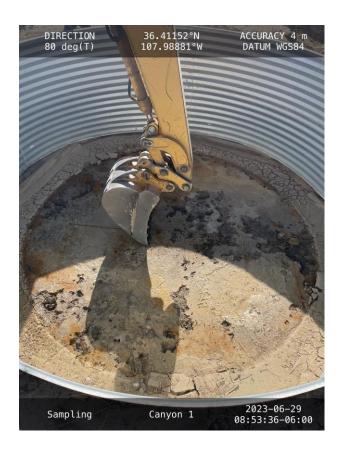
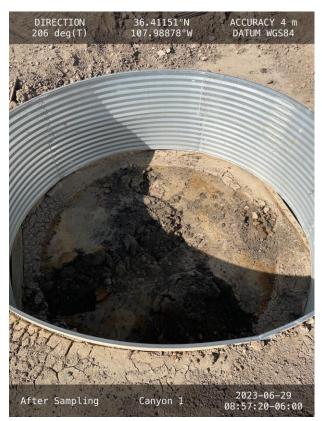
\*\*Please Note Required Photos for Closure\*\* Well site placard Photos of the BGT prior to closure The sample location or, more preferred, photos of actual sample collection Final state of the area after closure. Photos will require captioning including direction of photo, date and time of photo and a description of the image contents.
