Pit, Below-Grade Tank, or
Proposed Alternative Method Permit or Closure Plan Application

Hilcorp Energy Company
San Juan Basin
Below Grade Tank Closure Report

Lease Name: Hughes 9

API No.: 30-039-06282

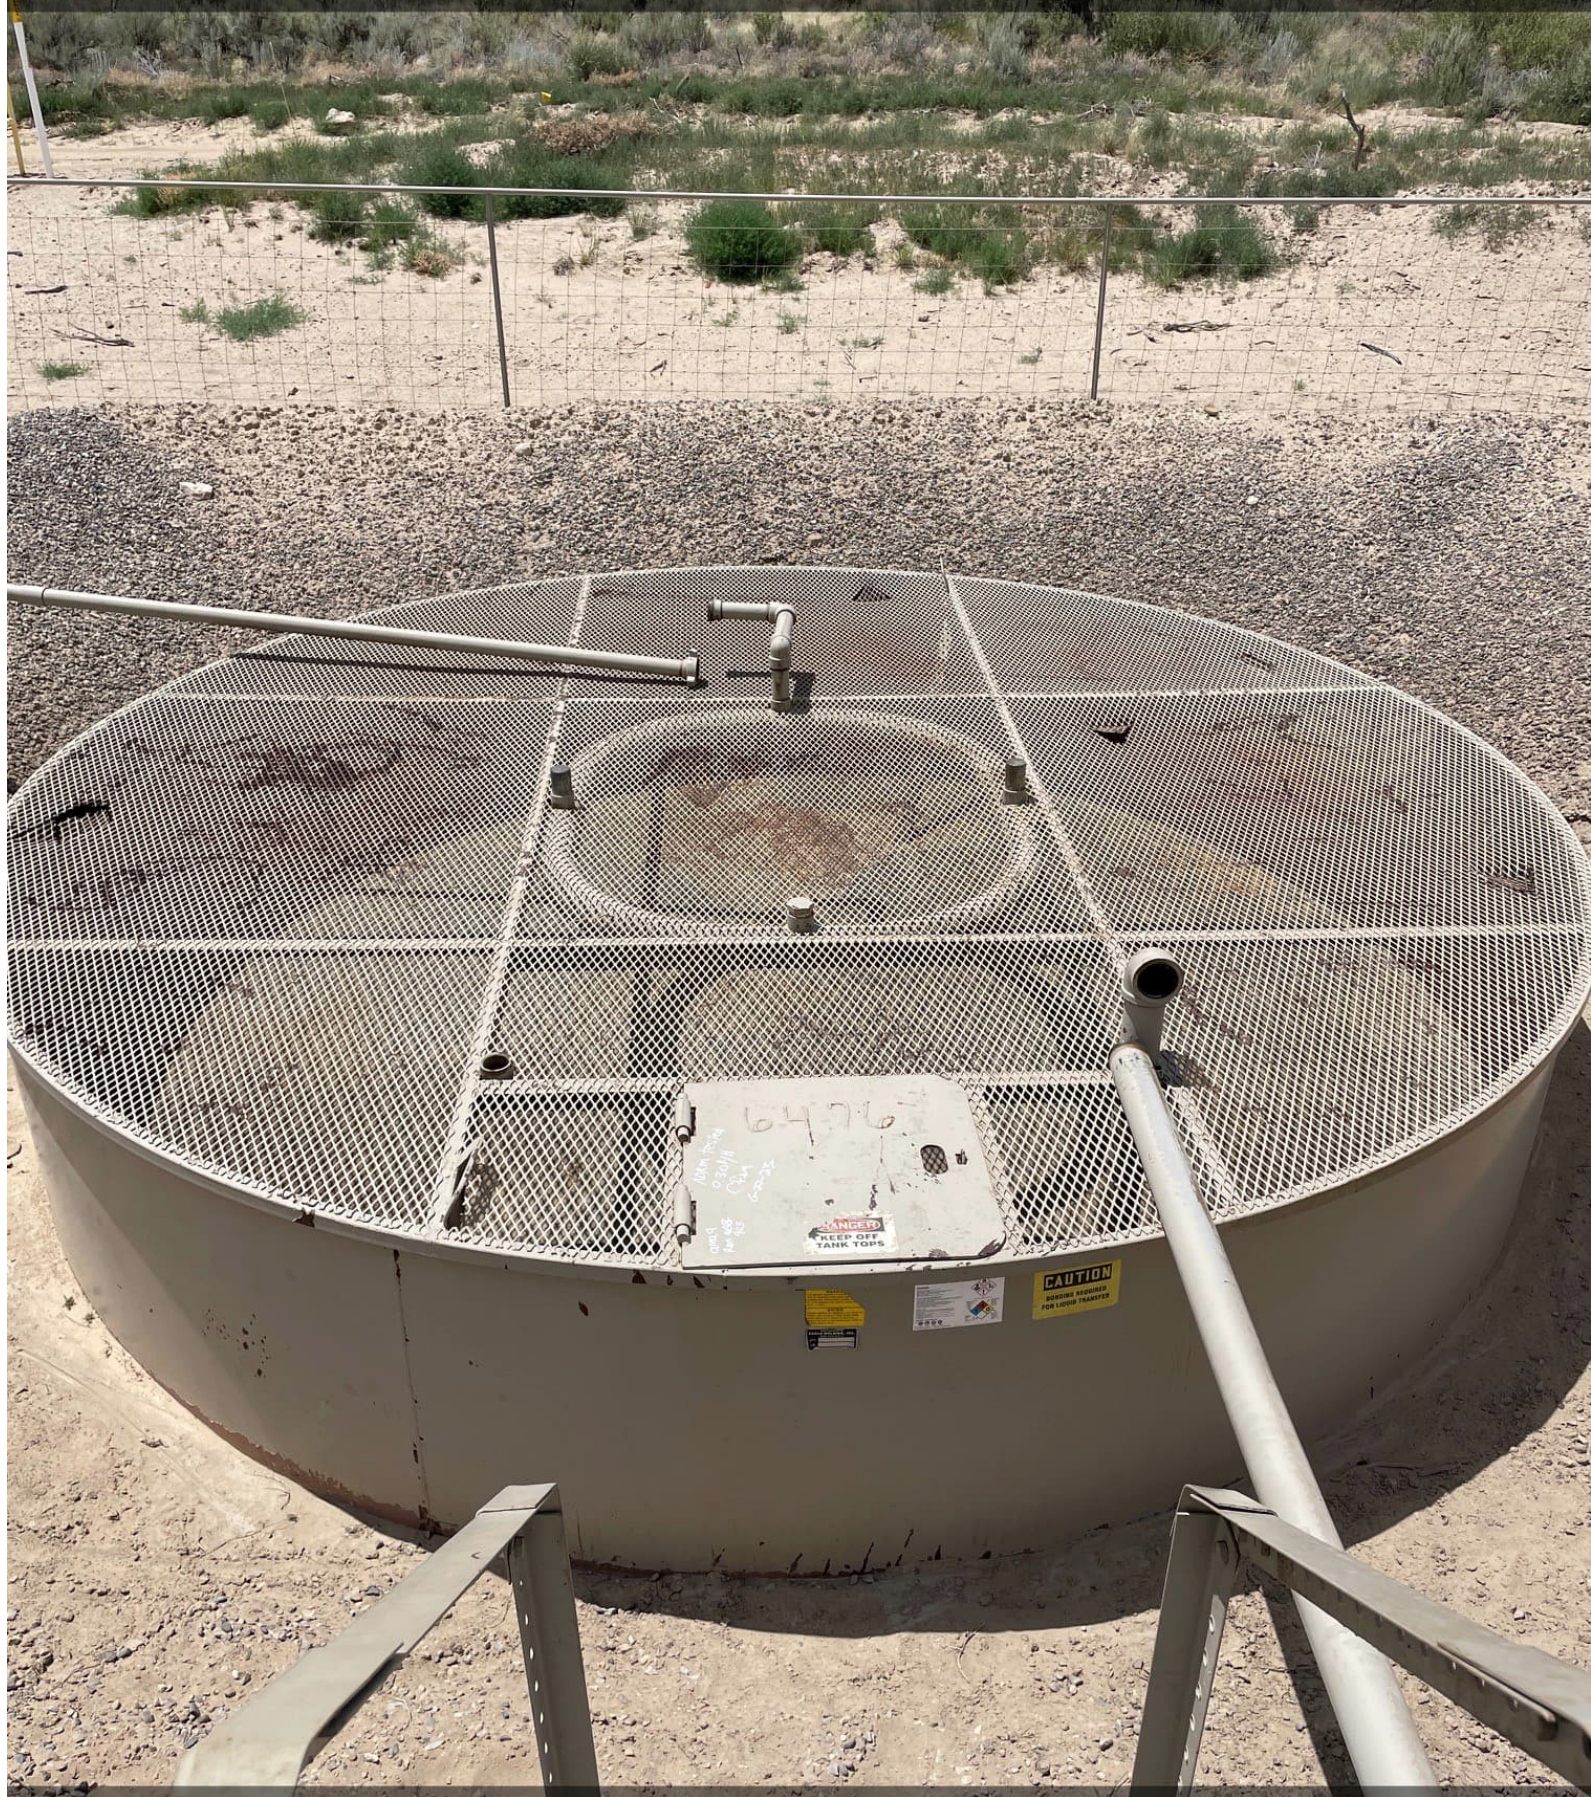
Hughes 9

Before Removal

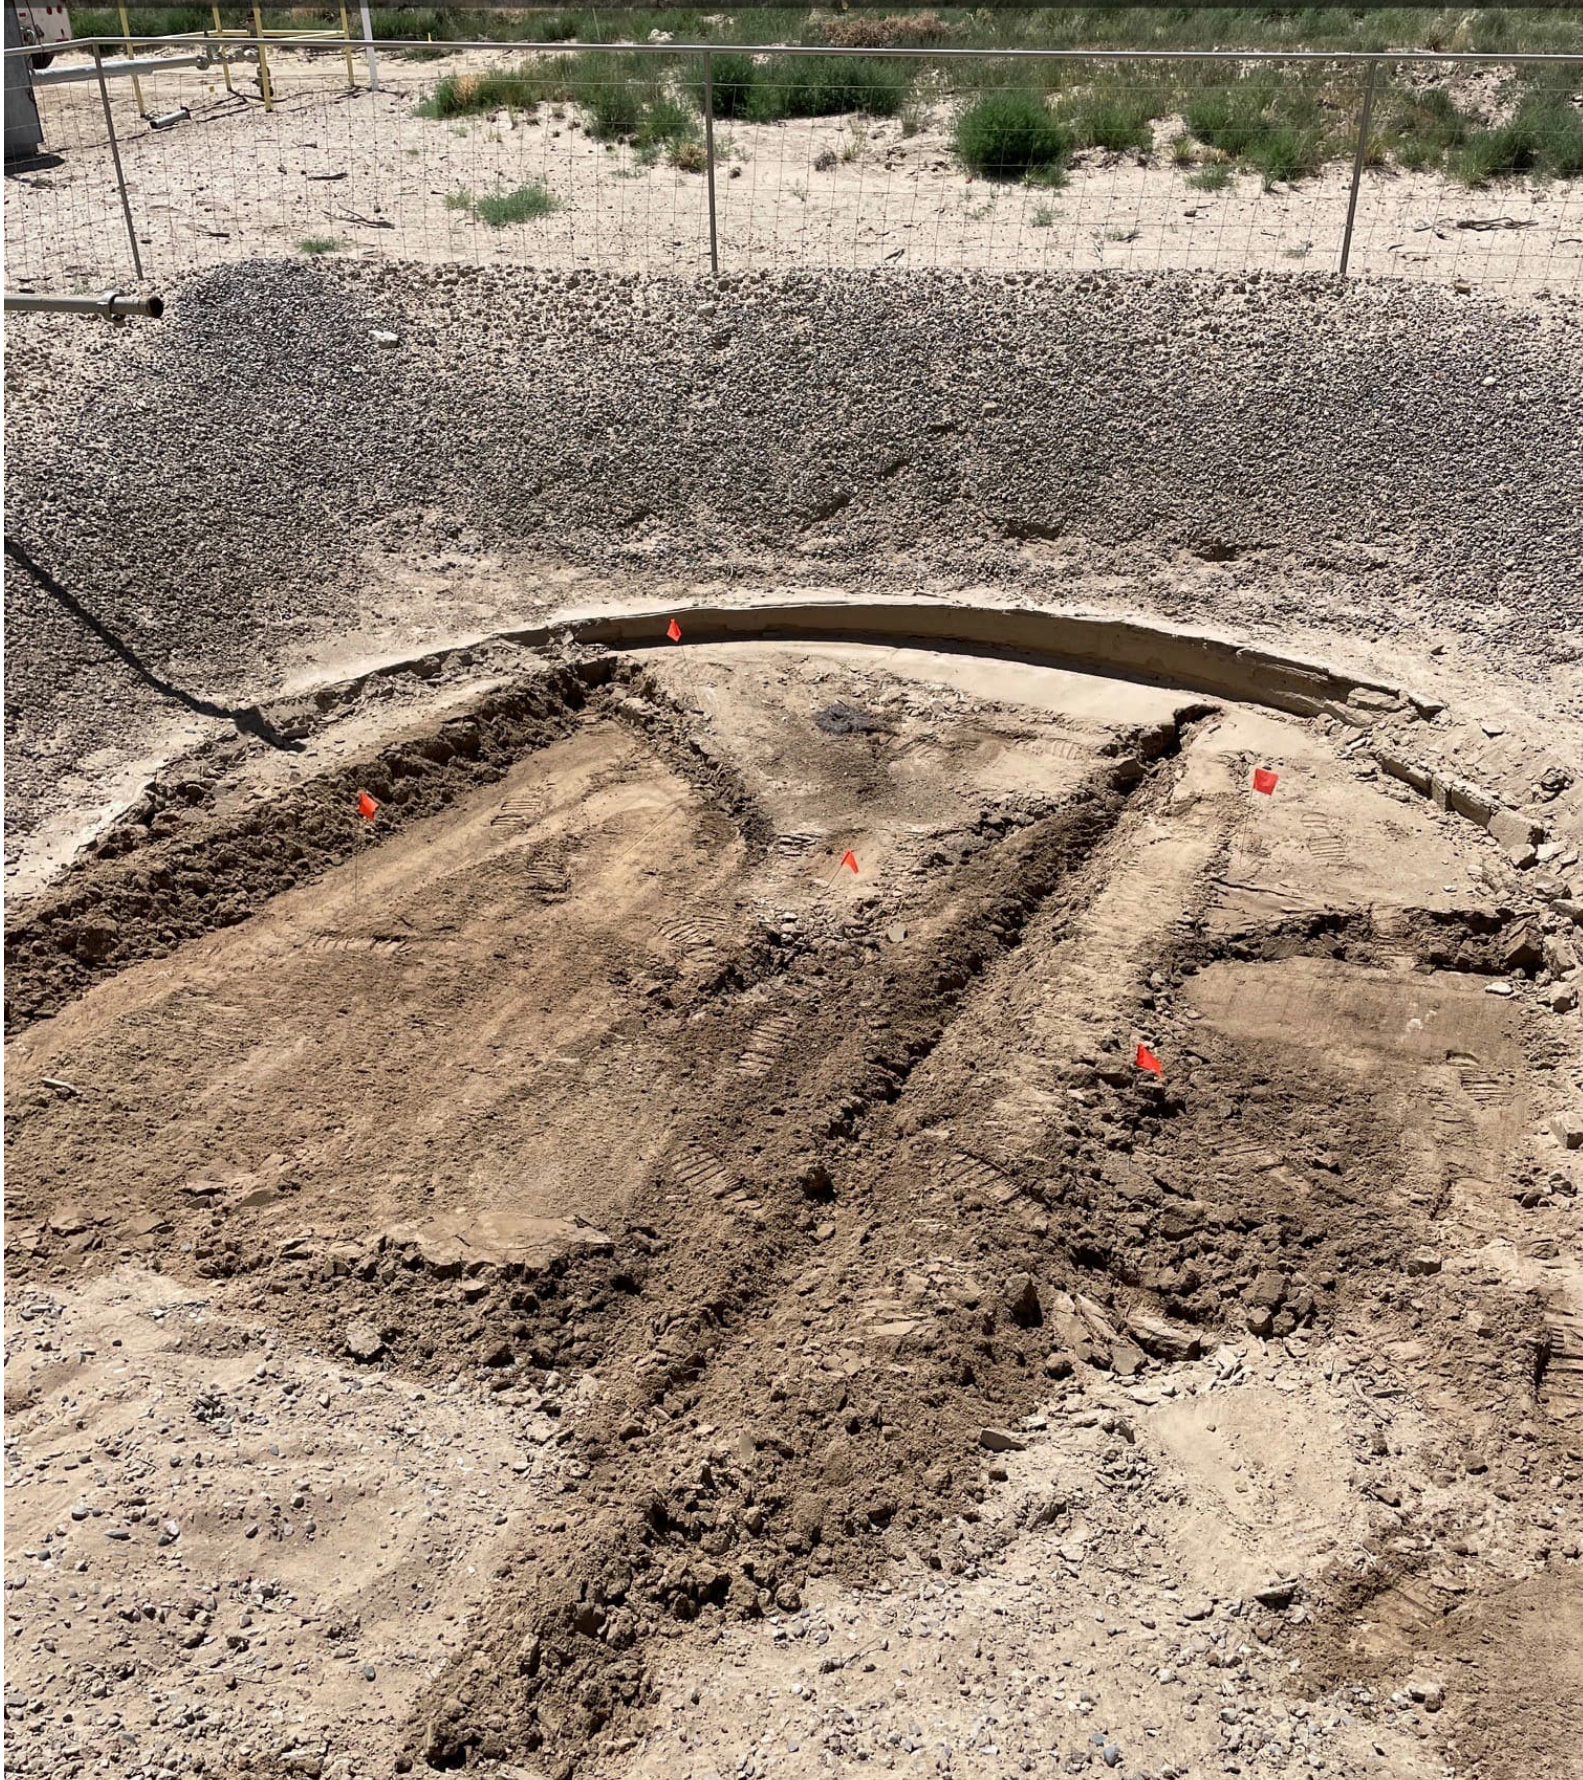
Hughes 9

After Removal
with Composite
Sample Points

A five point composite sample was taken of the below-grade tank using sampling tools and all samples tested per Subsection B of 19.15.17.1 3(B)(1)(b). (Sample results attached). Form C-141 is attached.

The below-grade tank area passed all requirements of Paragraph (4) of Subsection E of 19.15.17.13 NMAC and was backfilled with compacted, non-waste containing, earthen material.
