Hilcorp Energy Company San Juan Basin Below Grade Tank Closure Report

Lease Name: McClanahan 8 API No.: 30-045-07279

McClanahan 8 30-045-07279 BGT Closure Pictures

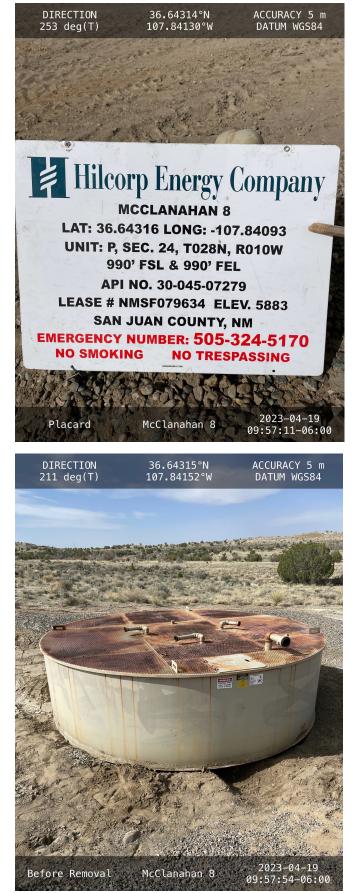
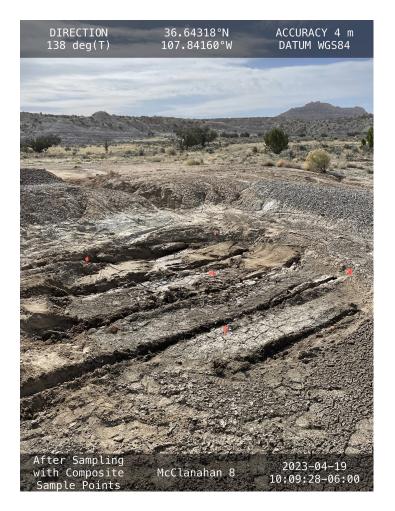
The below-grade tank area was re-contoured to match fit, shape, line, form and texture of the surrounding area. Re-shaping including drainage control, to prevent ponding and erosion. Natural drainages were unimpeded and water bars and/or silt traps were placed in areas where needed to prevent erosion on a large scale. Final recontour has a uniform appearance with smooth surface, fitting the natural landscape.

The below-grade tank area was backfilled and more than four feet of cover was achieved and the cover included one foot of suitable material to establish vegetation at the site.
