<u>Pit, Below-Grade Tank, or</u> Proposed Alternative Method Permit or Closure Plan Application

Hilcorp Energy Company San Juan Basin Below Grade Tank Closure Report

Lease Name: Huerfano Unit Com 551 API No.: 30-045-30453

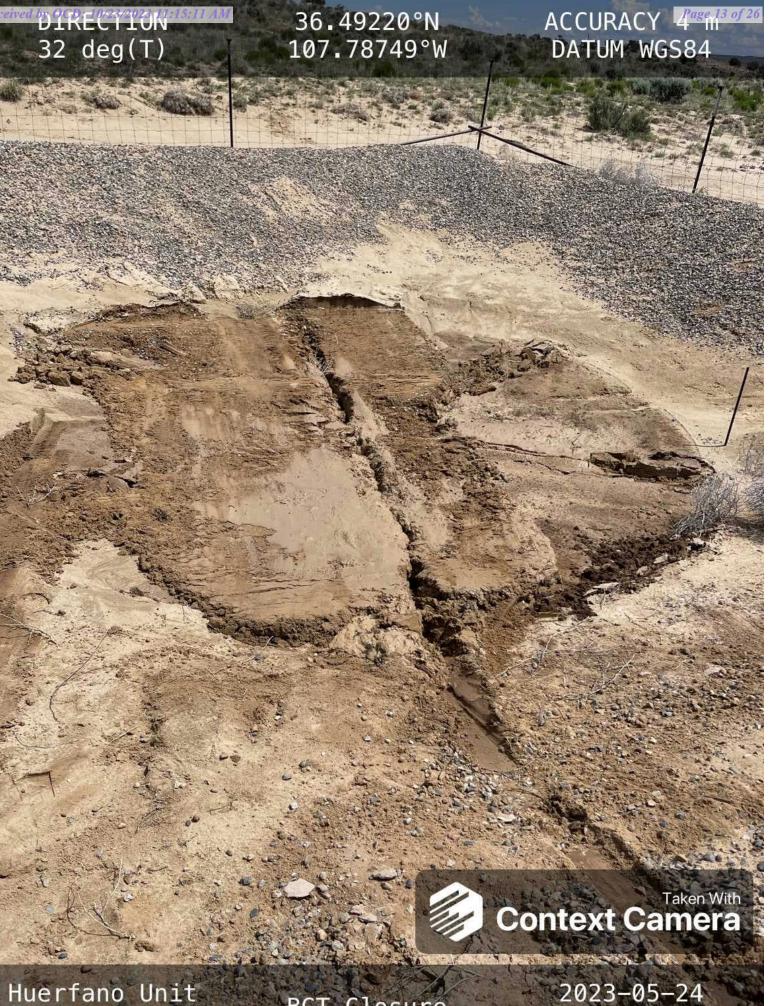
BGT Closure

Context Camera

Huerfano Unit

1 North

The below-grade tank referenced above was permitted and closed within 60 days of cessation of the below-grade tanks operation.

All on-site equipment associated with the below-grade tank was removed.

The below-grade tank area passed all requirements of Paragraph (4) of Subsection E of 19.15.17.13 NMAC and was backfilled with compacted, non-waste containing, earthen material.

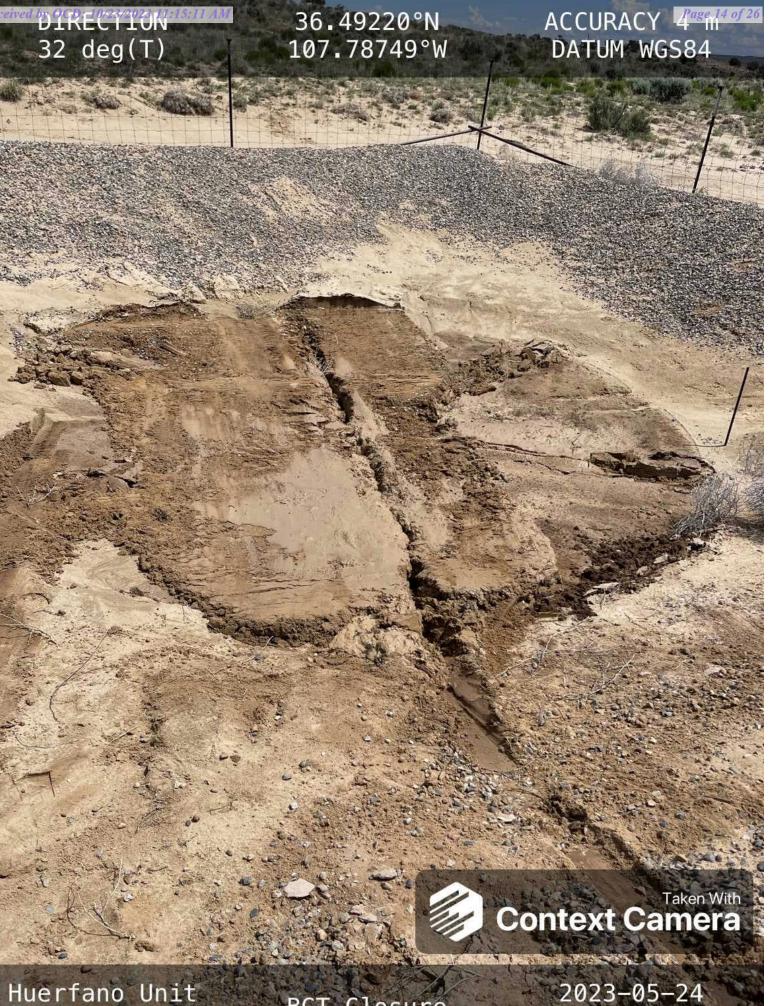
BGT Closure

11:32:44-06:00

The below-grade tank area was re-contoured to match fit, shape, line, form and texture of the surrounding area. Re-shaping including drainage control, to prevent ponding and erosion. Natural drainages were unimpeded and water bars and/or silt traps were placed in areas where needed to prevent erosion on a large scale. Final recontour has a uniform appearance with smooth surface, fitting the natural landscape.

The below-grade tank area was backfilled and more than four feet of cover was achieved and the cover included one foot of suitable material to establish vegetation at the site.
