Pit, Below-Grade Tank, or
Proposed Alternative Method Permit or Closure Plan Application

Hilcorp Energy Company
San Juan Basin
Below Grade Tank Closure Report

Lease Name: San Juan 29-6 Unit 70

API No.: 30-039-07517

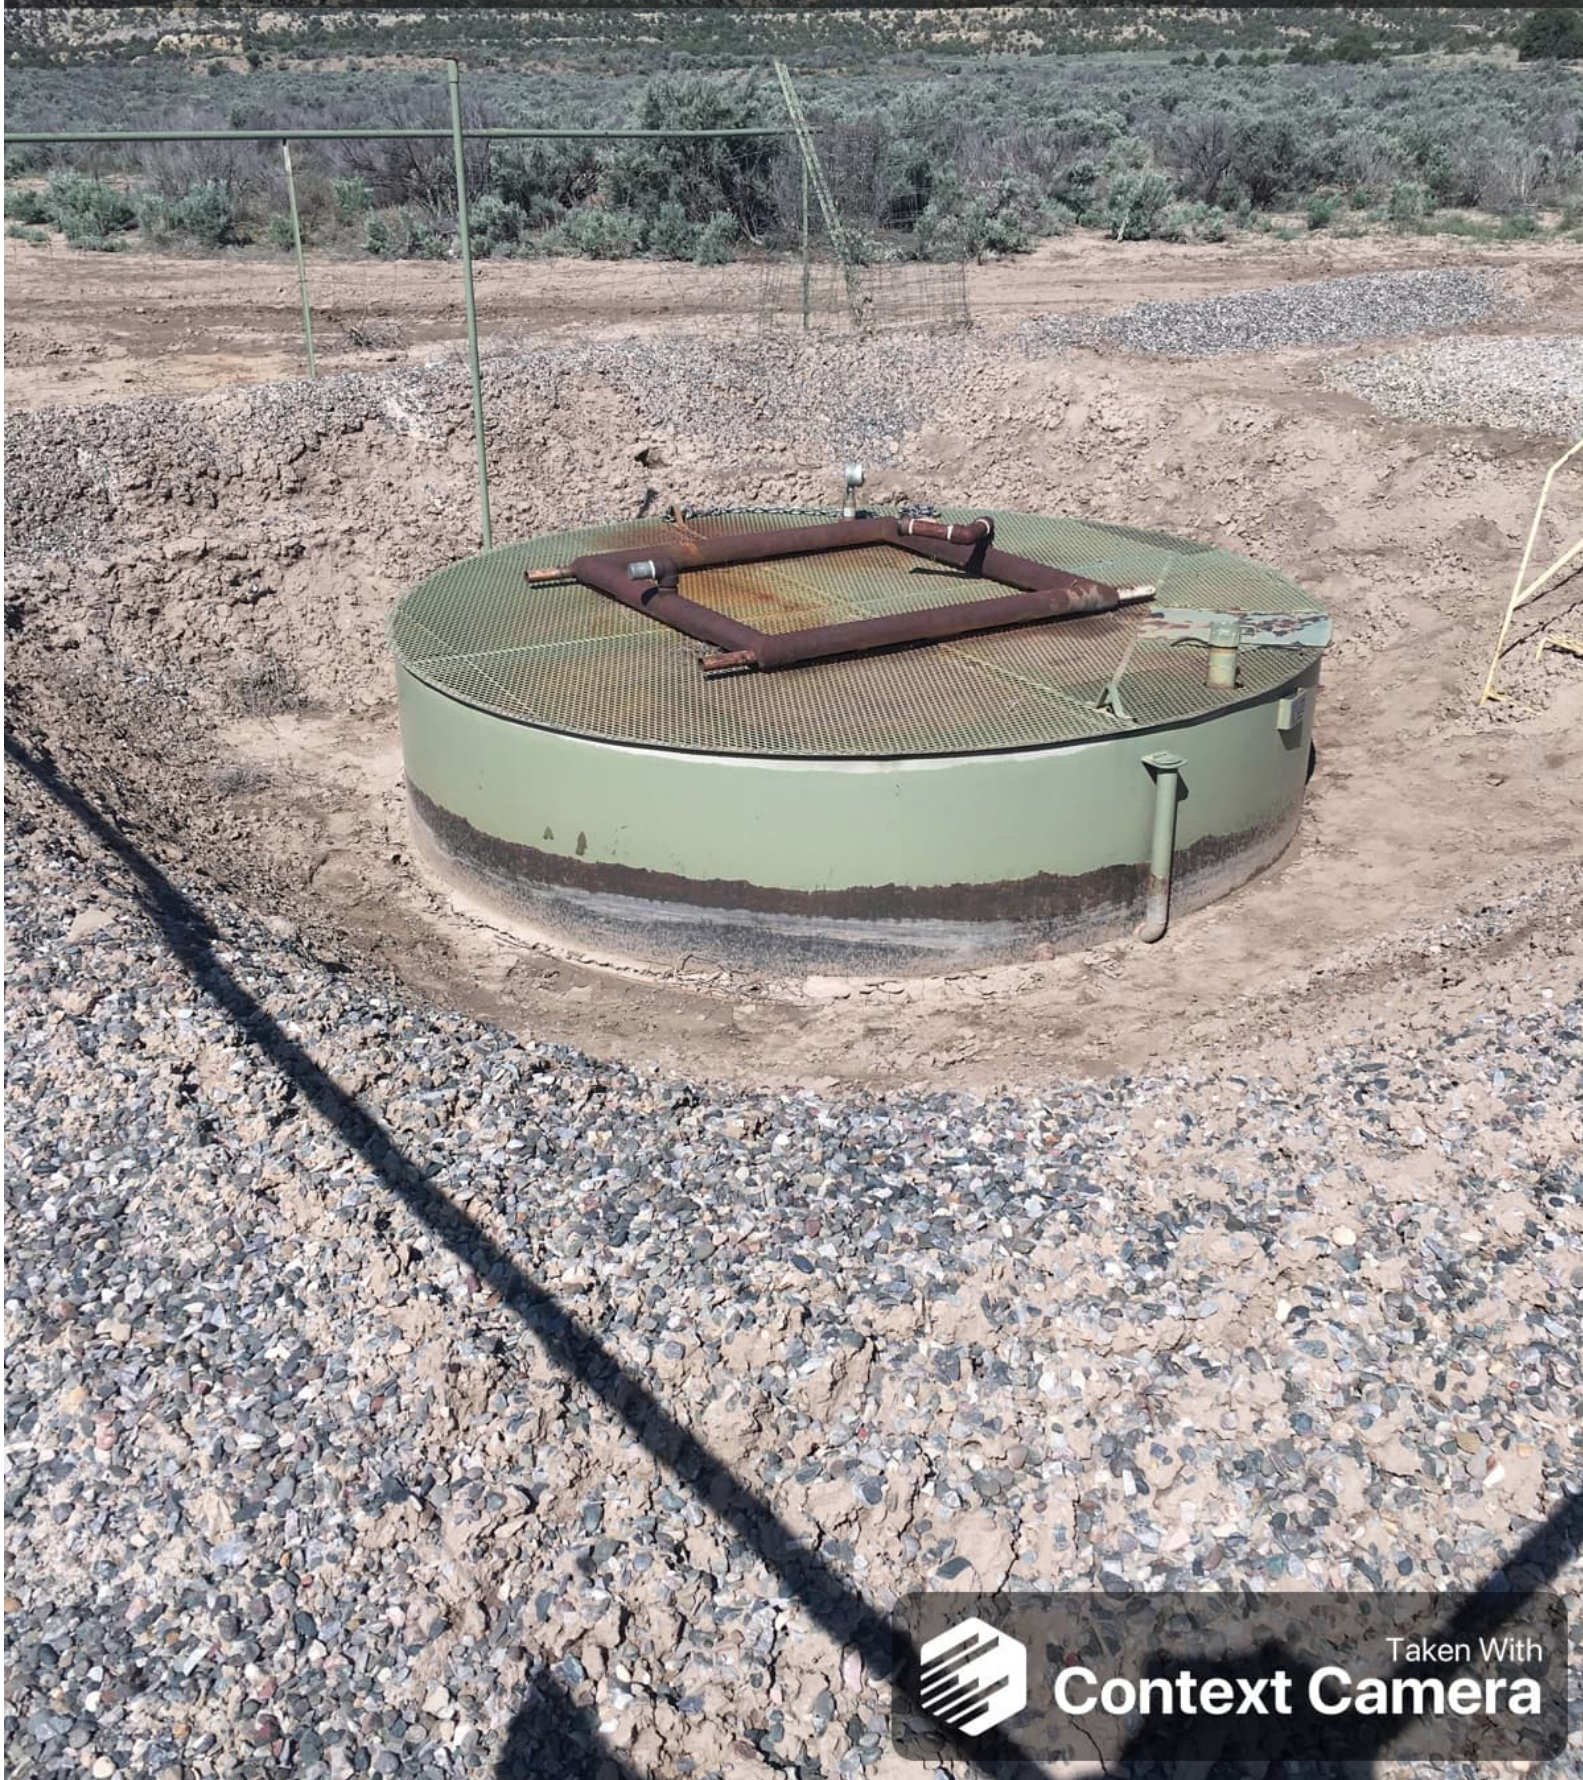
36.69262°N
107.49034°W

2023-05-22
09:52:48-06:00

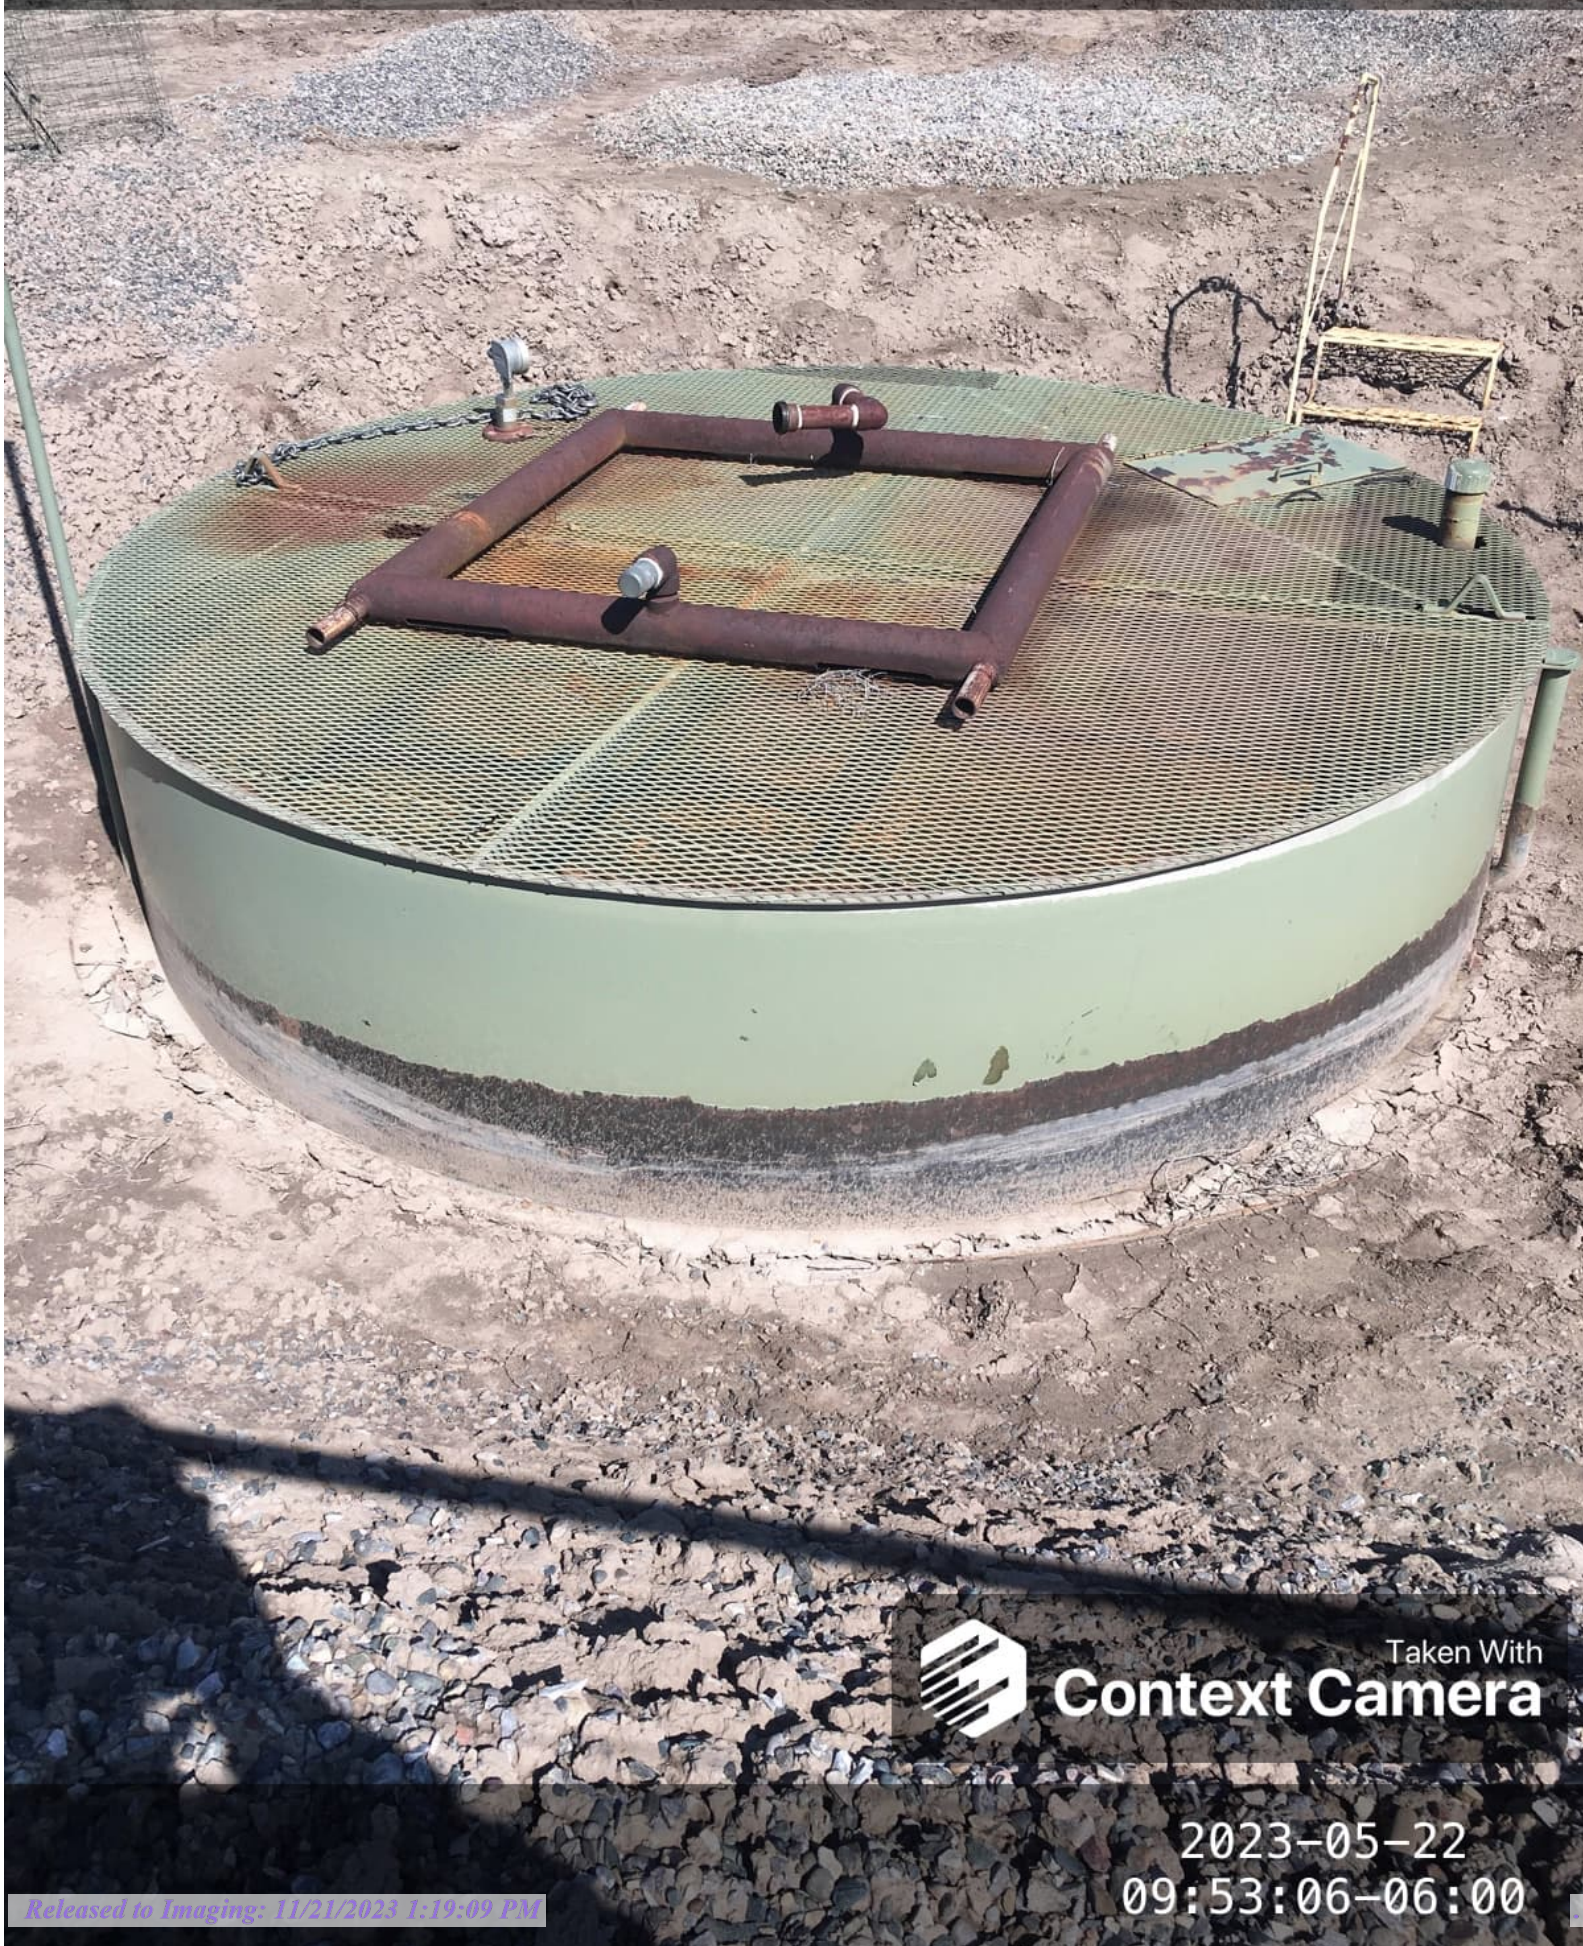
36.69258°N
107.49030°W

2023-05-22
09:53:06-06:00

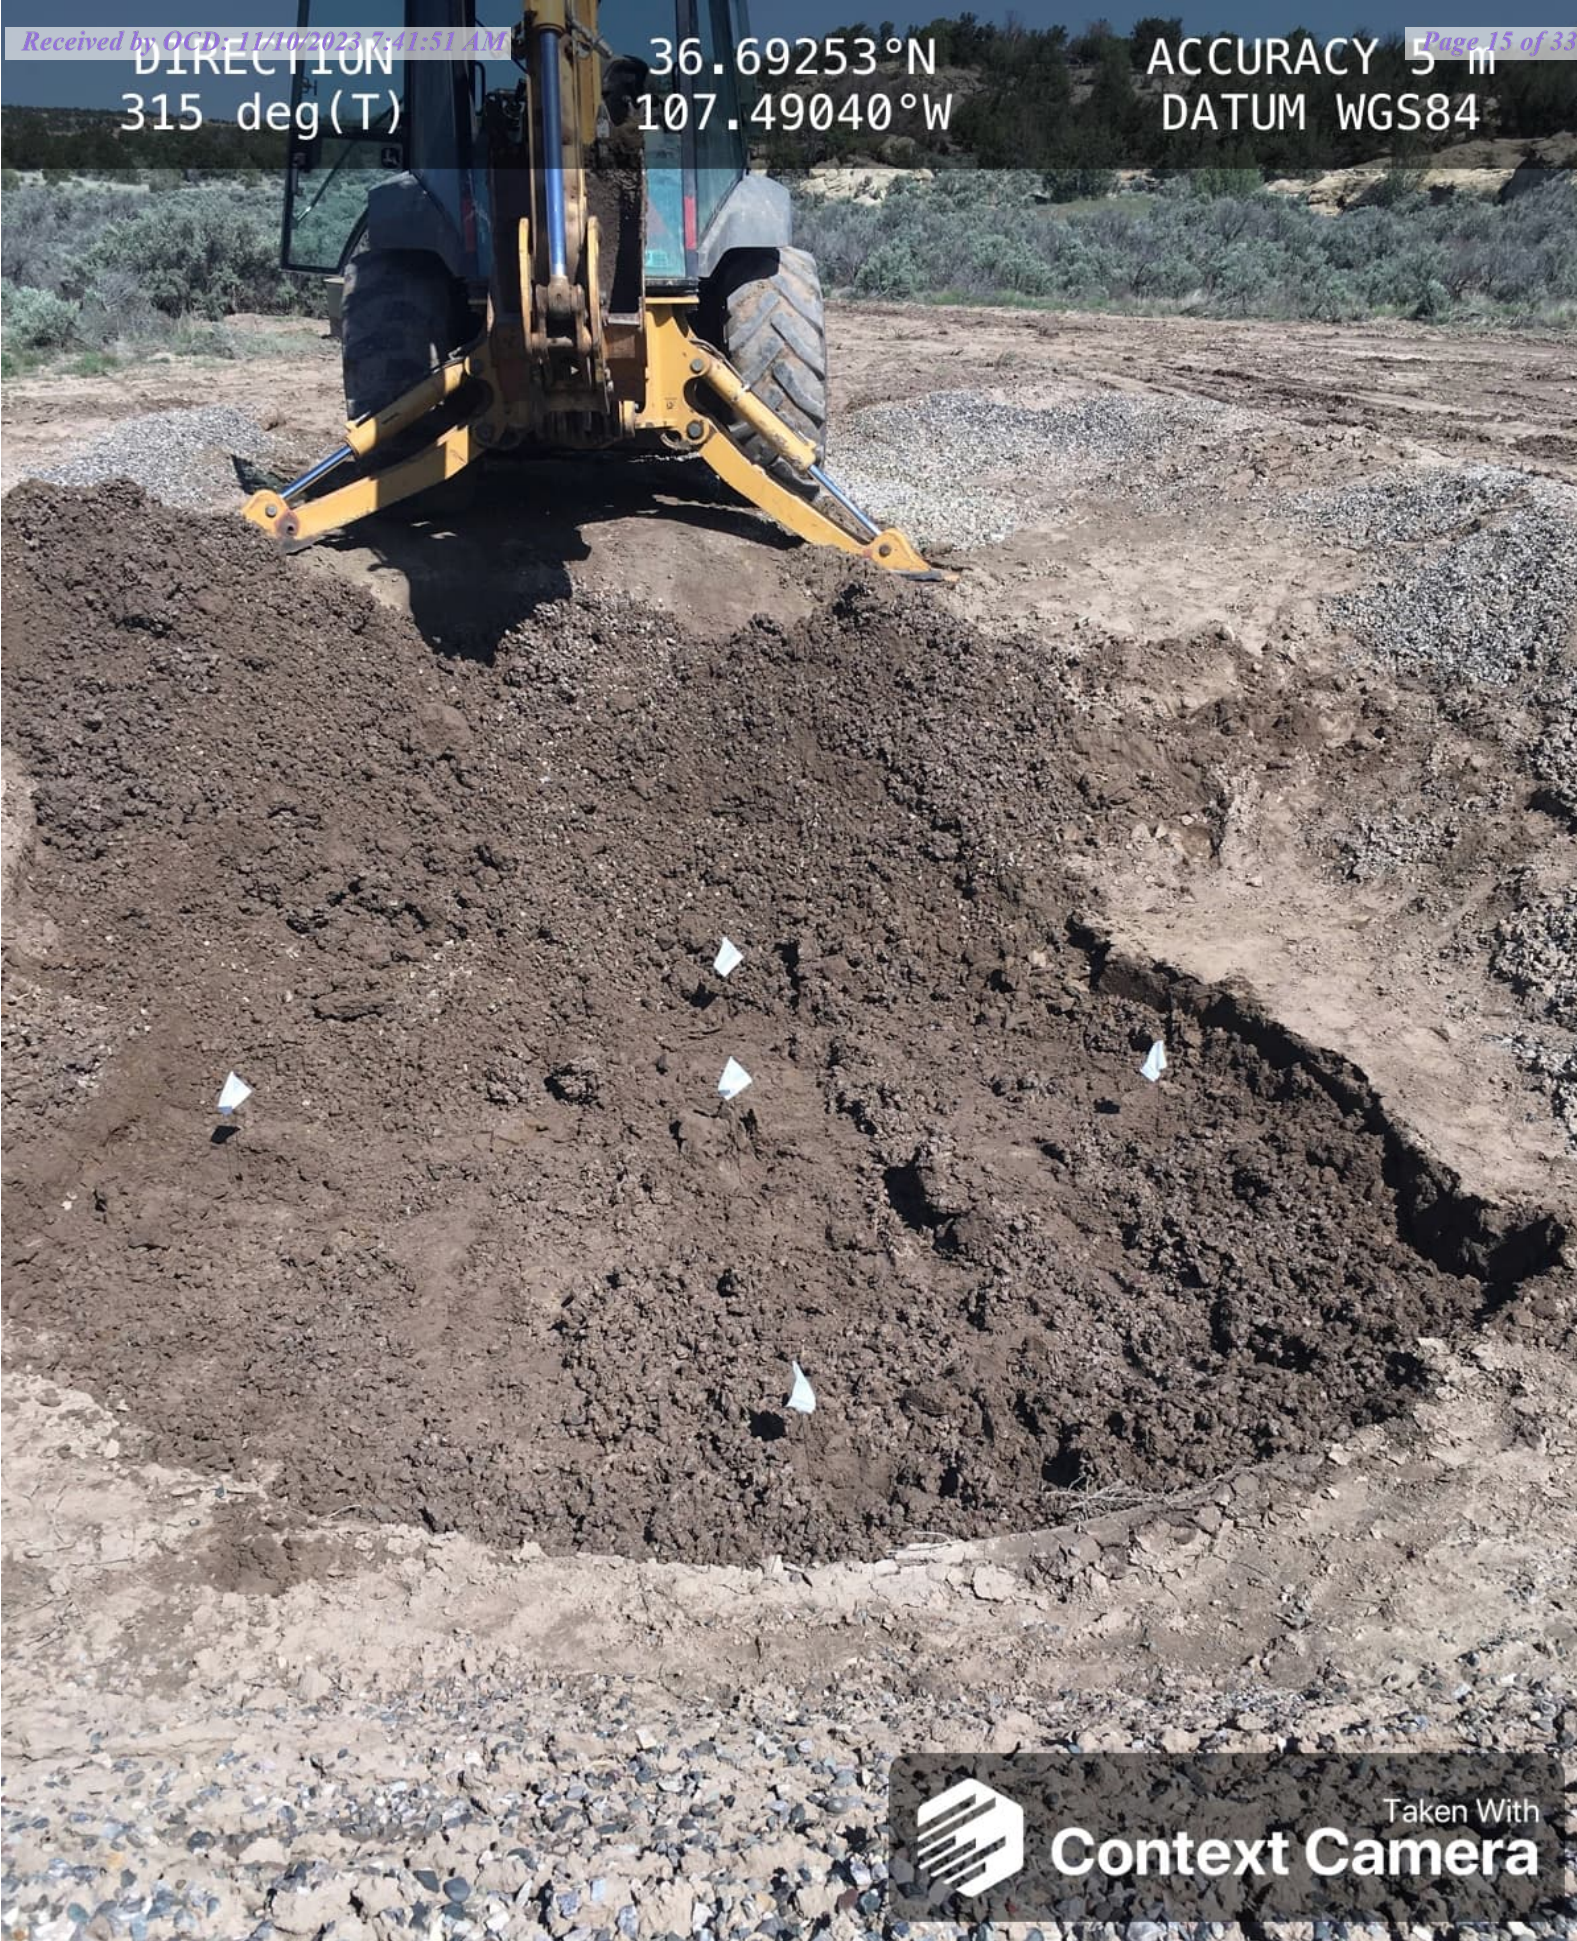
36.69253°N
107.49040°W

2023-05-22
10:16:27-06:00

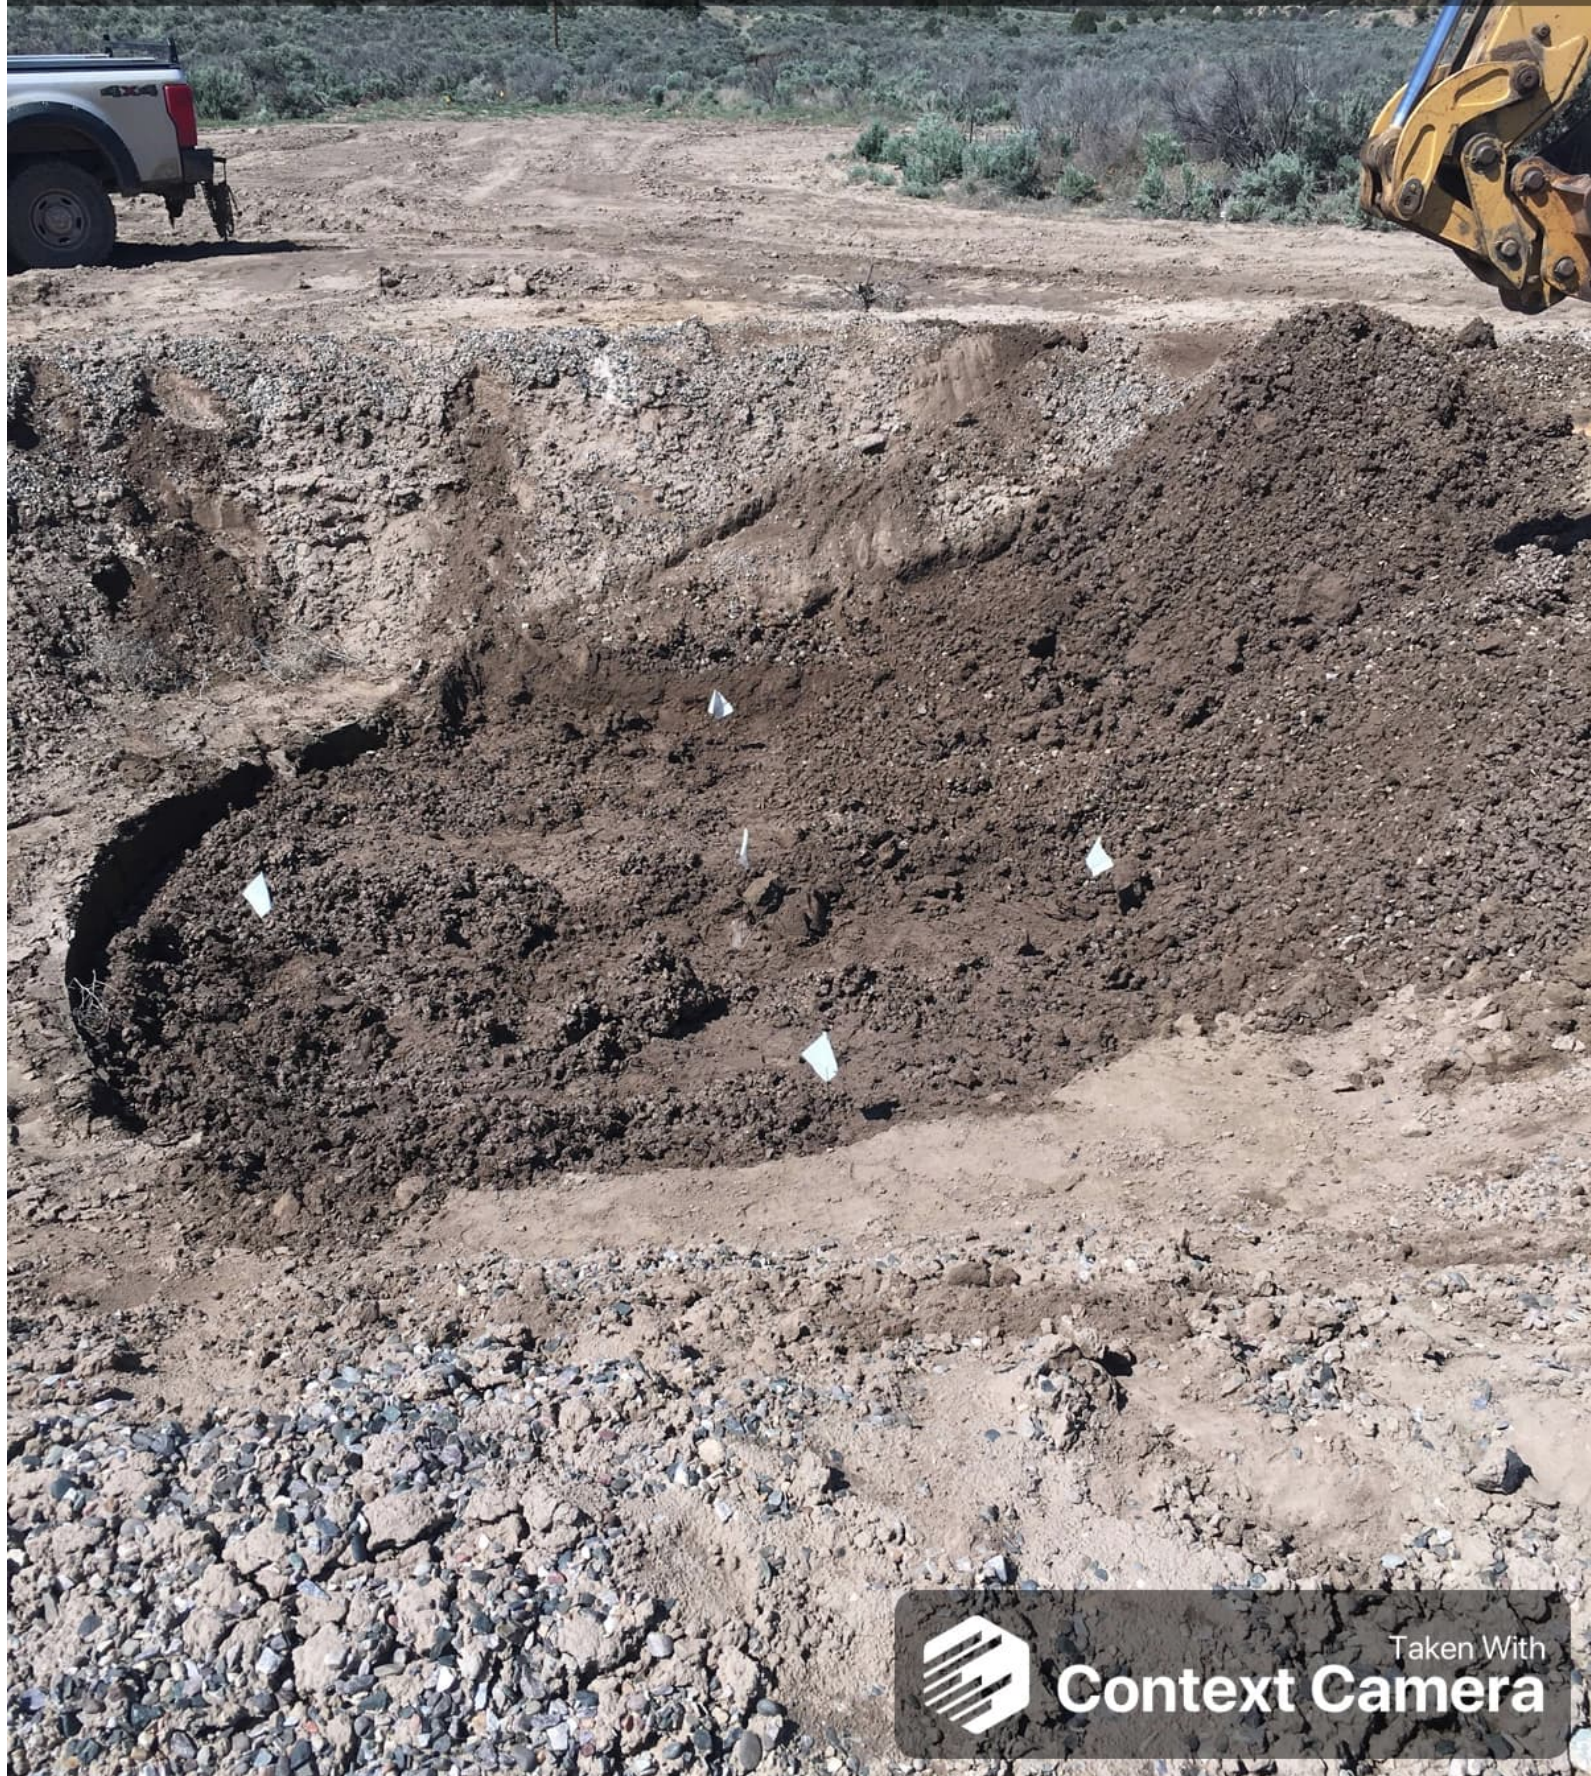
36.69261°N
107.49033°W

2023-05-22
10:16:41-06:00

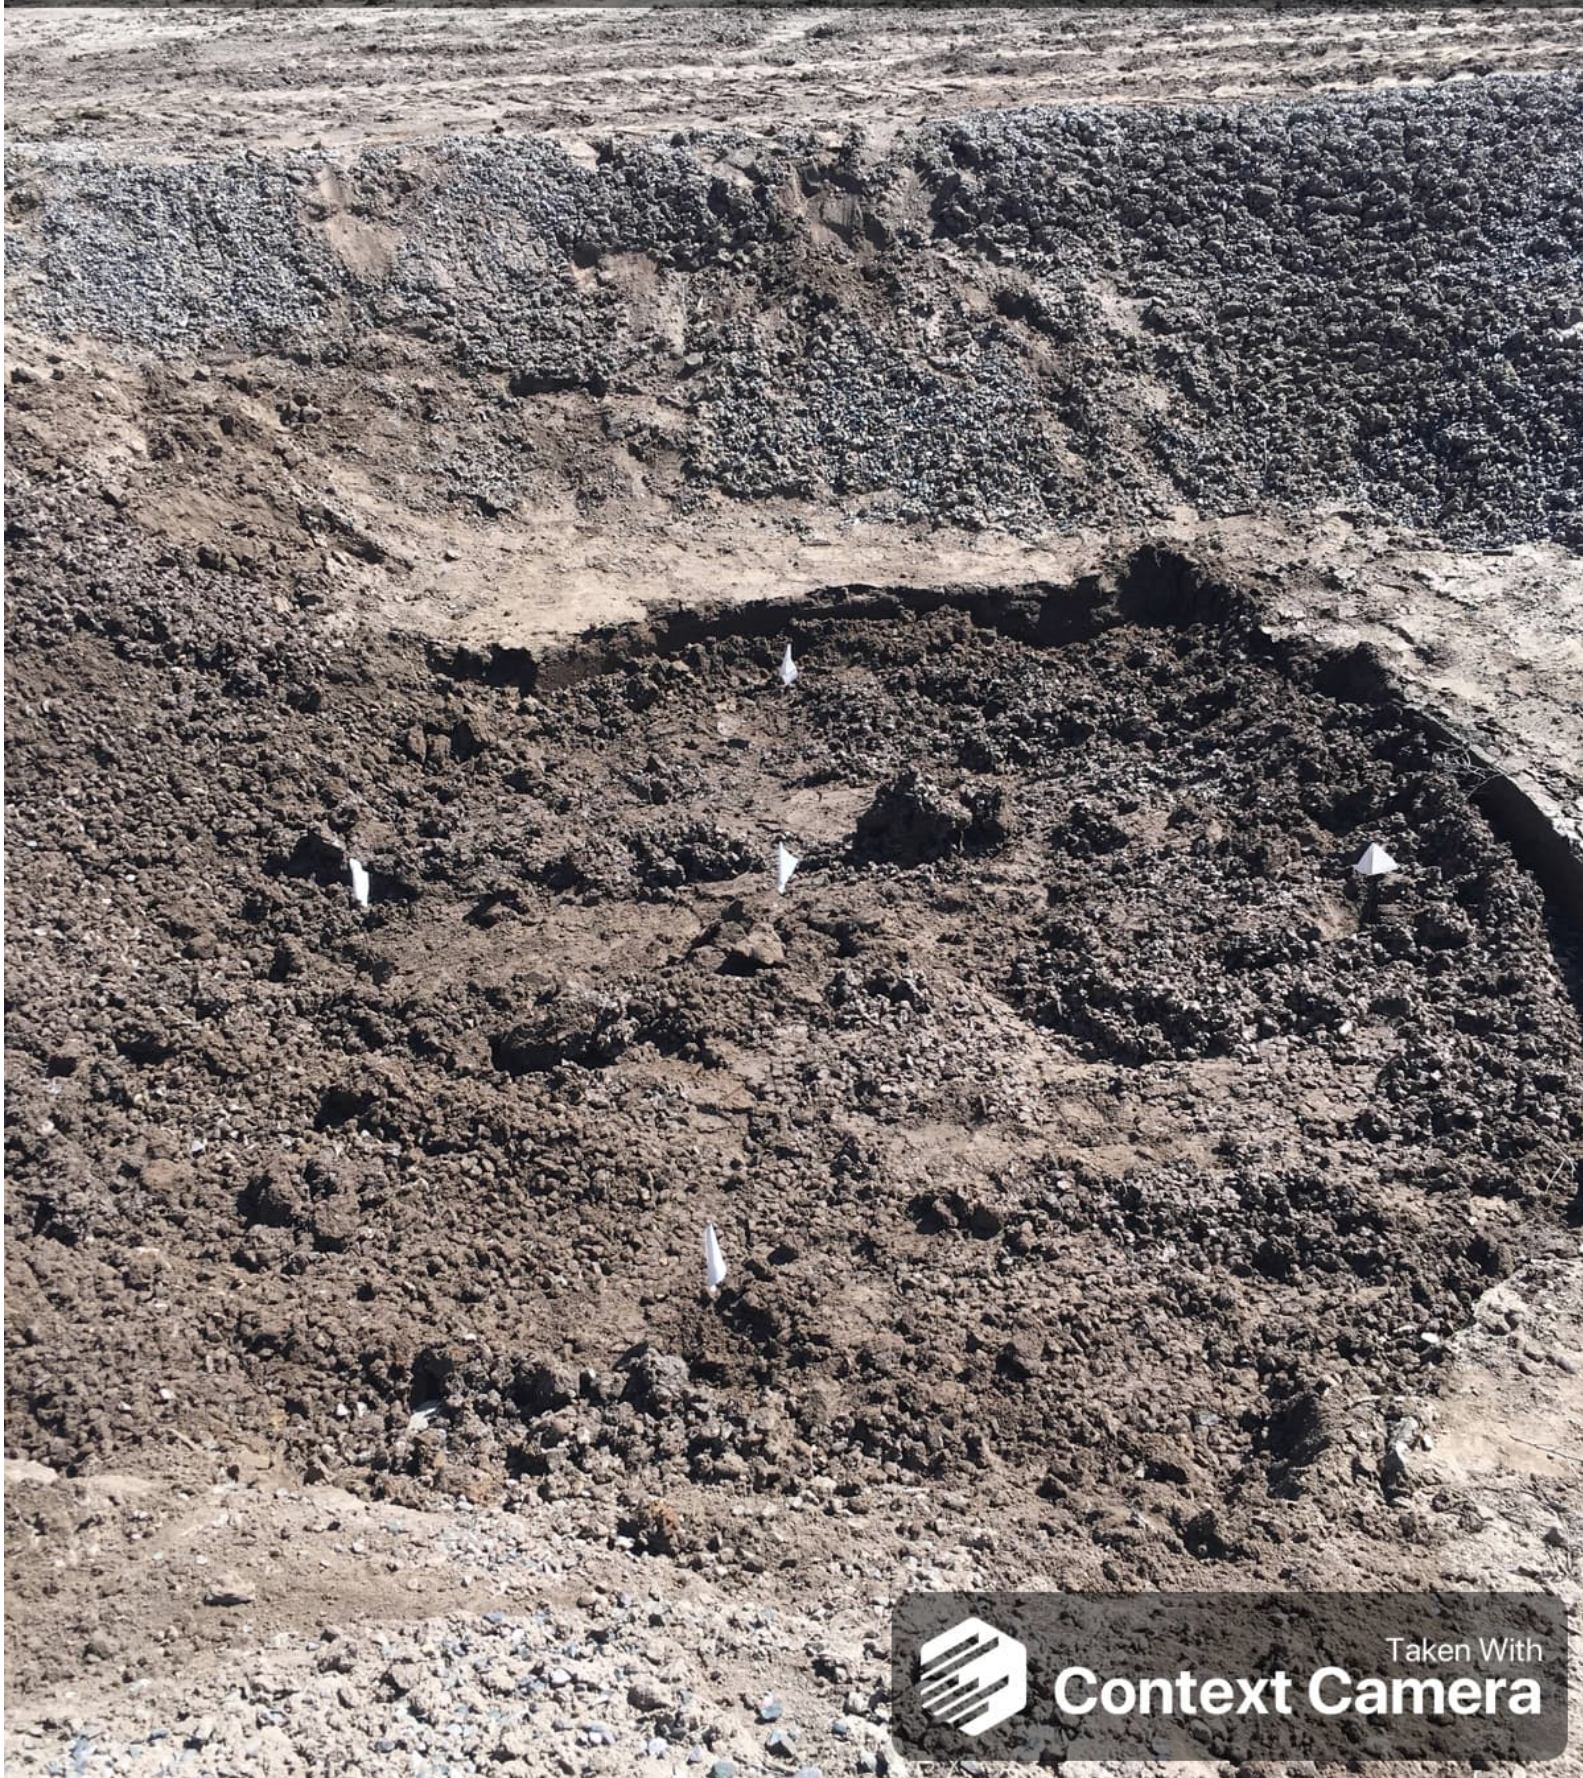
36.69254°N
107.49044°W

2023-05-22
10:17:12-06:00
