Pit, Below-Grade Tank, or
Proposed Alternative Method Permit or Closure Plan Application

Hilcorp Energy Company
San Juan Basin
Below Grade Tank Closure Report

Lease Name: San Juan 29-6 Unit 70

API No.: 30-039-07517

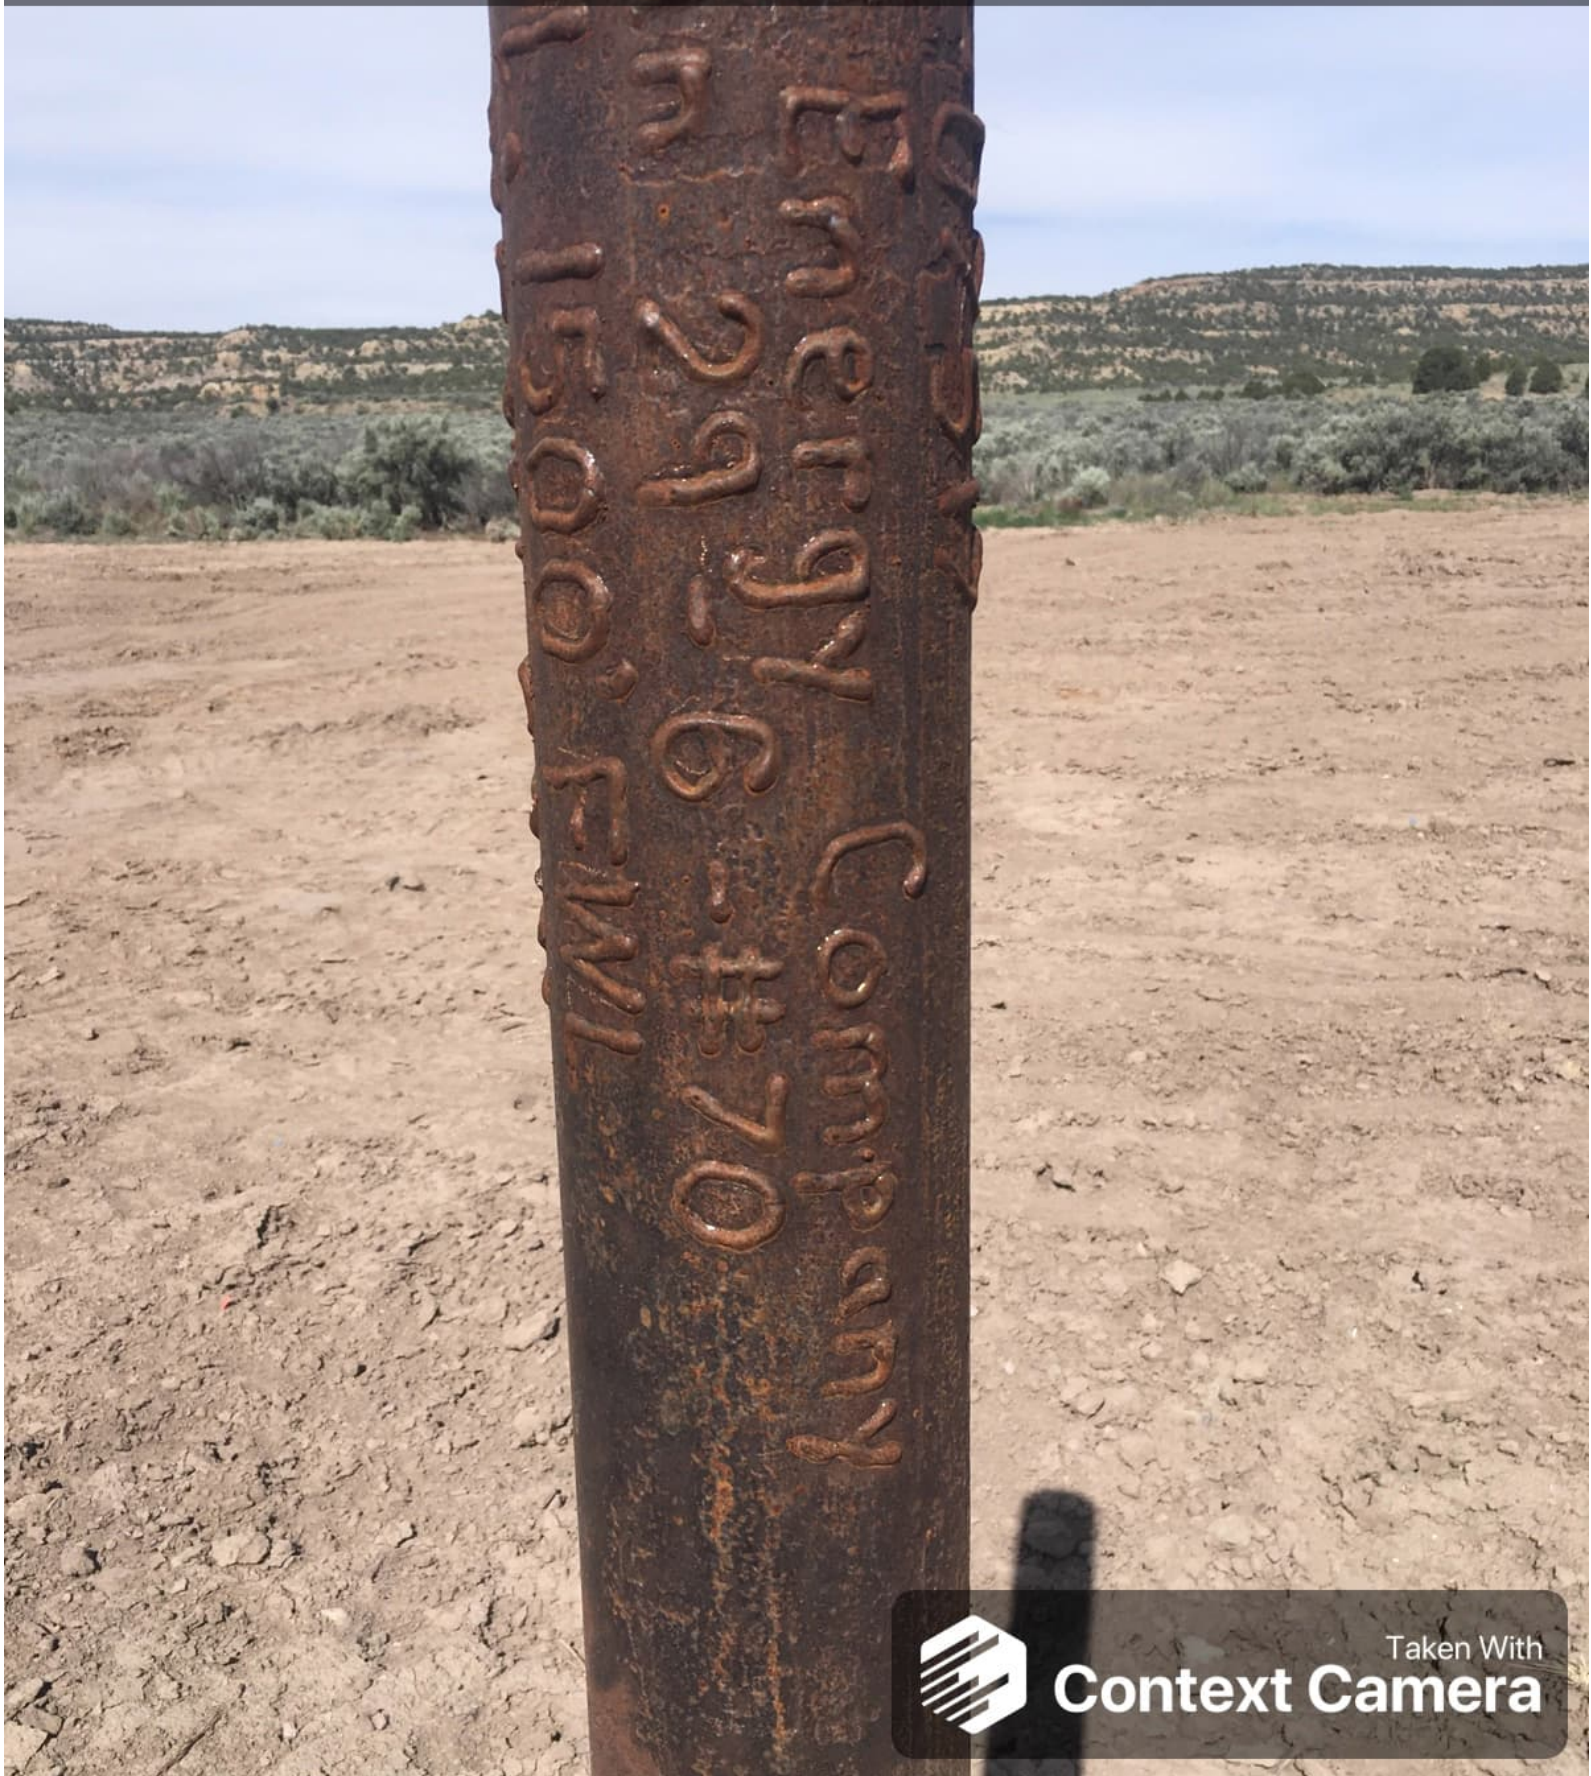
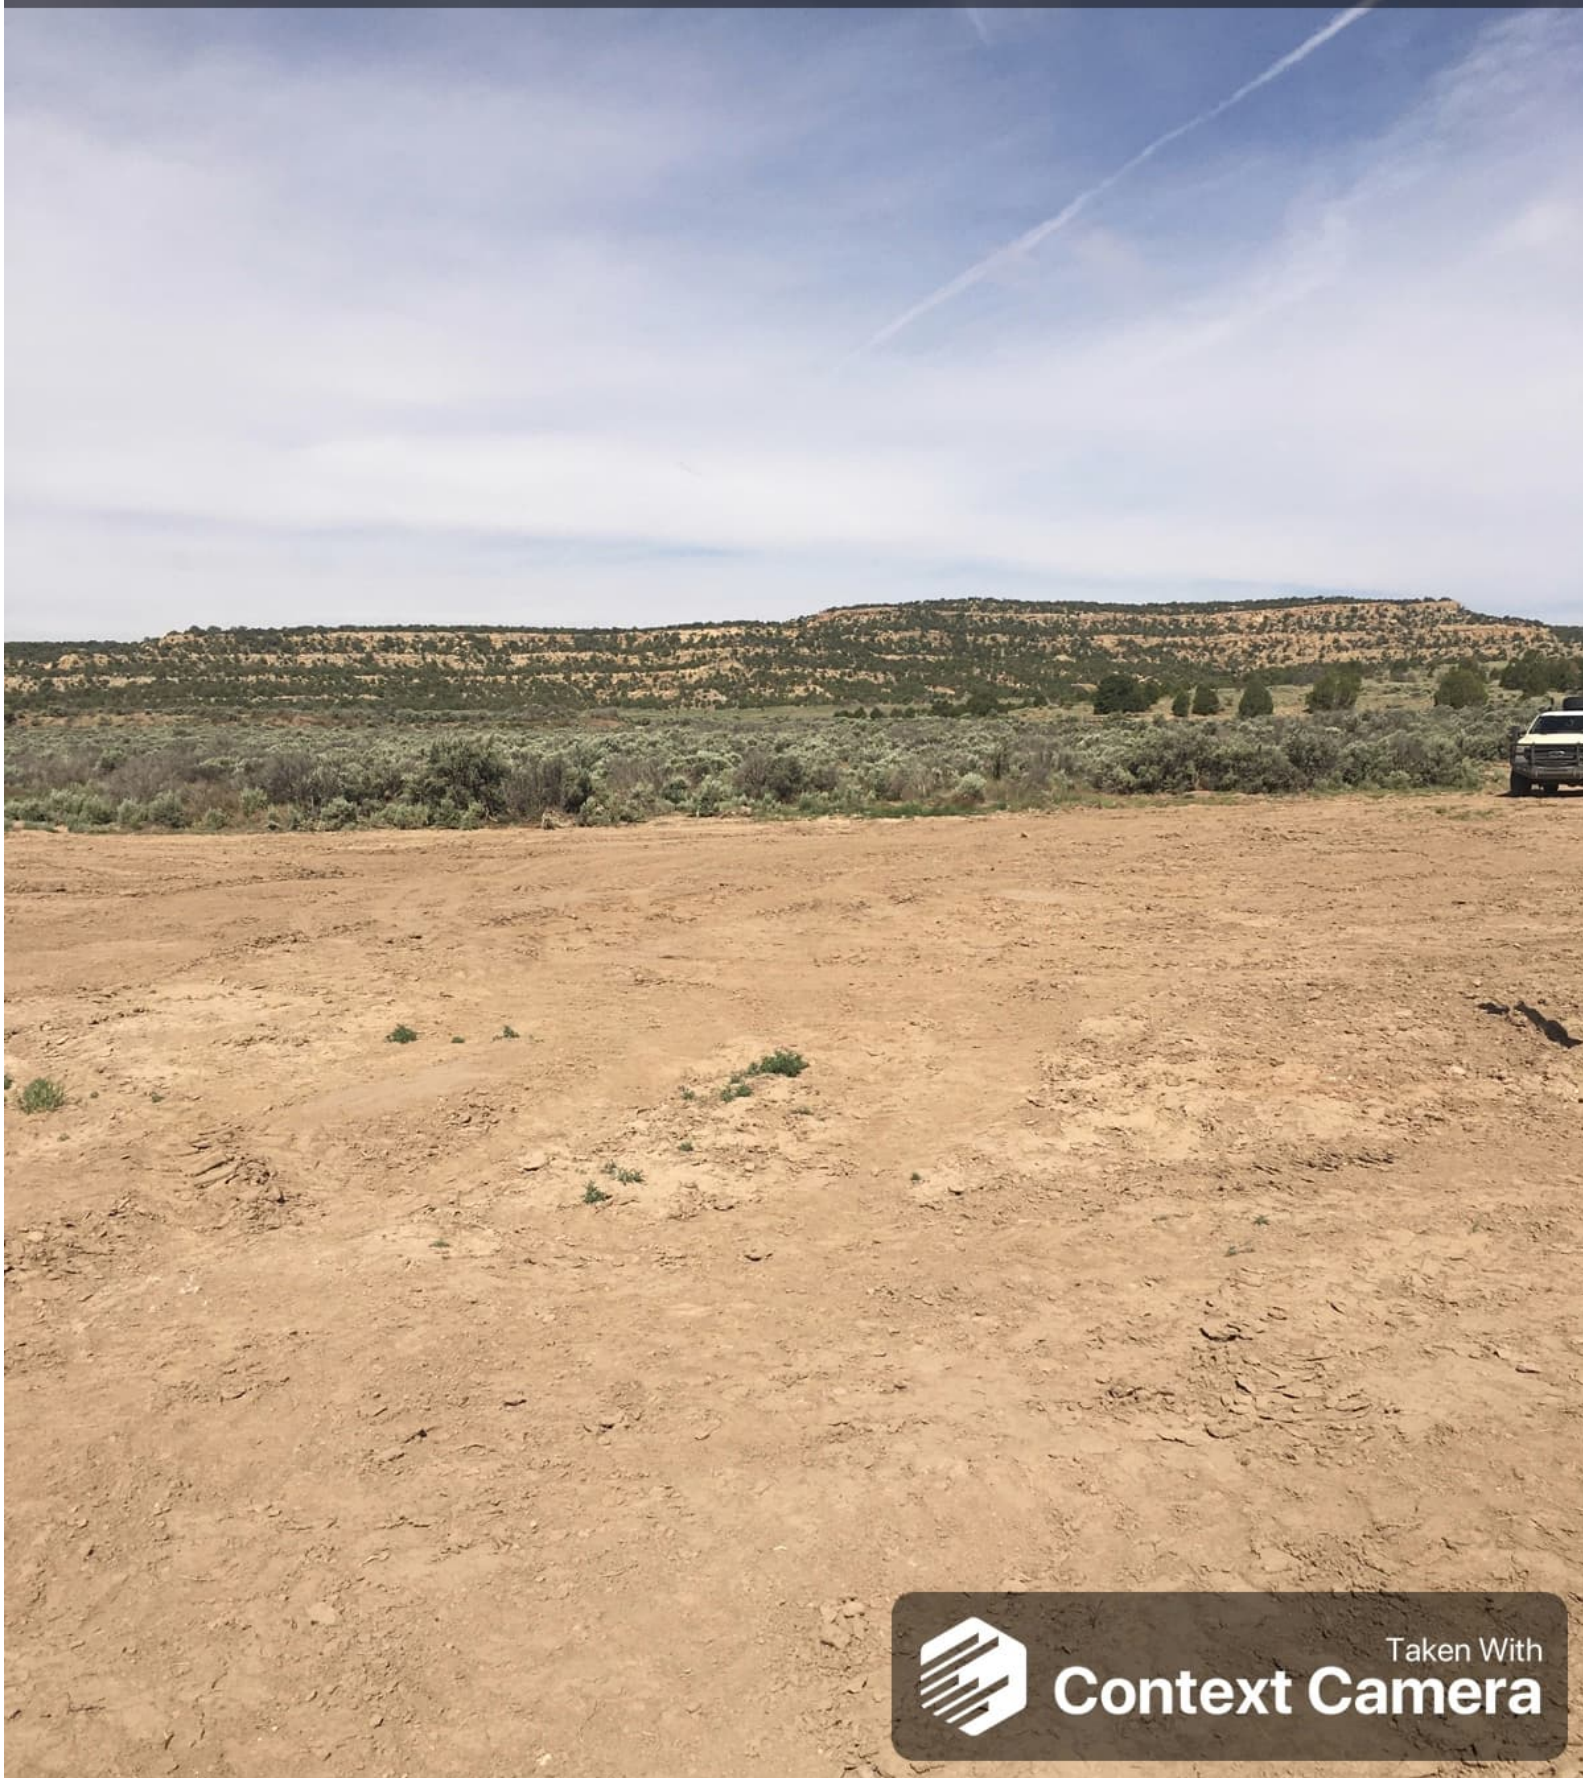
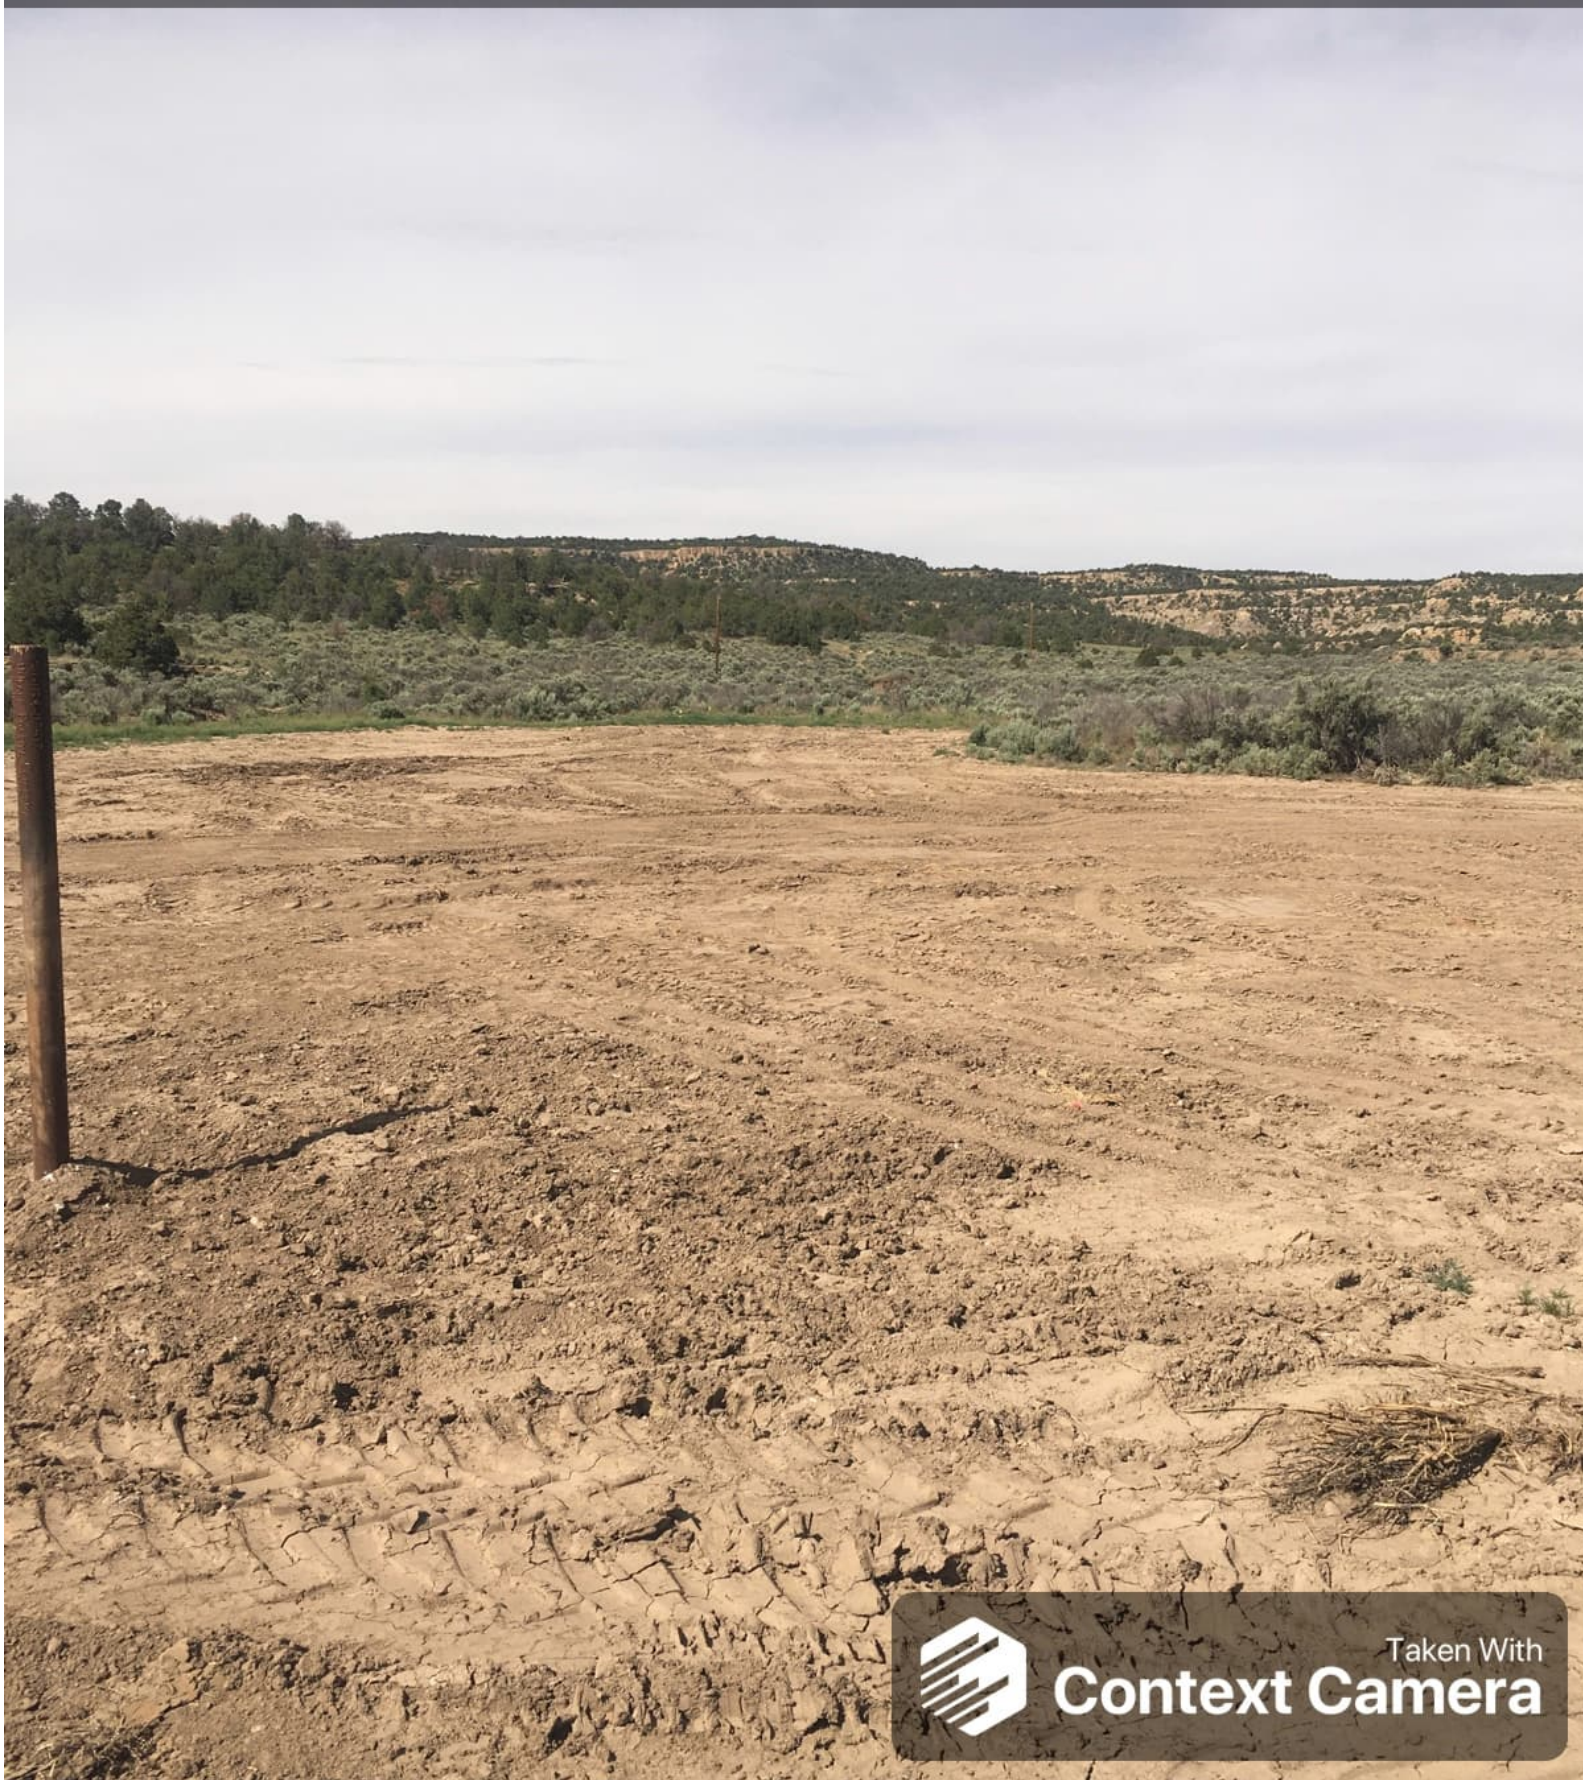
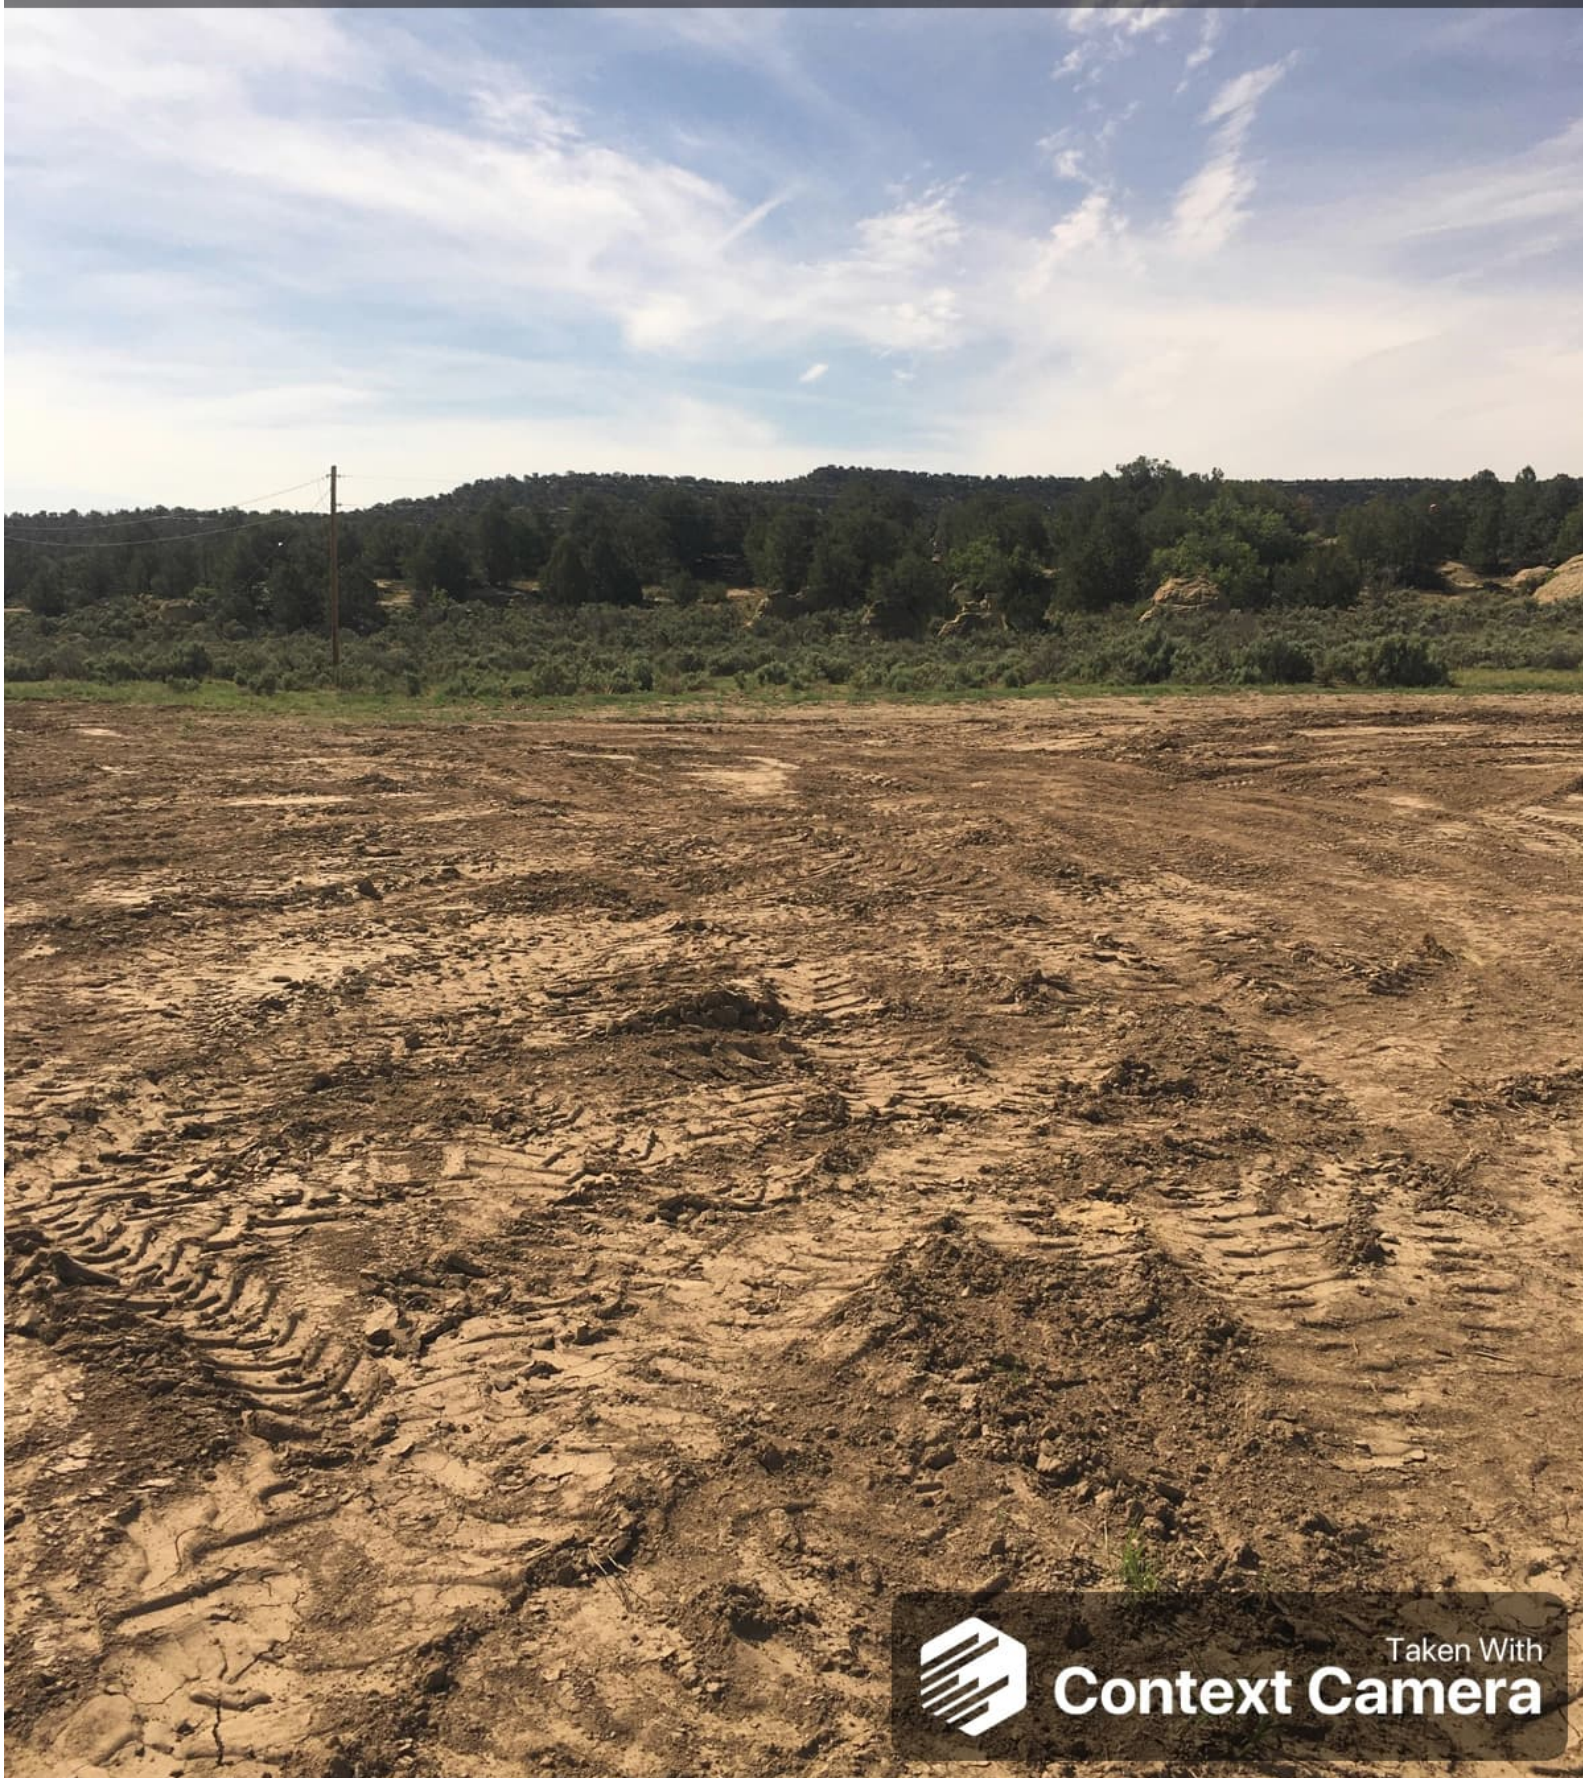
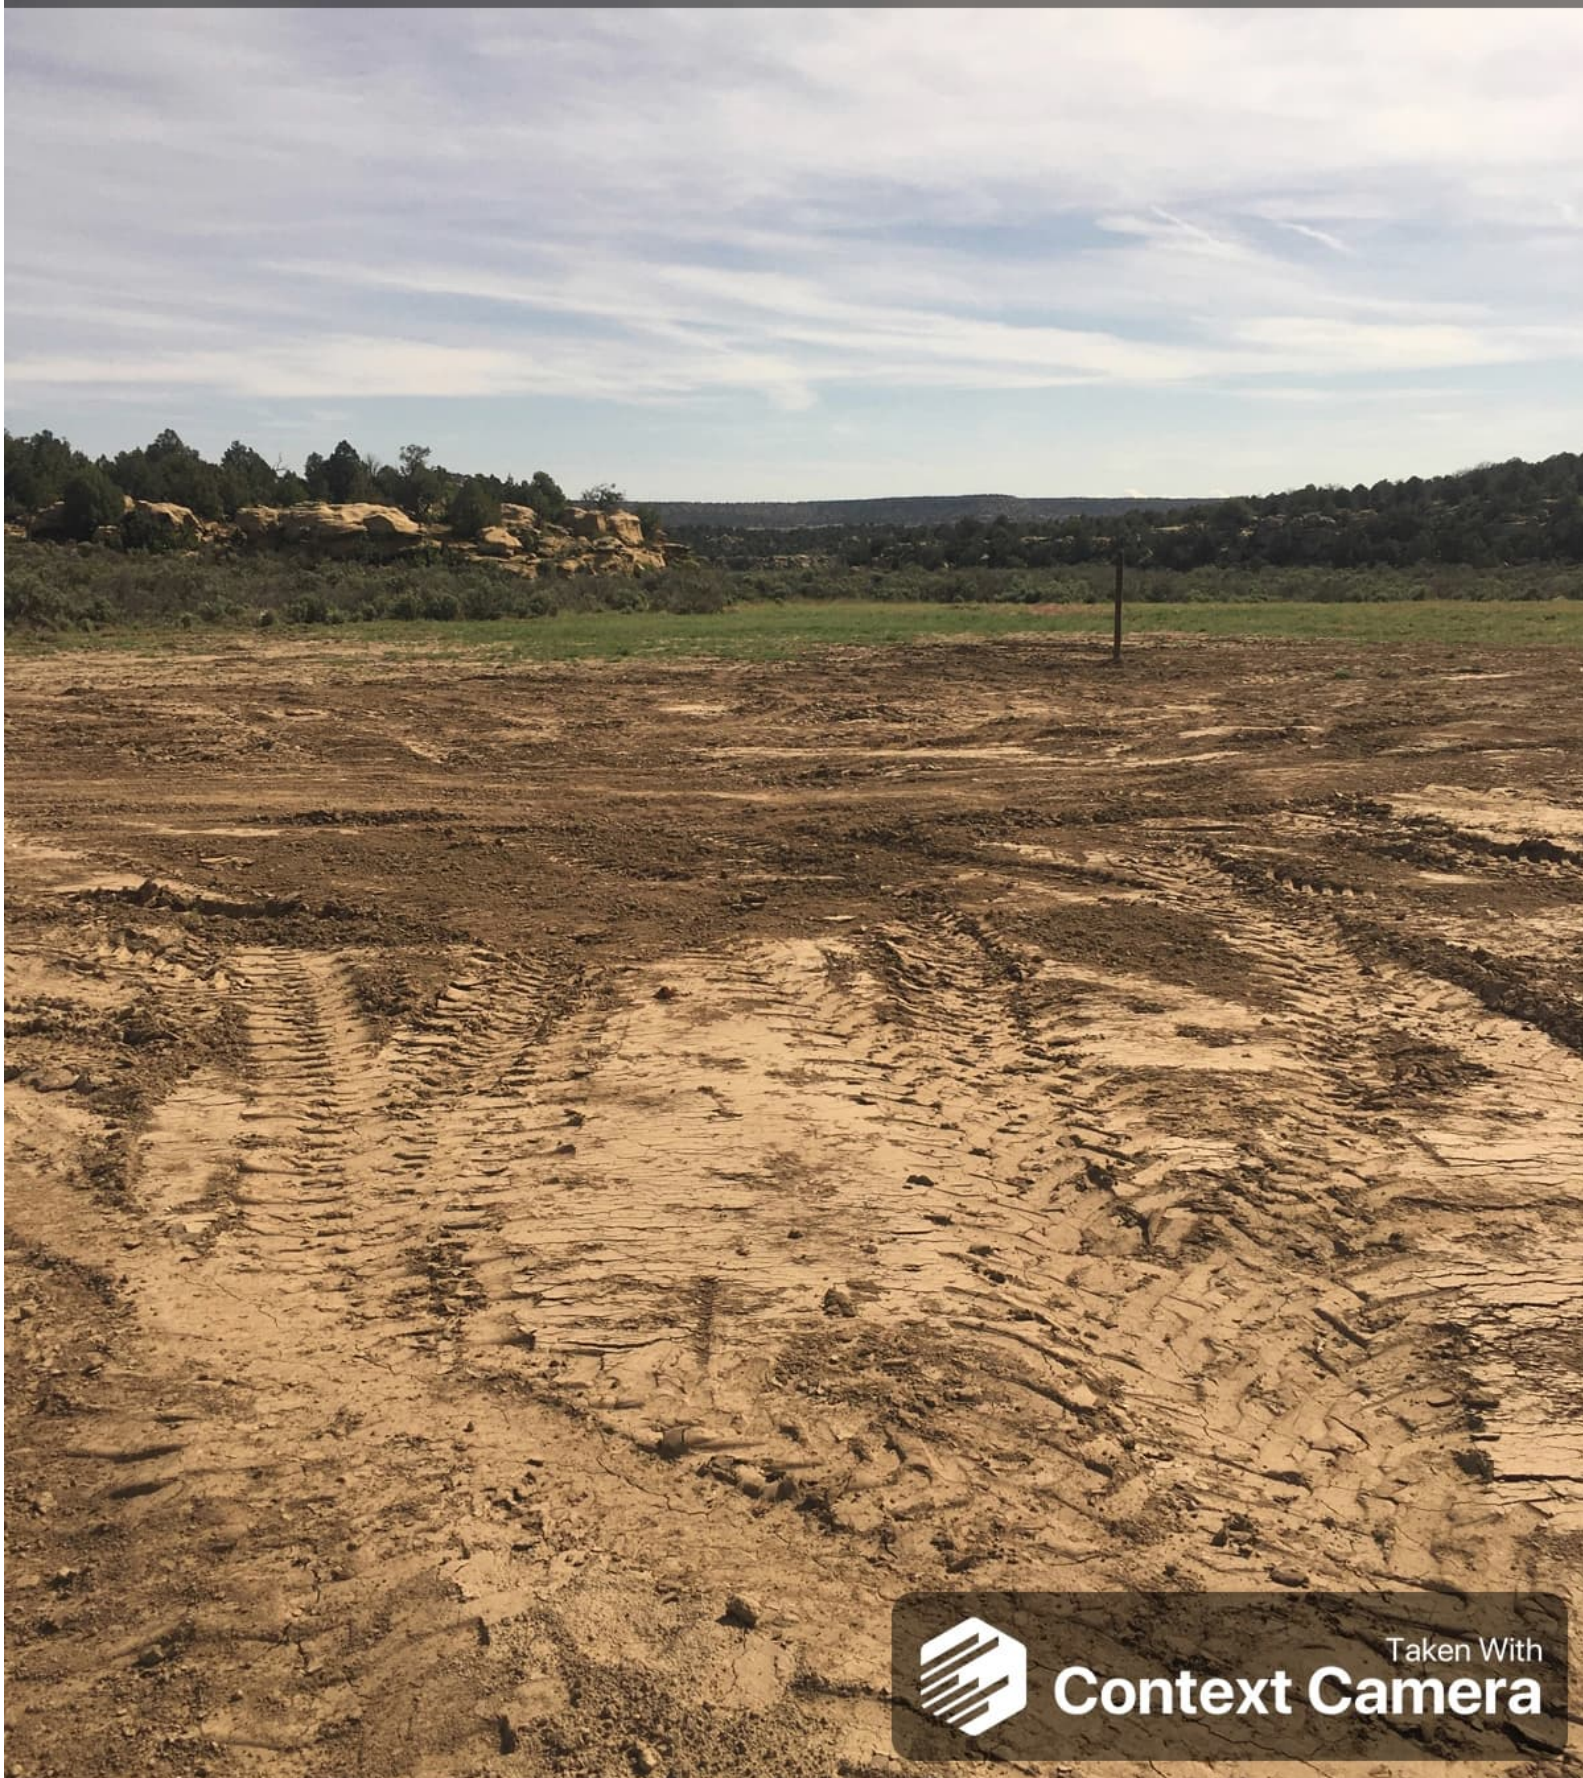
The below-grade tank area passed all requirements of Paragraph (4) of Subsection E of 19.15.17.13 NMAC and was backfilled with compacted, non-waste containing, earthen material.

The below-grade tank area was re-contoured to match fit, shape, line, form and texture of the surrounding area. Re-shaping including drainage control, to prevent ponding and erosion. Natural drainages were unimpeded and water bars and/or silt traps were placed in areas where needed to prevent erosion on a large scale. Final recontour has a uniform appearance with smooth surface, fitting the natural landscape.
