Pit, Below-Grade Tank, or
Proposed Alternative Method Permit or Closure Plan Application

**Hilcorp Energy Company
San Juan Basin
Below Grade Tank Closure Report**

Lease Name: HAMNER 7

API No.: 30-045-11719

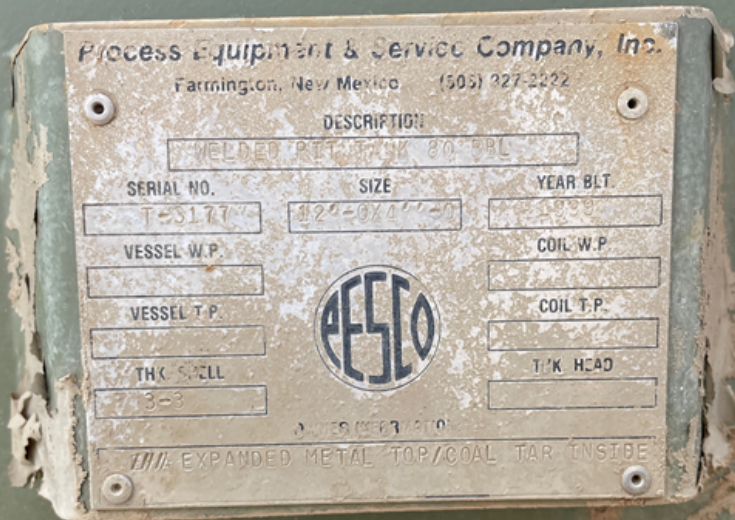
Tank Information

Hamner 7

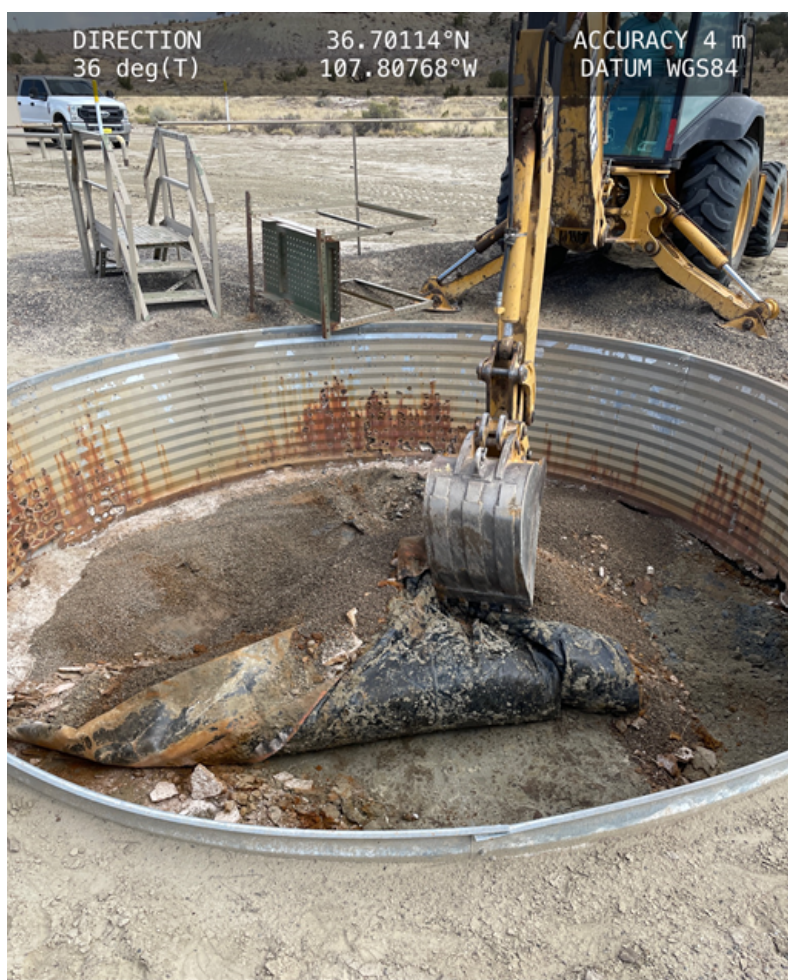
After Removal

The below-grade tank was disposed of in a division-approved manner.

All on-site equipment associated with the below-grade tank was removed.

Hamner 7

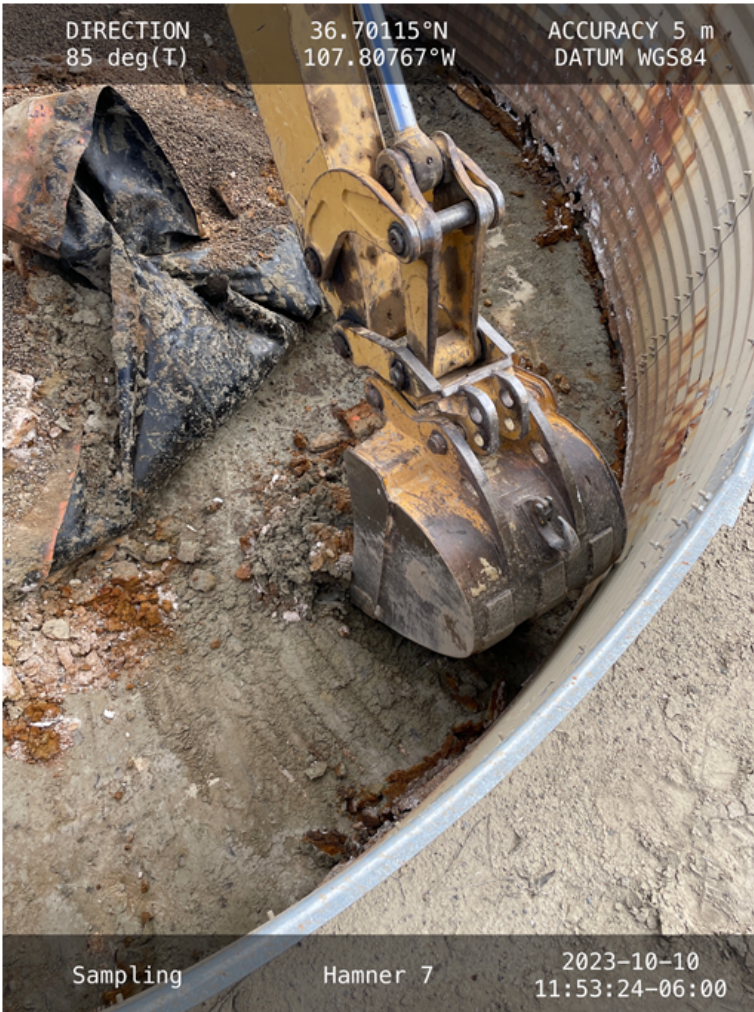
Sampling

A five point composite sample was taken of the below-grade tank using sampling tools and all samples tested per Subsection B of 19.15.17.1 3(B)(1)(b). (Sample results attached). Form C-141 is attached.

Hamner 7

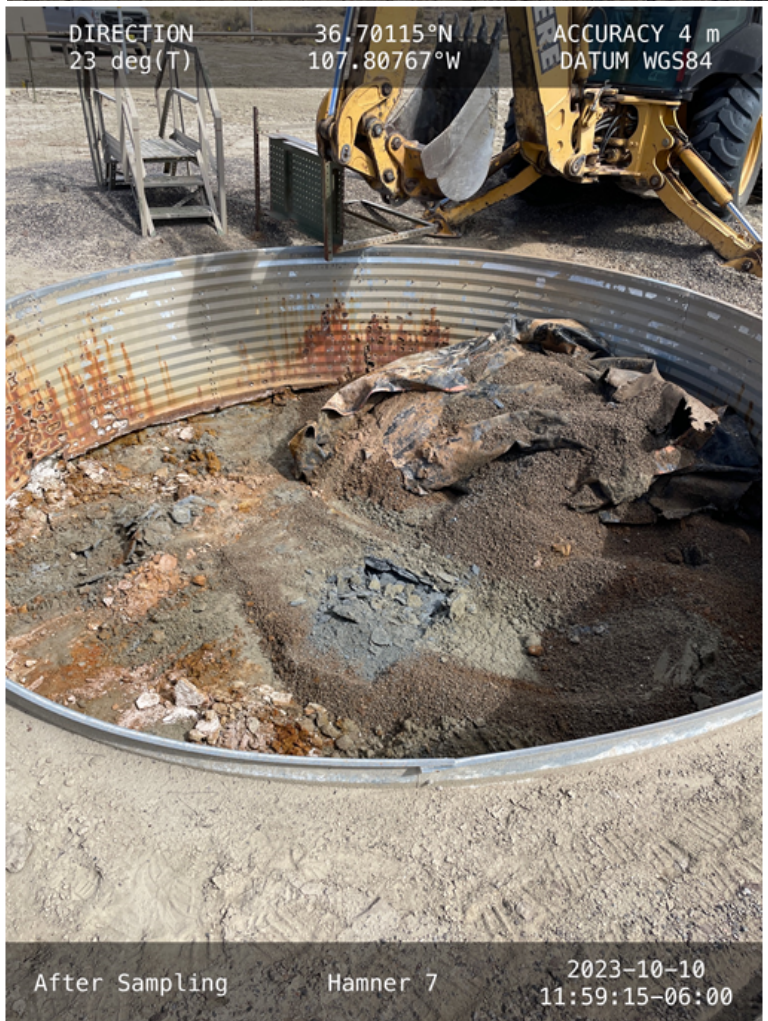
After Sampling

The below-grade tank area passed all requirements of Paragraph (4) of Subsection E of 19.15.17.13 NMAC and was backfilled with compacted, non-waste containing, earthen material.

Hamner 7
