Pit, Below-Grade Tank, or
Proposed Alternative Method Permit or Closure Plan Application

Facility or well name: STEDJE GAS COM 2R

Hilcorp Energy Company
San Juan Basin: New Mexico Assets
Below Grade Tank Closure Report

Lease Name: STEDJE GAS COM 2R
API No.: 30-045-30175

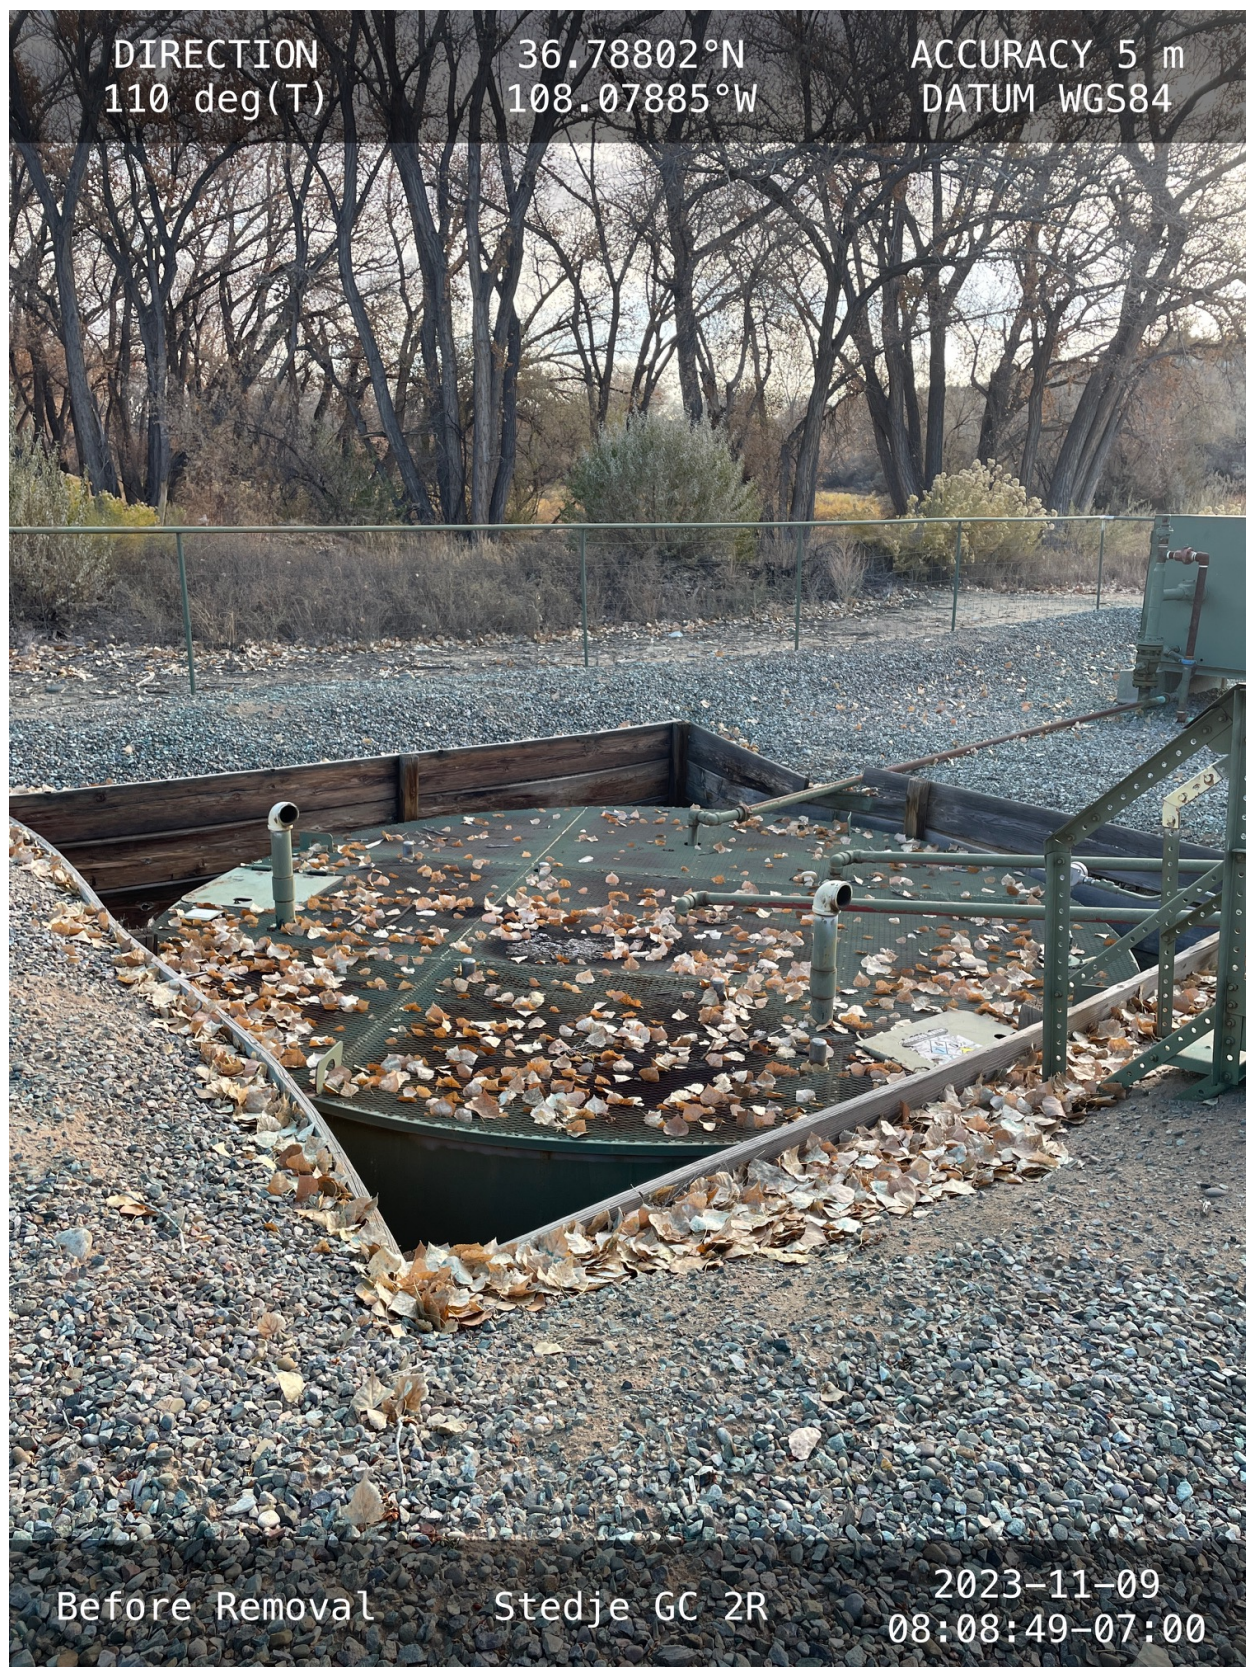
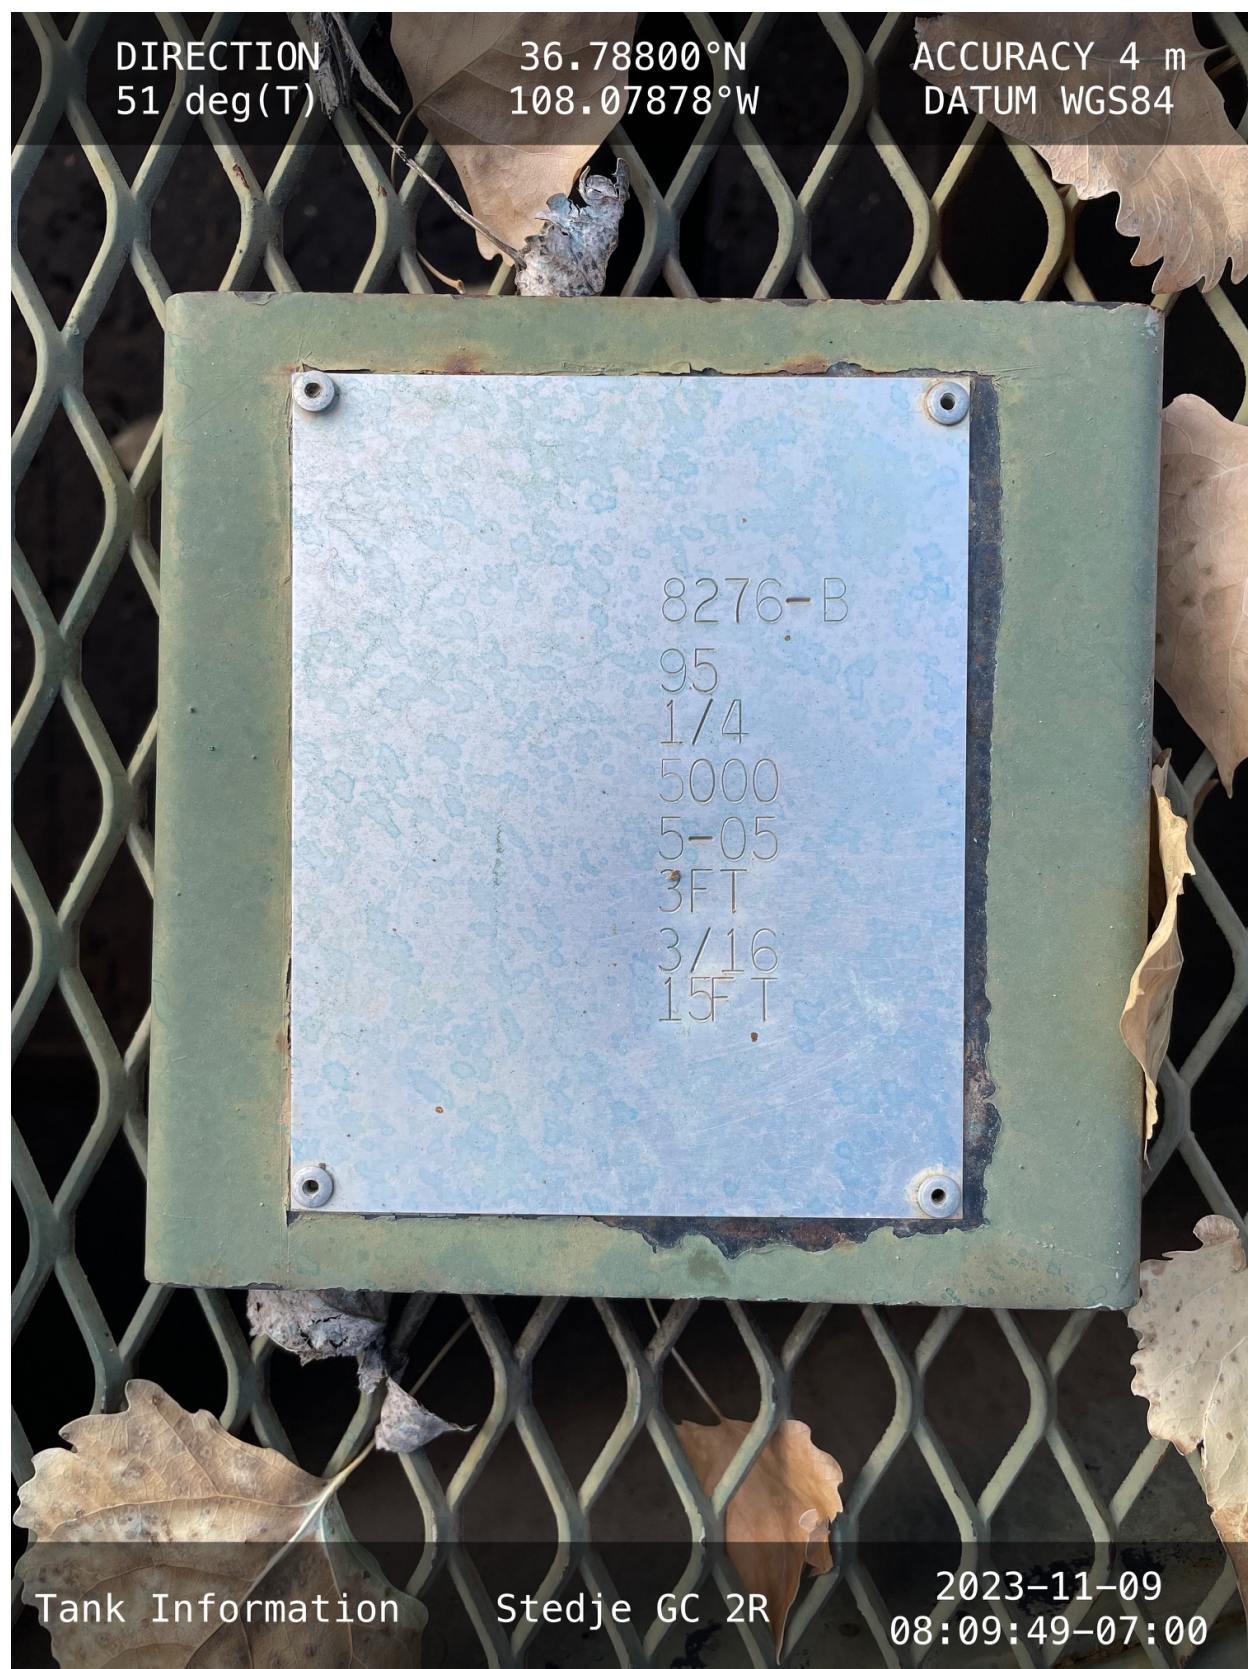
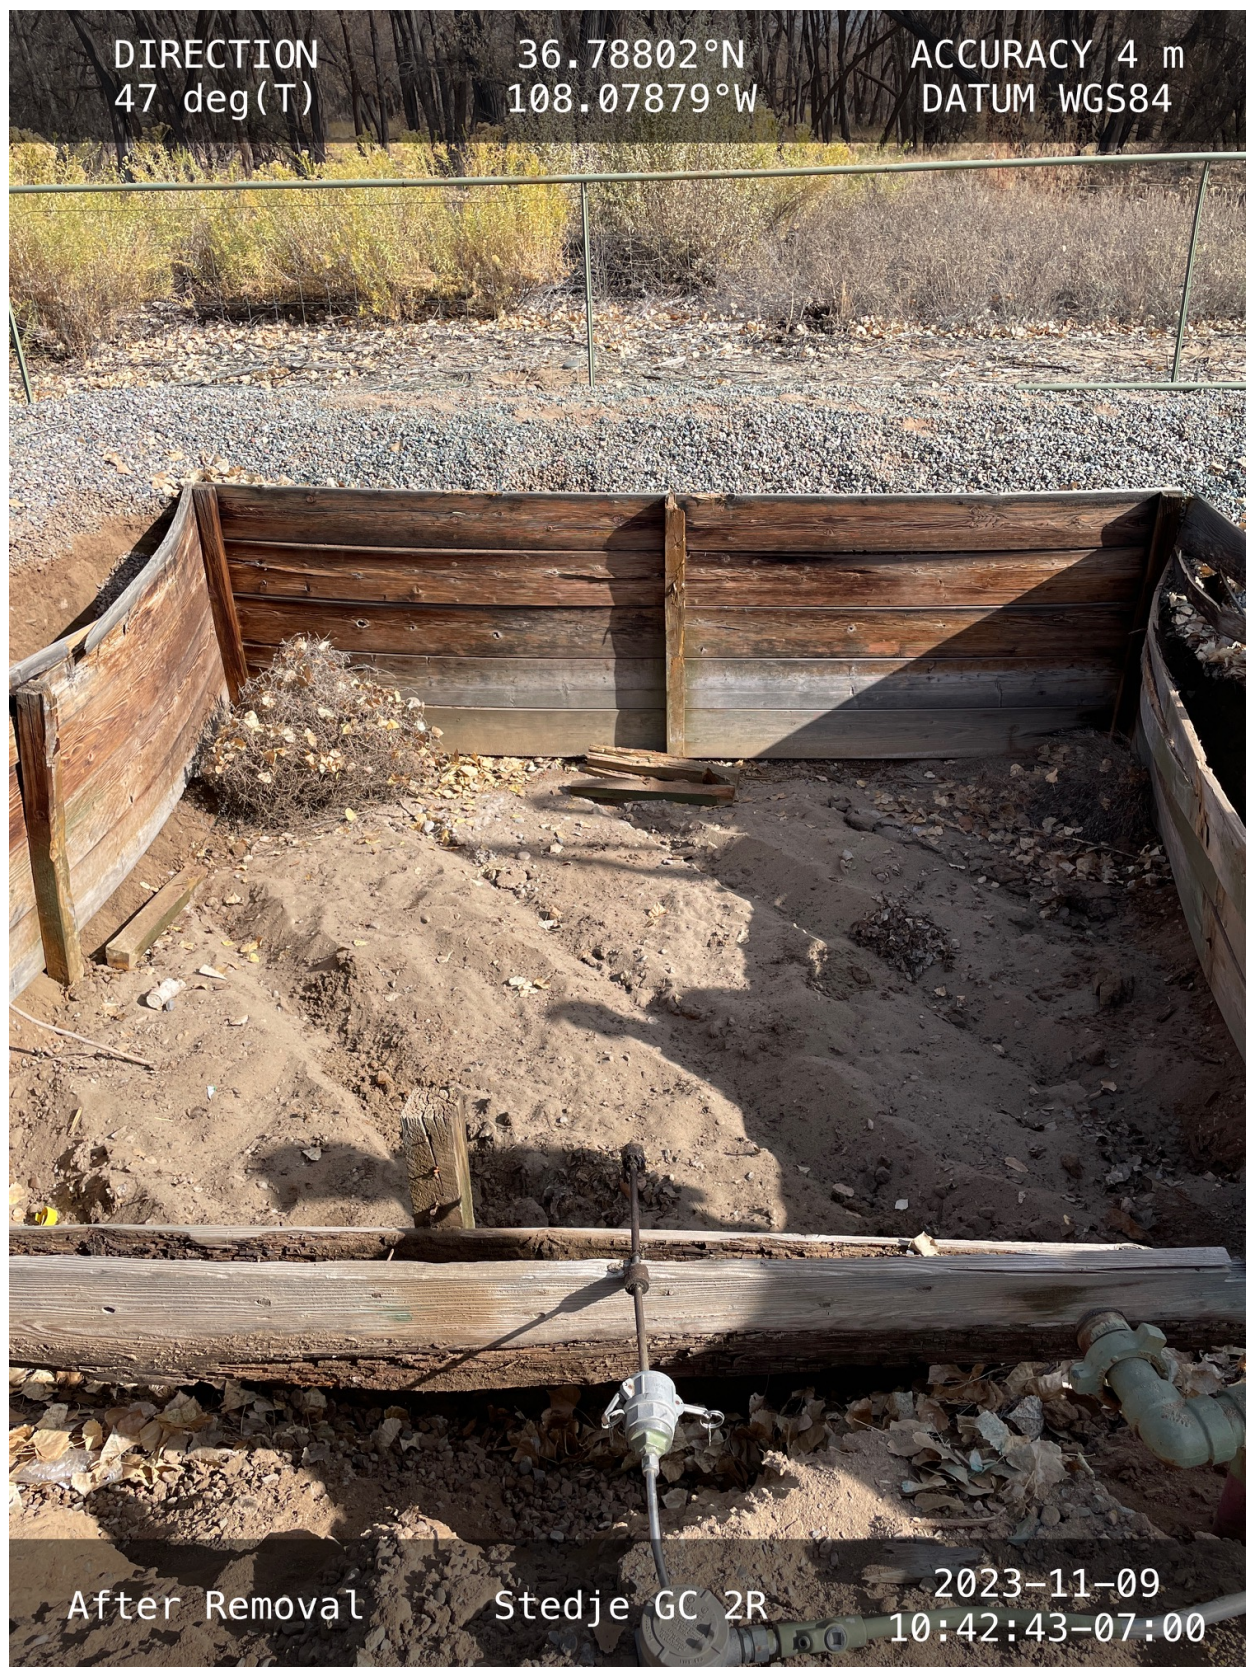
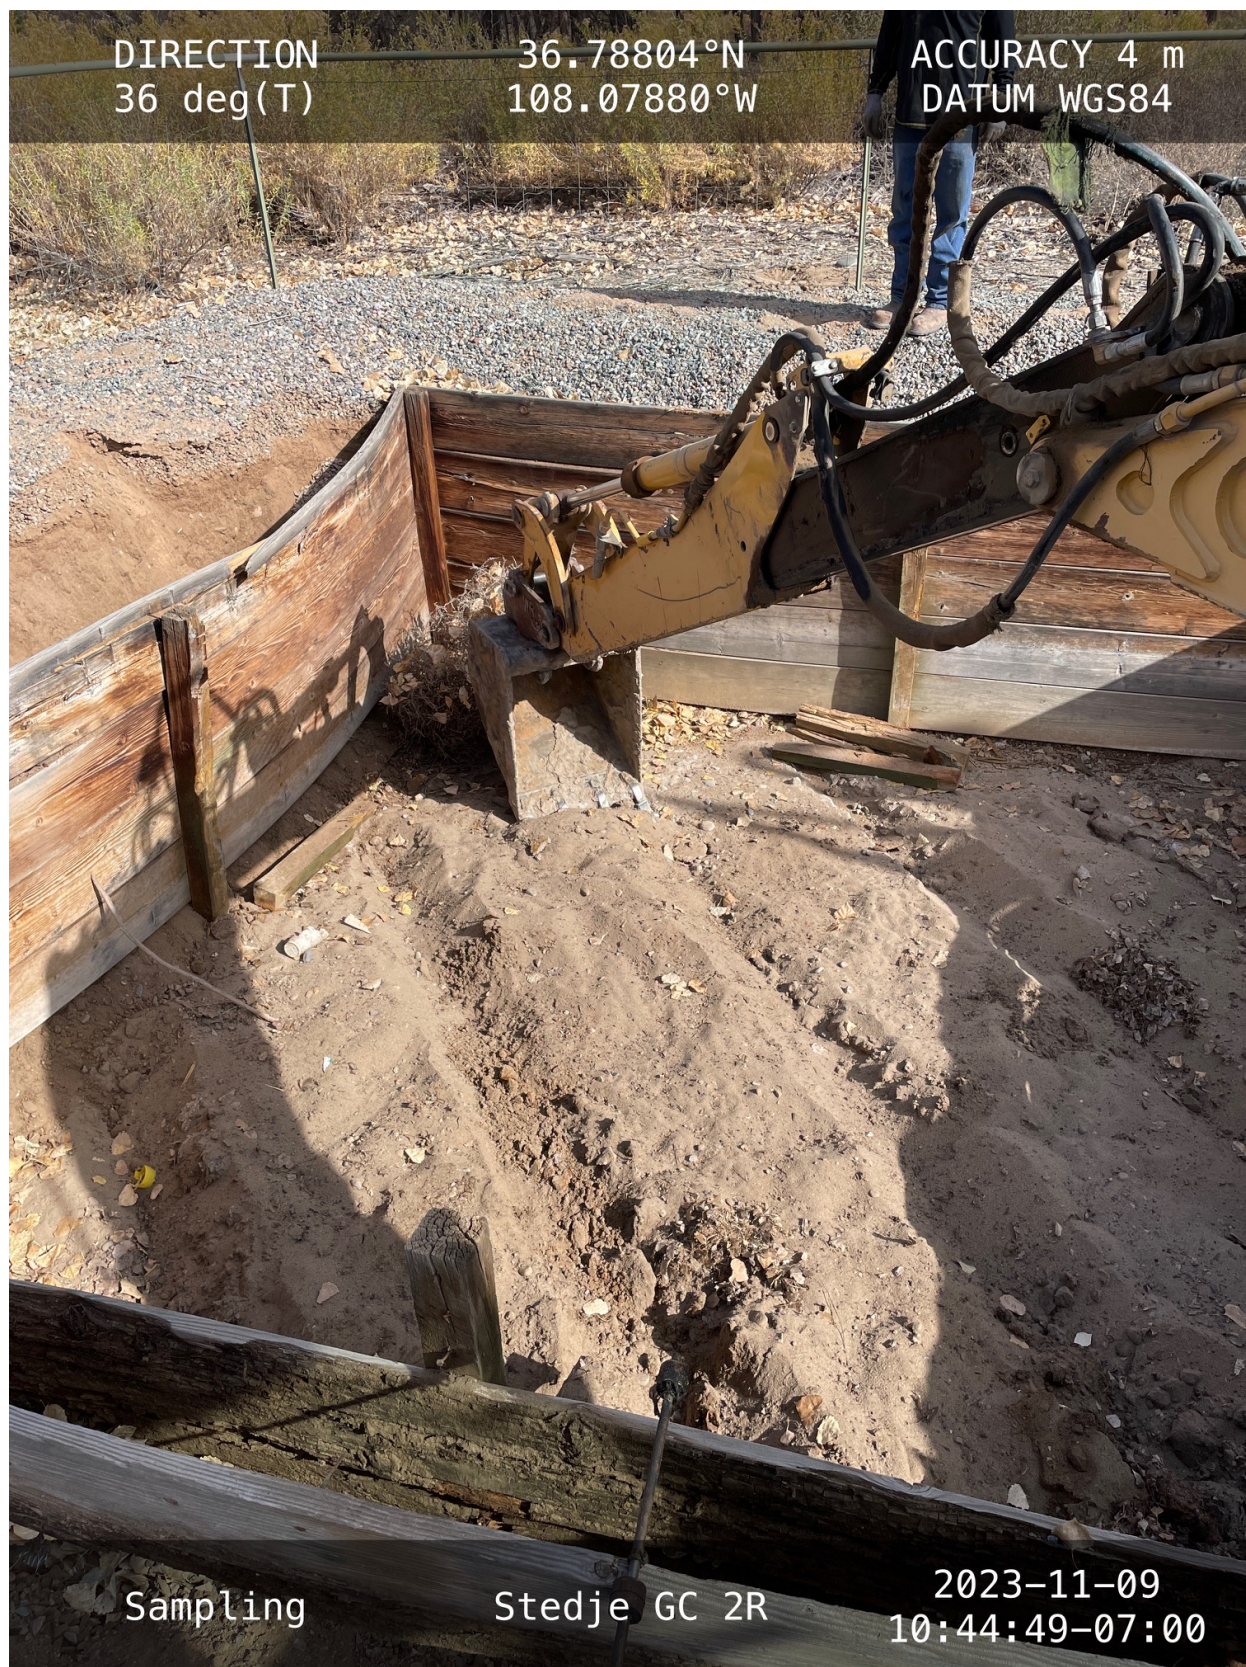
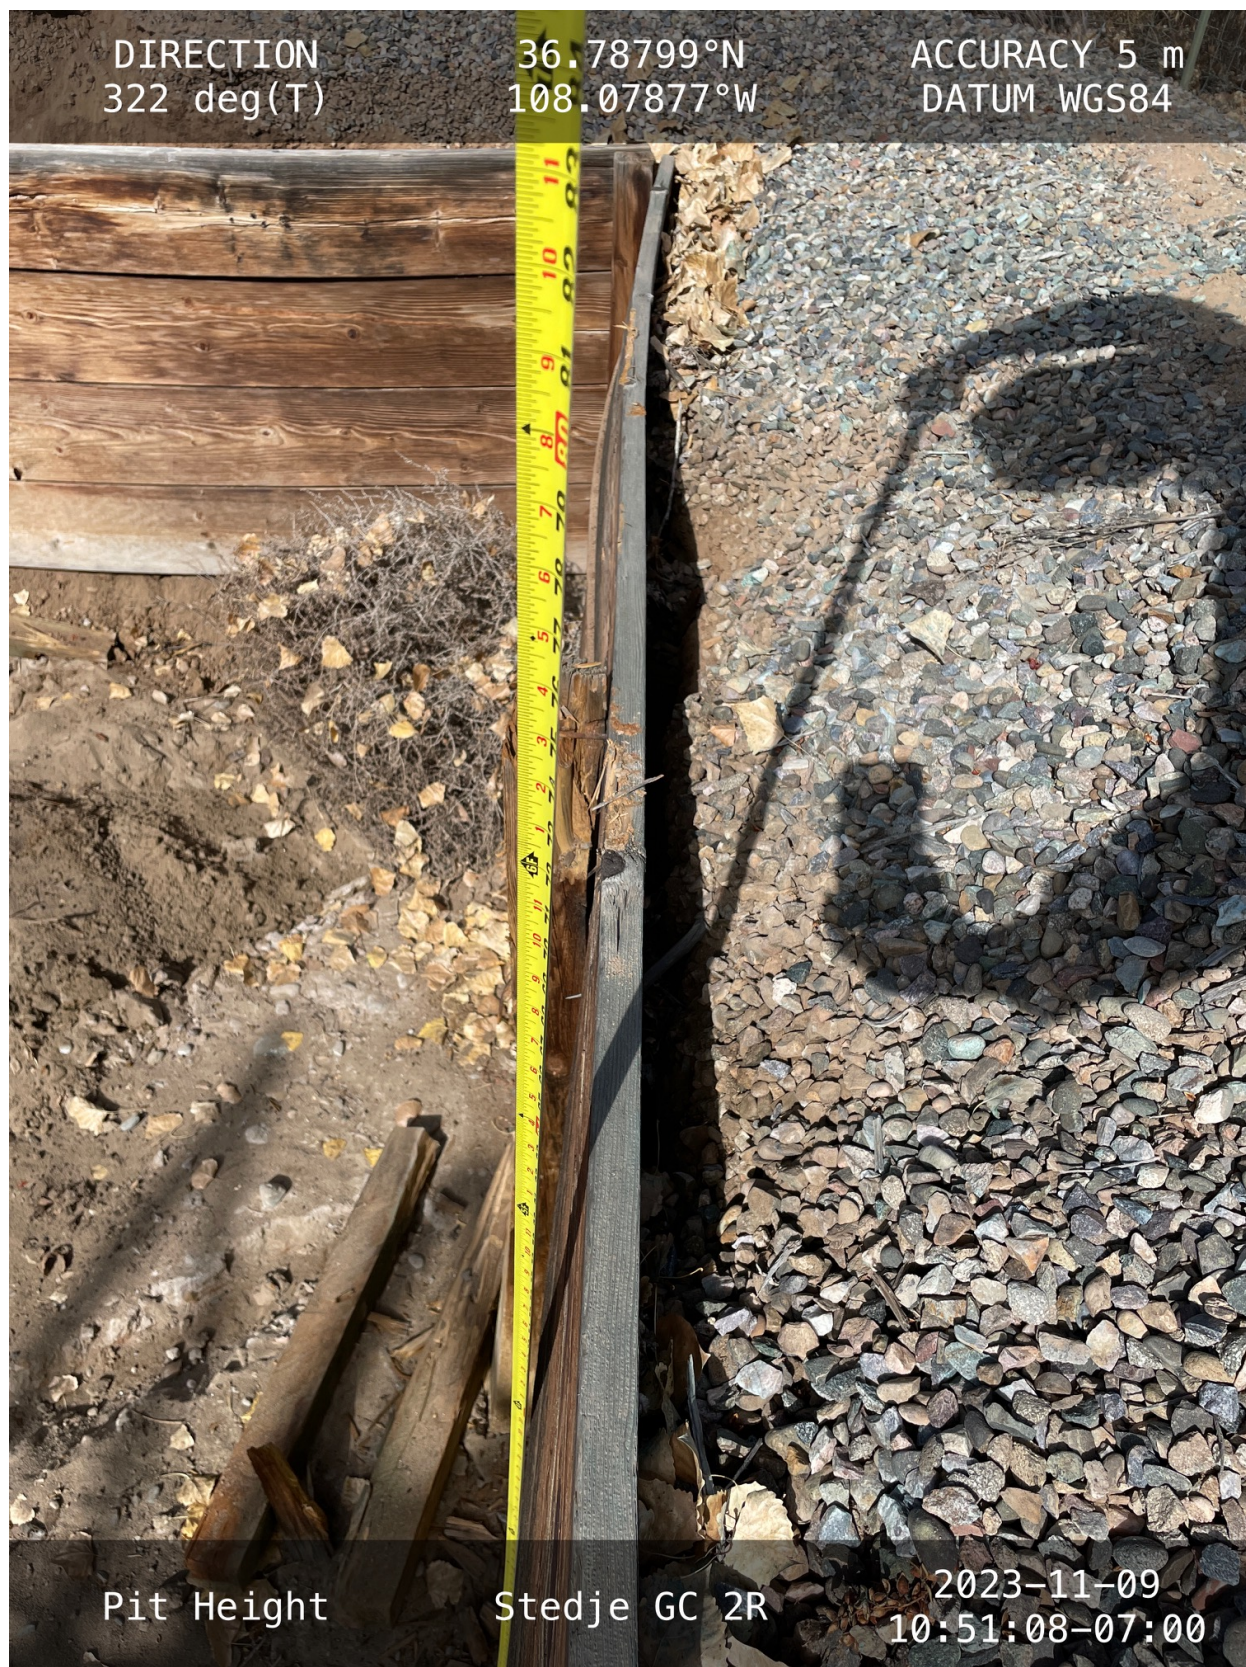
Stedje GC 2R

All on-site equipment associated with the below-grade tank was removed.

The former BGT area is required for production activities and reseeding will be completed upon plug and abandonment, per the procedure noted above.
