Pit, Below-Grade Tank, or  
Proposed Alternative Method Permit or Closure Plan Application

**Hilcorp Energy Company  
San Juan Basin  
Below Grade Tank Closure Report**

**Lease Name: Arizona Jicarilla 9**

**API No.: 30-039-21817**

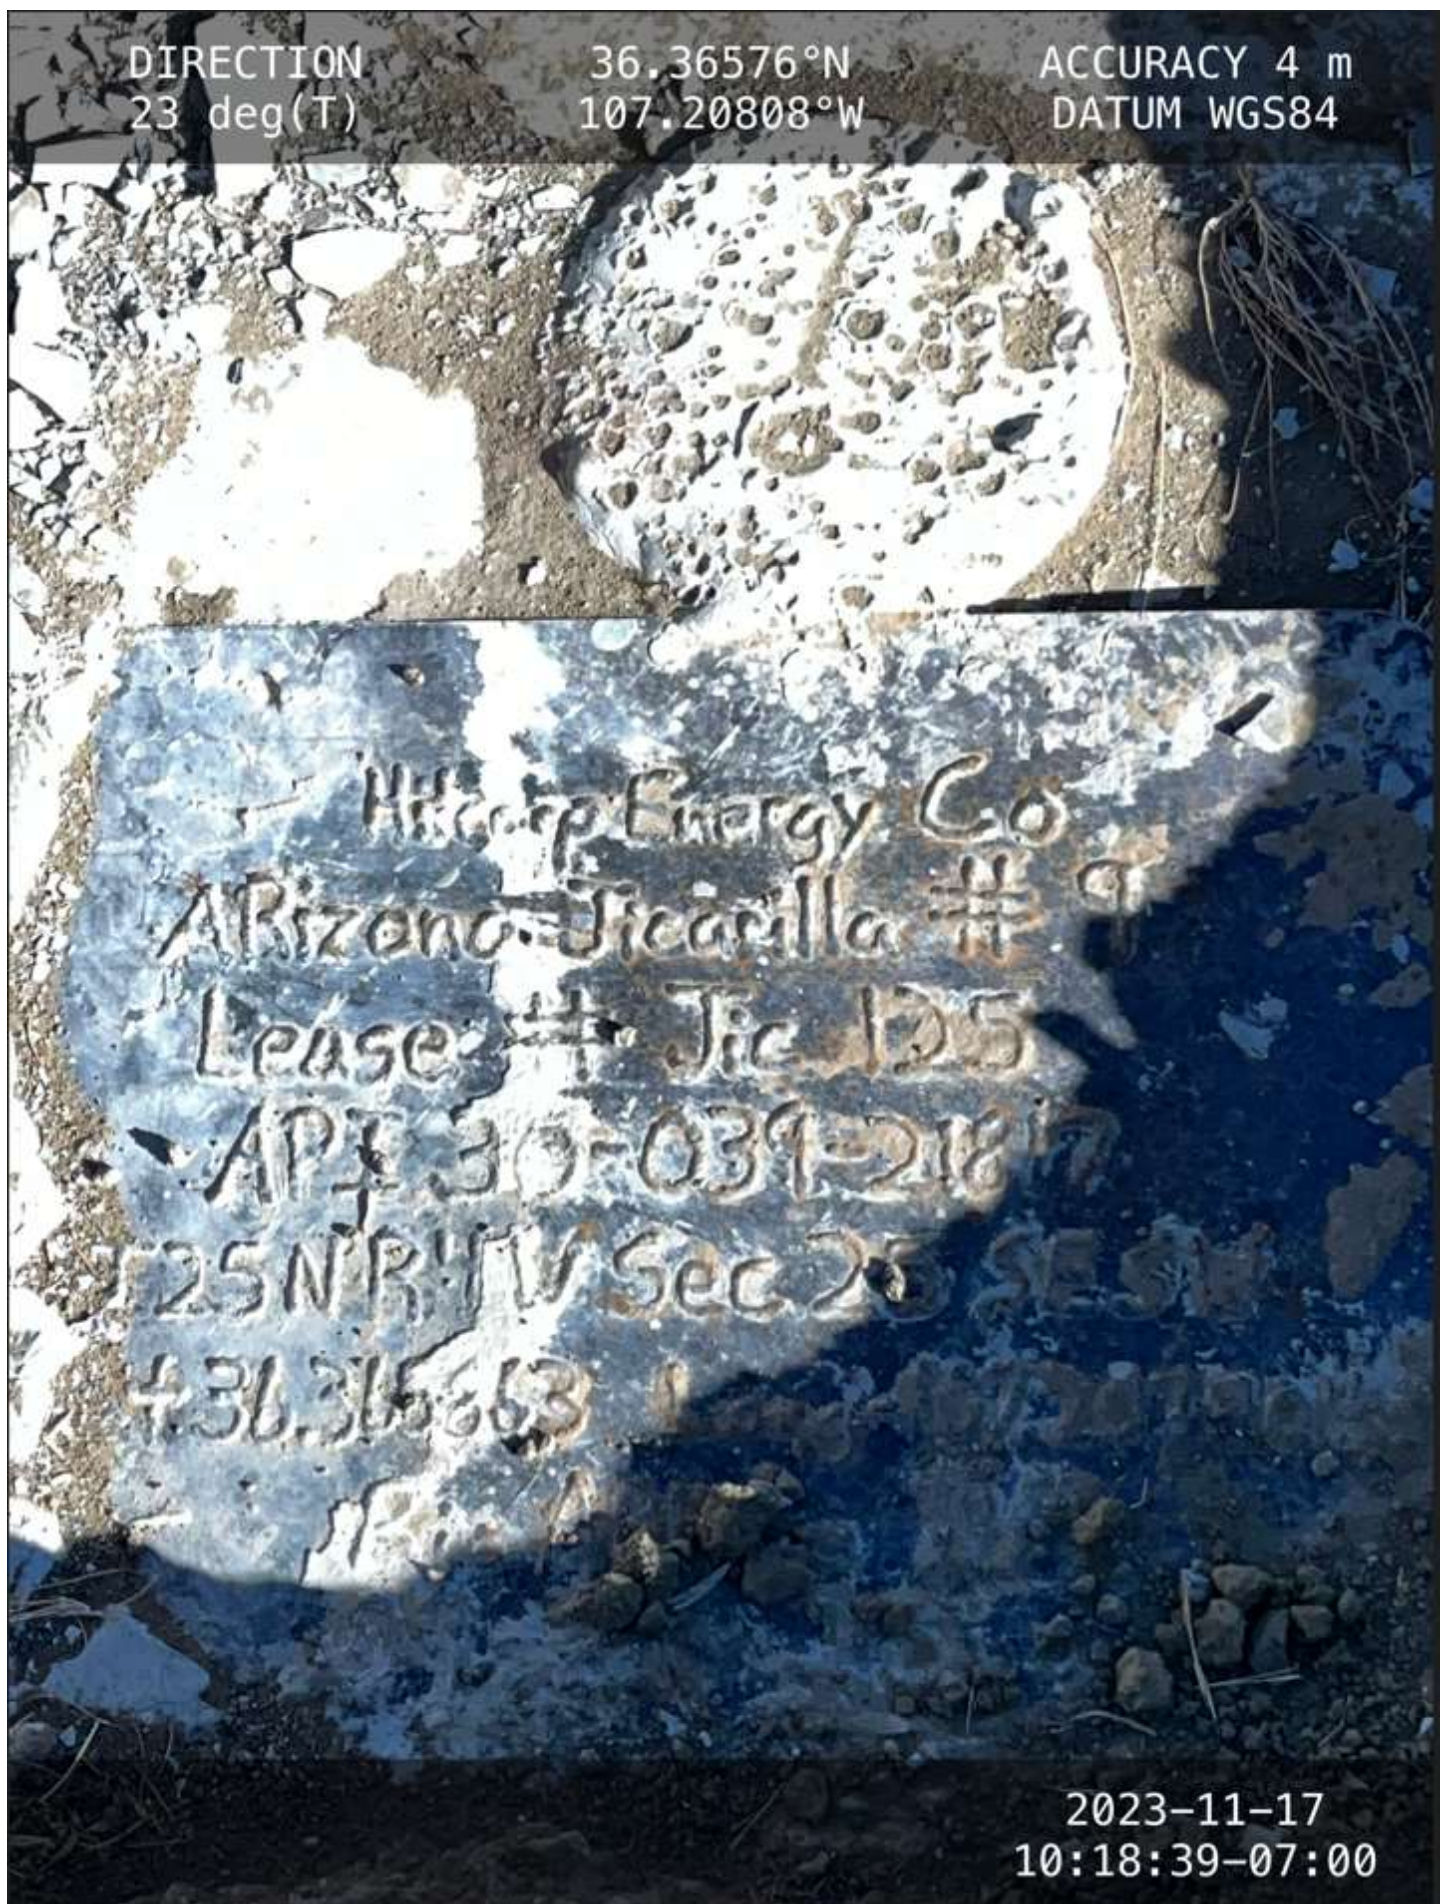
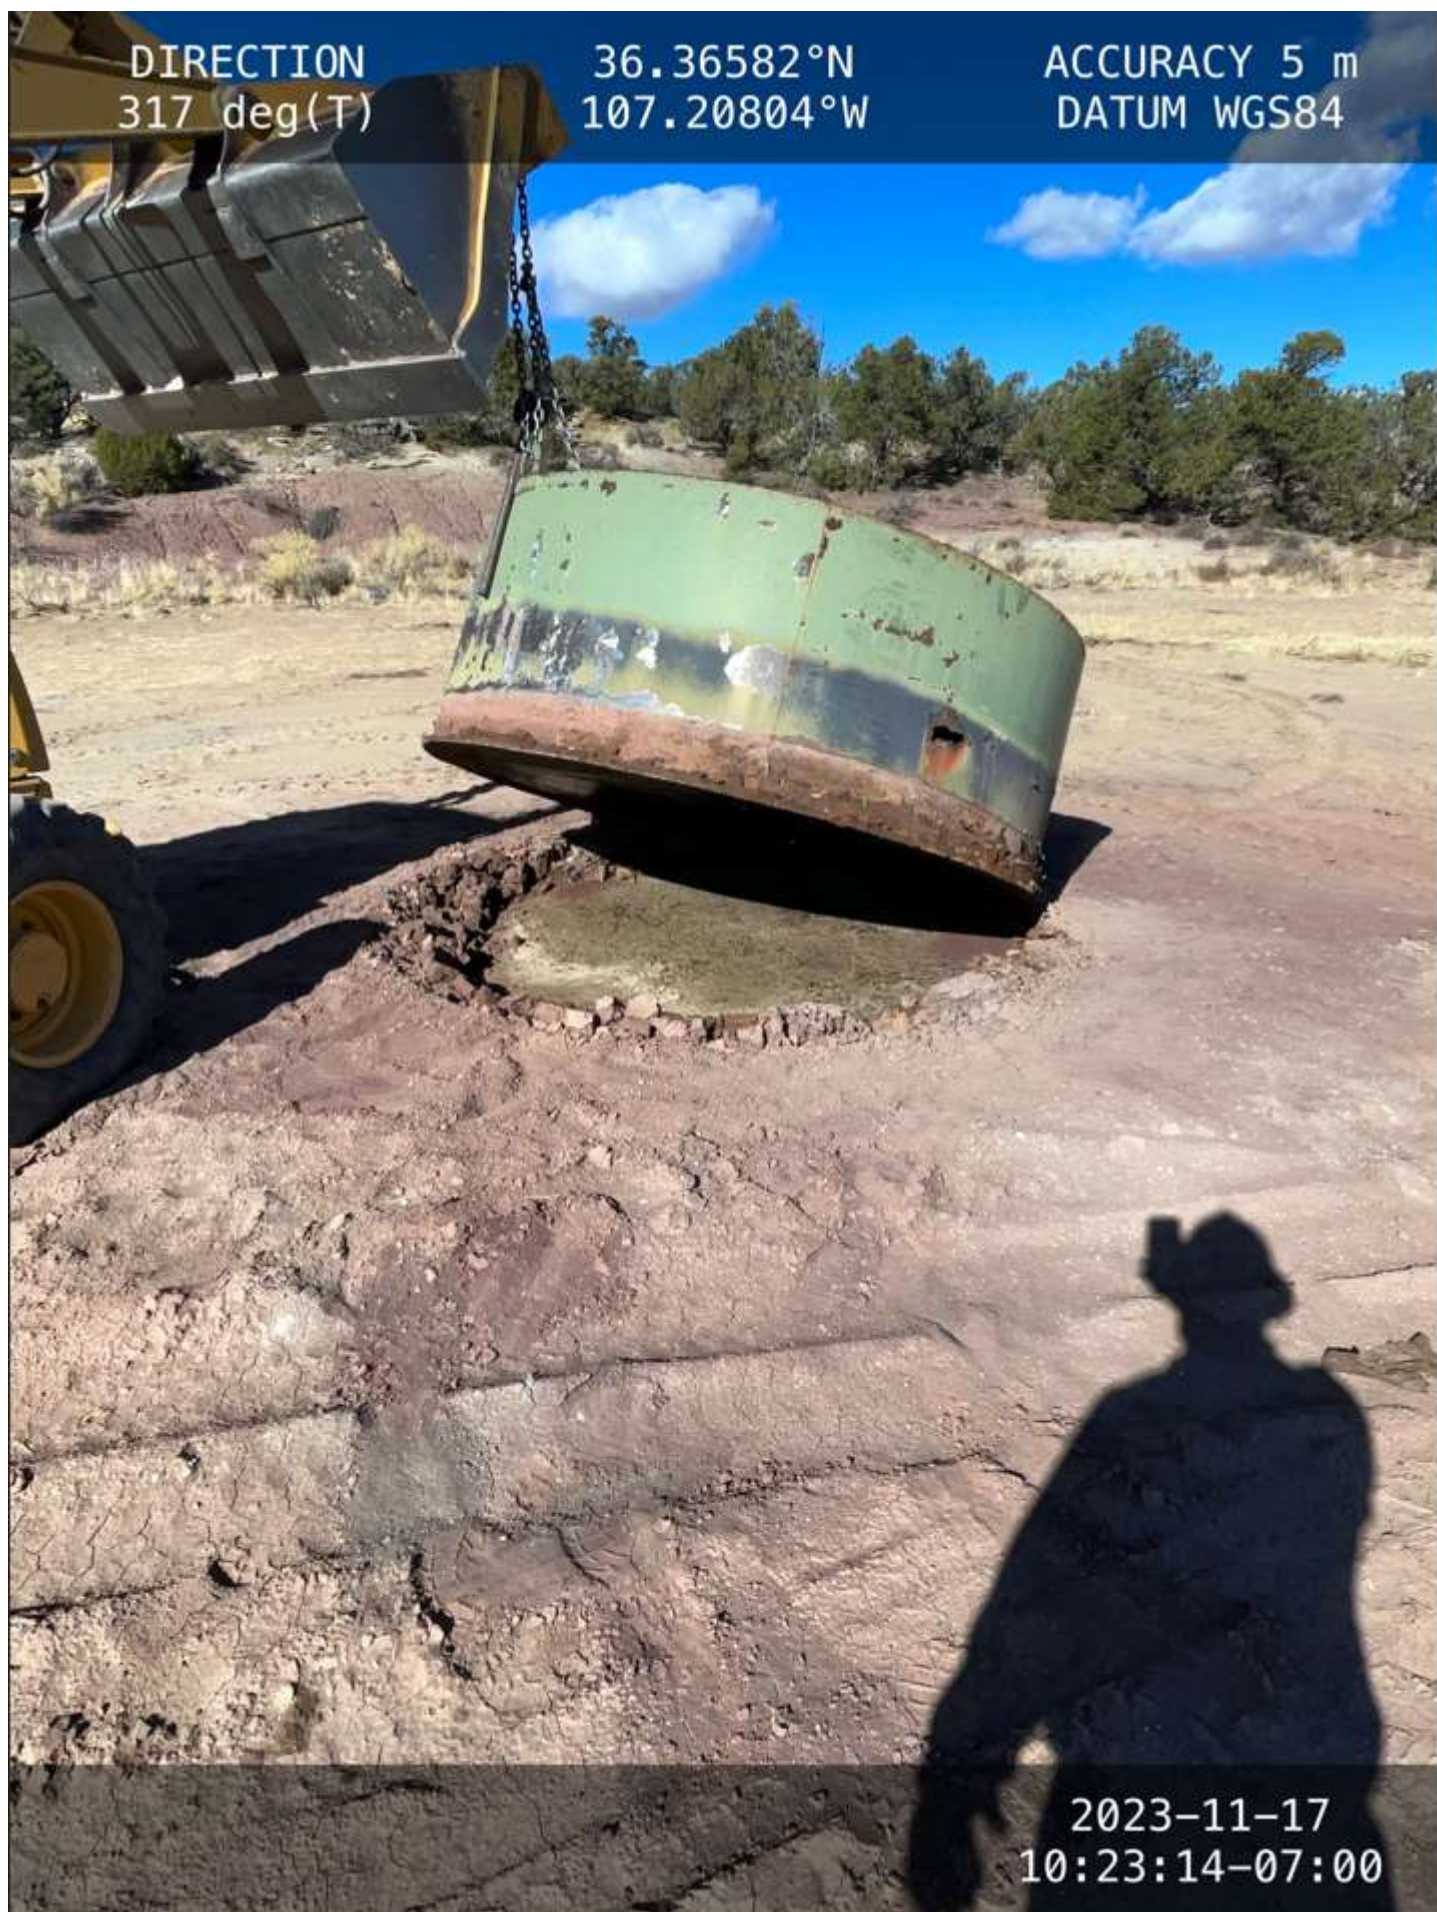
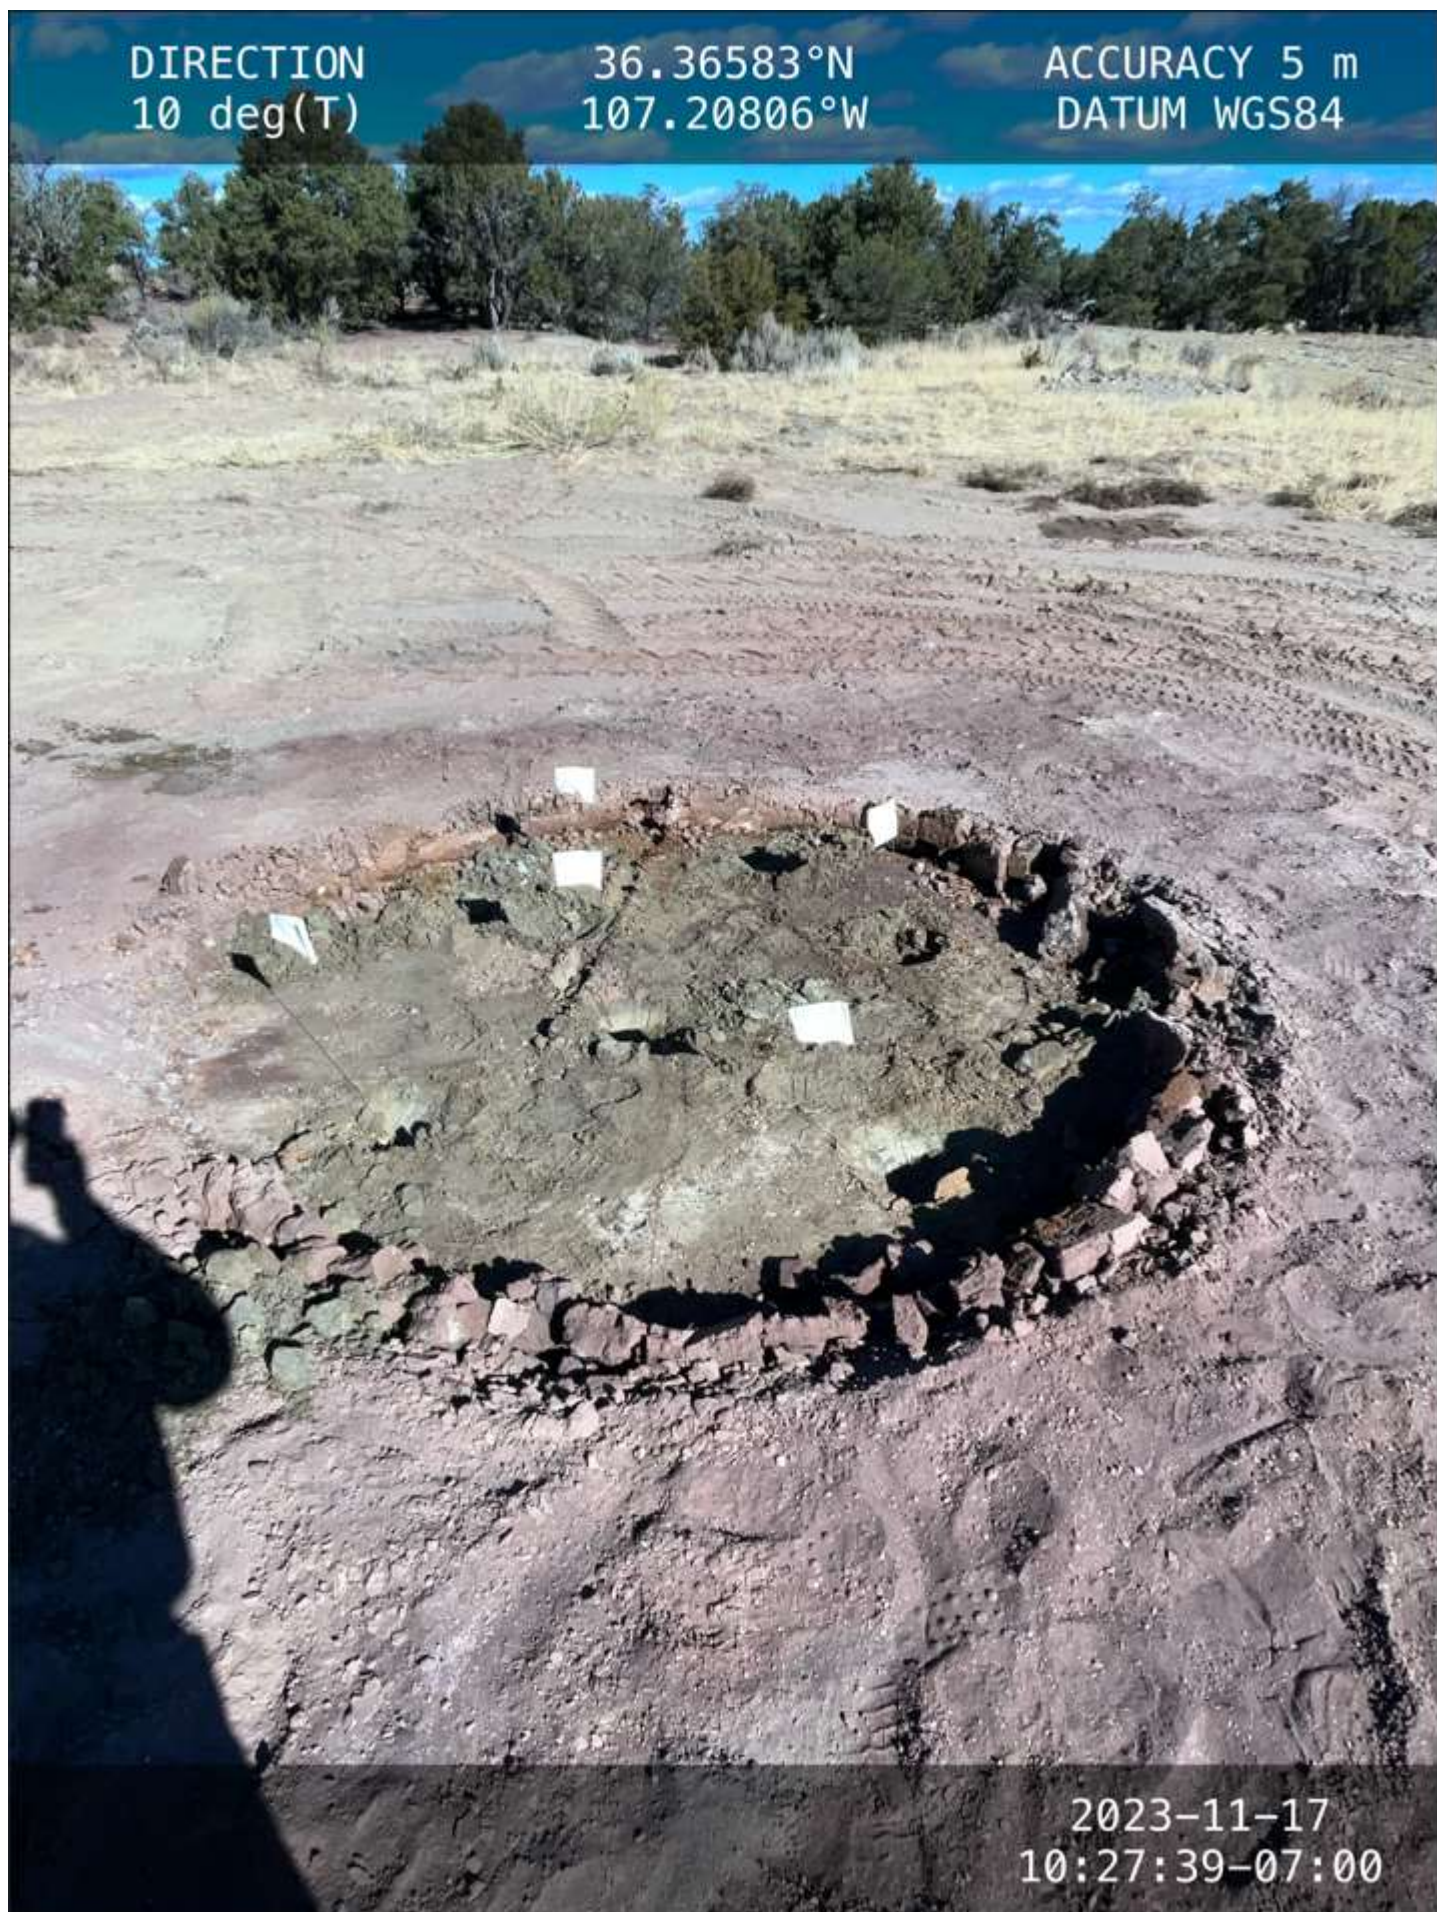
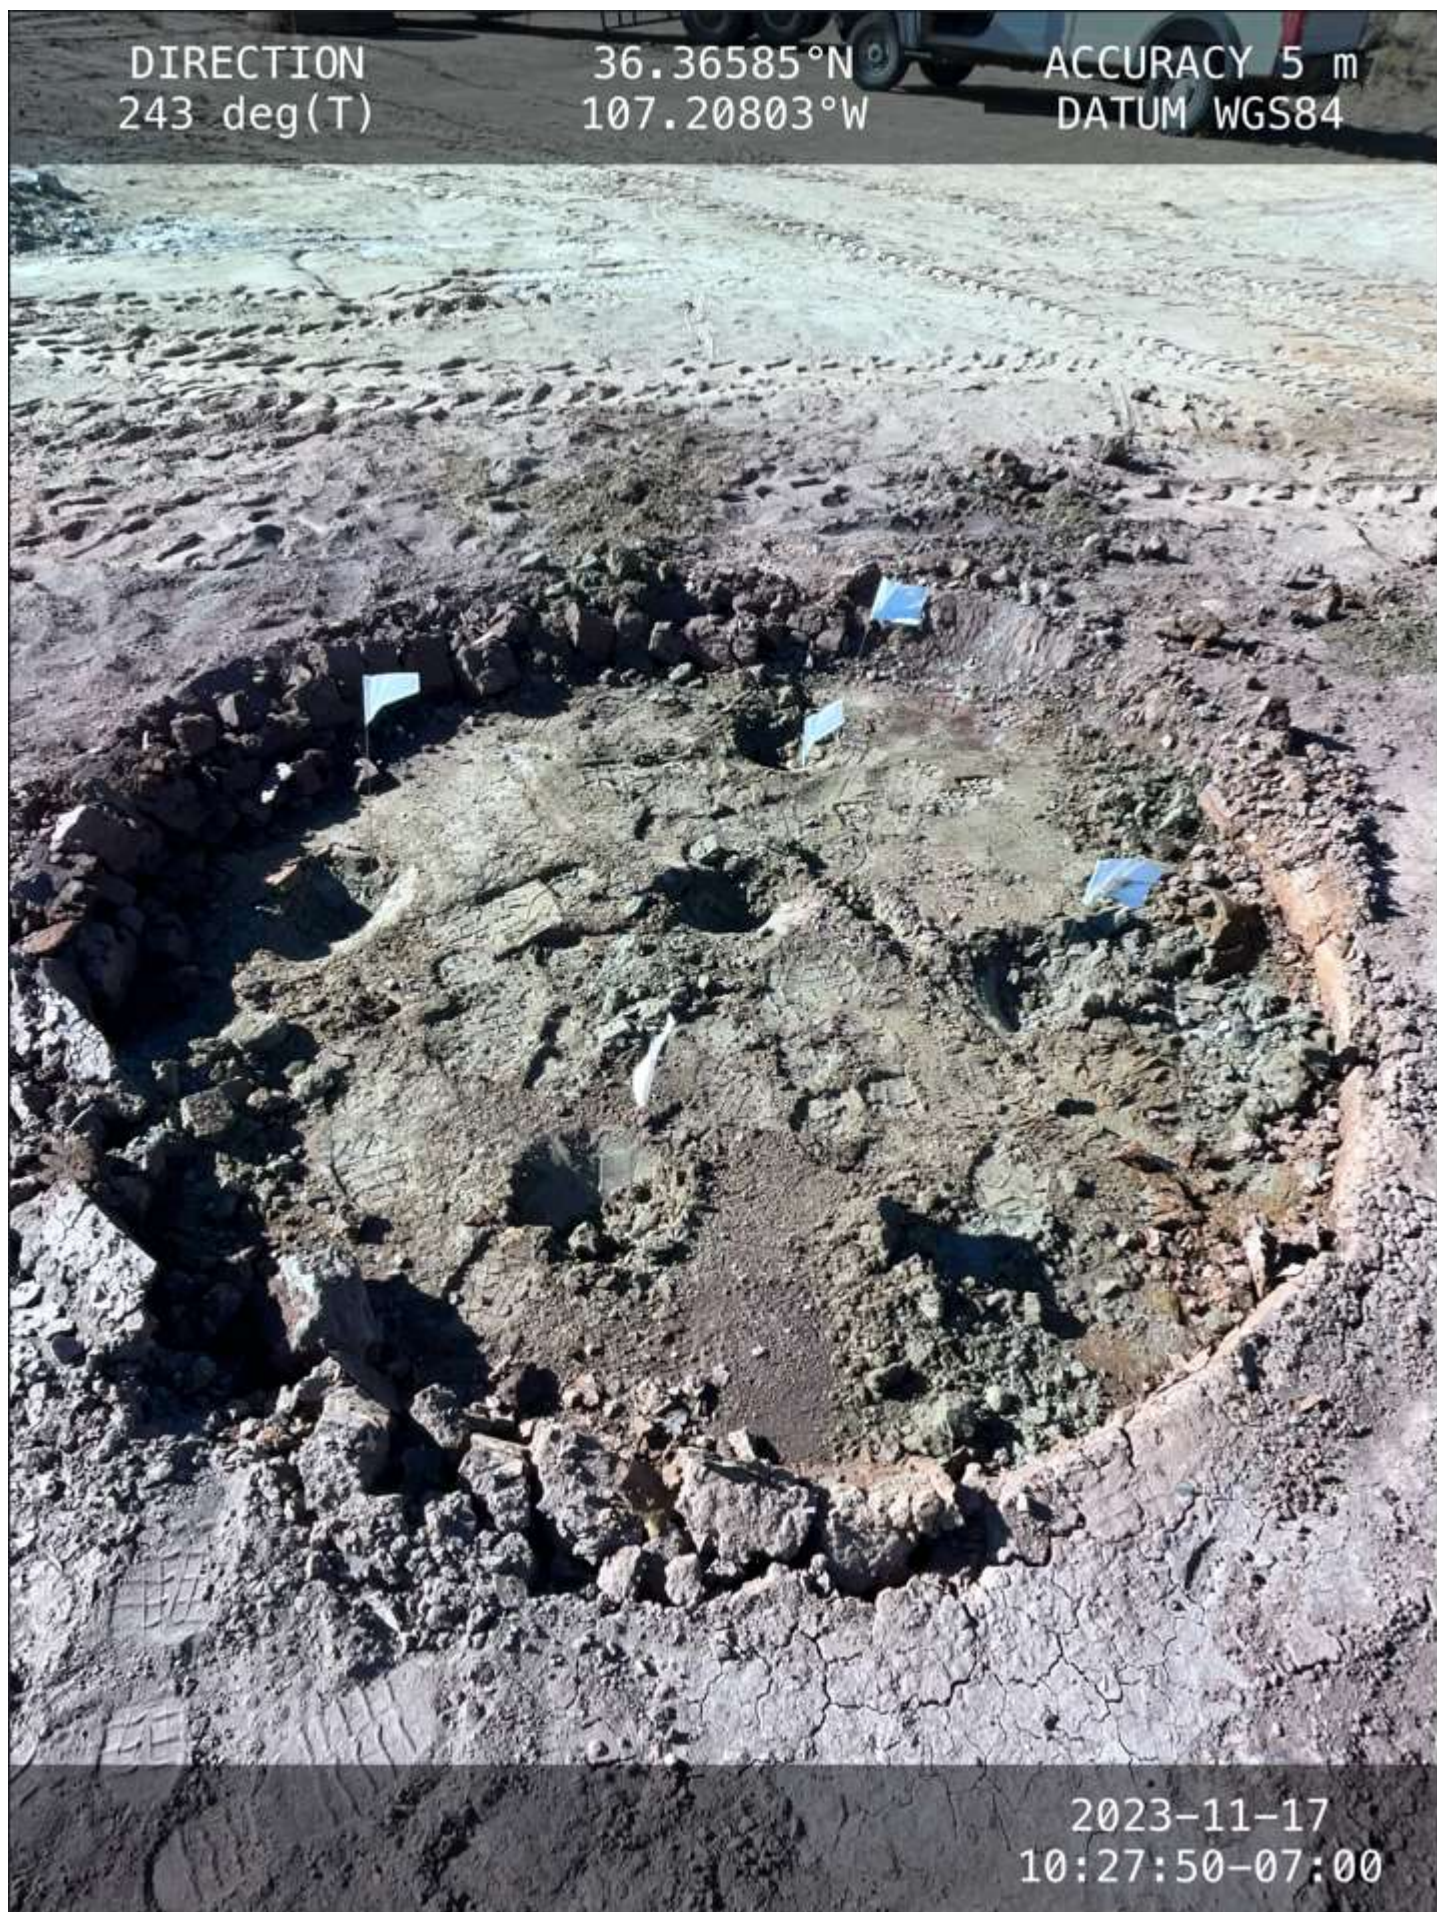
API # 30-039-21817

**The below-grade tank area was re-contoured to match fit, shape, line, form and texture of the surrounding area. Re-shaping including drainage control, to prevent ponding and erosion. Natural drainages were unimpeded and water bars and/or silt traps were placed in areas where needed to prevent erosion on a large scale. Final recontour has a uniform appearance with smooth surface, fitting the natural landscape.**

**The below-grade tank area passed all requirements of Paragraph (4) of Subsection E of 19.15.17.13 NMAC and was backfilled with compacted, non-waste containing, earthen material.**
