Pit, Below-Grade Tank, or
Proposed Alternative Method Permit or Closure Plan Application

1.
Operator: LOGOS Operating, LLC OGRID #: 289408
Address: 2010 Afton Place, Farmington, NM 87401
Facility or well name: ROSA UNIT 012B
API Number: 30-039-26555 OCD Permit Number: _____
U/L or Qtr/Qtr P Section 15 Township 31N Range 6W County: Rio Arriba
Center of Proposed Design: Latitude 36.89356 Longitude -107.44240 NAD83
Surface Owner: ☒ Federal ☐ State ☐ Private ☐ Tribal Trust or Indian Allotment

Project Name: Rosa Unit #12B

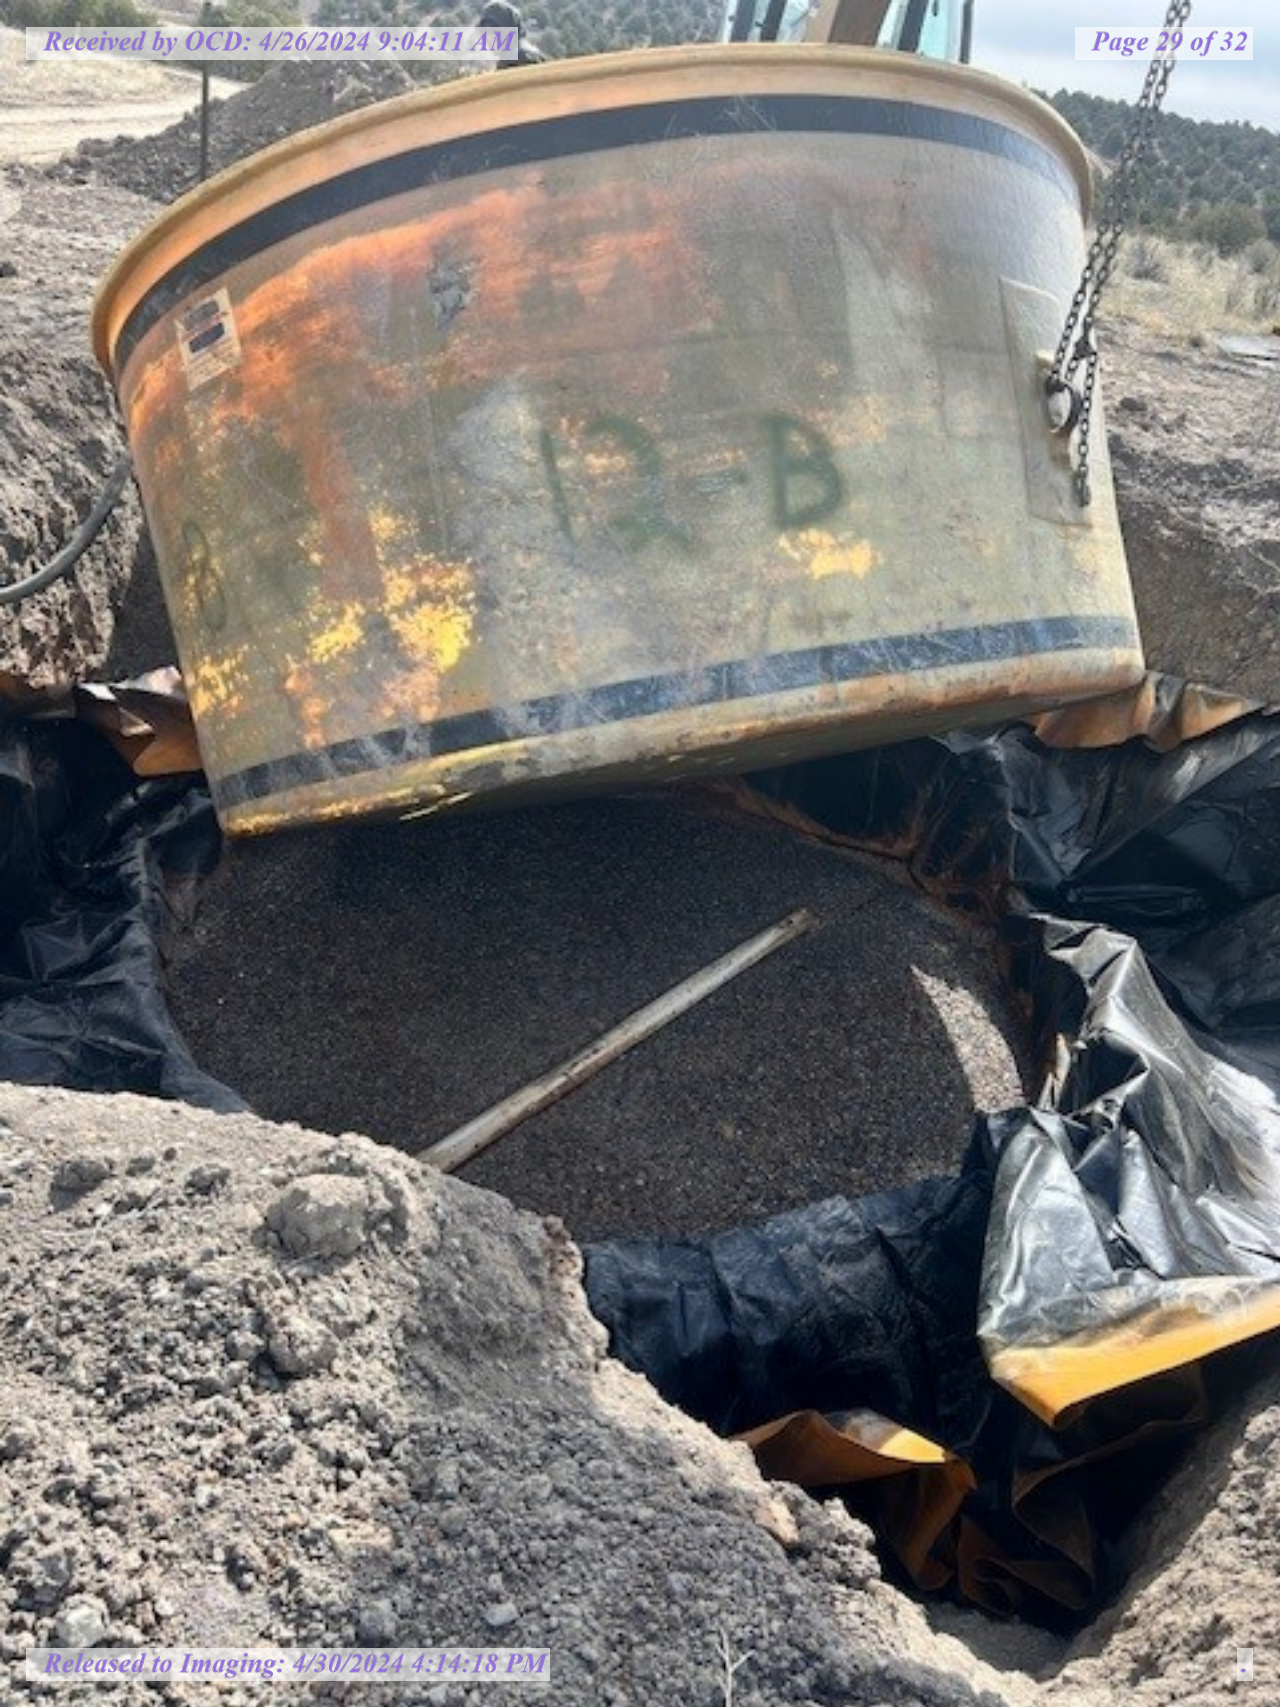
PSEC.15 T31N R06W NMPM
RIO ARriba COUNTY, NM

LAT: 36.89356 LONG: 107.44240
EMERGENCY CONTACT # 1-866-598-6220

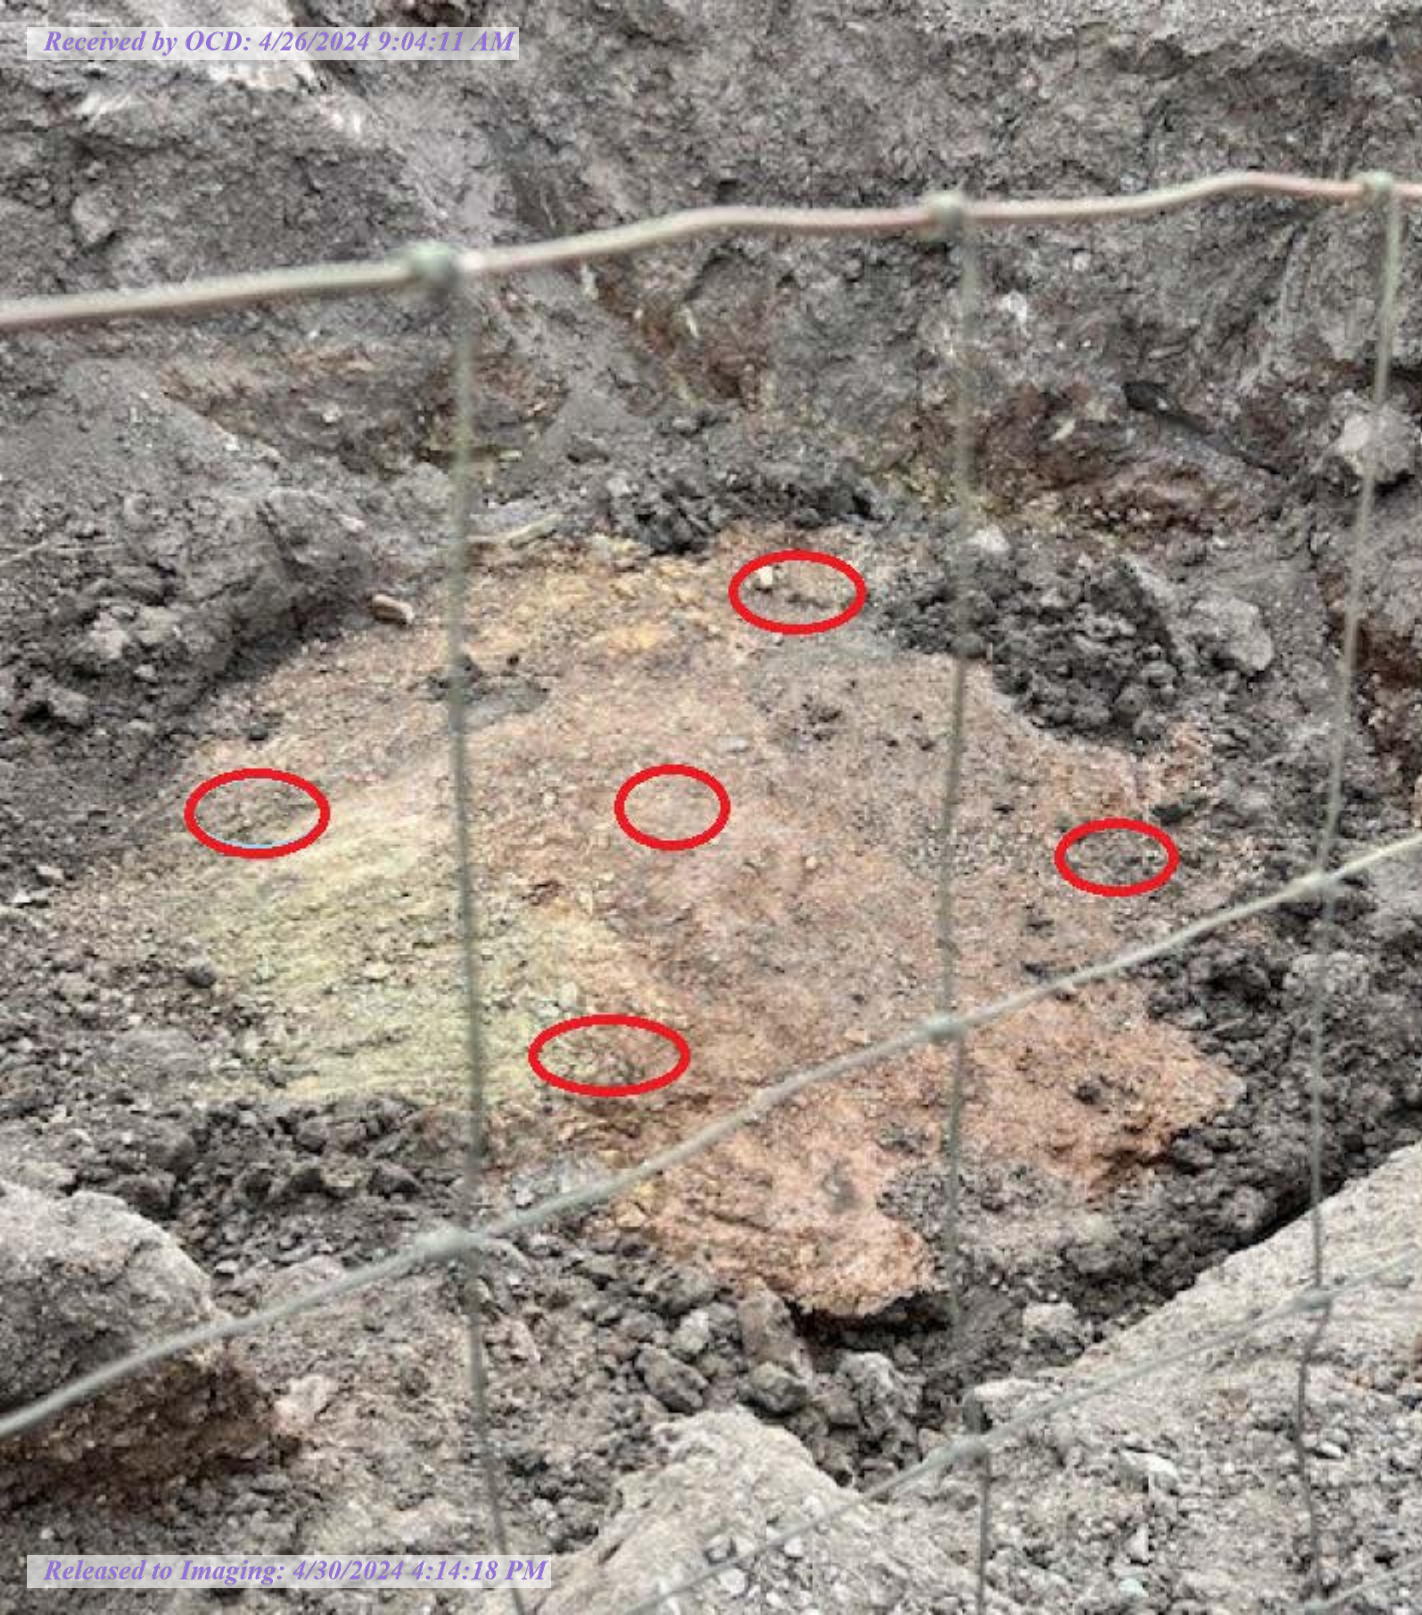
5 POINT COMPOSITE SAMPLE- ROSA UNIT 12B

On April 16, 2024, LOGOS Operating LLC. removed the fiberglass below grade tank on the Rosa Unit #012B. When the BGT was removed no visible signs of staining or wet soil was observed. LOGOS collected (1) 5-point composite sample from where the BGT was removed. The closure samples were analyzed by Envirotech Labs, and all constituents analyzed were non-detect. No representative from BLM or NMOCD was onsite to witness all confirmation sampling.
