Pit, Below-Grade Tank, or Proposed Alternative Method Permit or Closure Plan Application

1.
 Operator: MorningStar Operating OGRID #: 330132
 Address: 400 W 7Th Street, Fort Worth, TX 76109
 Facility or well name: Midway State #001
 API Number: 30-025-22794 OCD Permit Number: P1-04581
 U/L or Qtr/Qtr F Section 12 Township 17S Range 36E County: Lea
 Center of Proposed Design: Latitude 32.8504486 Longitude -103.309082 NAD83
 Surface Owner: ☐ Federal ☐ State ☒ Private ☐ Tribal Trust or Indian Allotment

In accordance with 19.15.17.13 NMAC, we respectfully request the closure of the closed-loop workover pit with the permit P1-04581 previously located on the Midway State #001 location (Well API: 30-025-22794). The well pad location and the adjacent legacy reserve pit has been remediated and reclaimed in accordance with 19.15.29.12 NMAC and 19.15.29.12 NMAC, and reseeded with the suitable seed mixture to restore the location to the natural conditions. At the time of this closure request, MorningStar Operating, LLC, is the surface owner at that location.

Midway State #001
30-025-22794

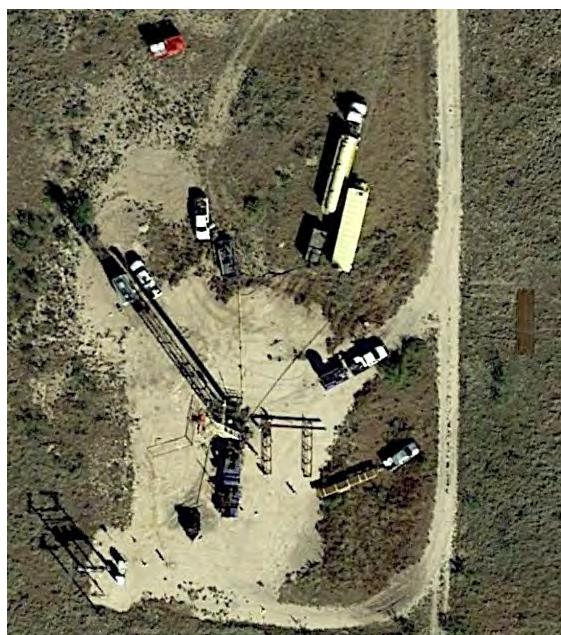
Fig. 1. Workover rig in 2017.

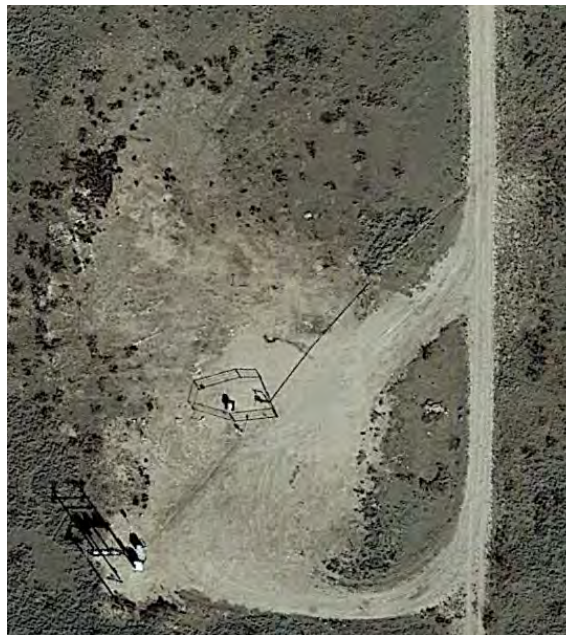
Fig. 2. The location after the 2012 workover.

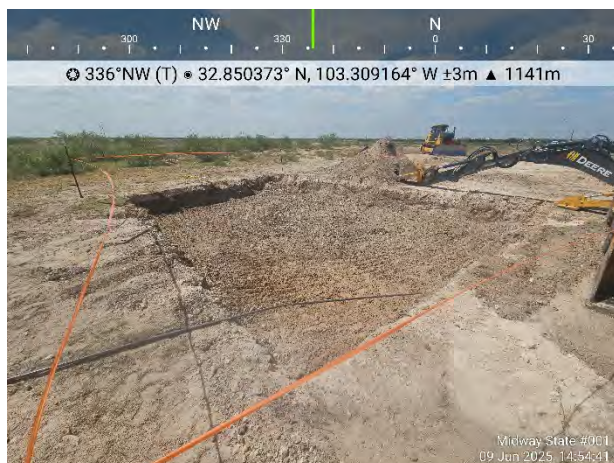
Figure 1. View of the excavation.

During remediation & reclamation activities, there were no liner material or frac fluids found at any point. All soils within upper 4-feet exceeding 600 mg/kg chloride concentration have been excavated and hauled for disposal at the approved facility. Following the excavation, location has been backfilled with clean, non-waste containing, locally sourced topsoil. As a result, the site has a uniform topsoil cover matching the natural background thickness, as required in 19.15.1.13 (H,3) NMAC. Based on the remedial & reclamation efforts described in this report, the site is fully compliant with closure requirements for the closed-loop systems, and no further actions are required at the site.

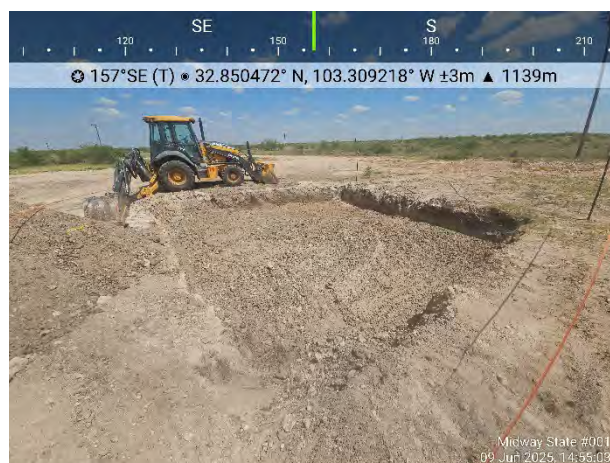
Figure 2. View of the excavation.

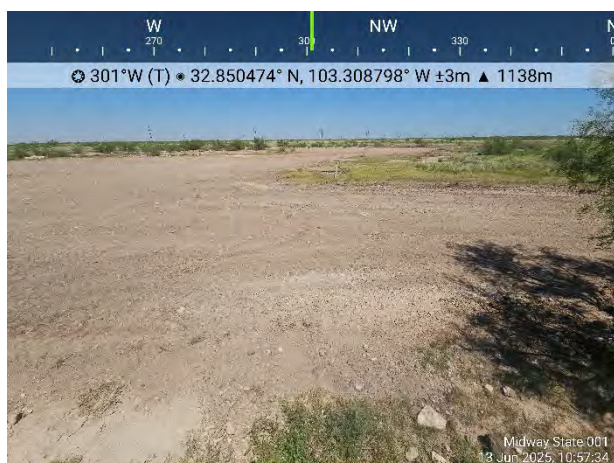
Figure 3. View of the reclaimed area.

The reclaimed area was seeded on June 13th, 2025, using a drill seeder at twice the recommended rate with the NMSLO-approved Coarse seed mixture. The reclaimed areas were watered to promote seed germination. The site will be monitored for revegetation, soil stability and noxious weeds as described in the reclamation plan.

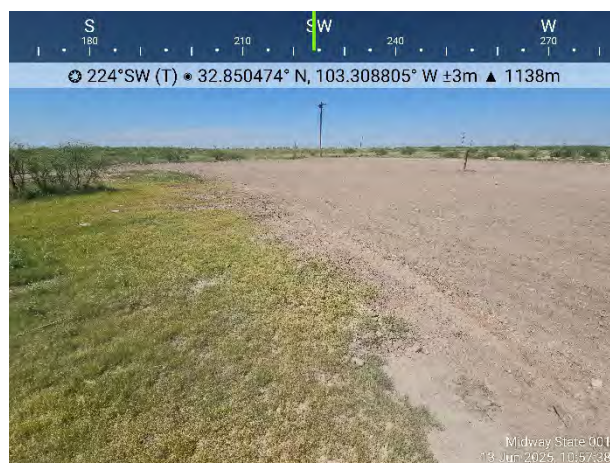
Figure 4. View of the reclaimed area.

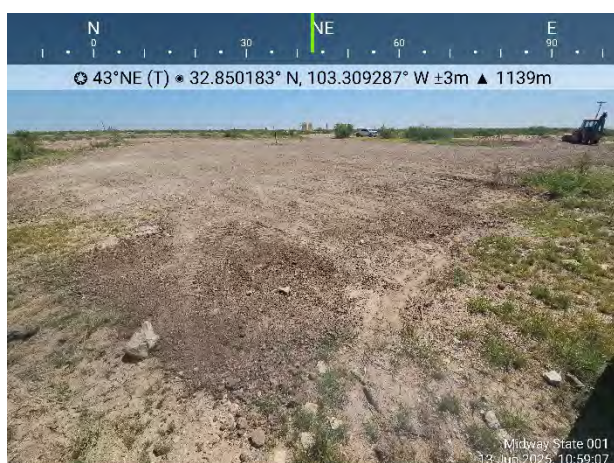
Figure 5. View of the reclaimed area.

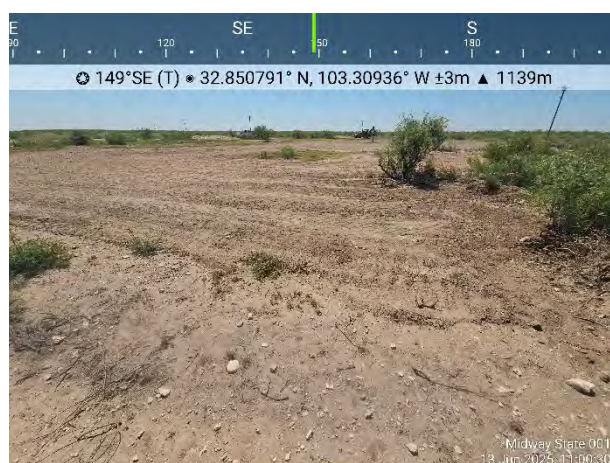
Figure 6. View of the reclaimed area.

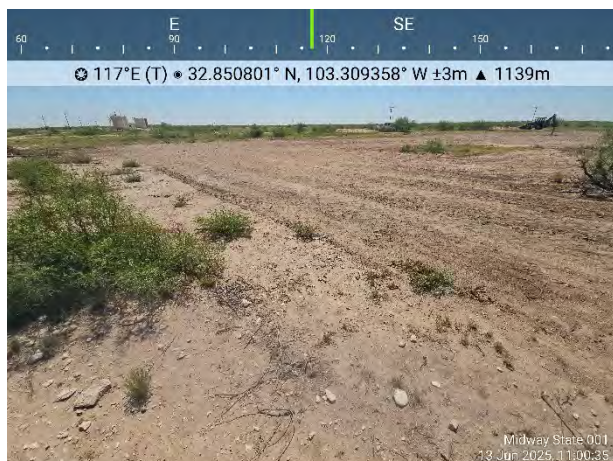
Figure 7. View of the reclaimed area.

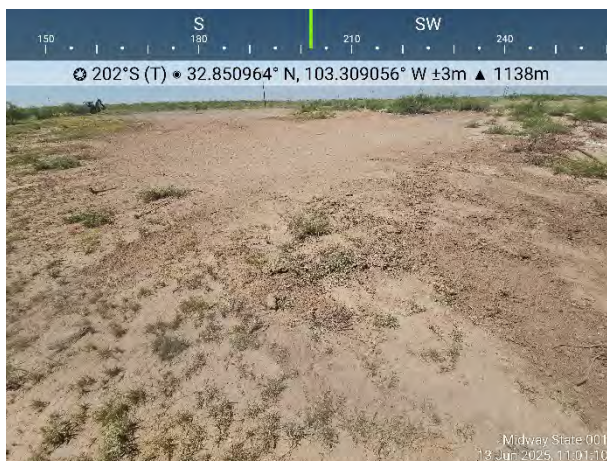
Figure 8. View of the reclaimed area.

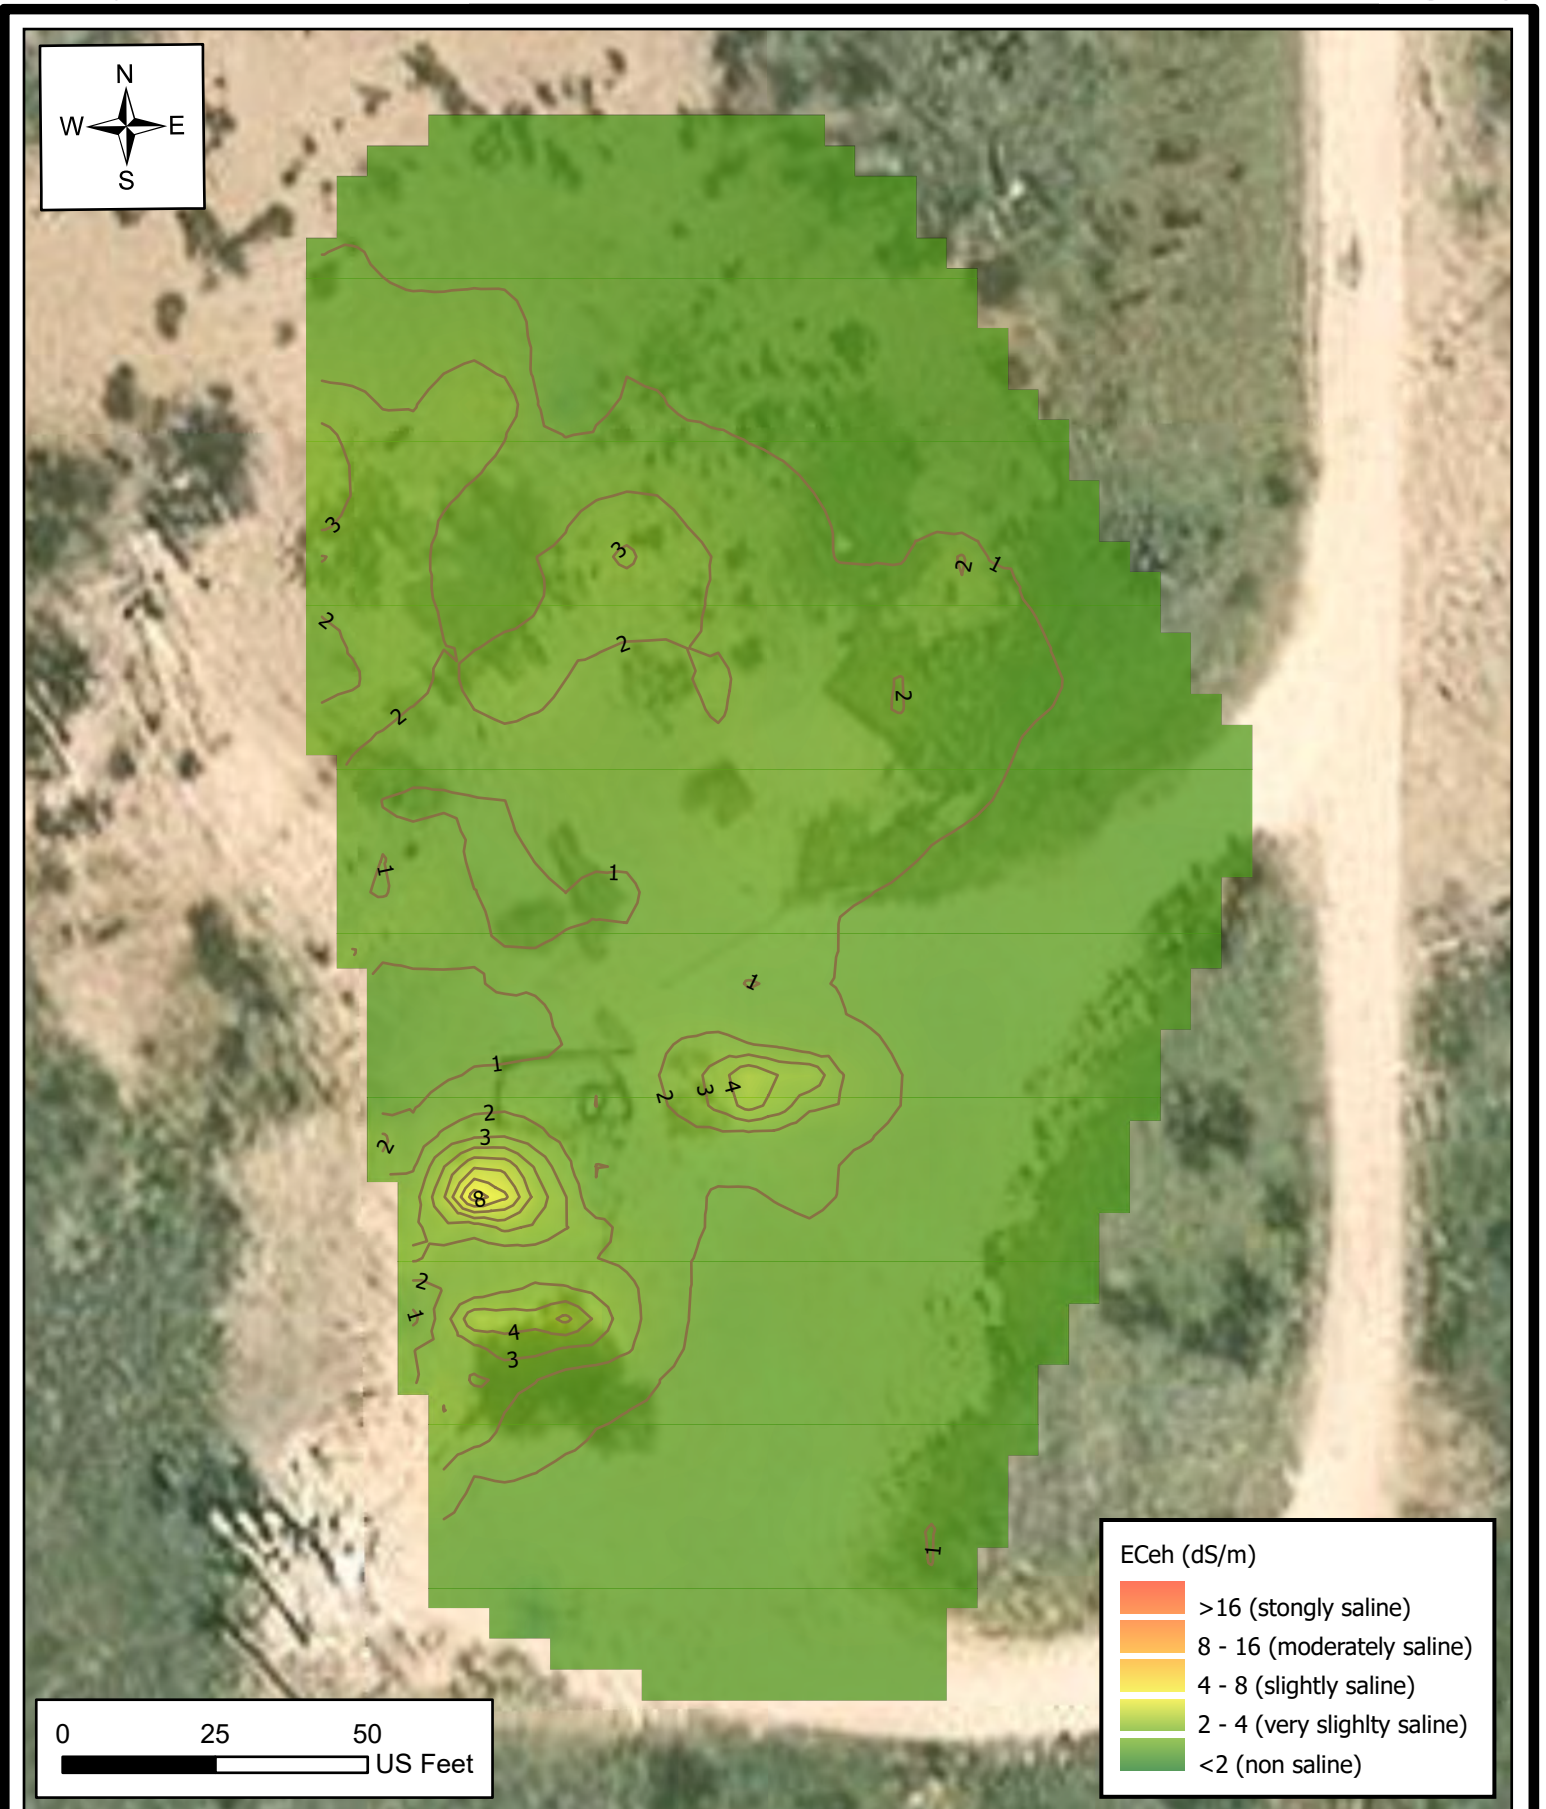
Per the results of EM Survey of legacy reserve pit and the site pad surface, one area of approximately 200 square feet south of the plugged well was found to have an EC > 4 dS/m representing higher salinity within an upper 1-foot layer of the soil surface. No significant chloride concentrations were found within the upper 4 feet at any other area of the reserve pit or site pad, as all other areas show EC ≤ 4 dS/m. The visualization of EM Survey is shown in Plat 2 and Plat 3.

EM Survey (0-1 ft bgs)

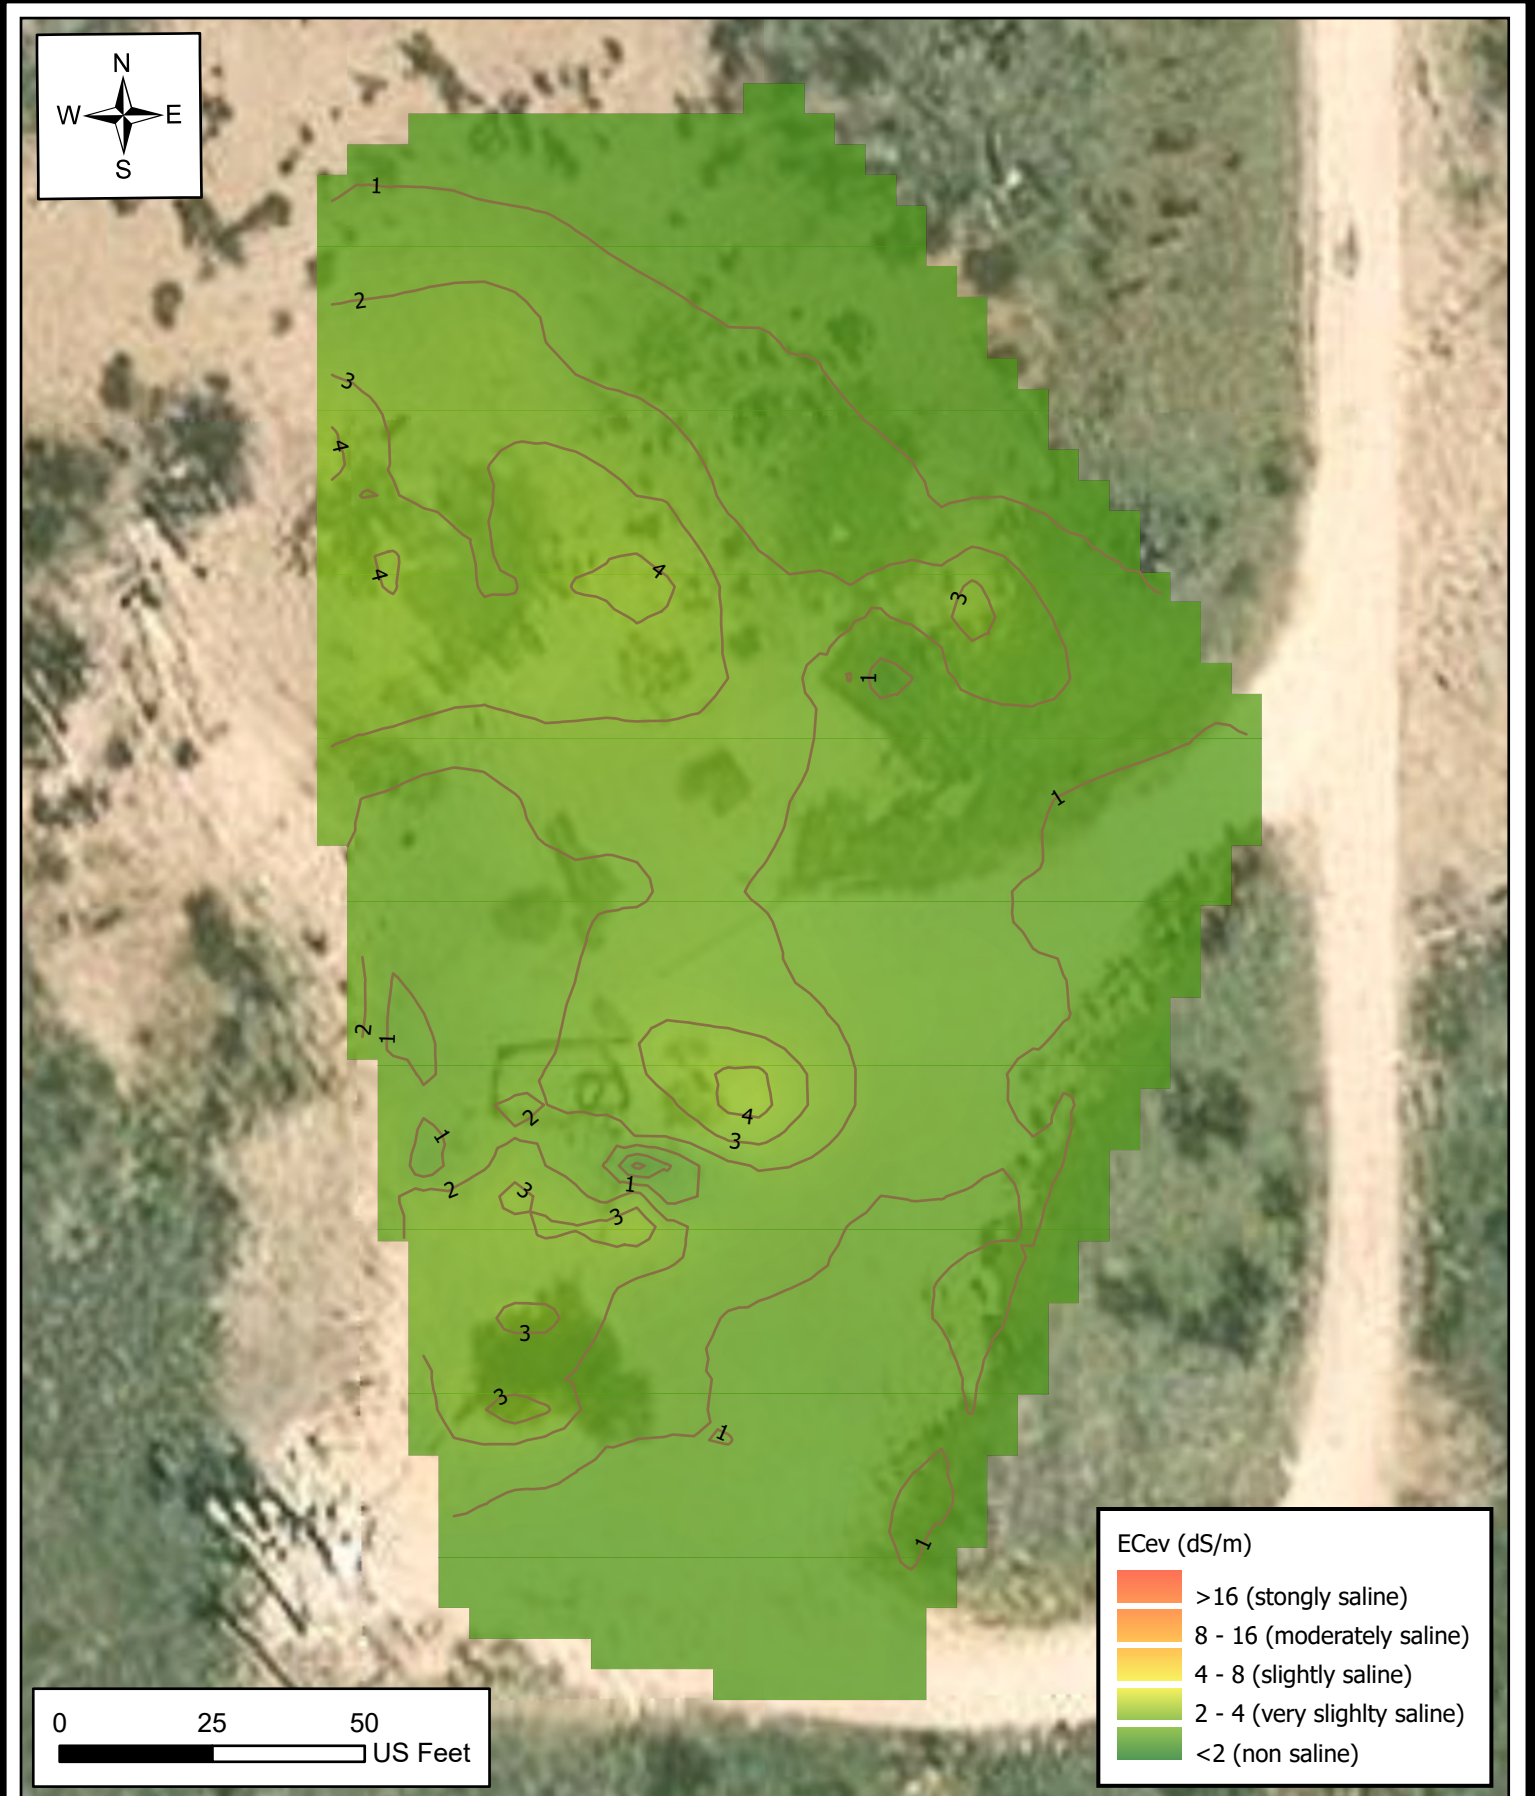
EM Survey (1-4 ft bgs)
