**cBZH2526540205**

**Compliance**

**Achievement and**

**Closure**

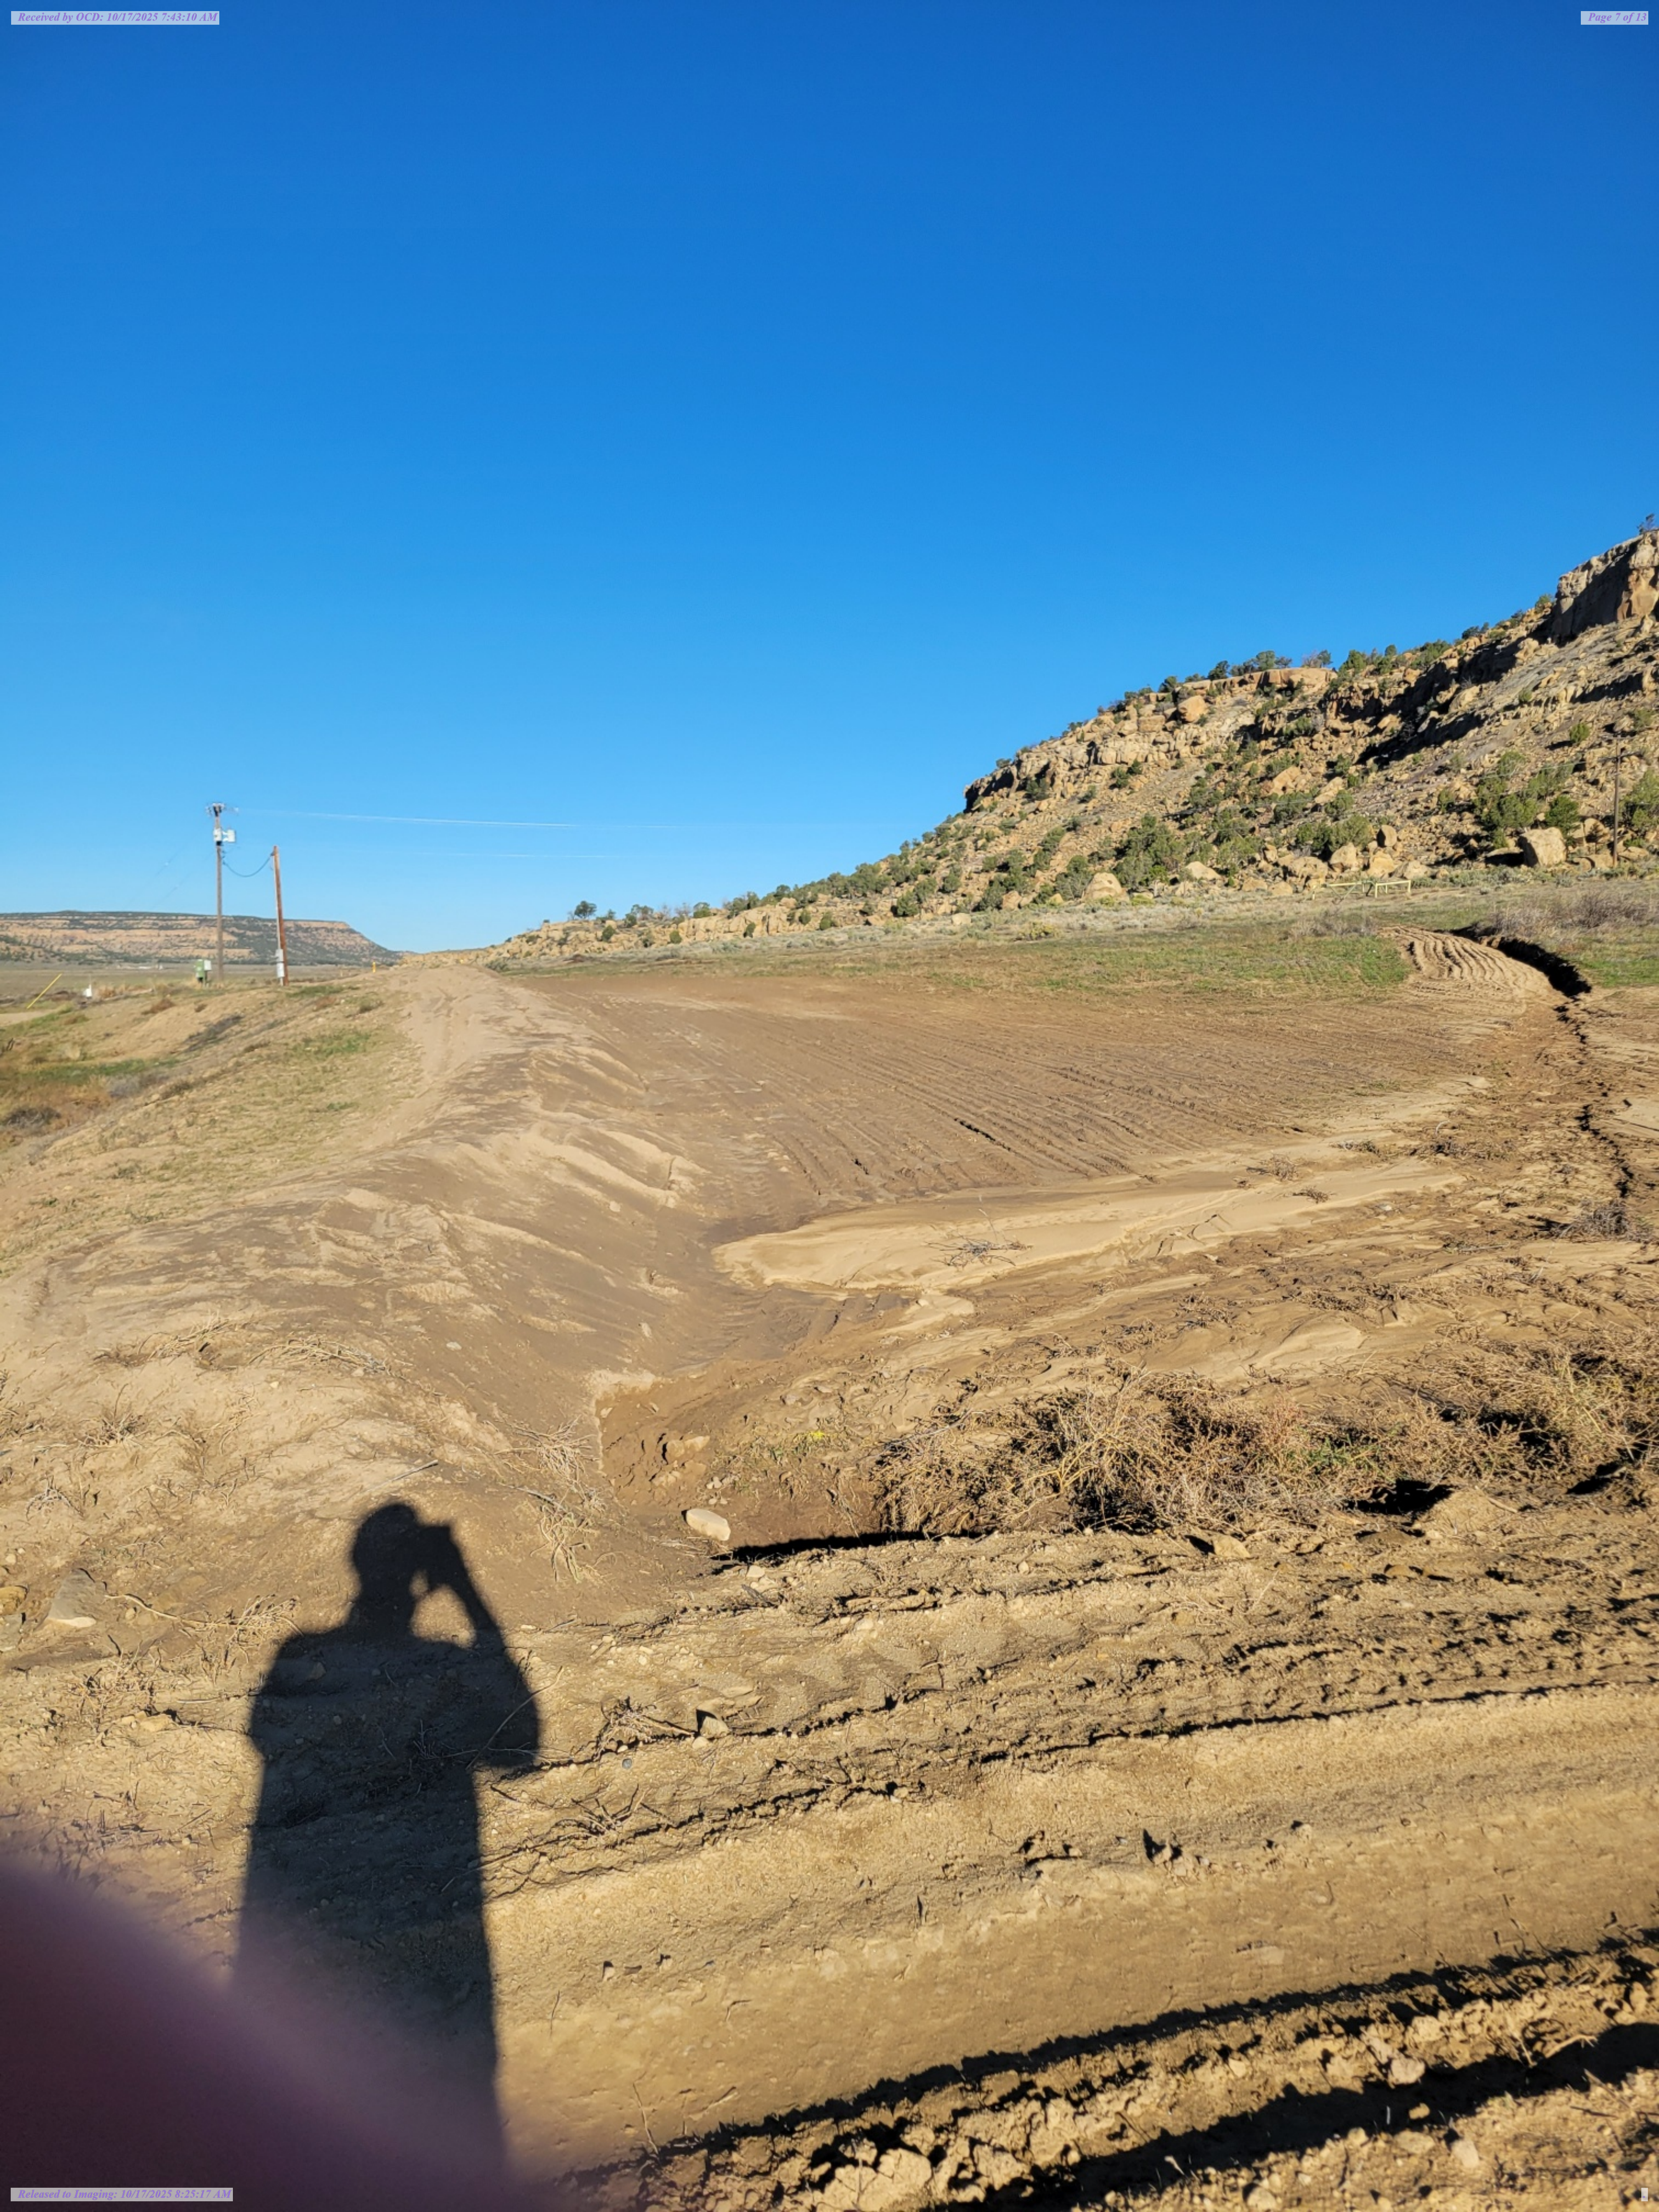
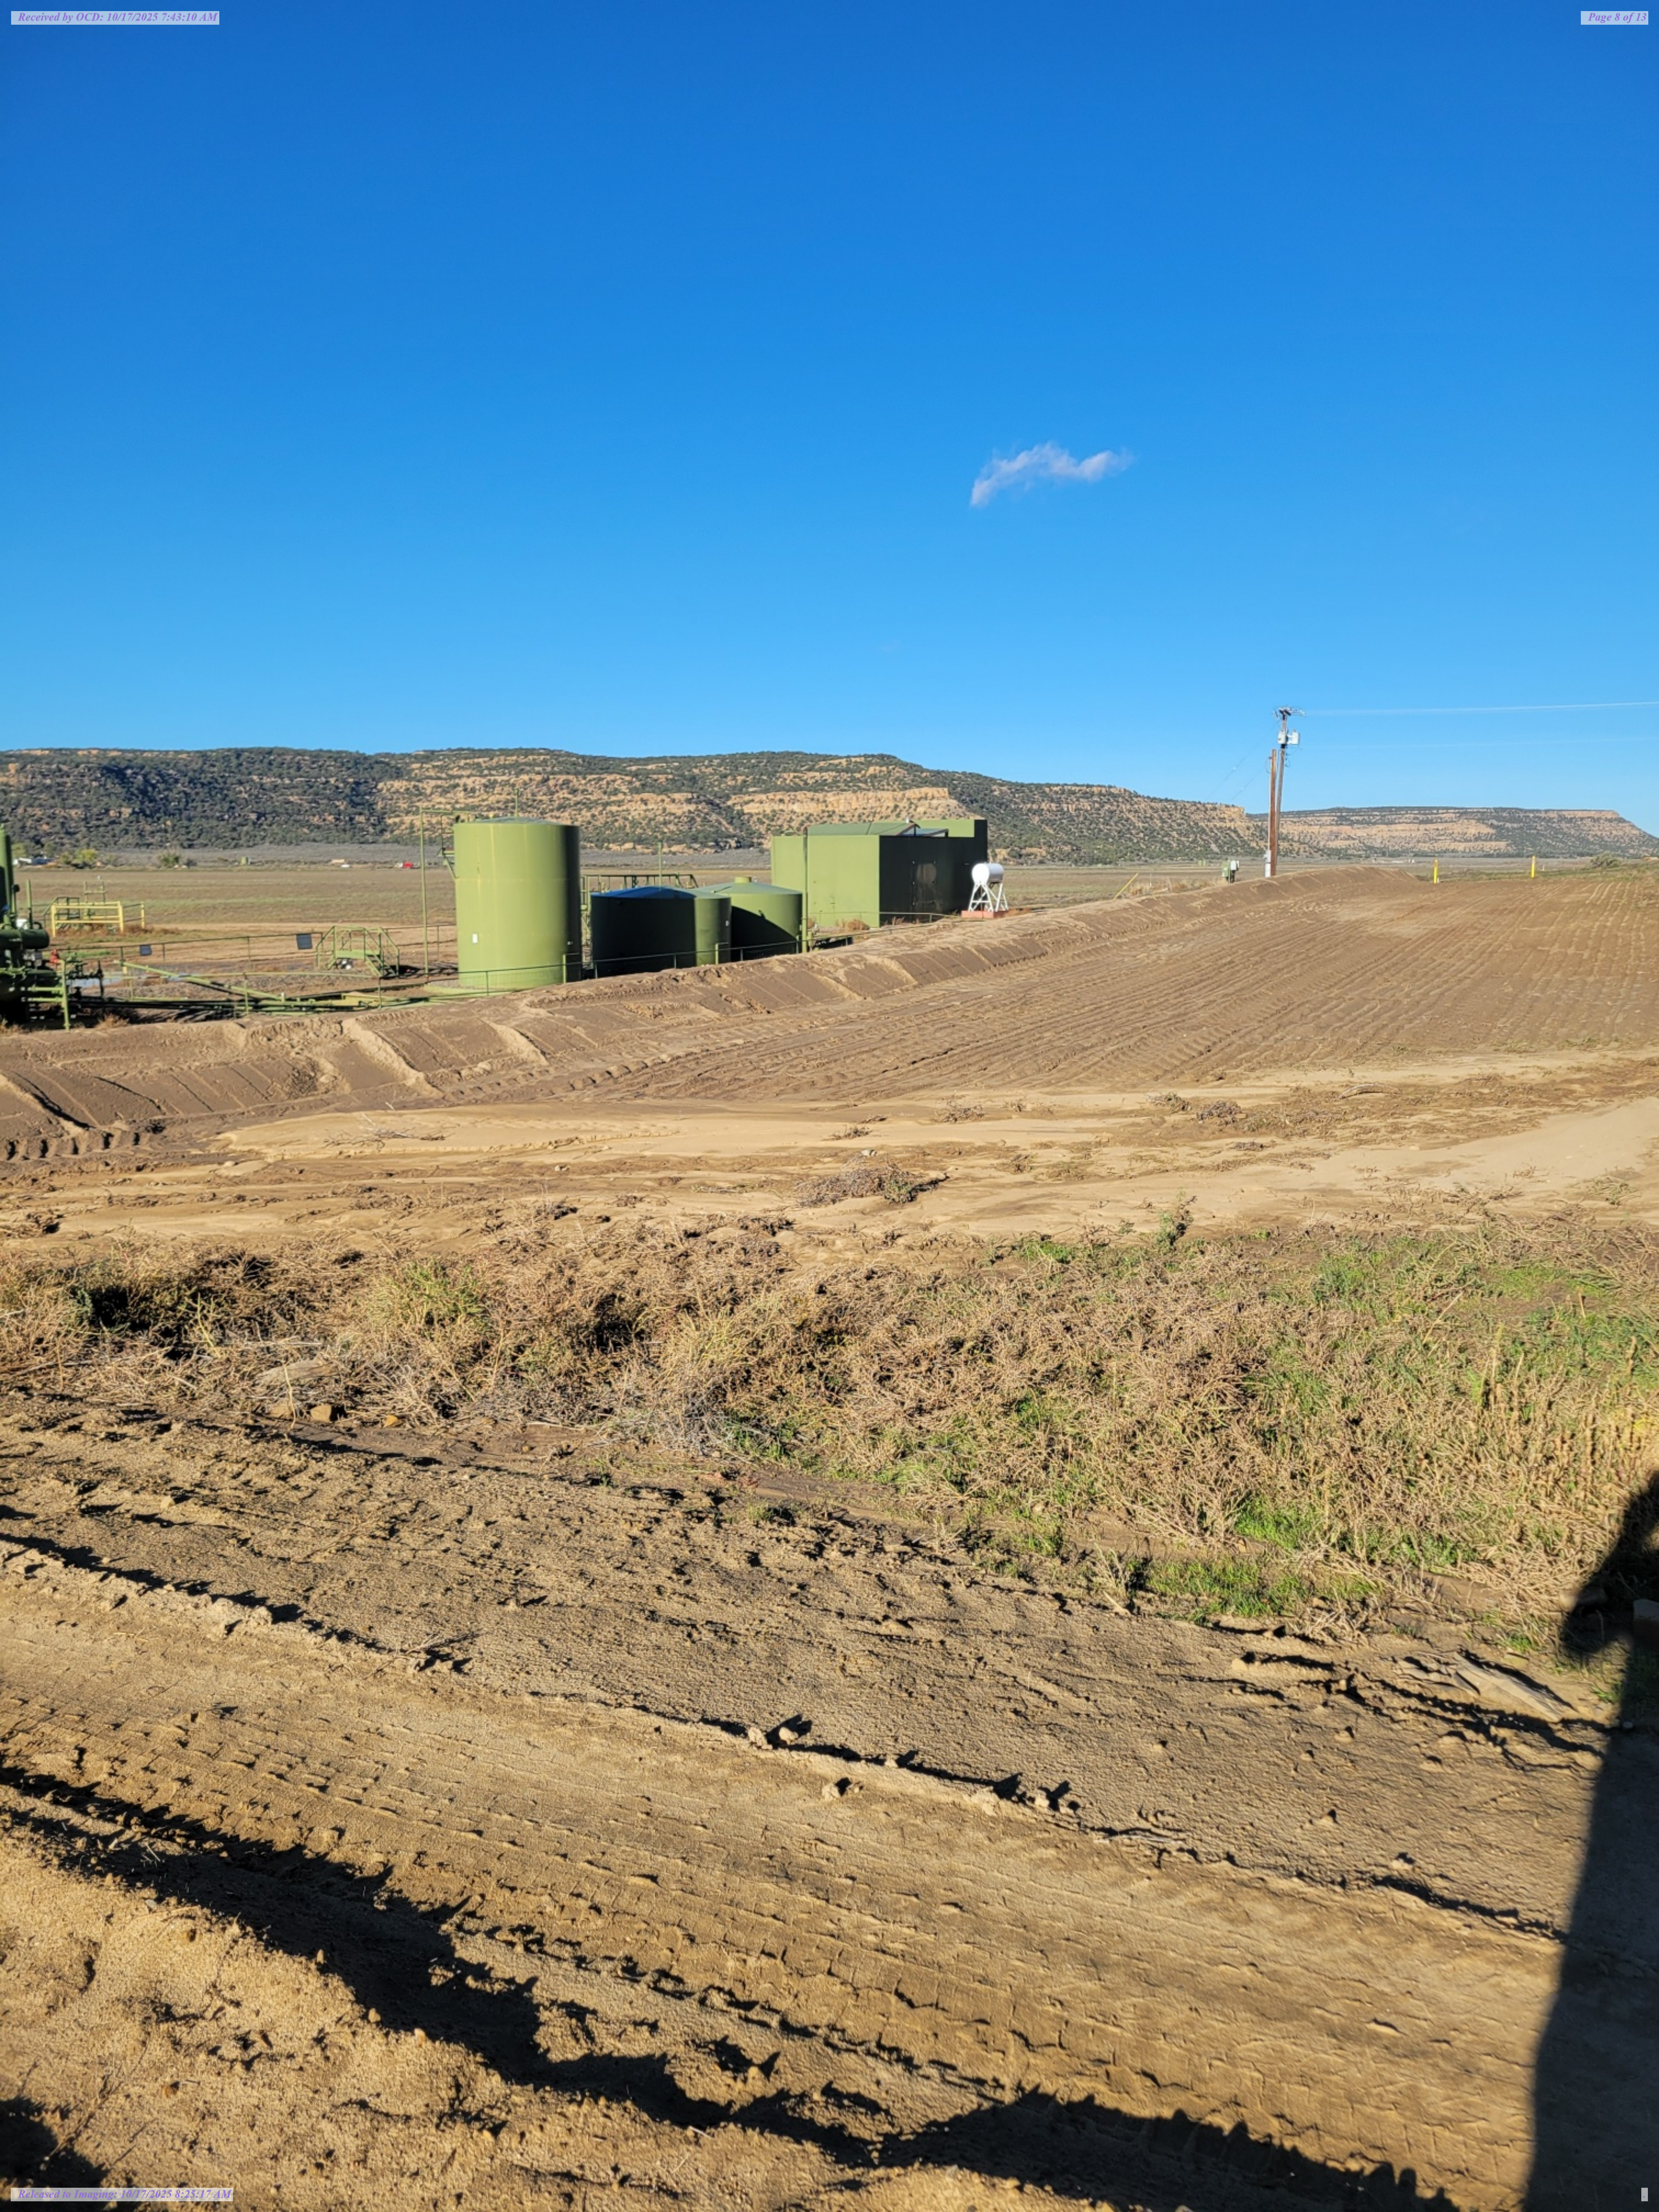
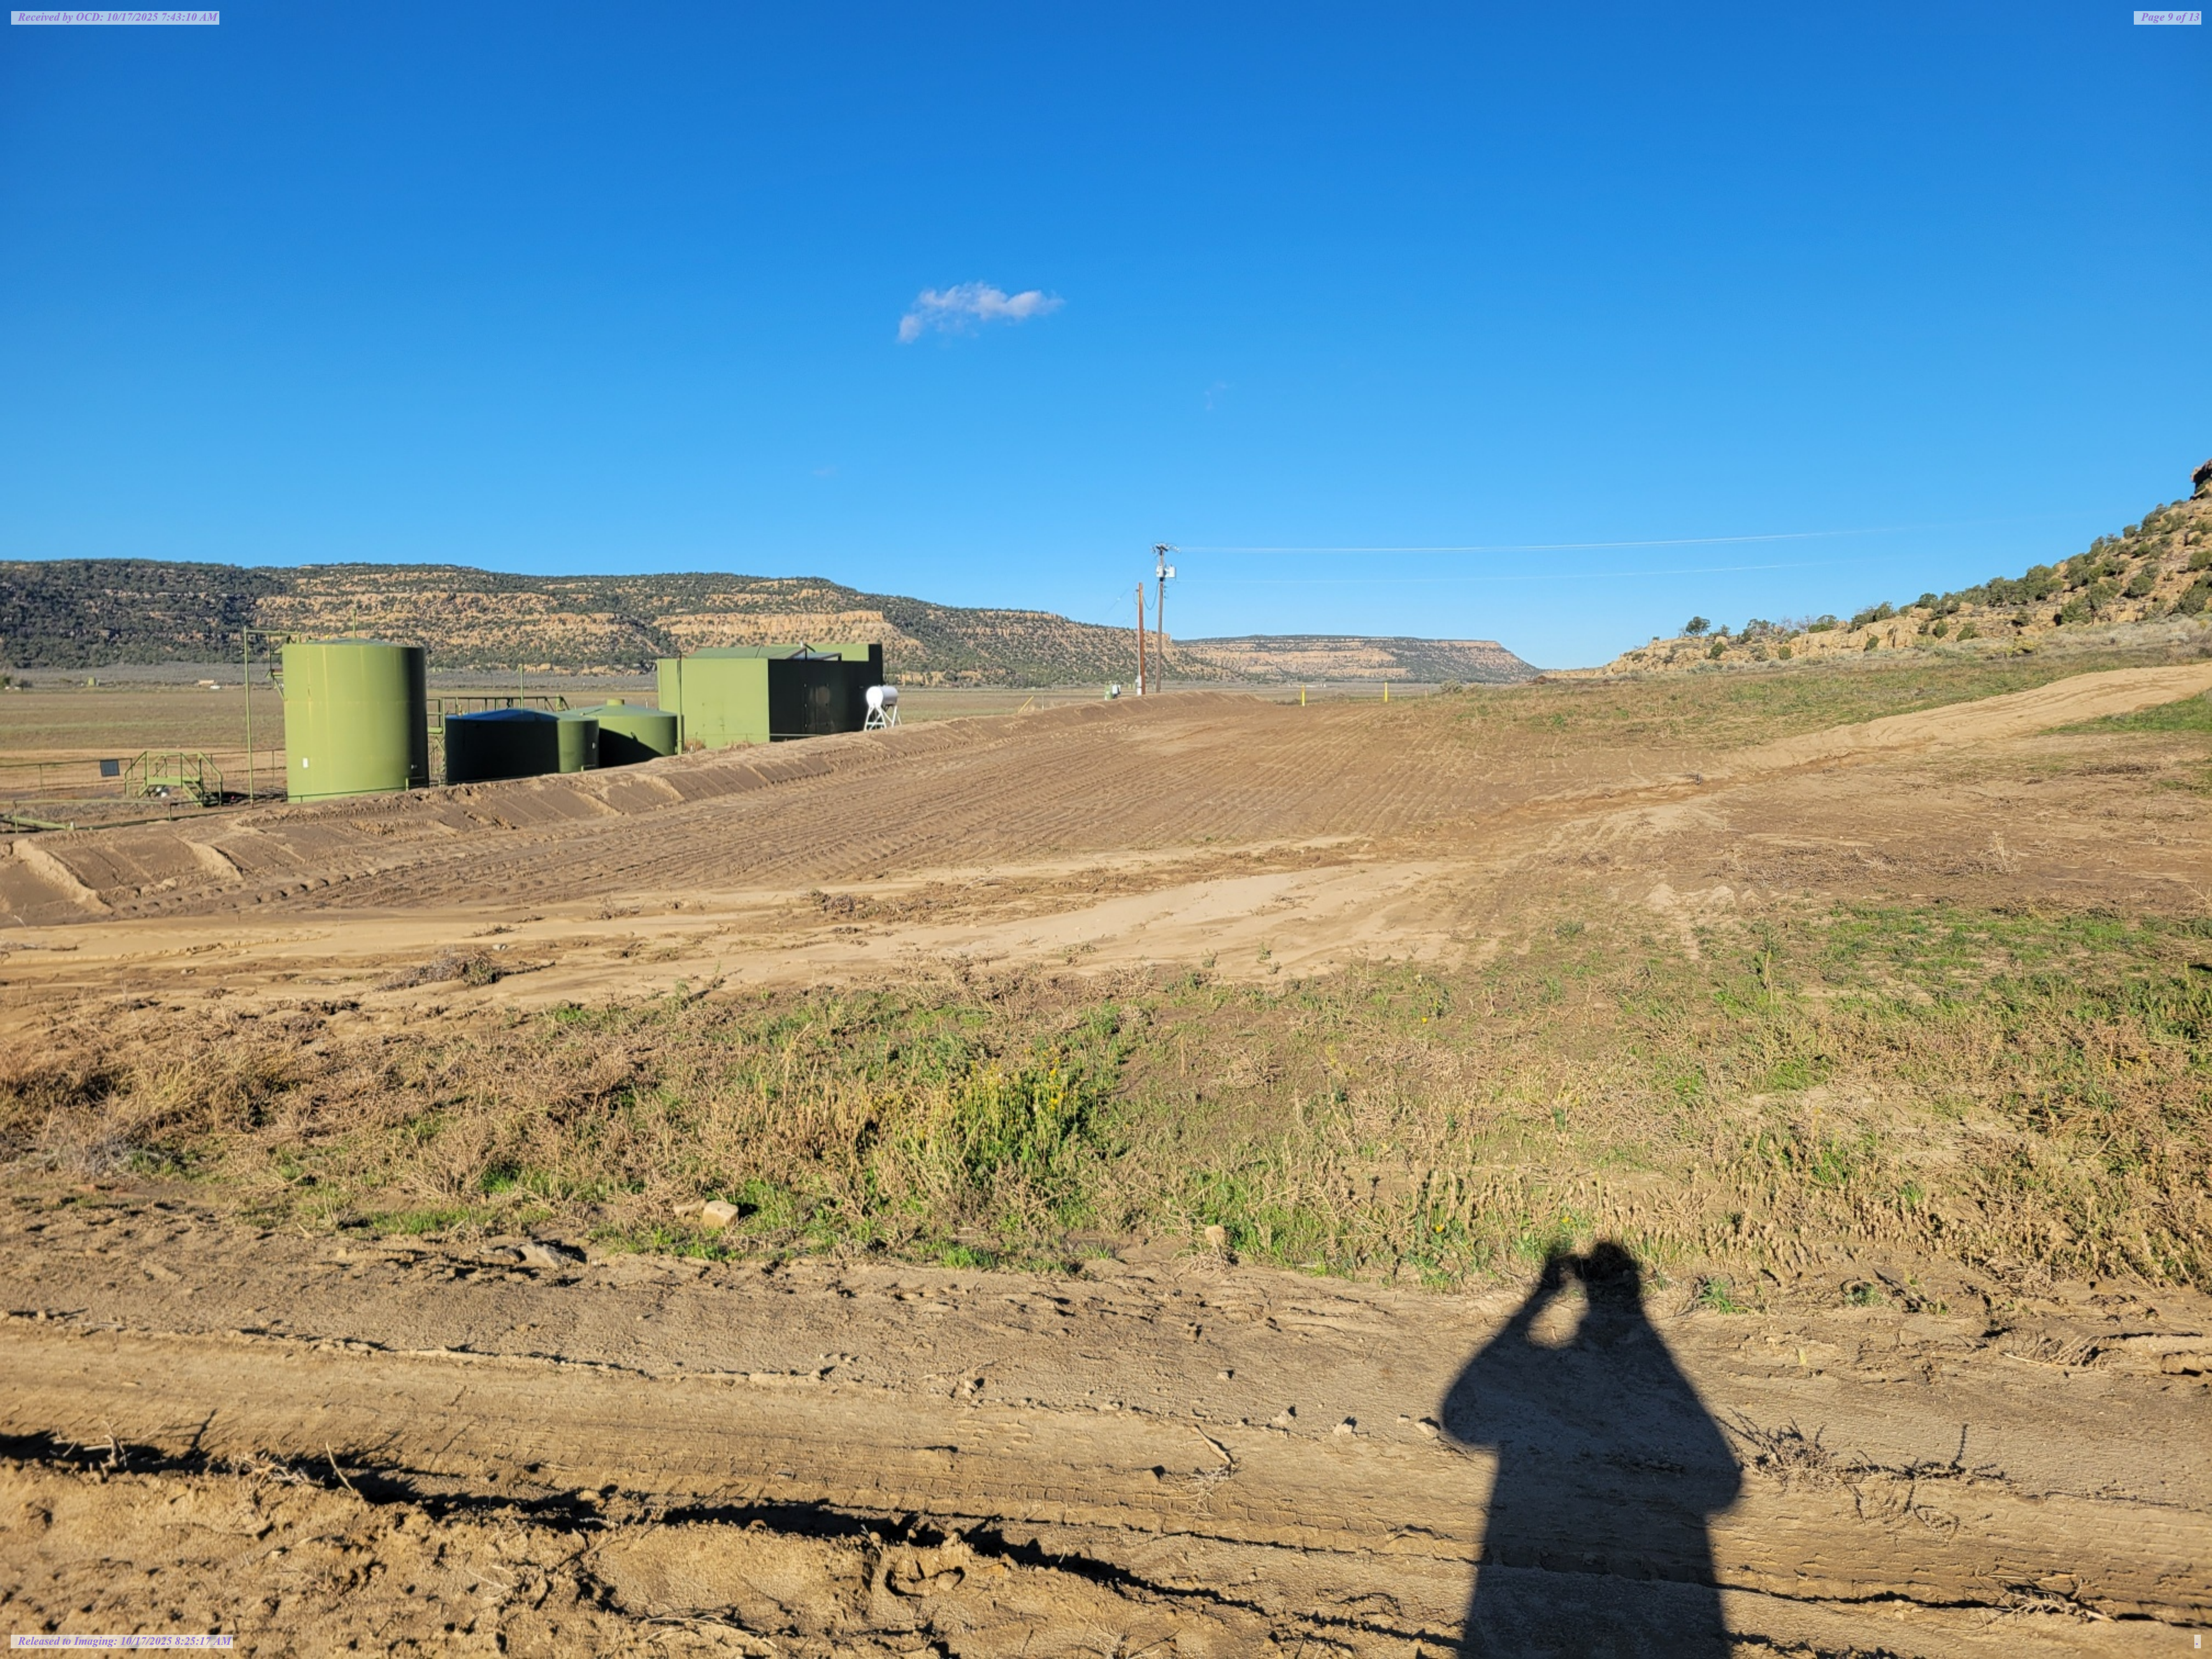
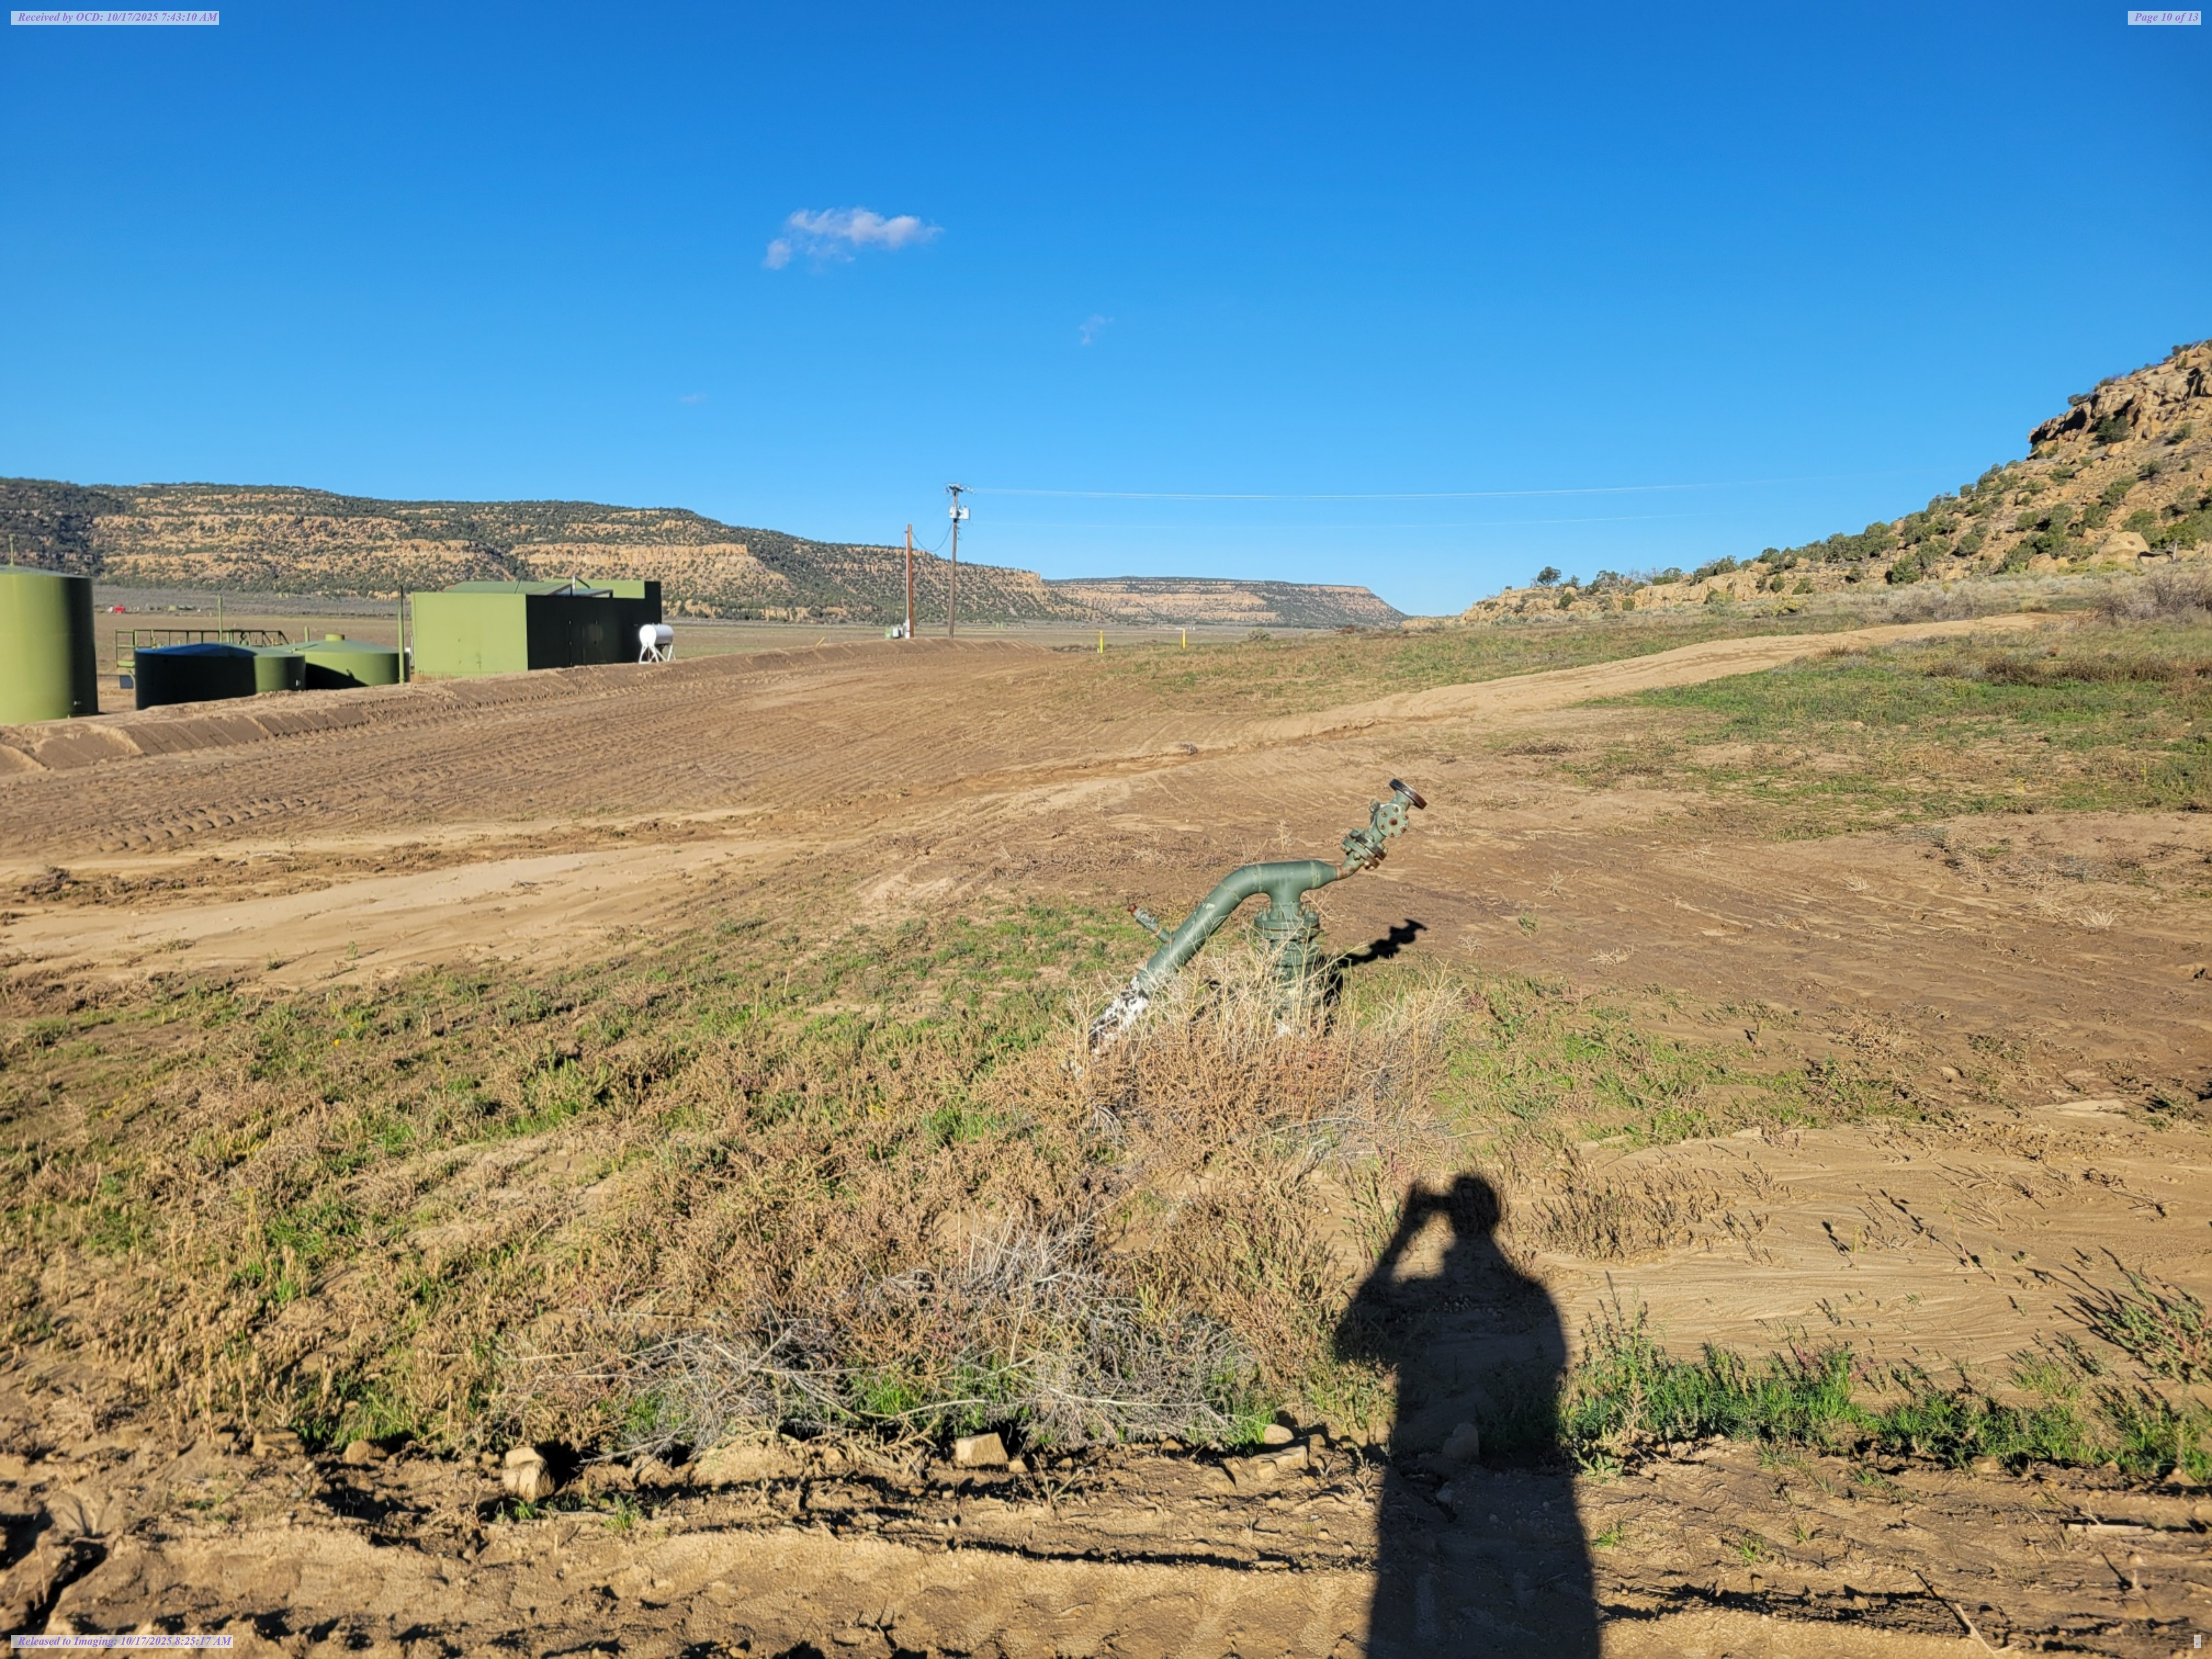
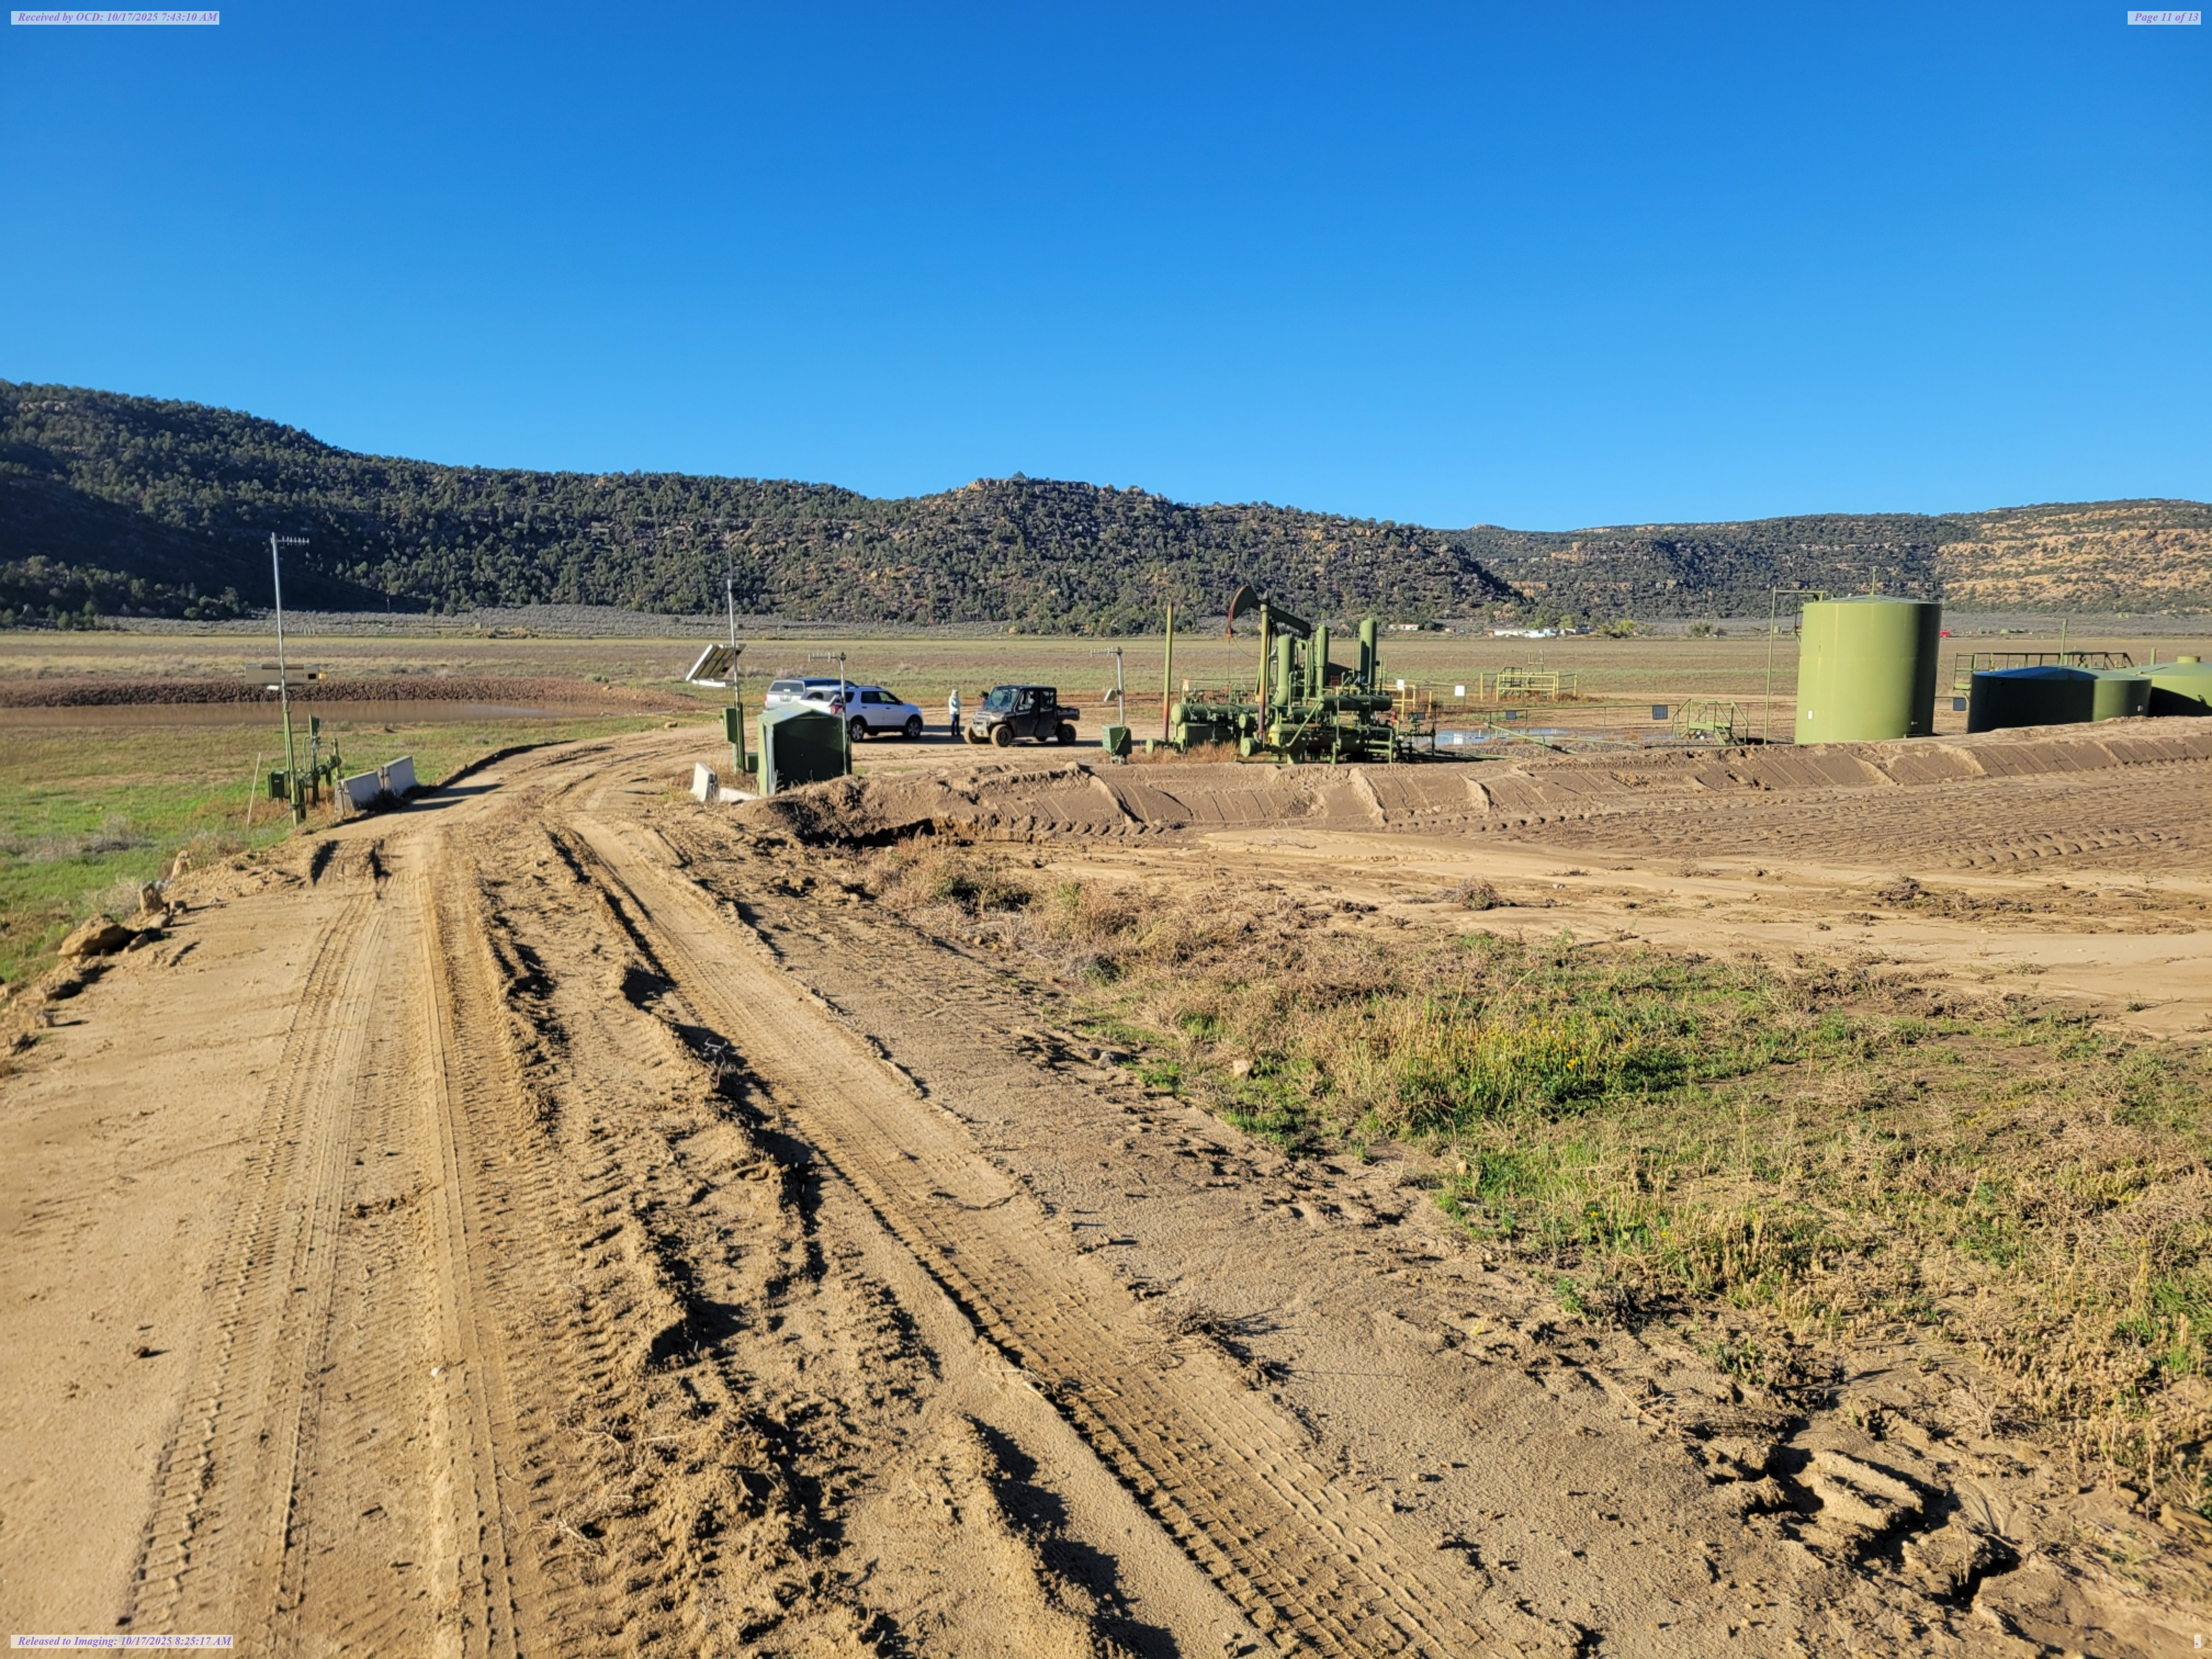
| Violation | Title | Action Due |
|---|---|---|
| cBZH2526540205 | 19.15.17 Pits, Closed-Loop Systems, Below Grade Tanks and Sumps Noncompliance with Requirements (Construction, Operations or Closure)<br><i>(Pursuant to 19.15.17.11 I. (3) NMAC effective 6/16/2008, The operator shall construct a below-grade tank to prevent overflow and the collection of surface water run-on. Inspection was prompted by landowner complaint as the BGT overflowed due to a precipitation event.)</i> | 10/17/2025 |

| INC # | Well | Action | Due Date | Hilcorp Comment |
|---|---|---|---|---|
| cBZH2526540205 | | Pursuant to 19.15.17.11 I. (3) NMAC effective 6/16/2008, The operator shall construct a below-grade tank to prevent overflow and the collection of surface water run-on. Inspection was prompted by landowner complaint as the BGT overflowed due to a precipitation event.) | 10/17/2025 | Hilcorp will remove the BGT in accordance with the procedures outlined in NMAC 19.15.17.13. In addition, Hilcorp installed flood mitigation features to minimize impacts due to precipitation and flooding events. A ditch was established upstream of the existing berm and the existing culvert was cleaned out. The ditch is approximately 2' deep. The berm was reestablished with 8 loads of material and is approximately 3' tall. Figure attached for reference. |

You will be receiving an approval for an application shortly. The application I am creating will include a copy of this email chain and the photos of the berm, ditch, and culvert work. This is to document the closure of **cBZH2526540205** and to document the approval of the extension and witnessing requirements for **cBZH2526540158**.

We appreciate the due date extension to 12/17/2025 for cBZH2526540158. Please see the attached photos for cBZH2526540205 and let us know if these are enough to close the compliance.
