BUCKEYE STATE AF #003
Soil Chloride Results
Pad of Former Salt Water Disposal Well
December 2023

BUCKEYE STATE AF #003
Soil Chloride Results
Former Tank Battery Location
December 2023

BUCKEYE STATE AF #003
Soil TPH Results
Former Tank Battery Location
December 2023

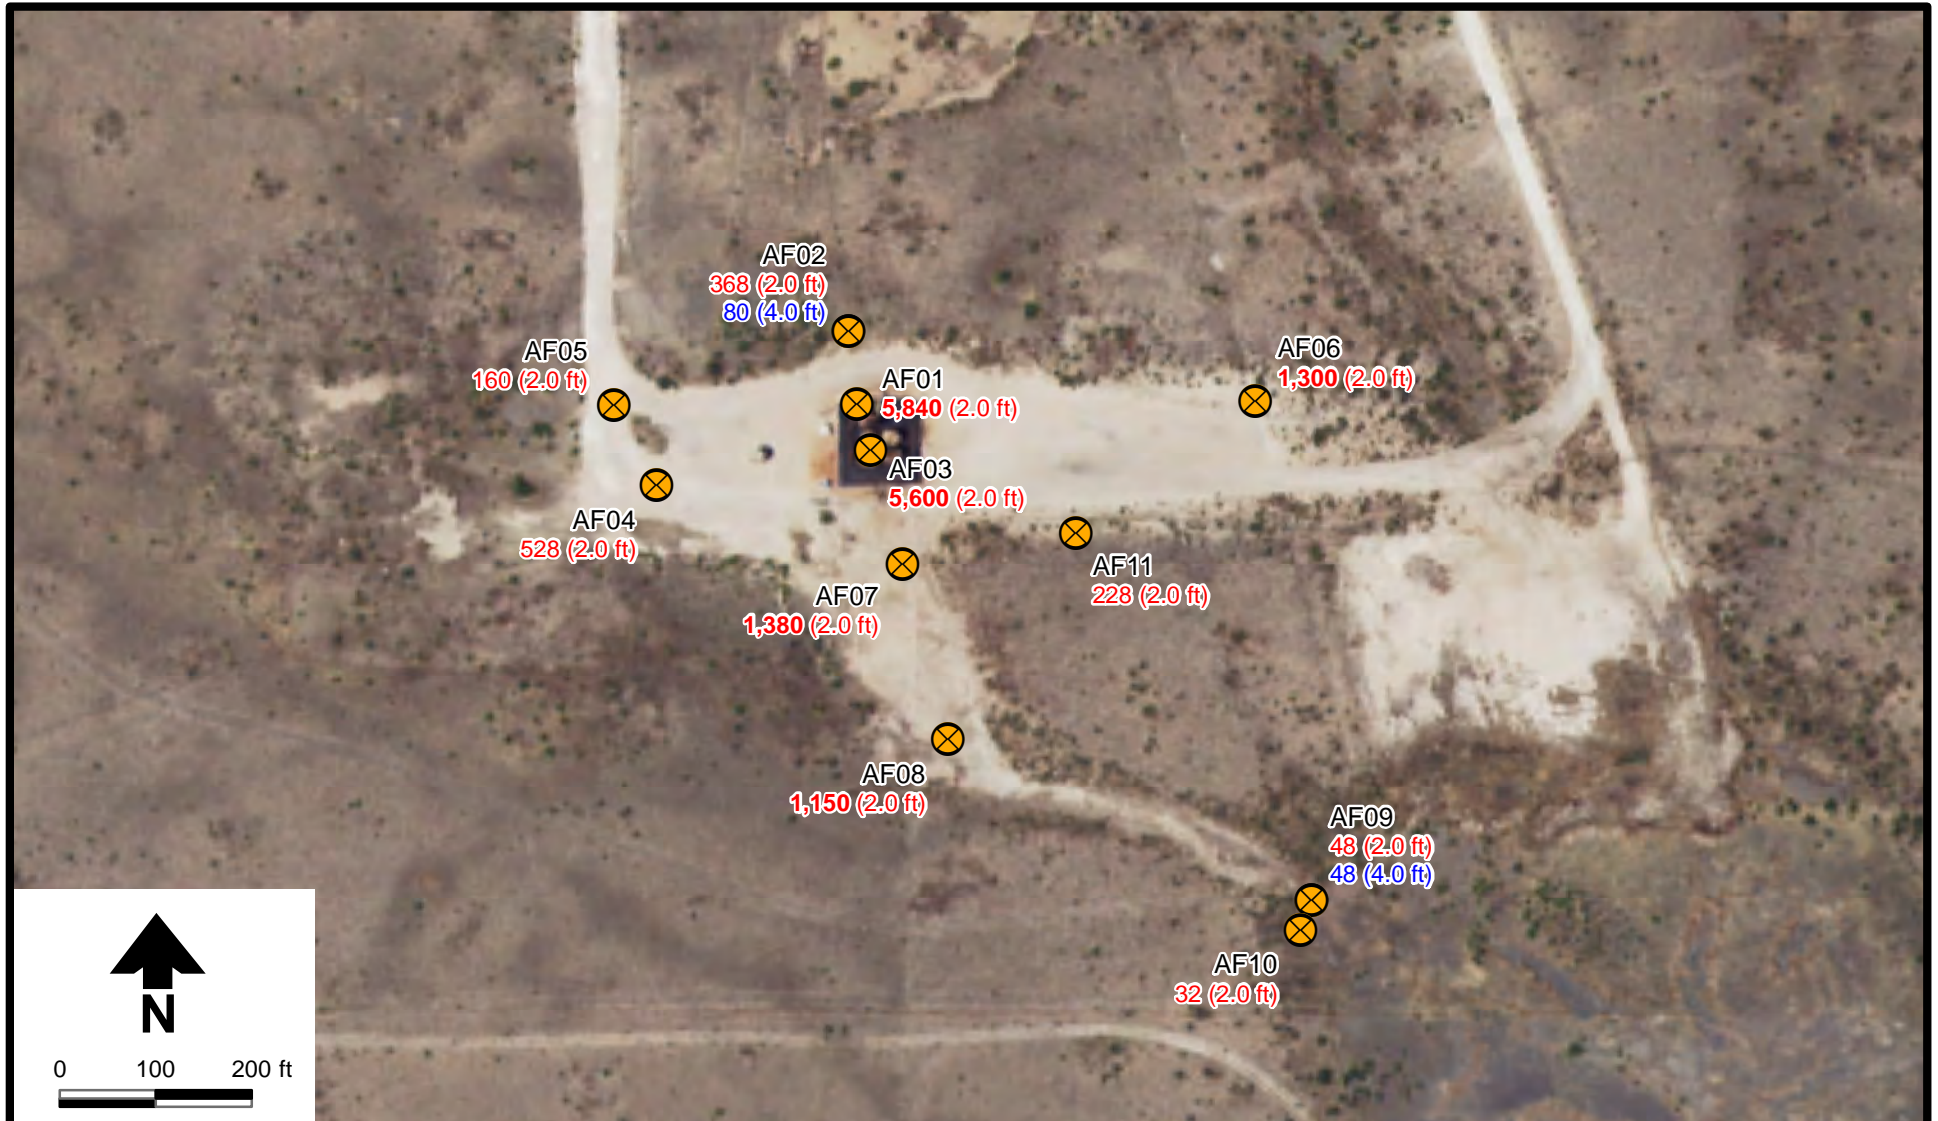
Figure 3b

- AF02 Soil Chloride (mg/kg)
- 368 (2.0 ft) **Shallow** (Depth)
- 80 (4.0 ft) **Deep** (Depth)
- December 2023 sample location

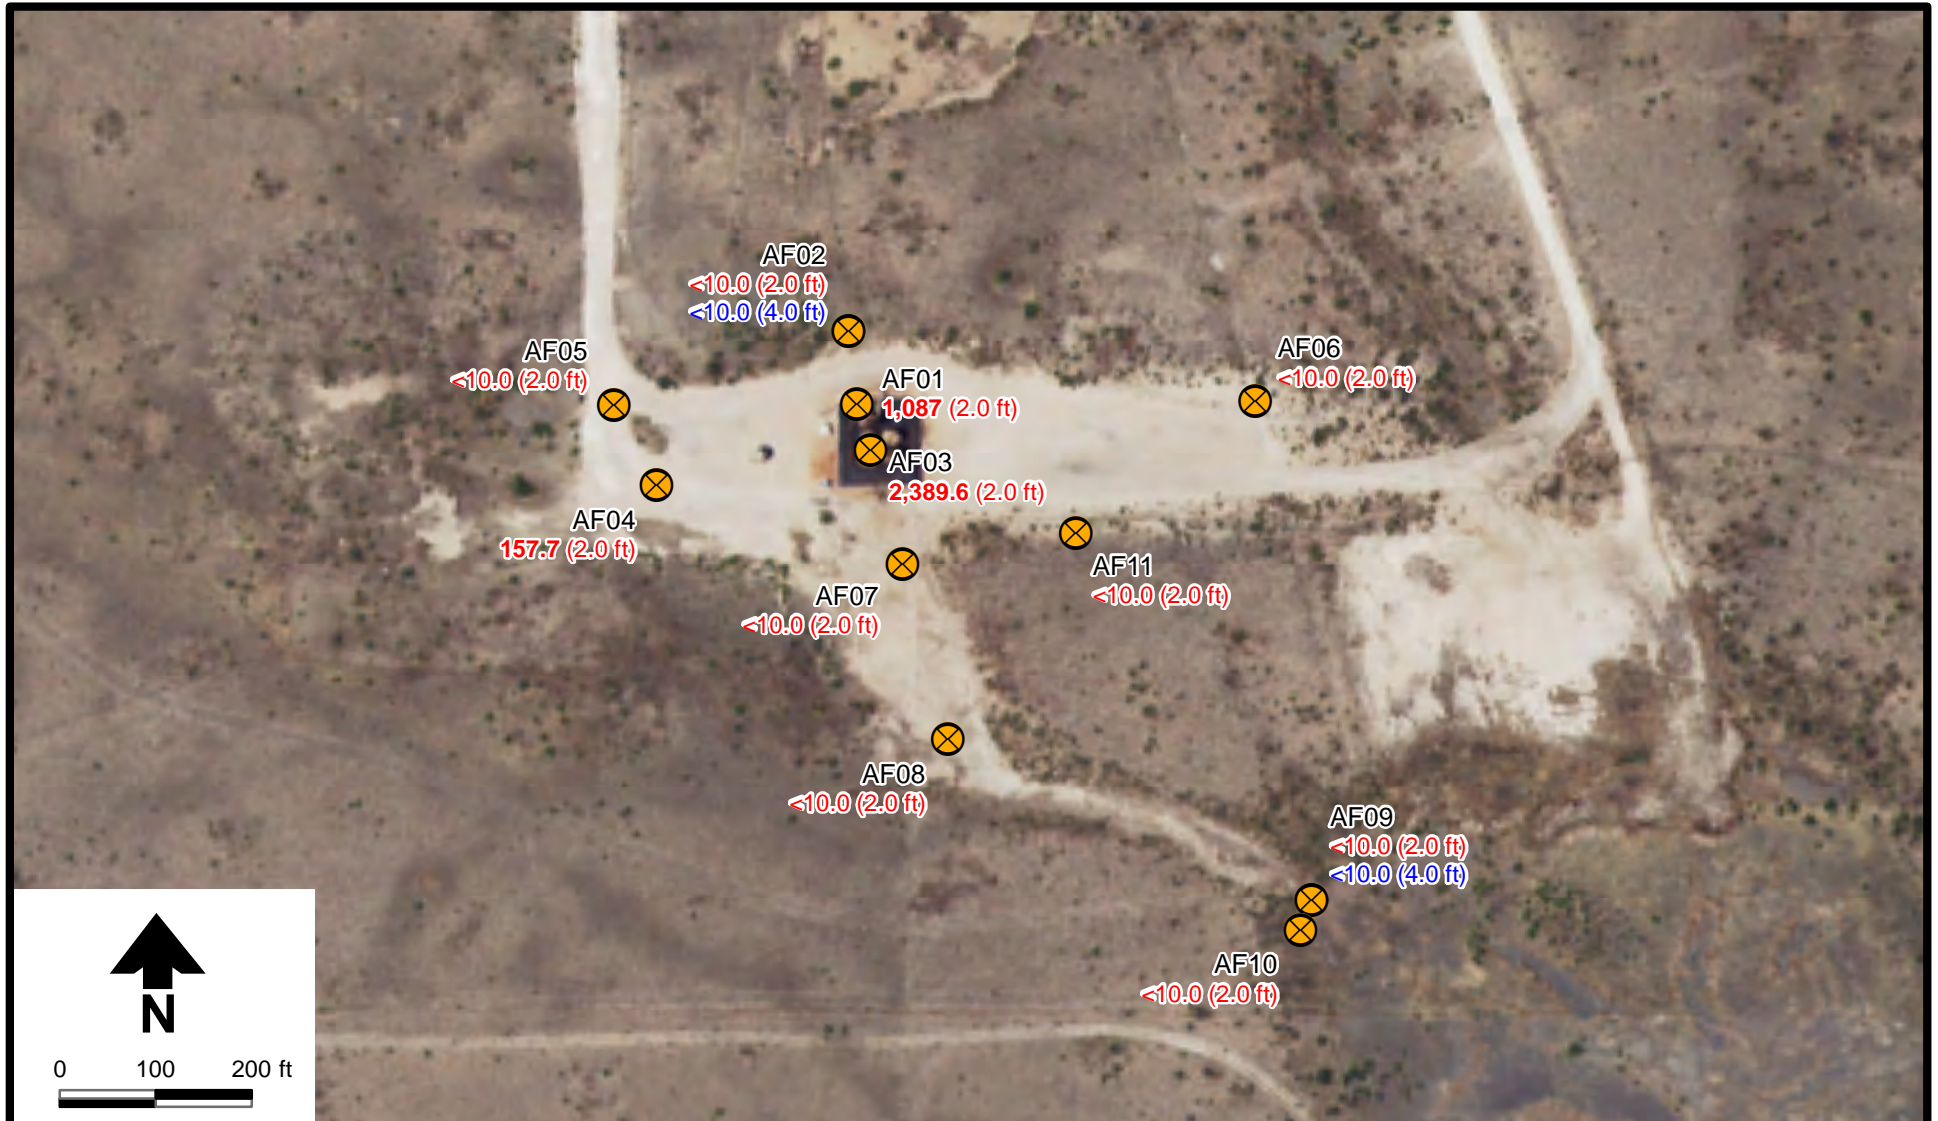
Figure 4b

- AF02 Soil TPH (mg/kg)
- <10.0 (2.0 ft) **Shallow** (Depth)
- <10.0 (4.0 ft) **Deep** (Depth)
- ⊗ December 2023 sample location

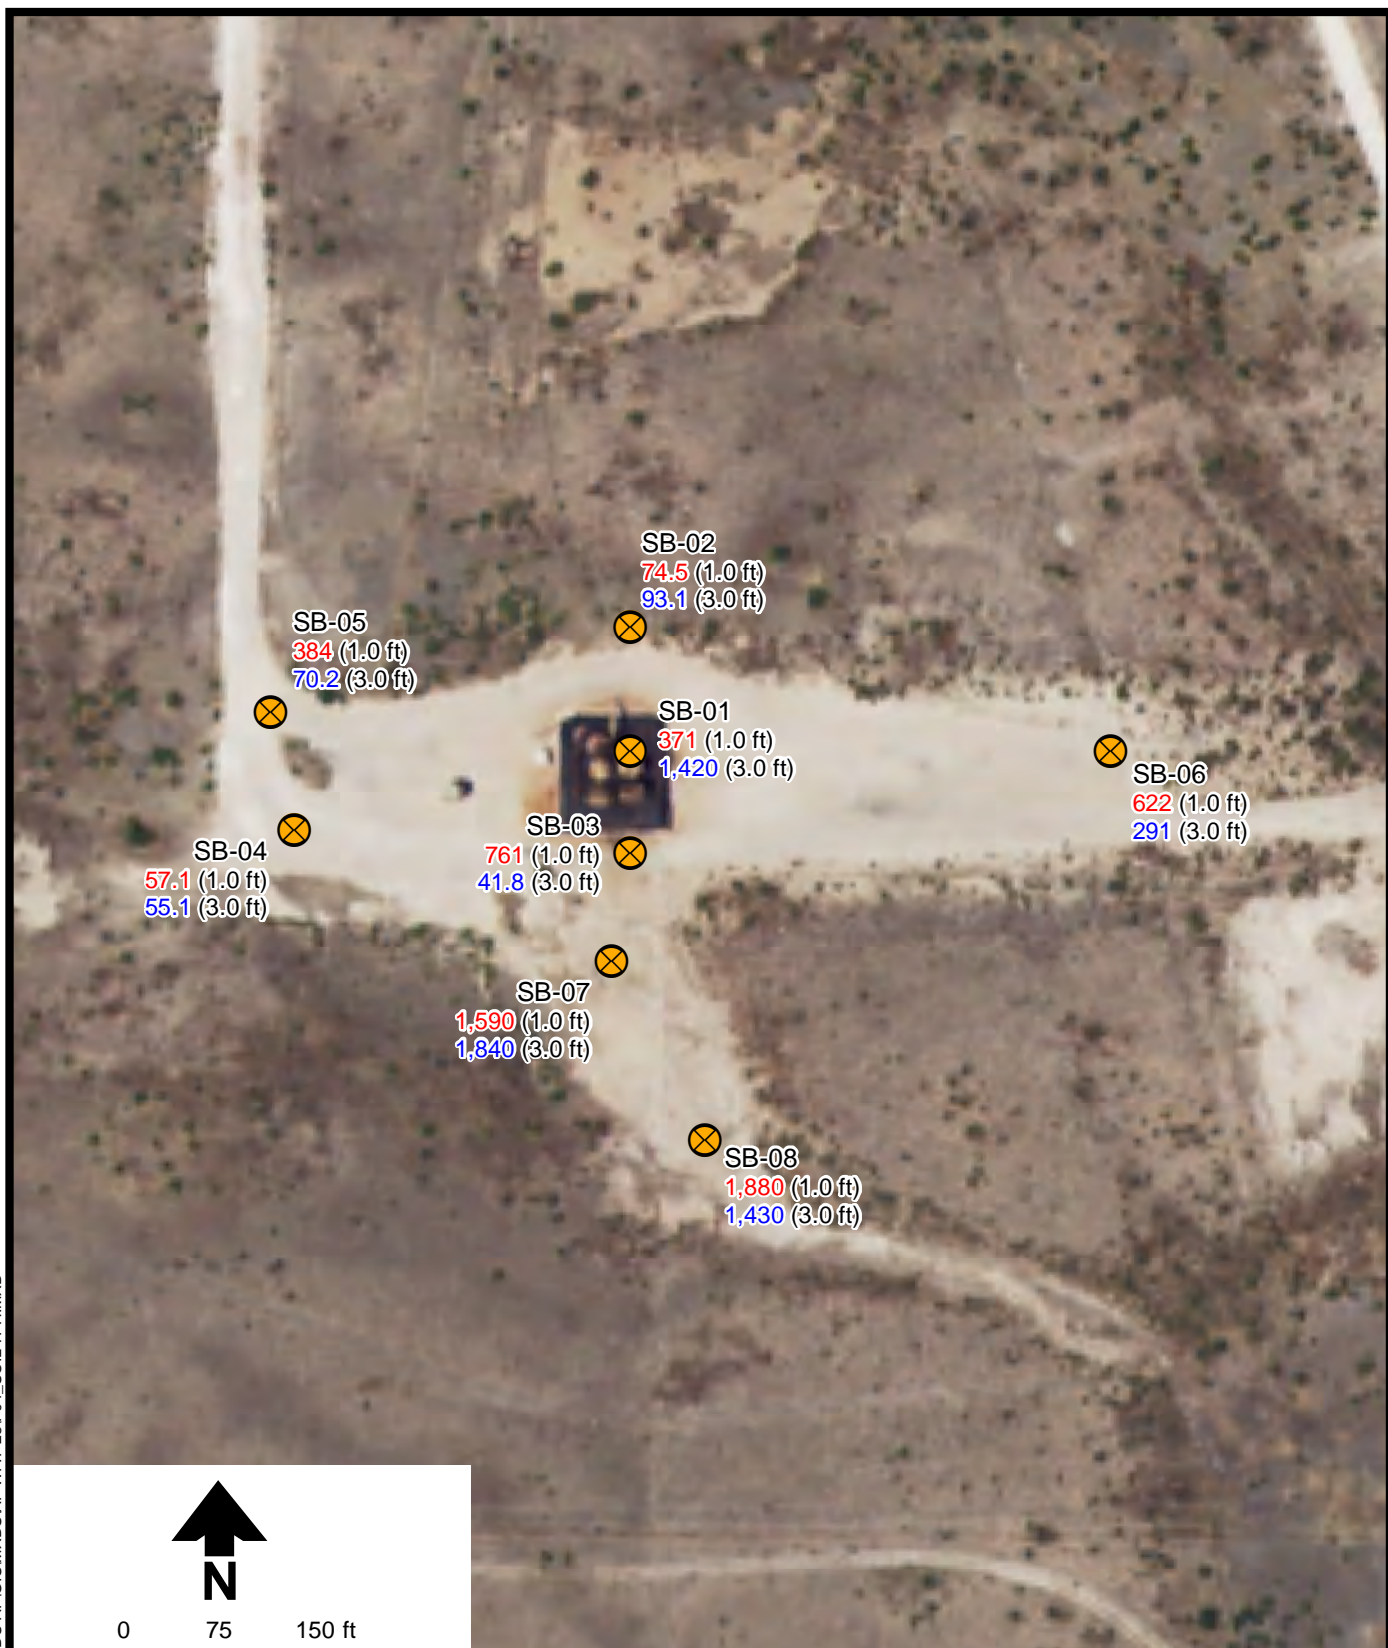
Note: TPH = Total Petroleum Hydrocarbons Source: Aerial imagery (NAIP, 2022).

- Explanation**
- SB-01 TPH concentration (mg/kg)
 - 371 (1.0 ft) **Shallow** (Depth)
 - 1,420 (3.0 ft) **Deep** (Depth)
 - ⊗ Sample location

BUCKEYE STATE AF #003
Soil Borehole Investigation
TPH Concentrations in Soil

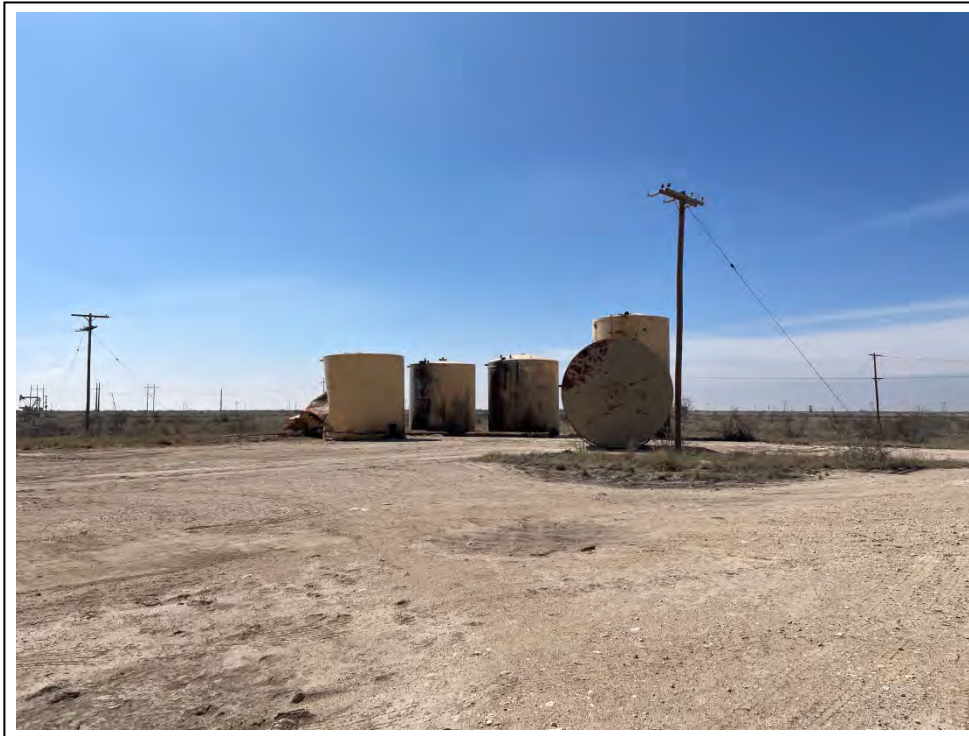
1. Empty ASTs staged for removal

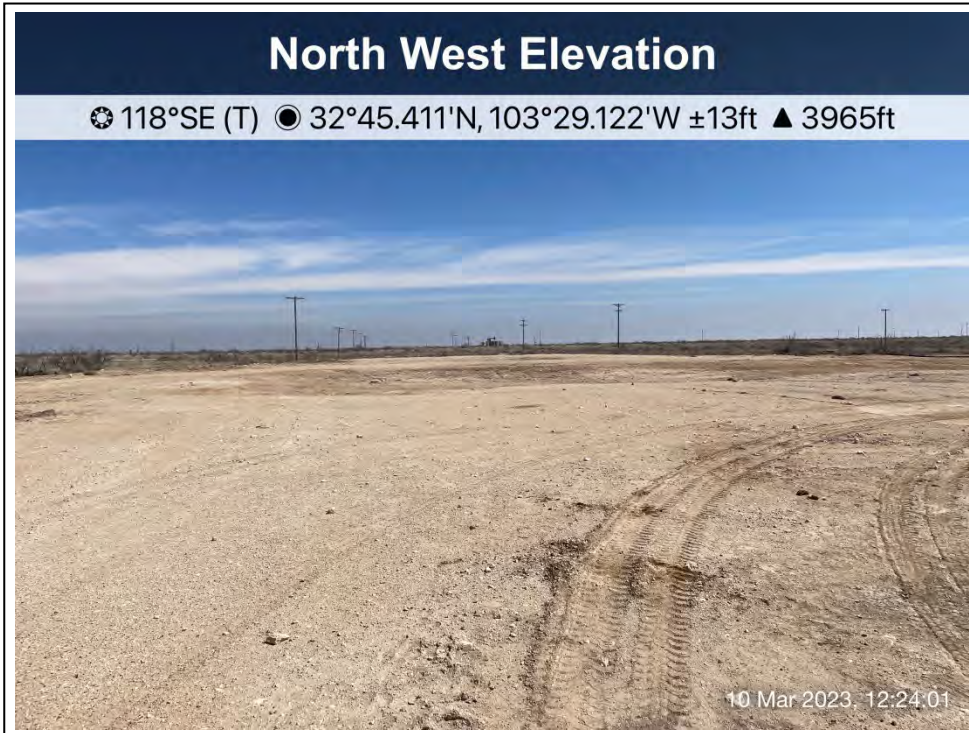
2. Unvegetated area to be reclaimed
