**RE: LINER INSPECTION REPORT  
BILLIKEN CENTRAL TANK BATTERY (NRM2026543414)**

Devon Energy Production Company  
Billiken Central Tank Battery (NRM2026543414)

**Appendix A**  
**PHOTO LOG, FIELD NOTES & LINER INSPECTION FORM**

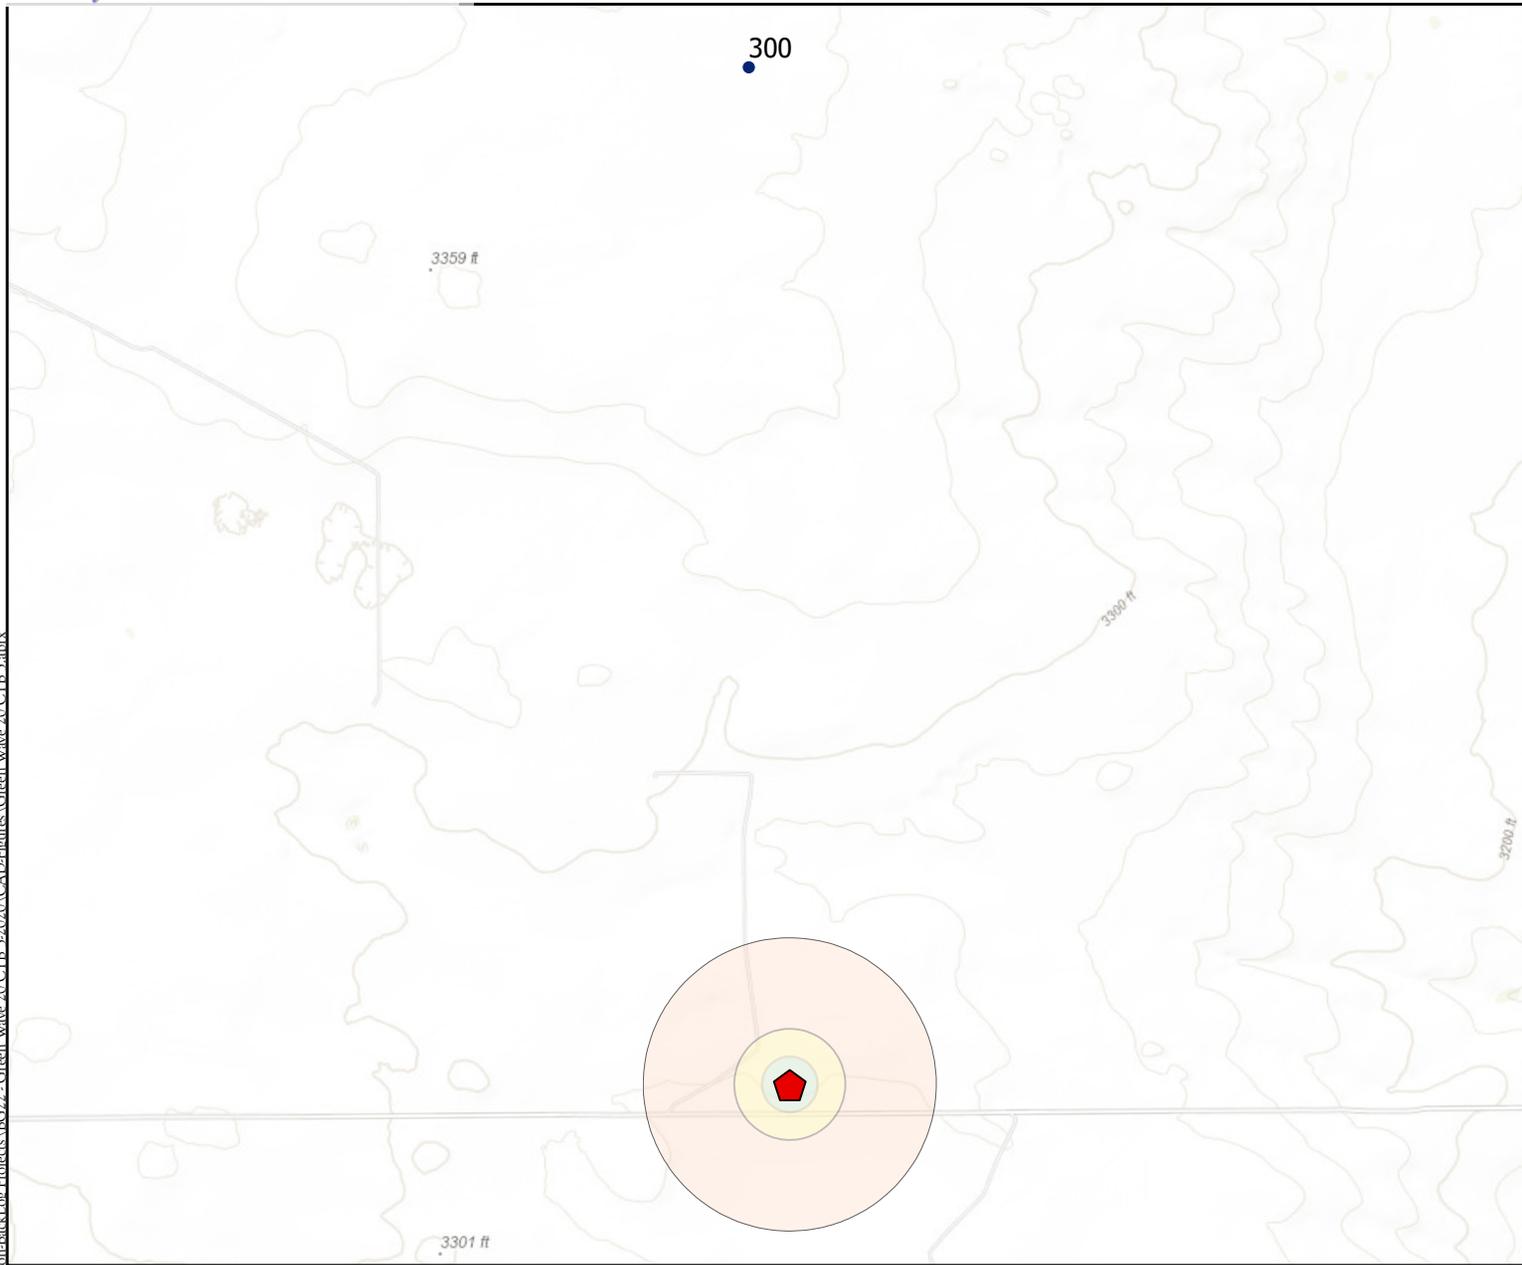
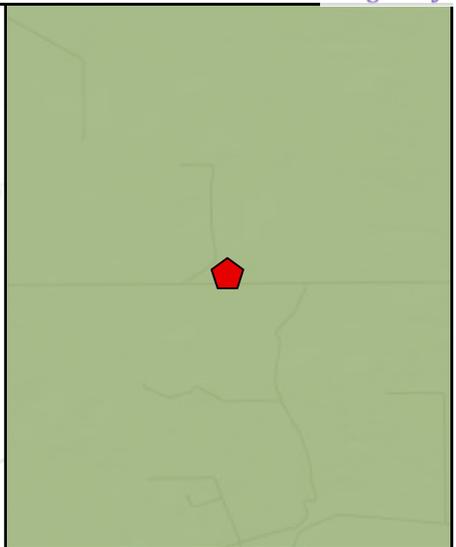
Figure 1

**Site Map**  
 Billiken Central Tank Battery - Devon Energy Production Company  
 32.0658564, -103.41413200, Lea County, New Mexico

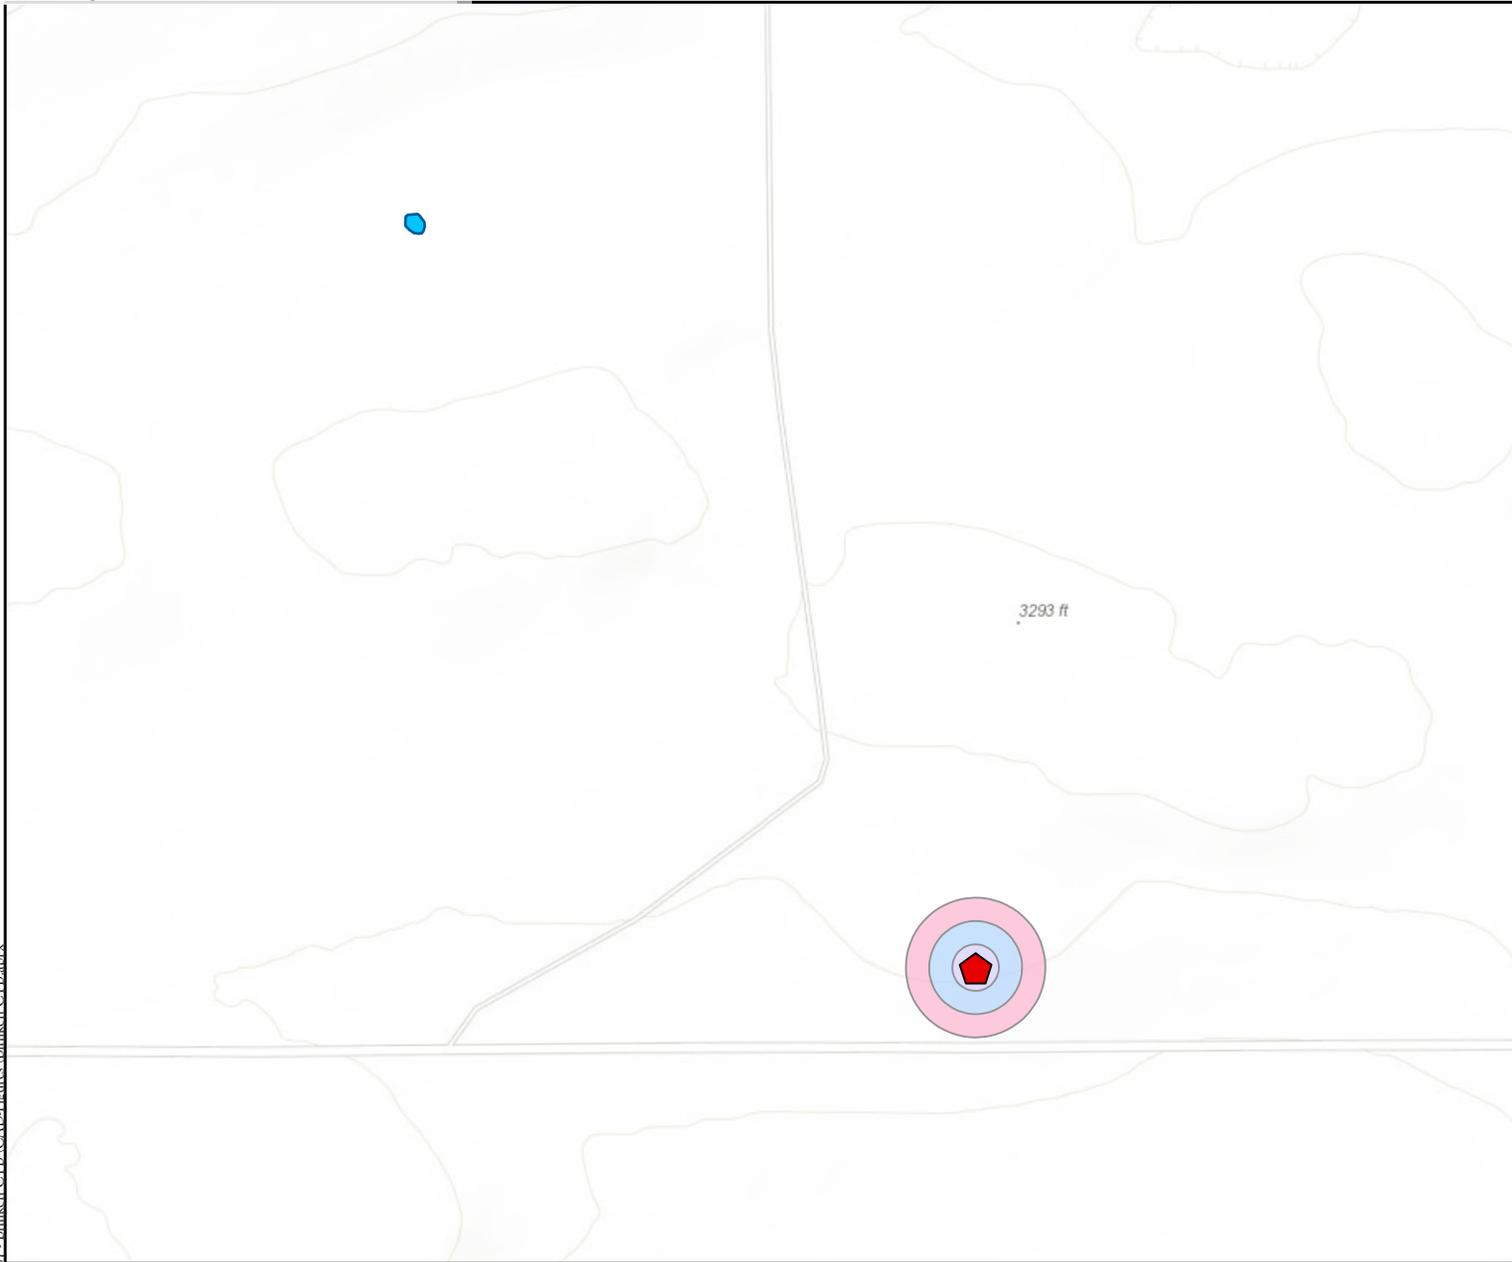
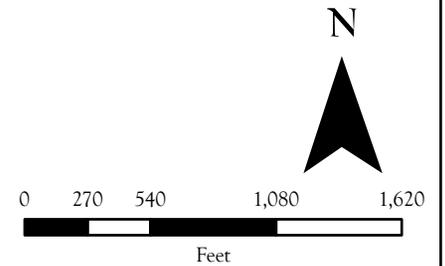
Figure 2

Surface Water Protection Map  
 Billiken Central Tank Battery - Devon Energy Production Company  
 UL: M S: 6 T: 26S R: 35E, Lea County, New Mexico

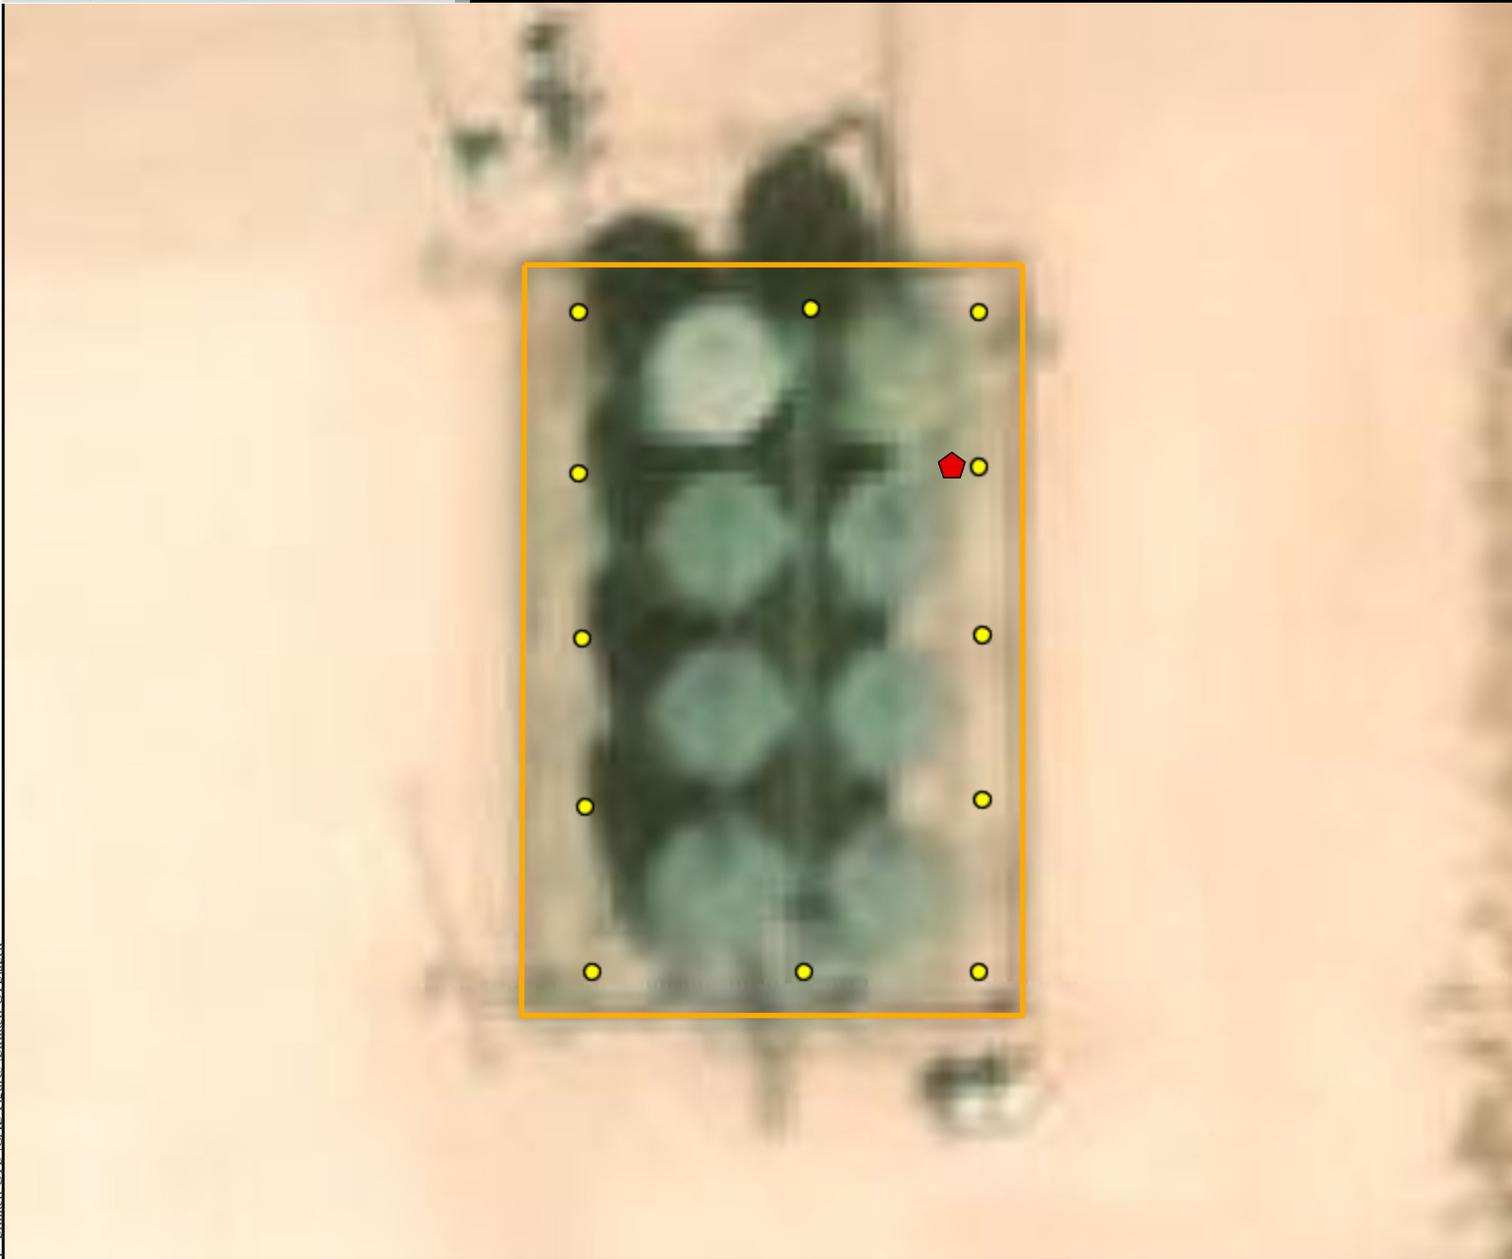
Figure 3

Secondary Containment

*Site and Sample Location Map*  
 Billiken Central Tank Battery - Devon Energy Production Company  
 UL: M S: 6 T: 26S R: 35E, Lea County, New Mexico
