**RE: LINER INSPECTION REPORT  
BILLIKEN CENTRAL TANK BATTERY (NRM2026543414)**

Devon Energy Production Company  
Billiken Central Tank Battery (NRM2026543414)

**Appendix A**  
**PHOTO LOG, FIELD NOTES & LINER INSPECTION FORM**

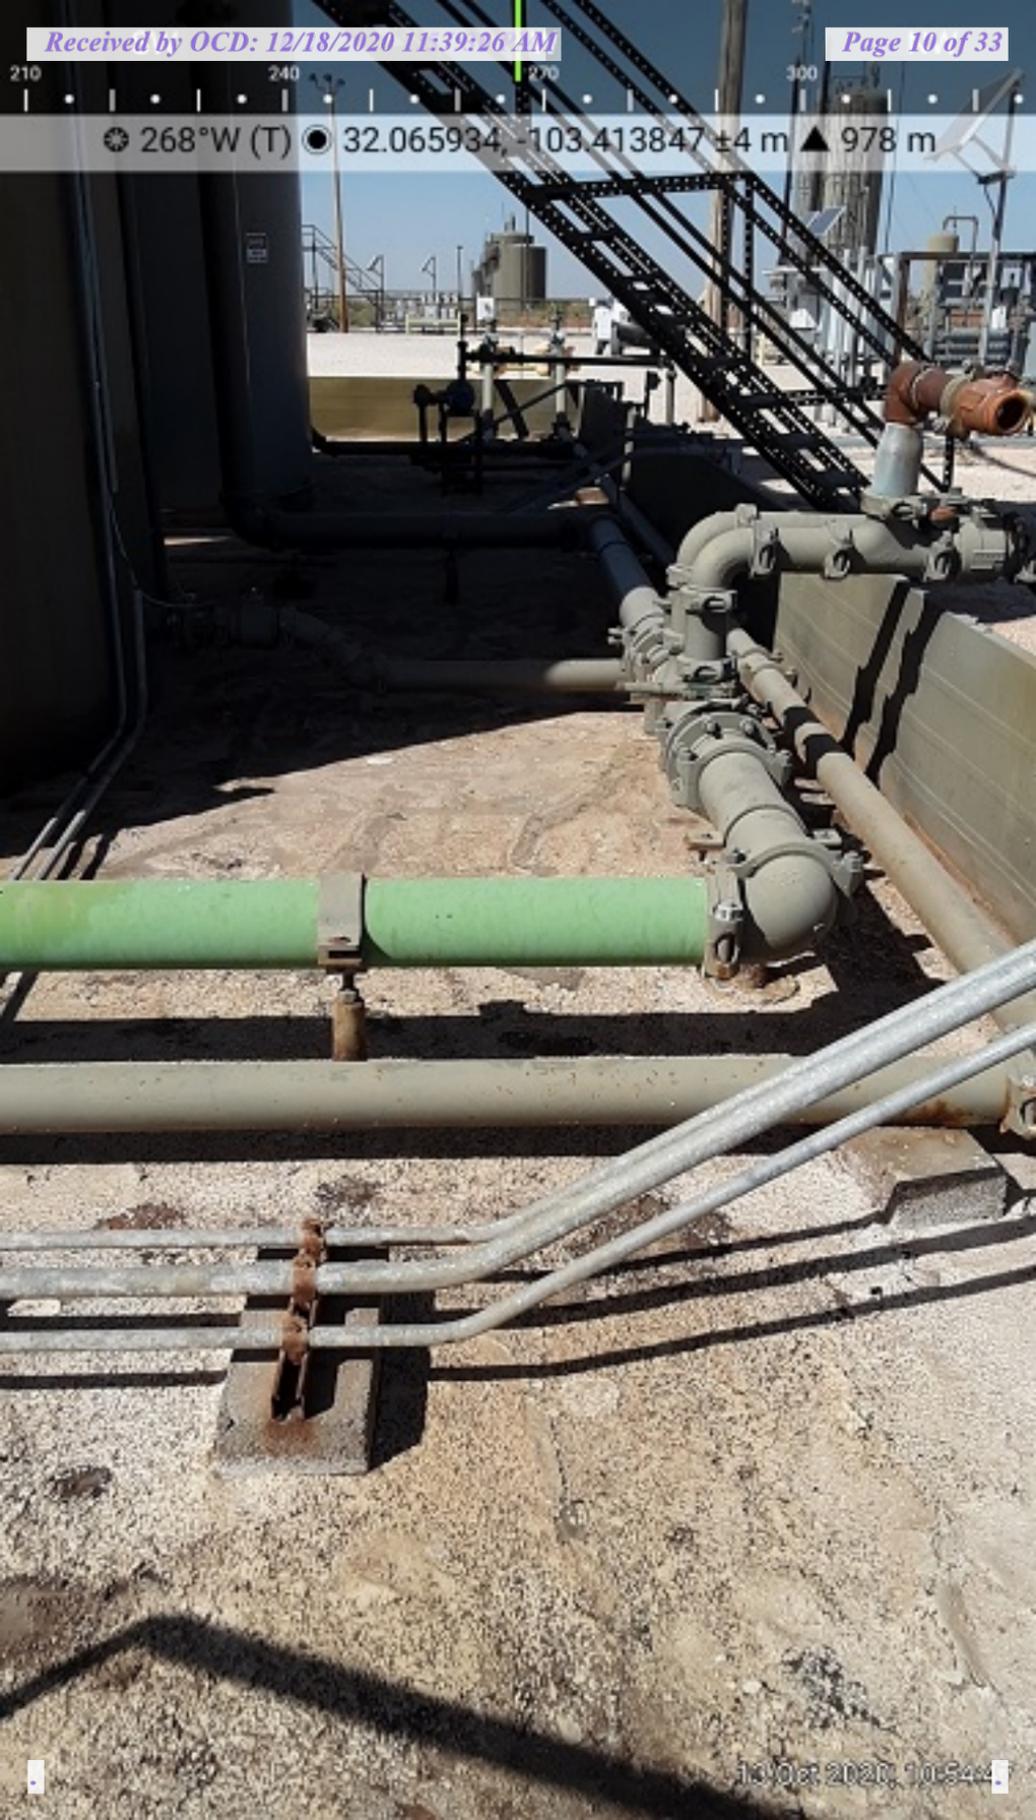
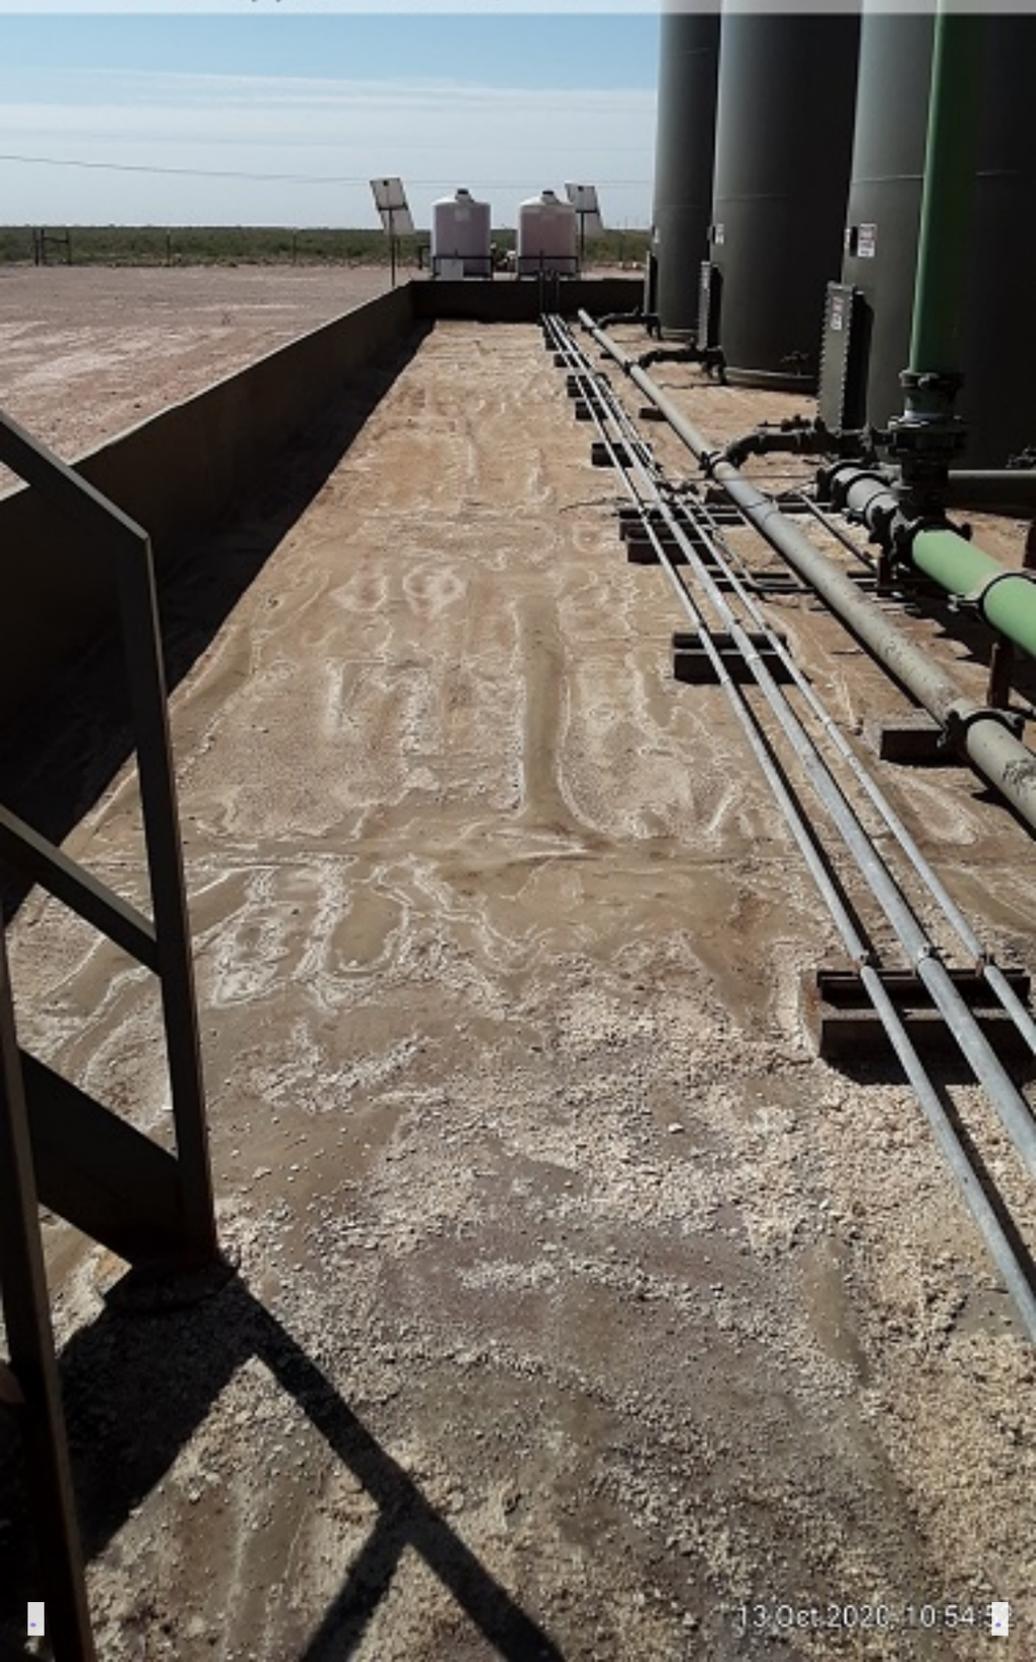
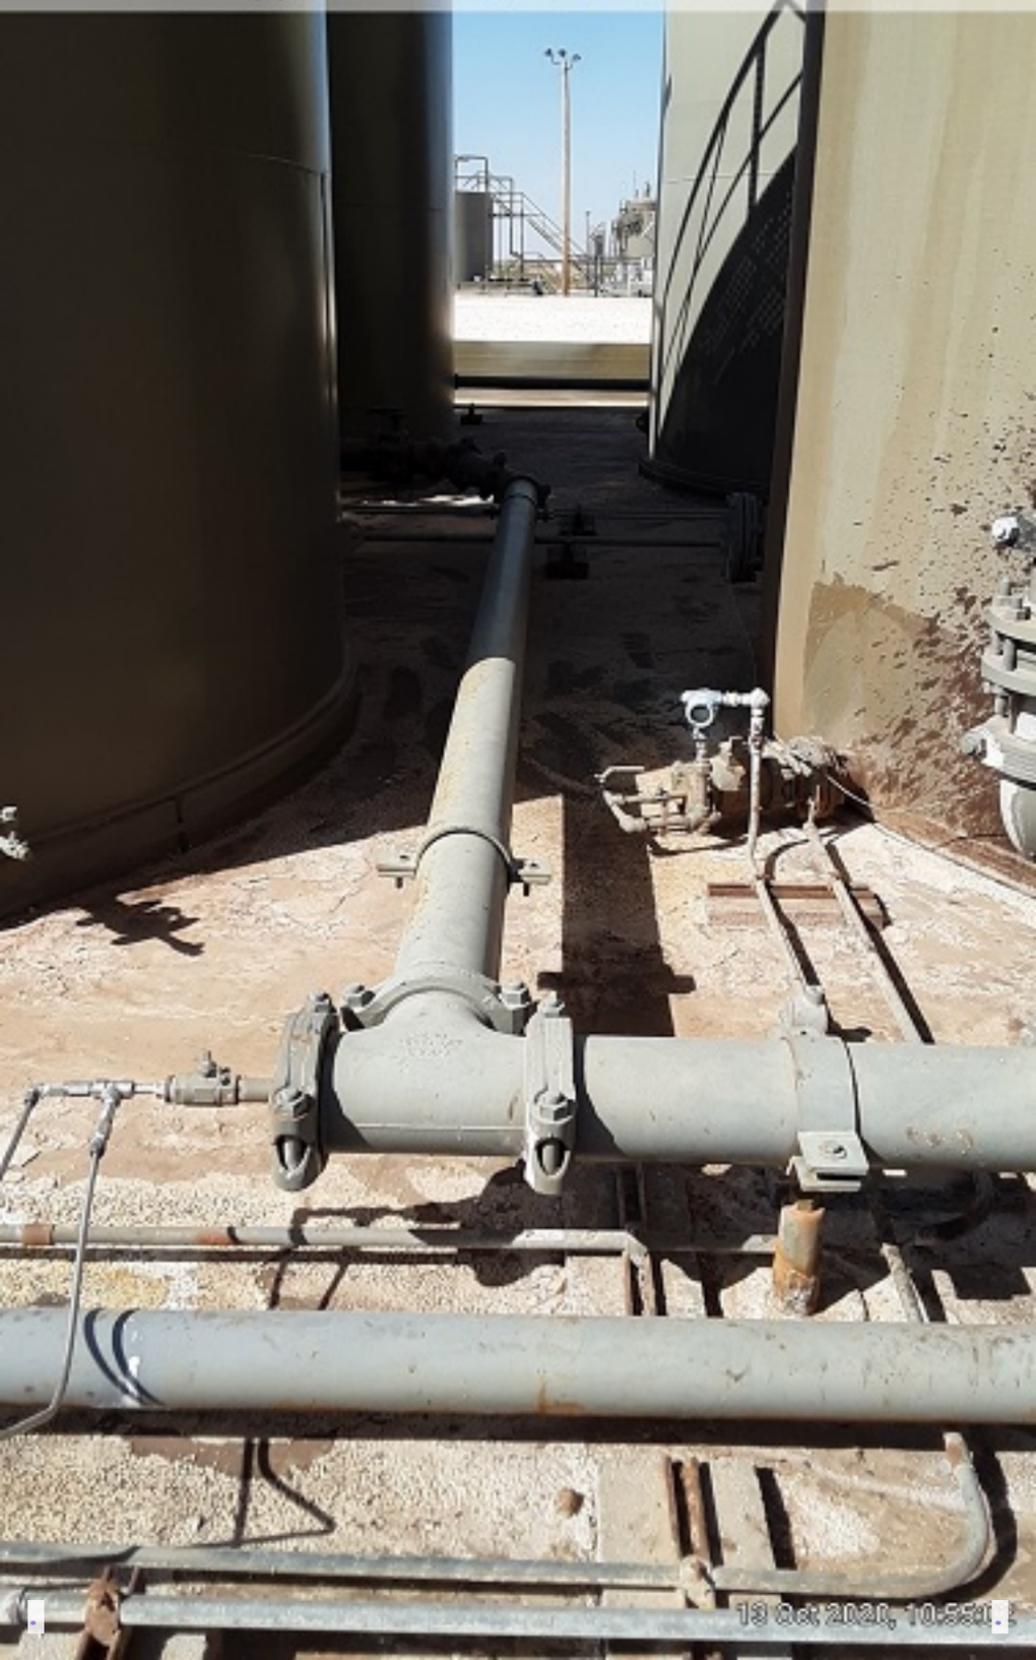
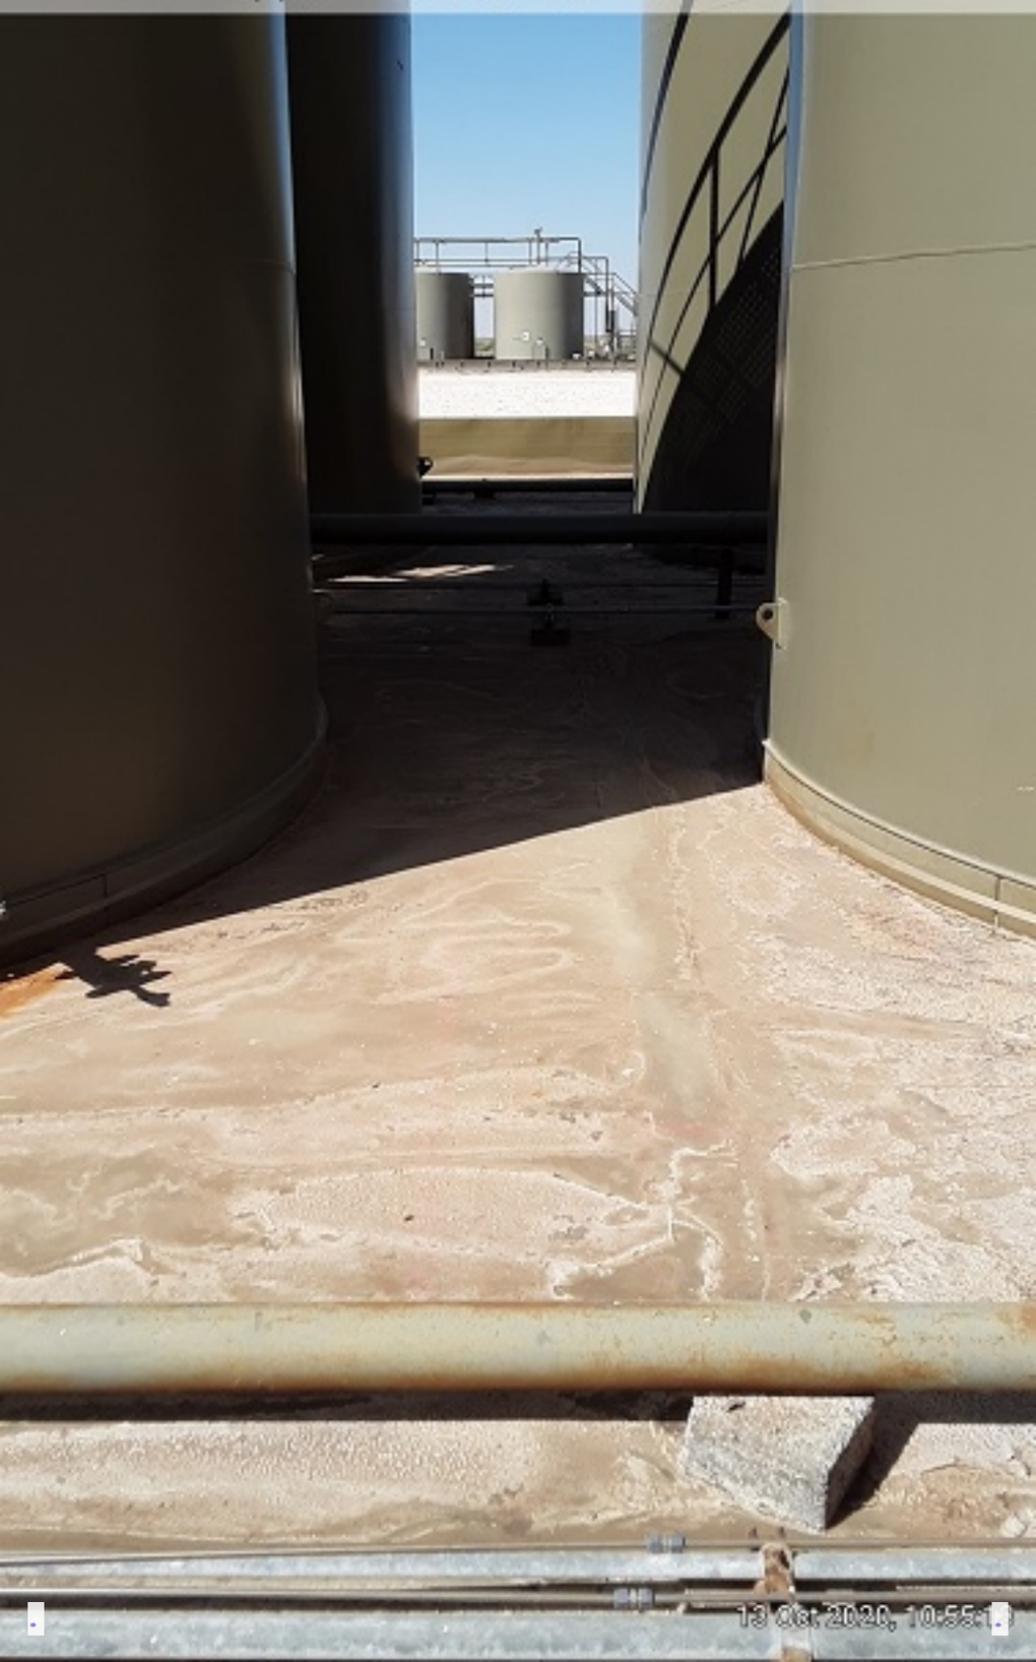
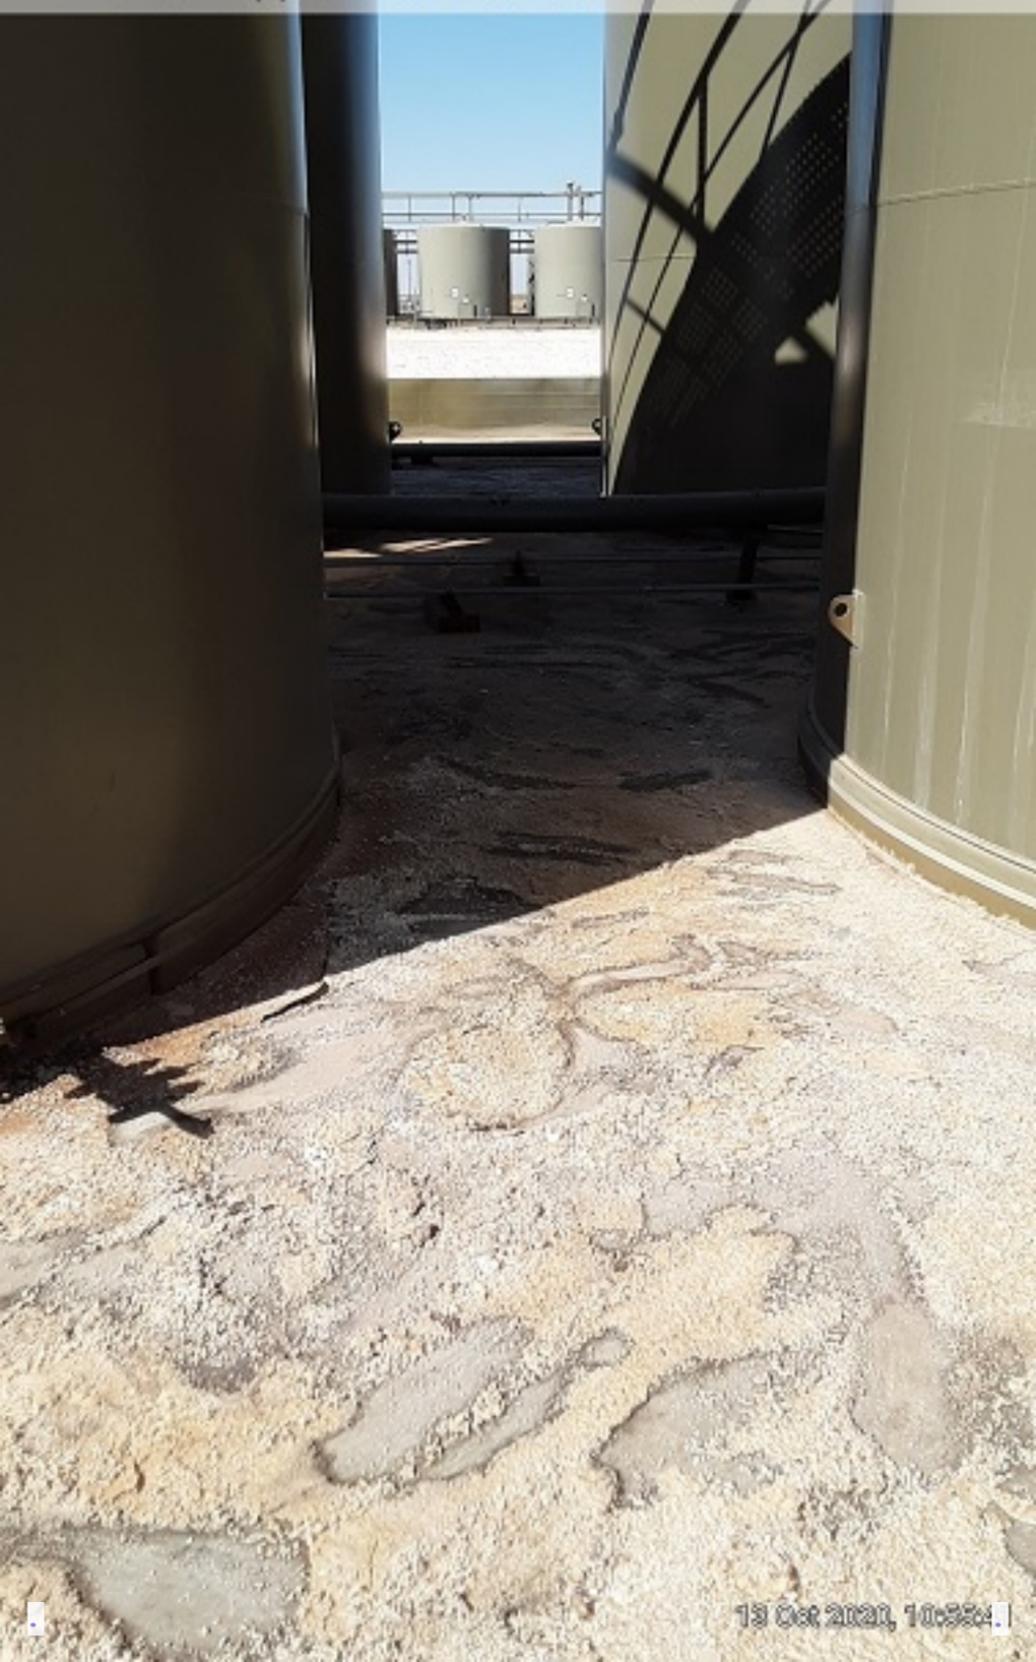
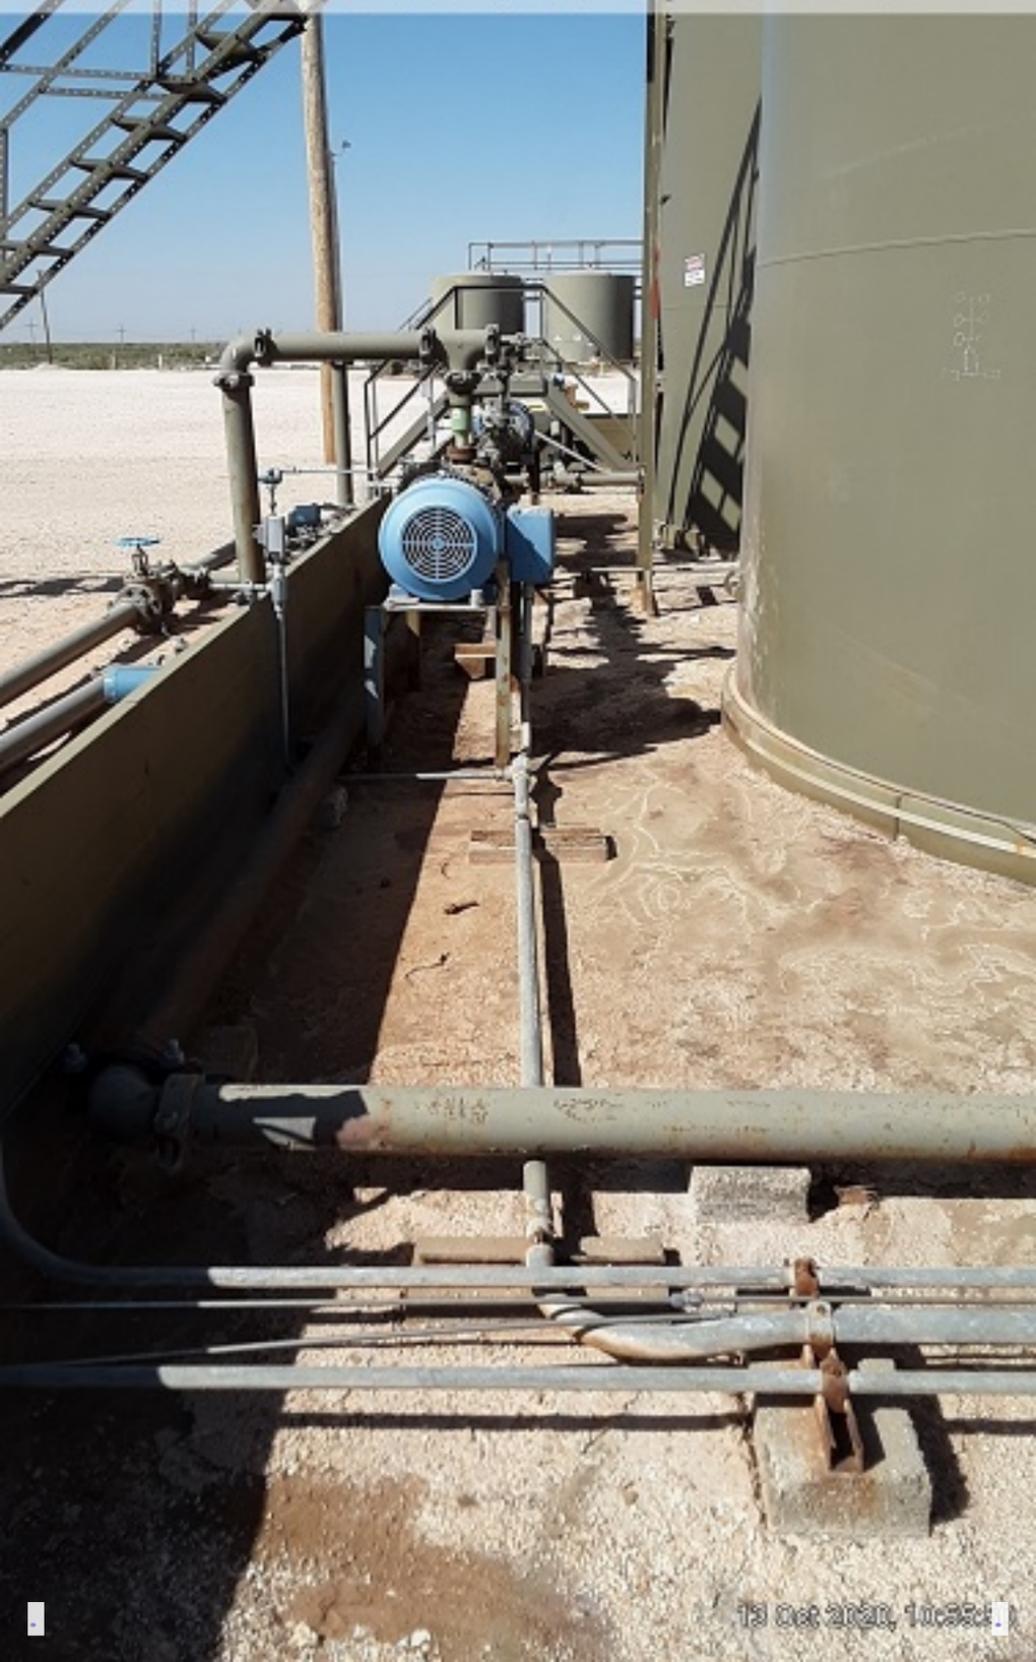
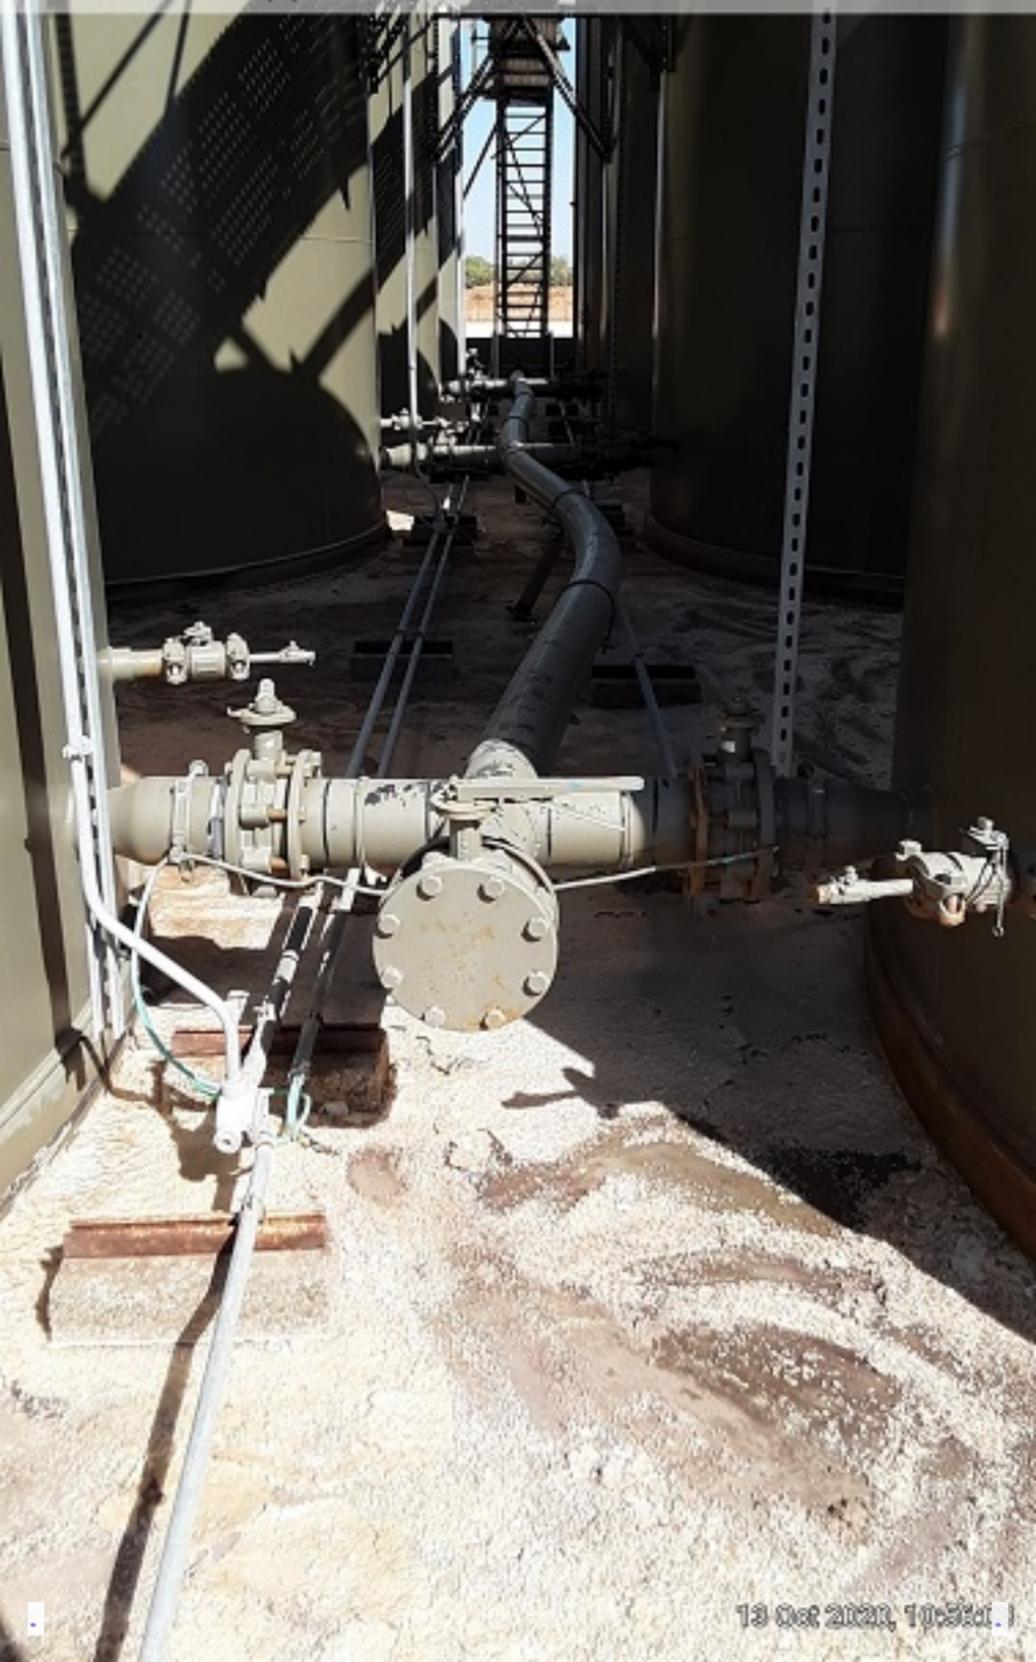
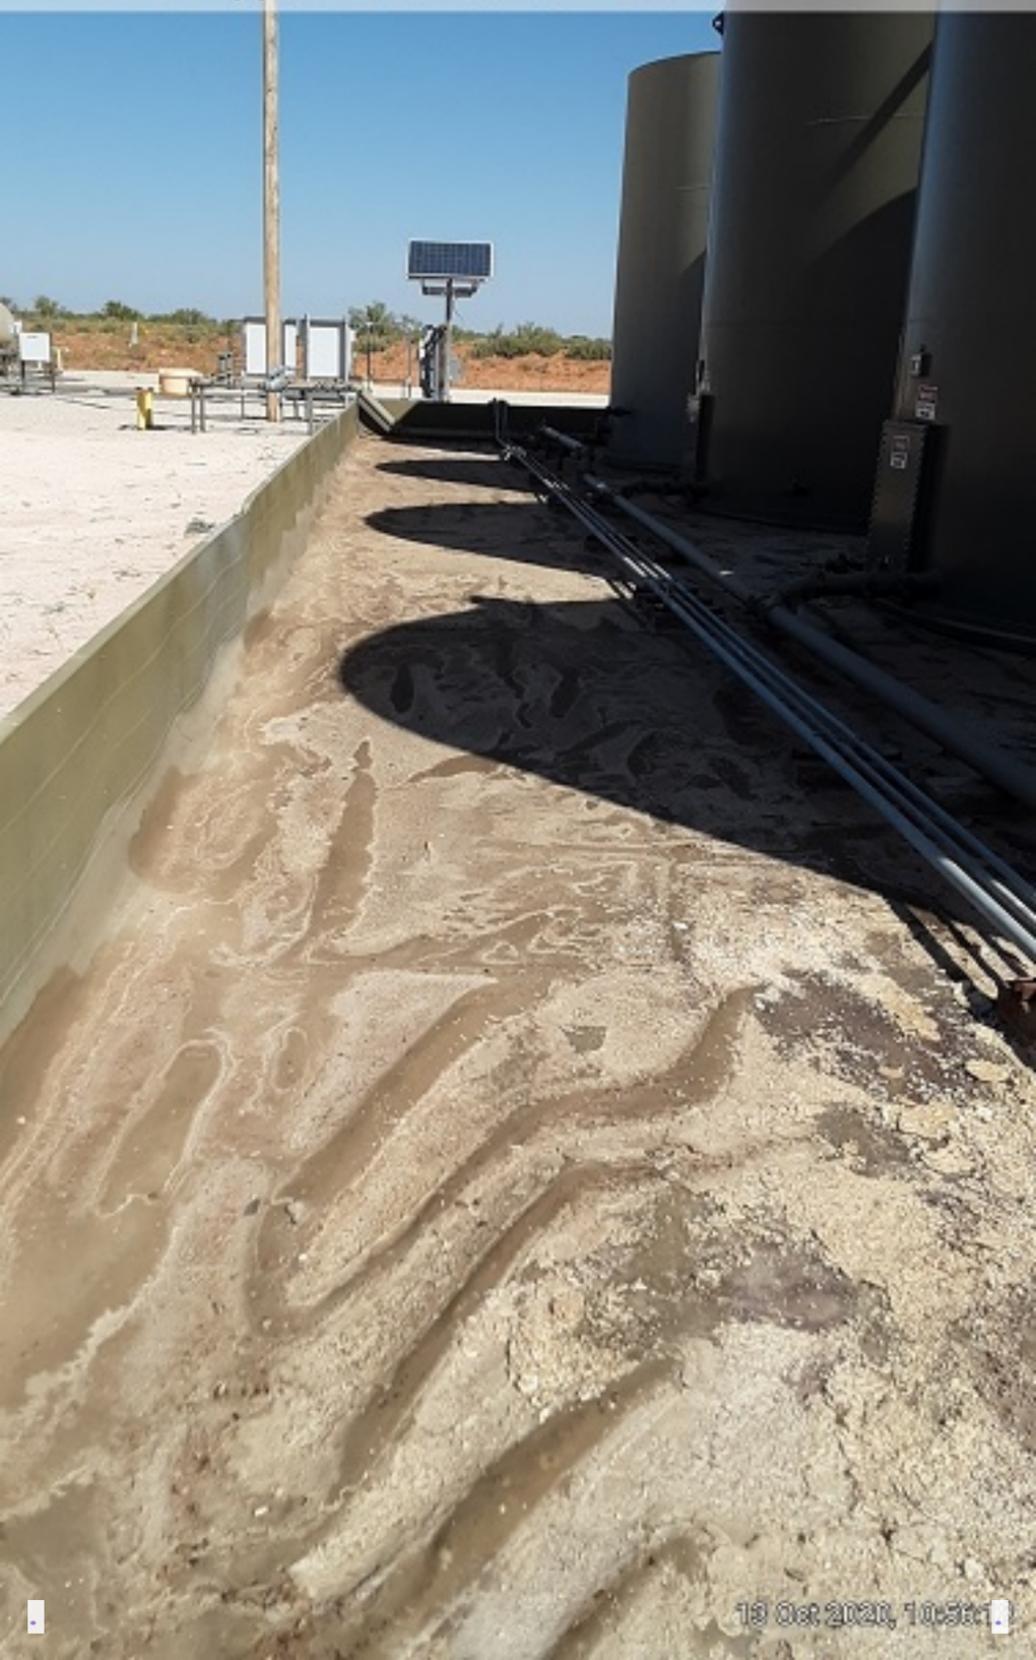
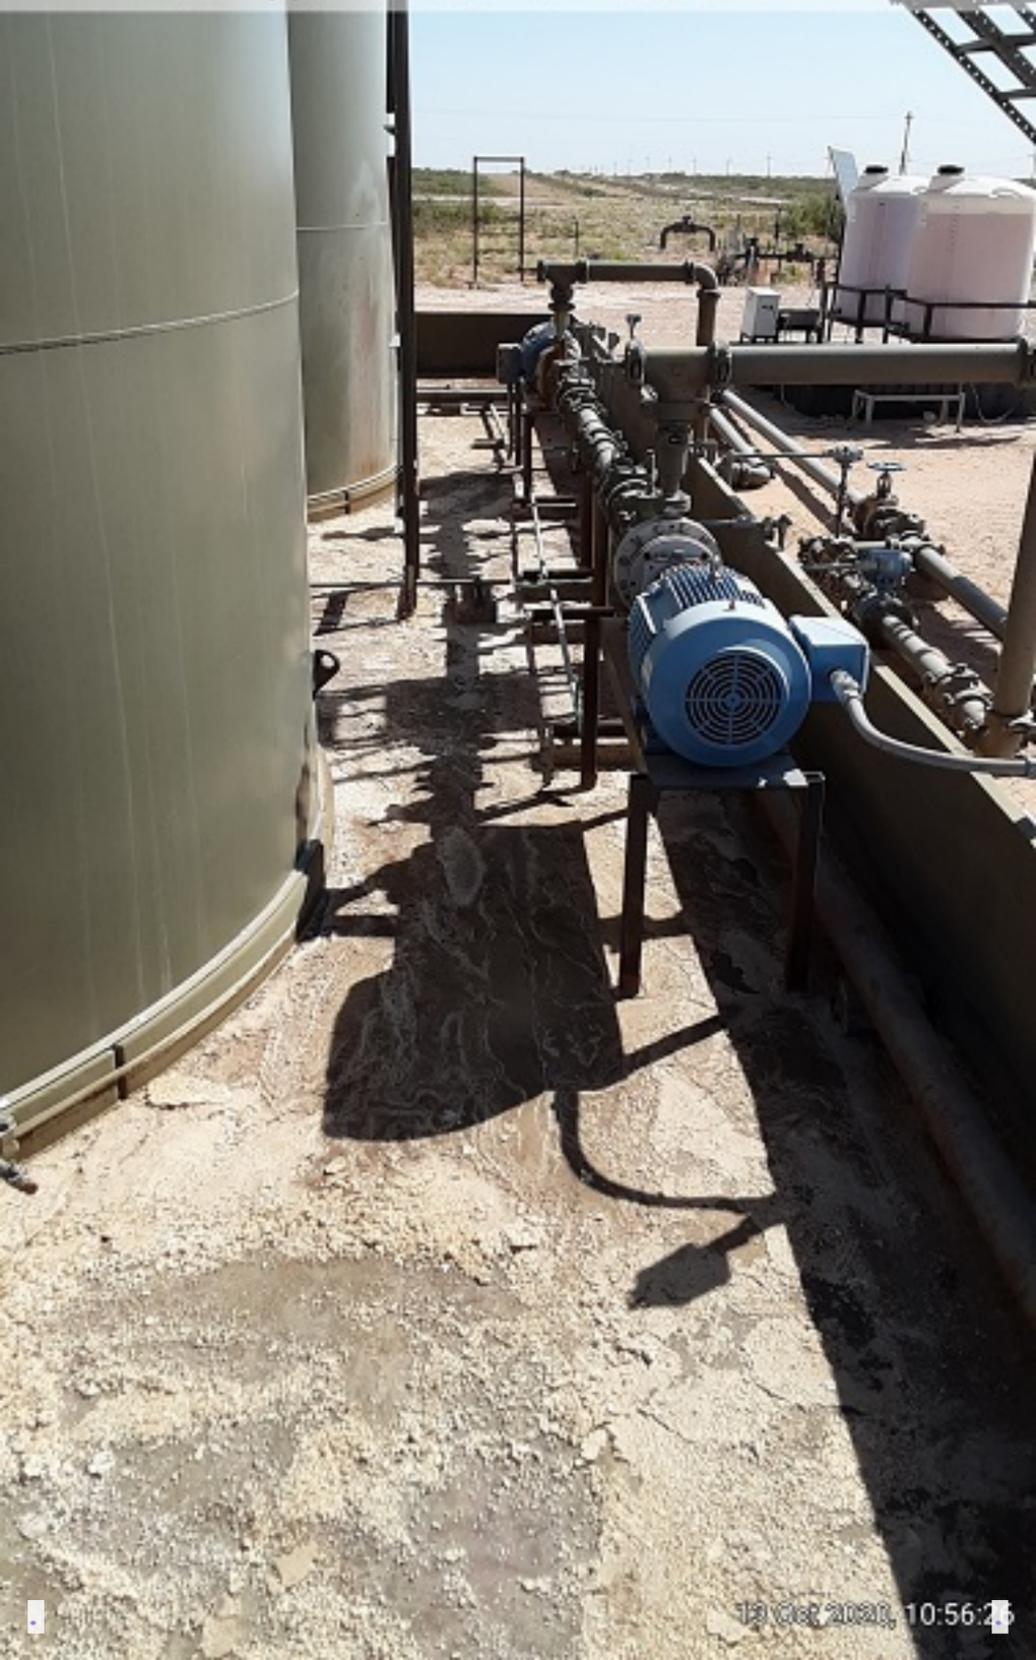
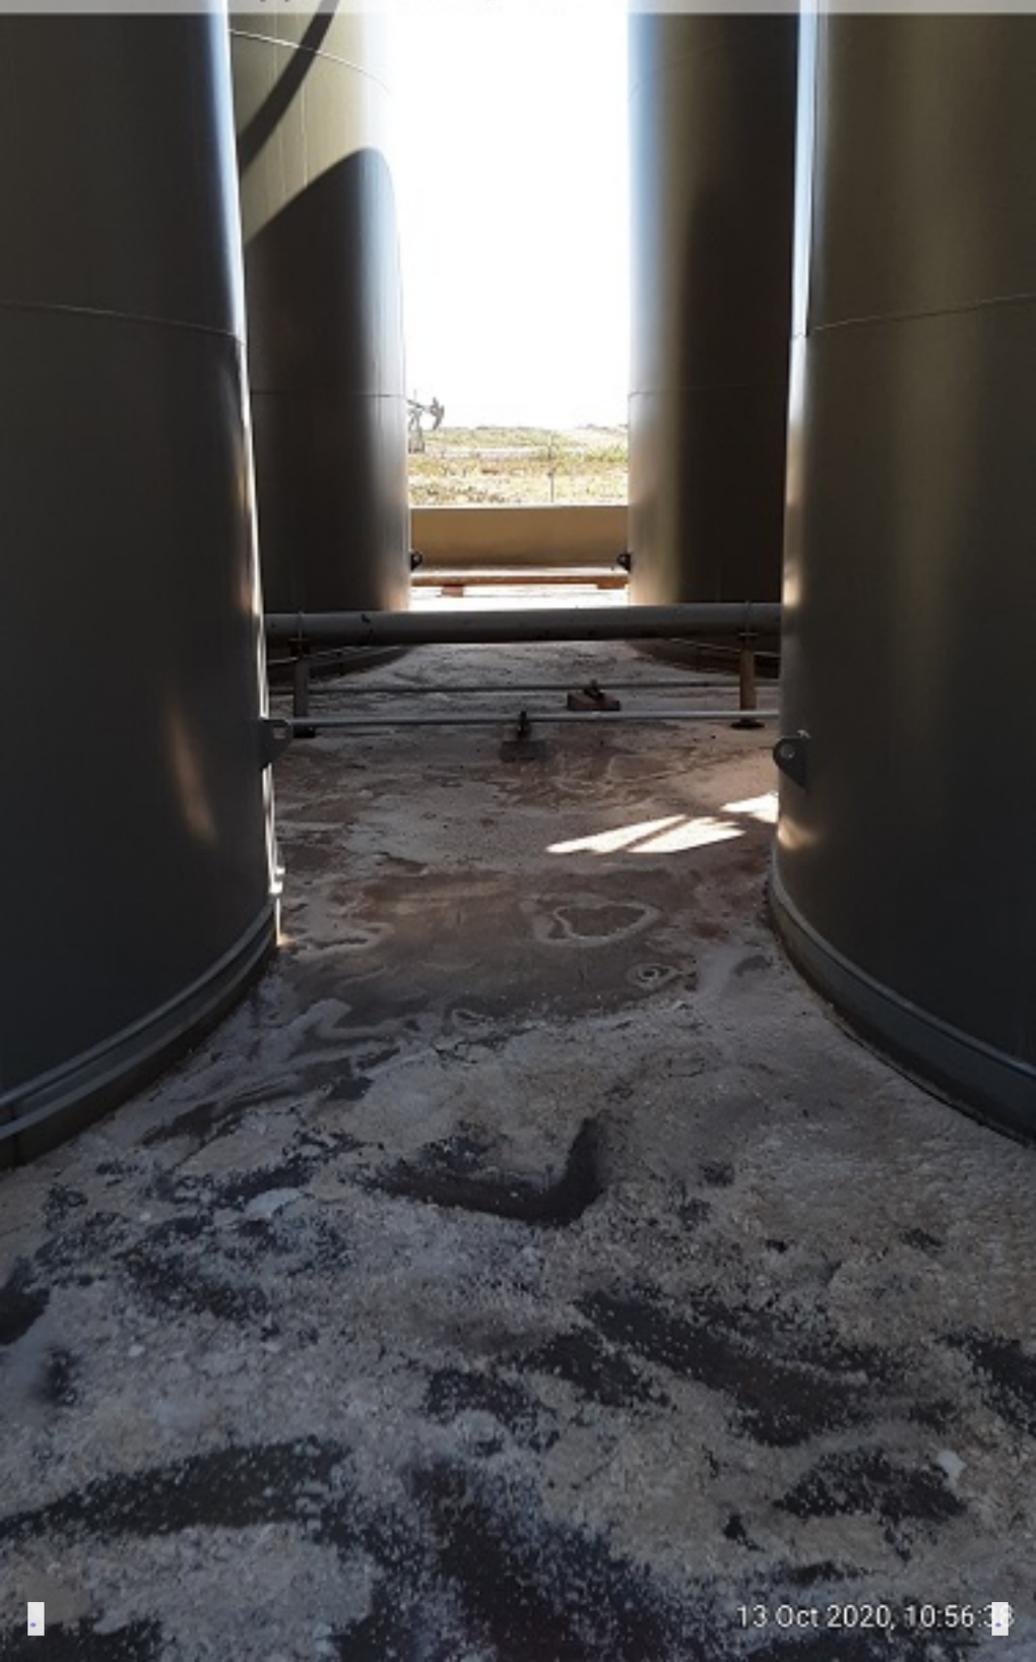
At the request of Devon, SMA conducted a liner integrity inspection per requirements of 19.15.29.11.A(5)(a) NMAC. NMOCD was notified on September 8, 2020 that the liner inspection was to occur, and the inspection was conducted on October 13, 2020. After a thorough visual inspection of the liner within the tank battery containment, the liner appeared to be intact and had the ability to contain the leak in question. The location where the release occurred was identified, and SMA verified that the release did not occur outside of the lined containment. A photo log of the inspection is included in Appendix A.

- Arrived at Scheduled time of 10:30.
  - Walked to POR and examined if release was fully contained.
    - Release did stay in Secondary Containment.
  - Searched for tears and other Potential Compromises throughout Containment.
    - No Failures
    - Liner remained intact
    - Verified that outside of Containment was not compromised.
  - Took Photos of Containment.
  - Mapped Containment and Photograph locations
- Left Site

SMA recommends no further action for this release and requests the closure of NRM2026543414.
