Release Notification

**RE: Closure Request
JRU 119
Incident Number NRM2021847858
Eddy County, New Mexico**

On July 23, 2020, a corrosion hole in a steel flowline resulted in the release of 0.03 barrels (bbls) of crude oil and 43.46 bbls of produced water in the pasture area adjacent to the flowline. No fluids were recovered. XTO immediately reported the release to the New Mexico Oil Conservation Division (NMOCD) via email on July 24, 2020 and submitted a Release Notification Form C-141 on August 4, 2020. The release was assigned Incident Number NRM2021847858.

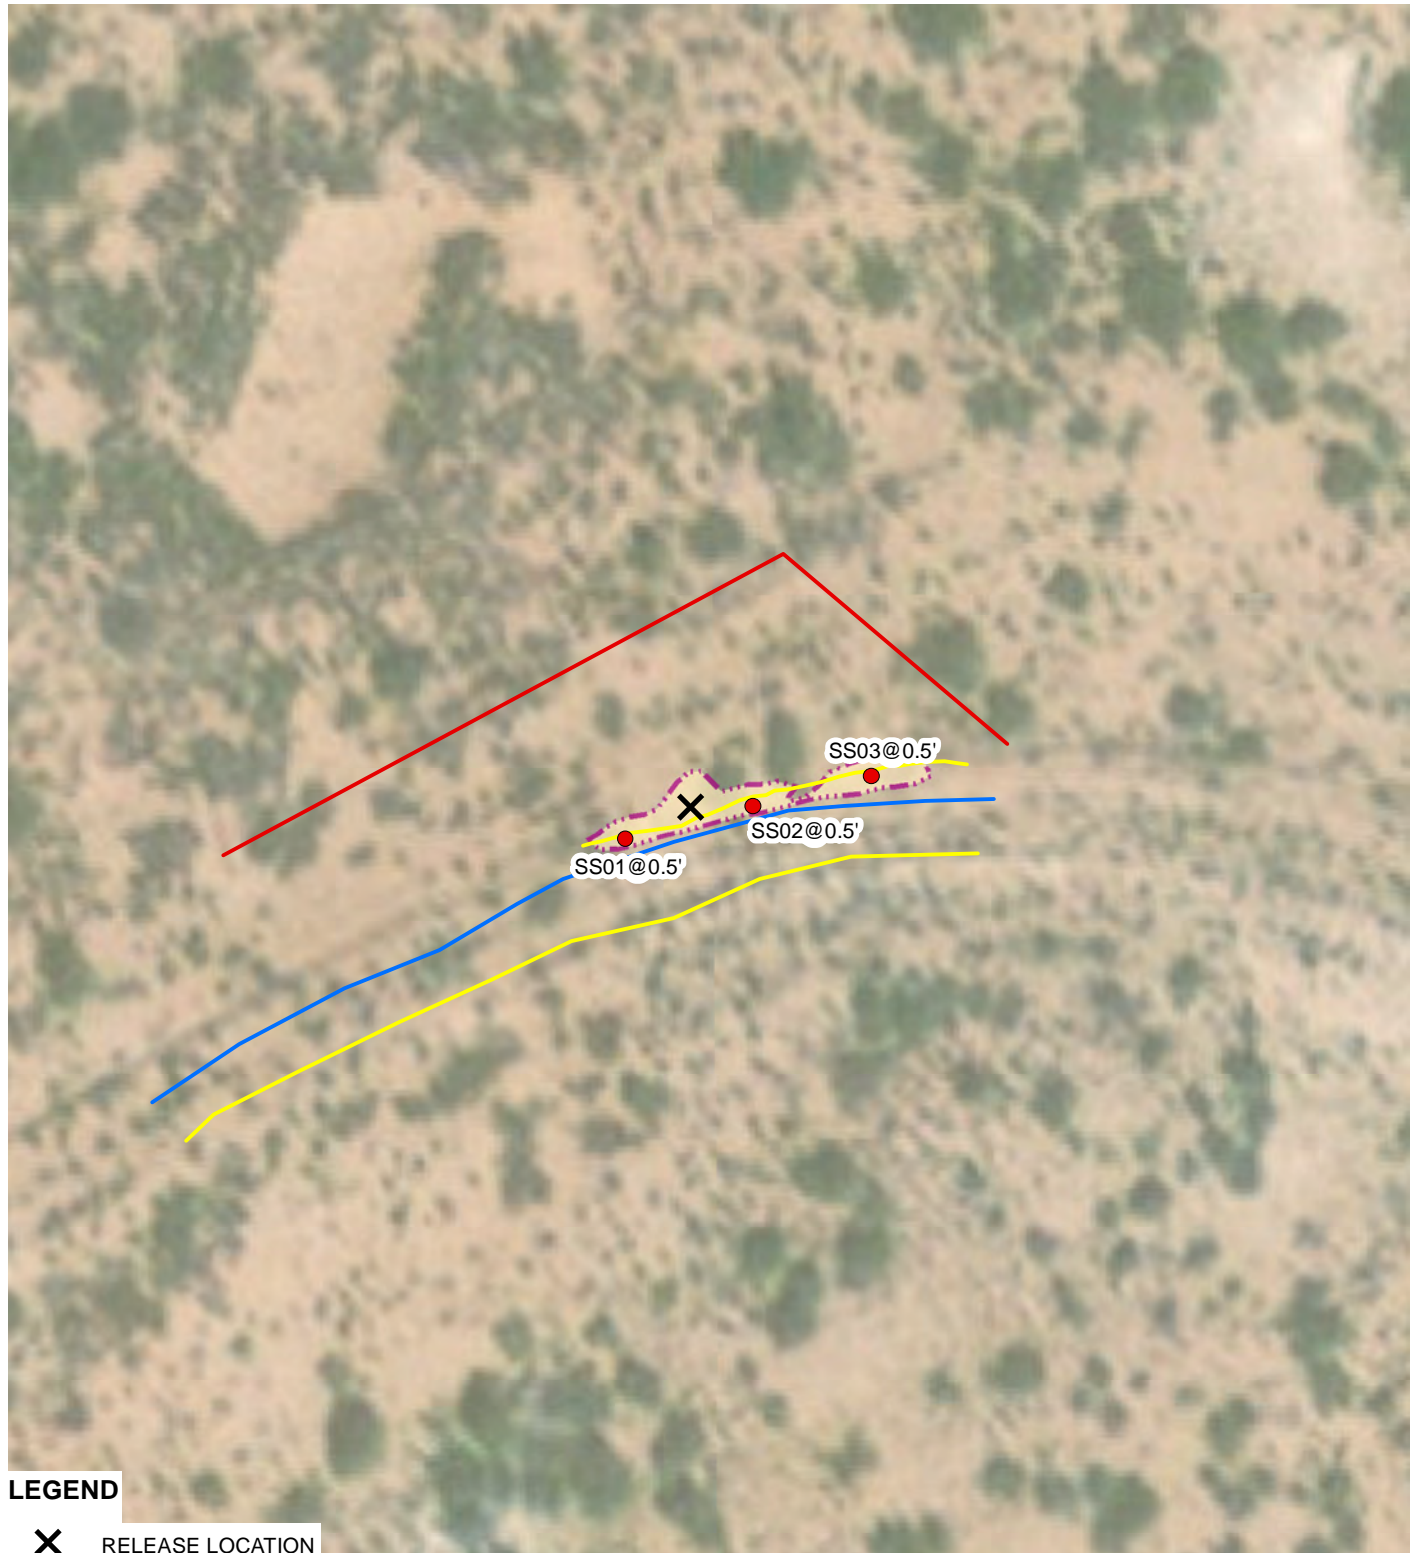
FIGURE 2
PRELIMINARY SOIL SAMPLE LOCATIONS
 JRU 119
 UNIT G SEC 17 T23S R31E
 EDDY COUNTY, NEW MEXICO
 XTO ENERGY, INC.

Laboratory analytical results for preliminary soil samples SS01 through SS03 indicated that TPH-GRO/TPH-DRO and TPH concentrations exceeded the Closure Criteria. Additionally, TPH and chloride concentrations exceeded the reclamation criteria applied to the top four feet. Based on visible staining in the release area, field screening activities, and laboratory analytical results for the preliminary soil samples, excavation of impacted soil was warranted.

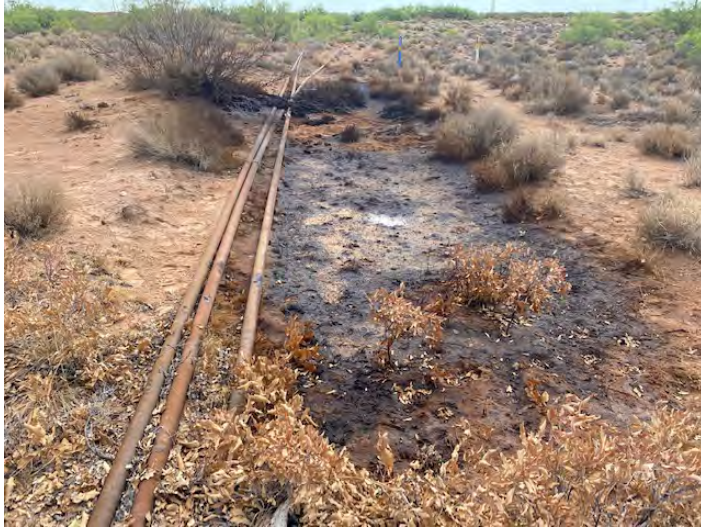
Photograph 1: View of release along steel flowline facing northeast.

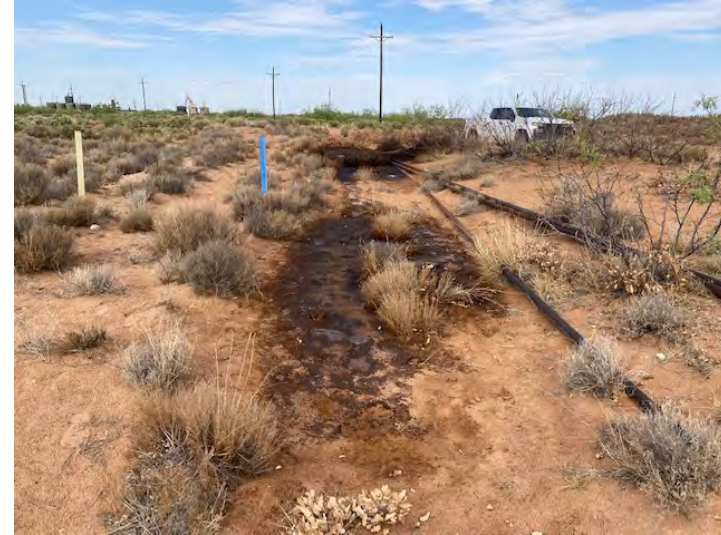
Photograph 2: View of release along steel flowline facing southwest.

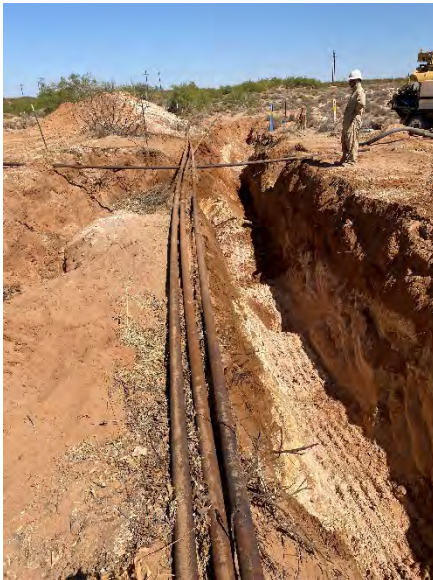
Photograph 3: View of final excavation facing northeast.

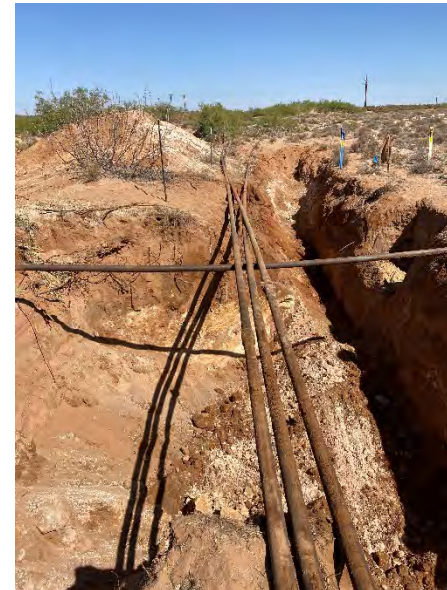
Photograph 4: View of final excavation extent facing northeast.
