Closure Report

Re: Turner Battery Transfer Line
Case #: NRM202346184

On 07/28/2020 a release occurred due to a 3rd party contractor striking an above ground flow line with the blade of a backhoe resulting in a loss of produced water. The release (GPS: 32.46680, -103.15340) is located north of Eunice, NM in unit letter F section 22 township 21S range 37E. A groundwater survey was conducted utilizing the NMOSE and USGS wells of record. The nearest well suggest that groundwater beneath the release is 35 feet below ground surface.

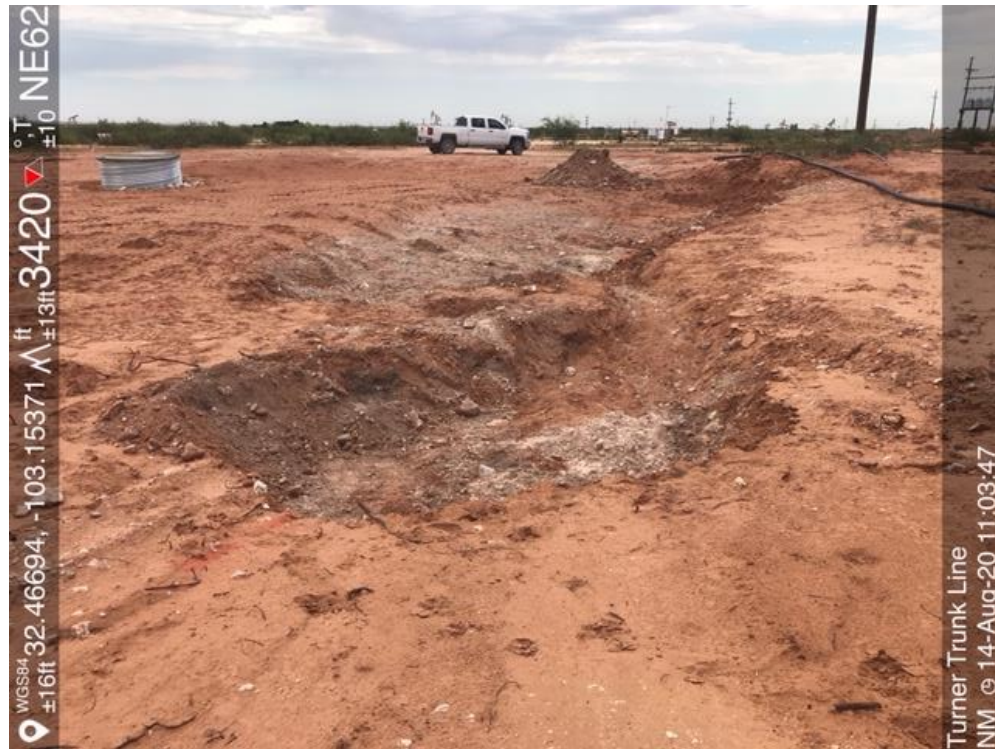
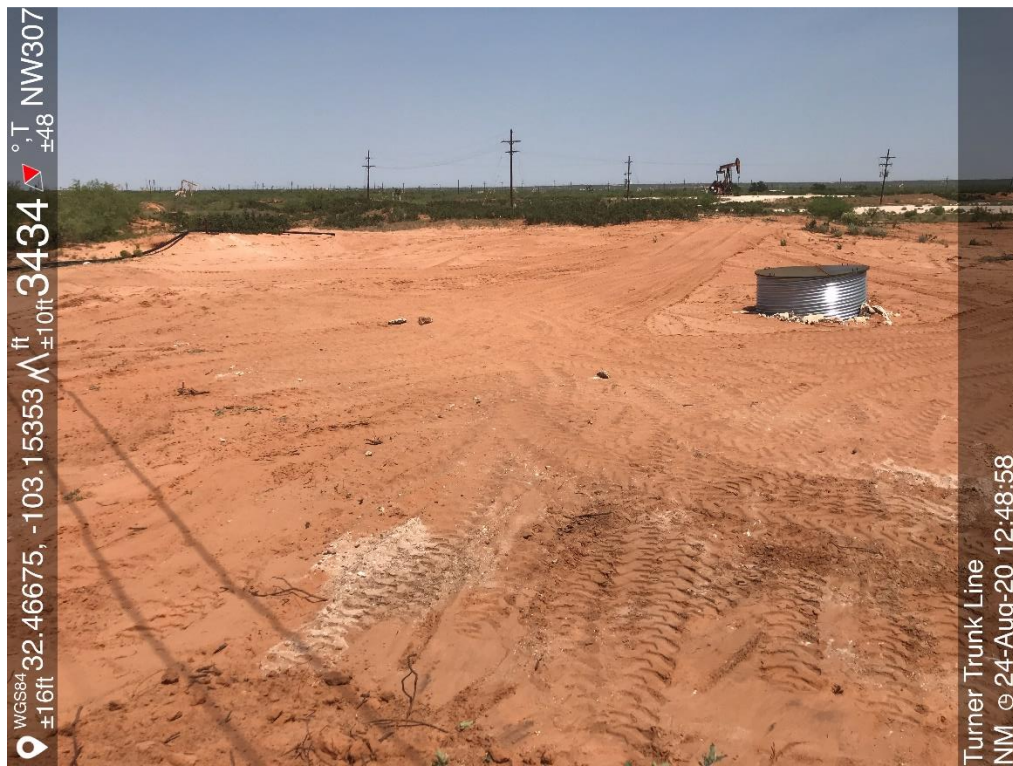
On 8/12/2020 the release area was excavated to a depth 1' foot. 5-point bottom and wall composite samples were collected not exceeding 200 square feet and submitted to a commercial laboratory for analysis of chloride, TPH, and BTEX. Analytical data confirms the excavation meets table 1 standards for releases less than 50 feet to groundwater. All excavated material (12 yards) was taken to an NMOCD approved facility. The area was backfilled with clean topsoil from the surrounding area and contoured. The disturbed area will be reseeded with the surface landowner's guidelines.
