Closure Report

2RP-5524

Site Name:	Height CC 6-7 Fed Com 34H	Incident ID: NRM2002750398
Company:	Oxy, Permian	
Legal Description:	U/L C, Section 25, T22S, R32E	
County:	Eddy County, NM	
GPS Coordinates:	N 32.25374 W -104.02507

Oxy Height CC 6-7 Fed Com 34H

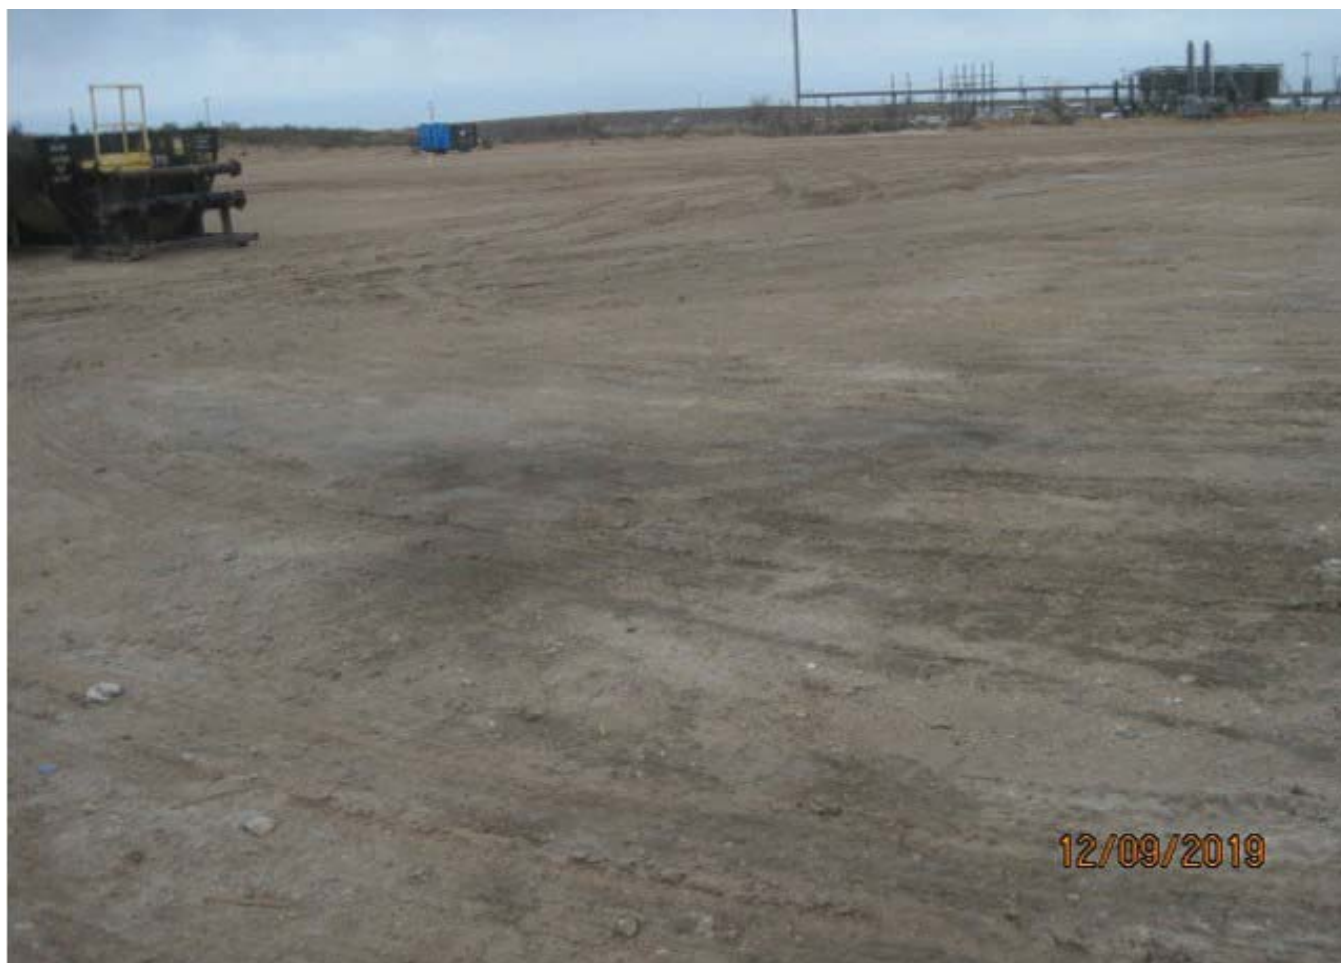
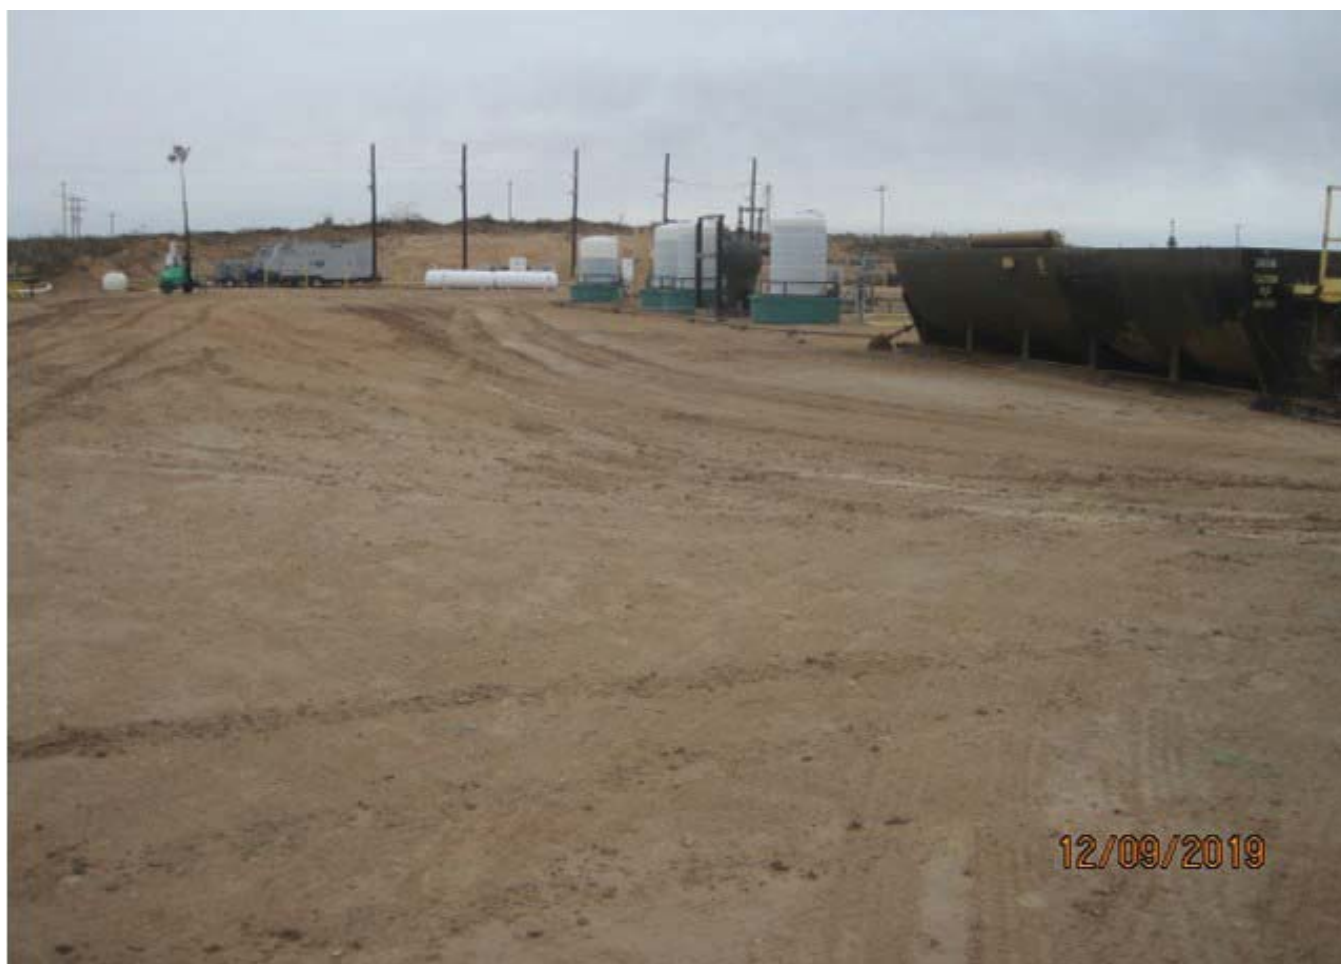
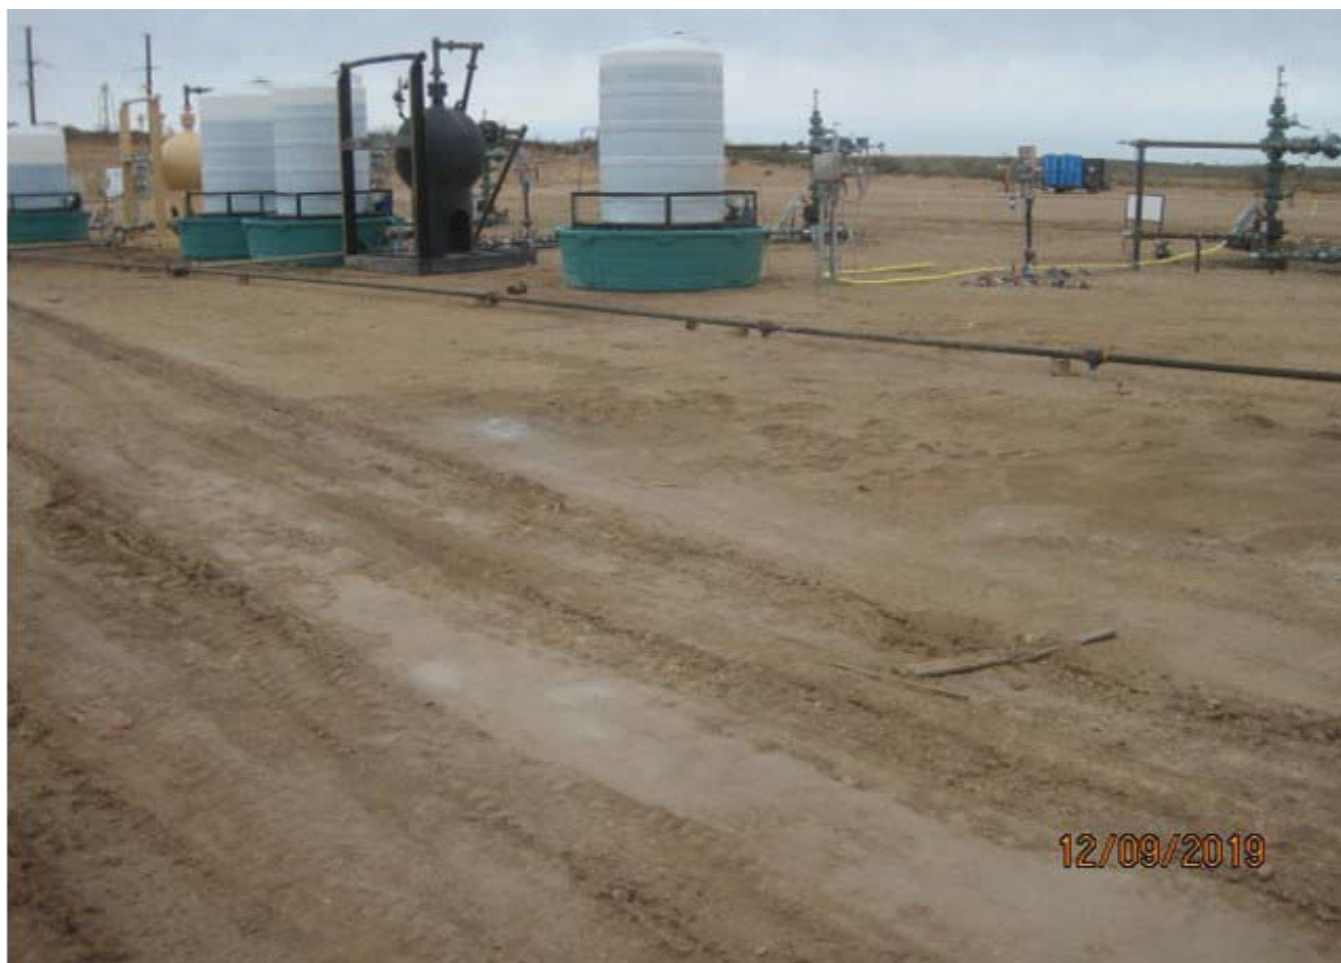
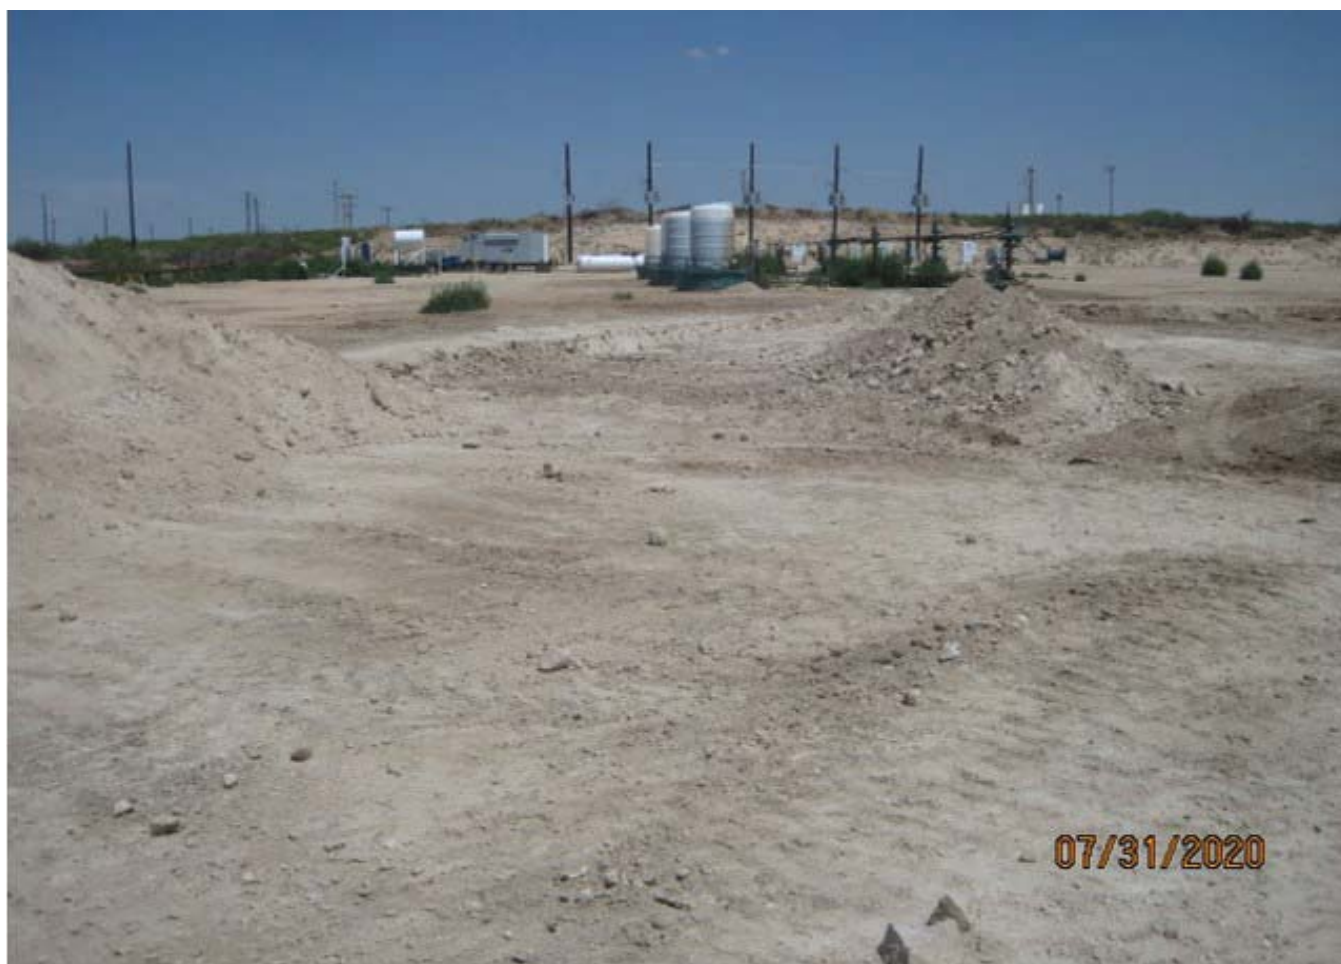
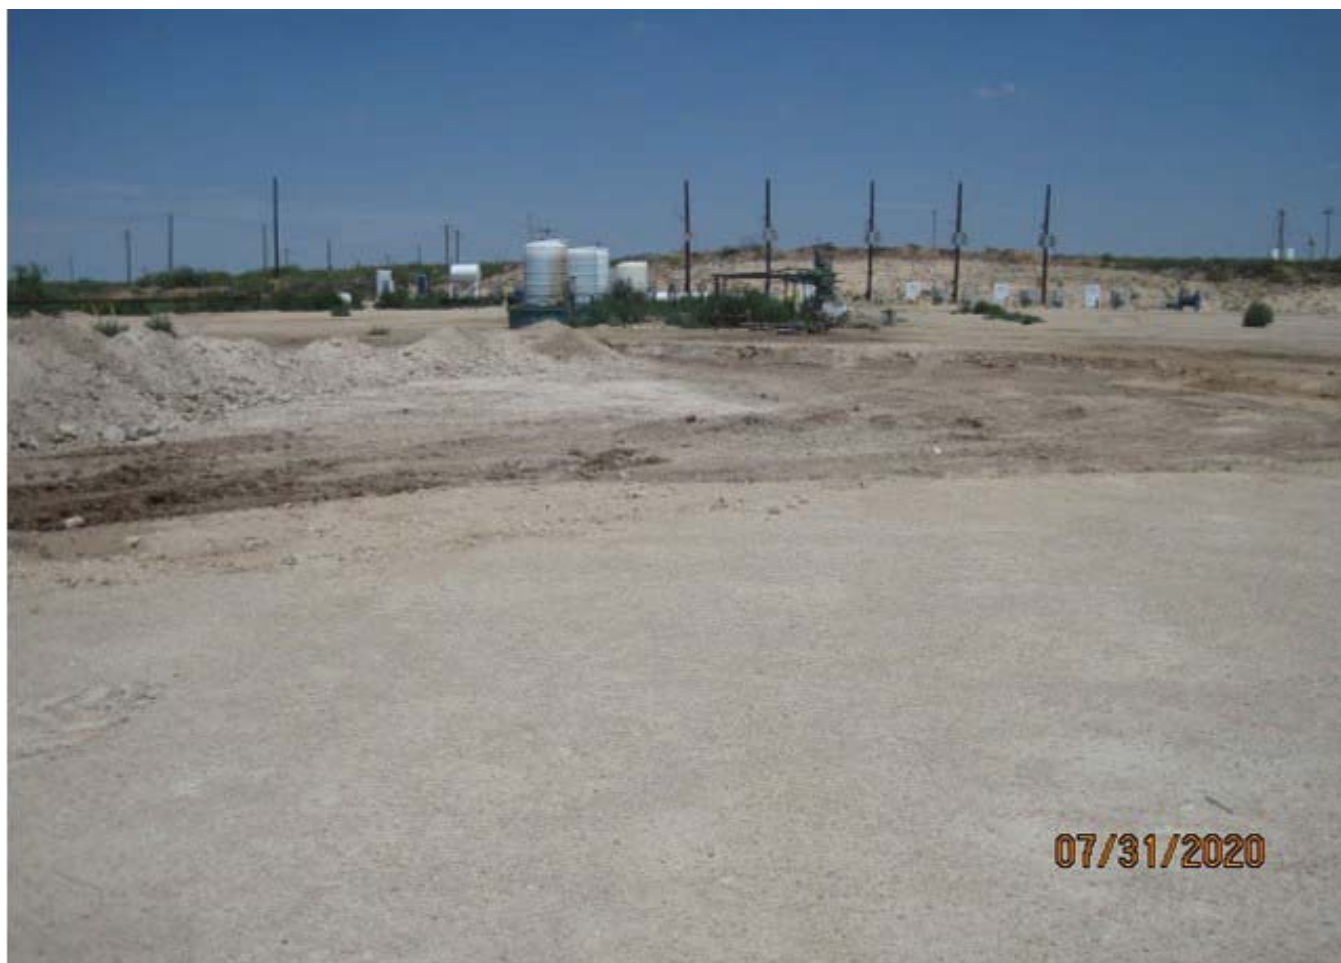
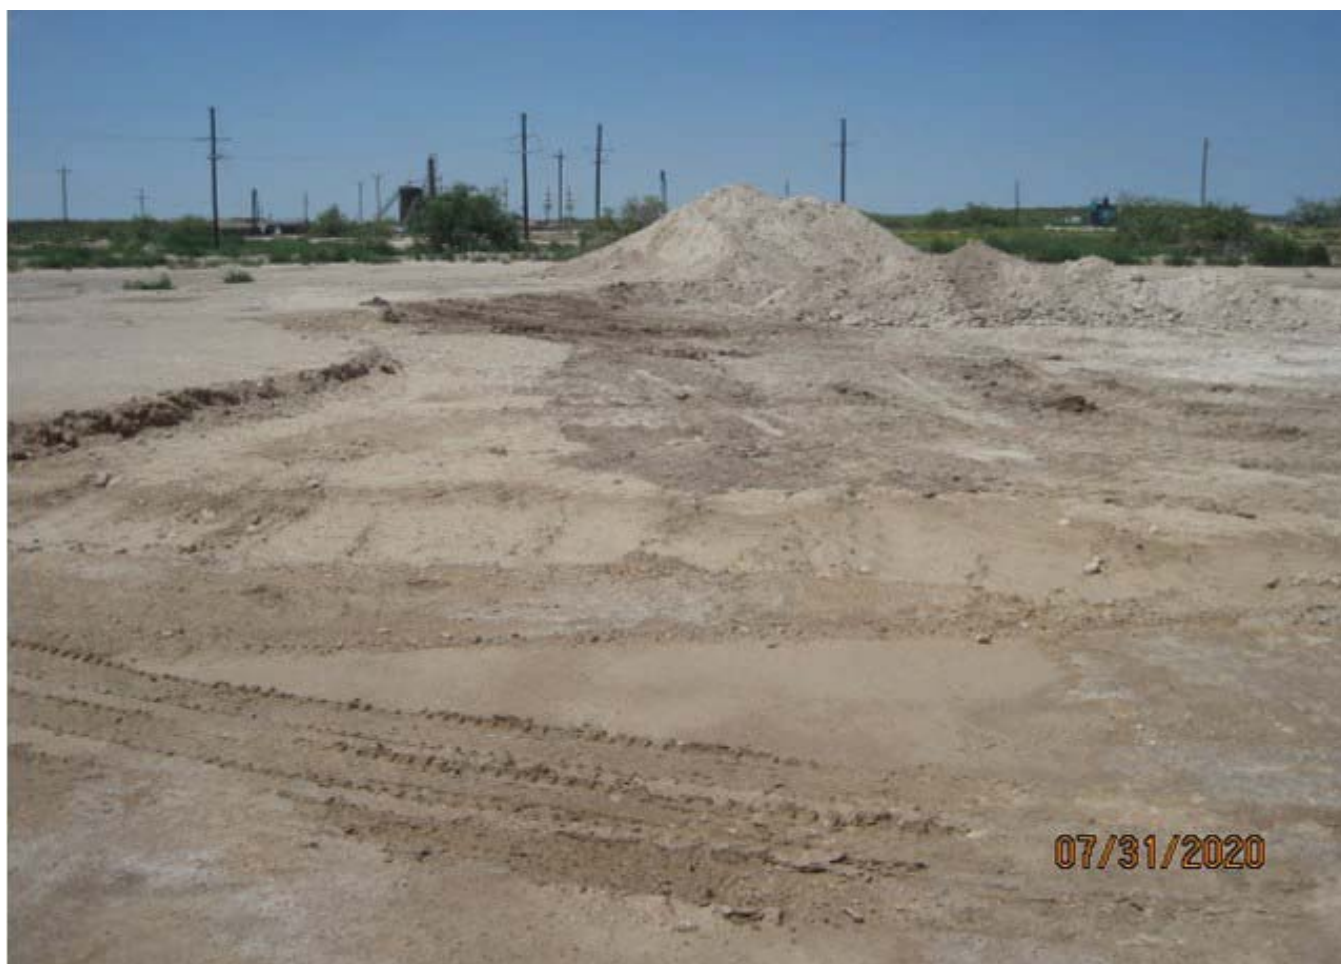
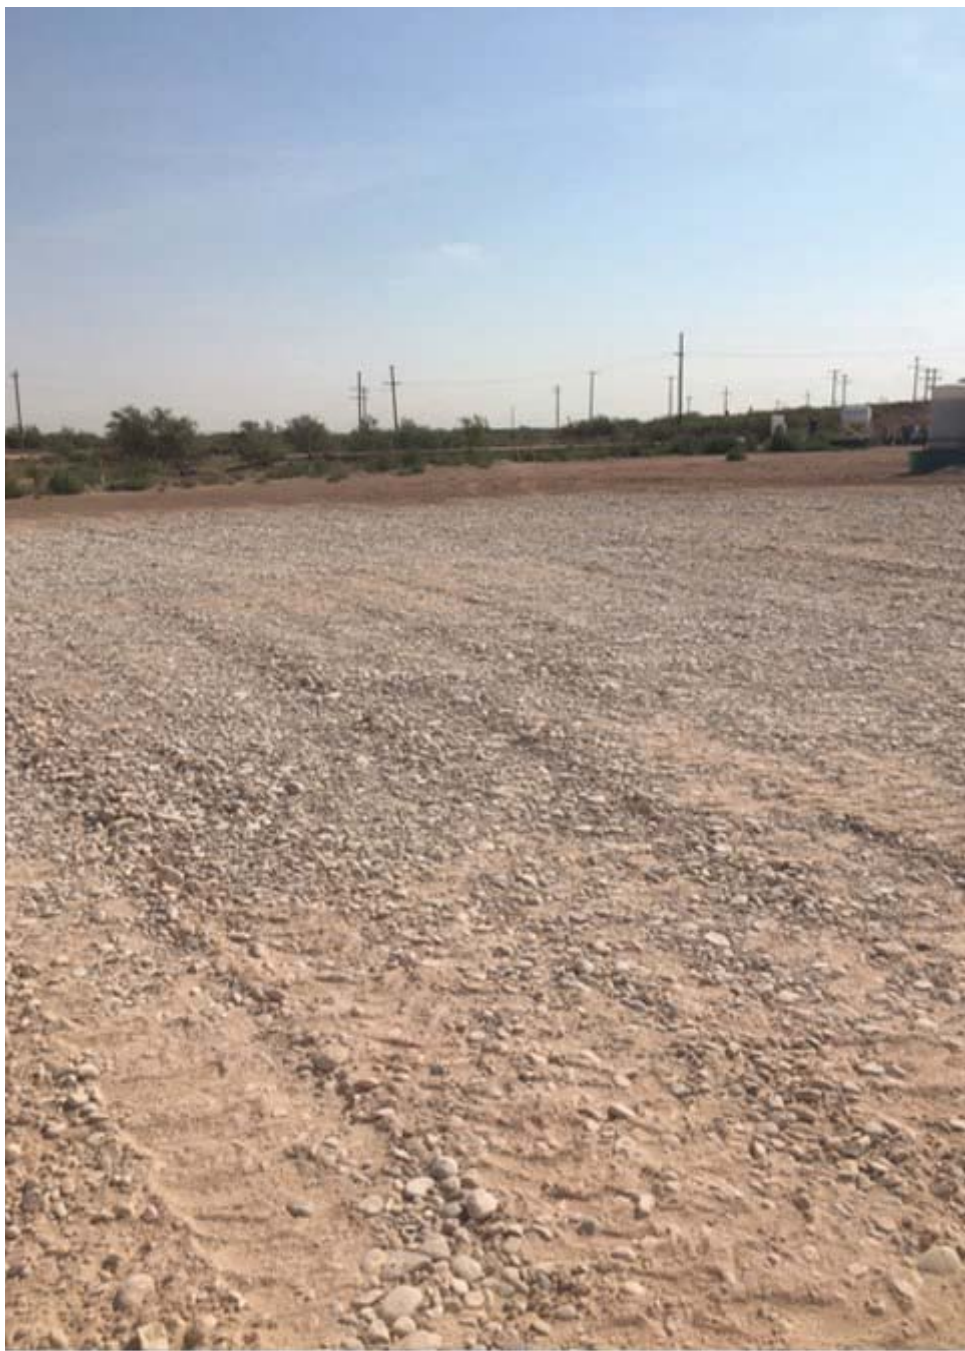
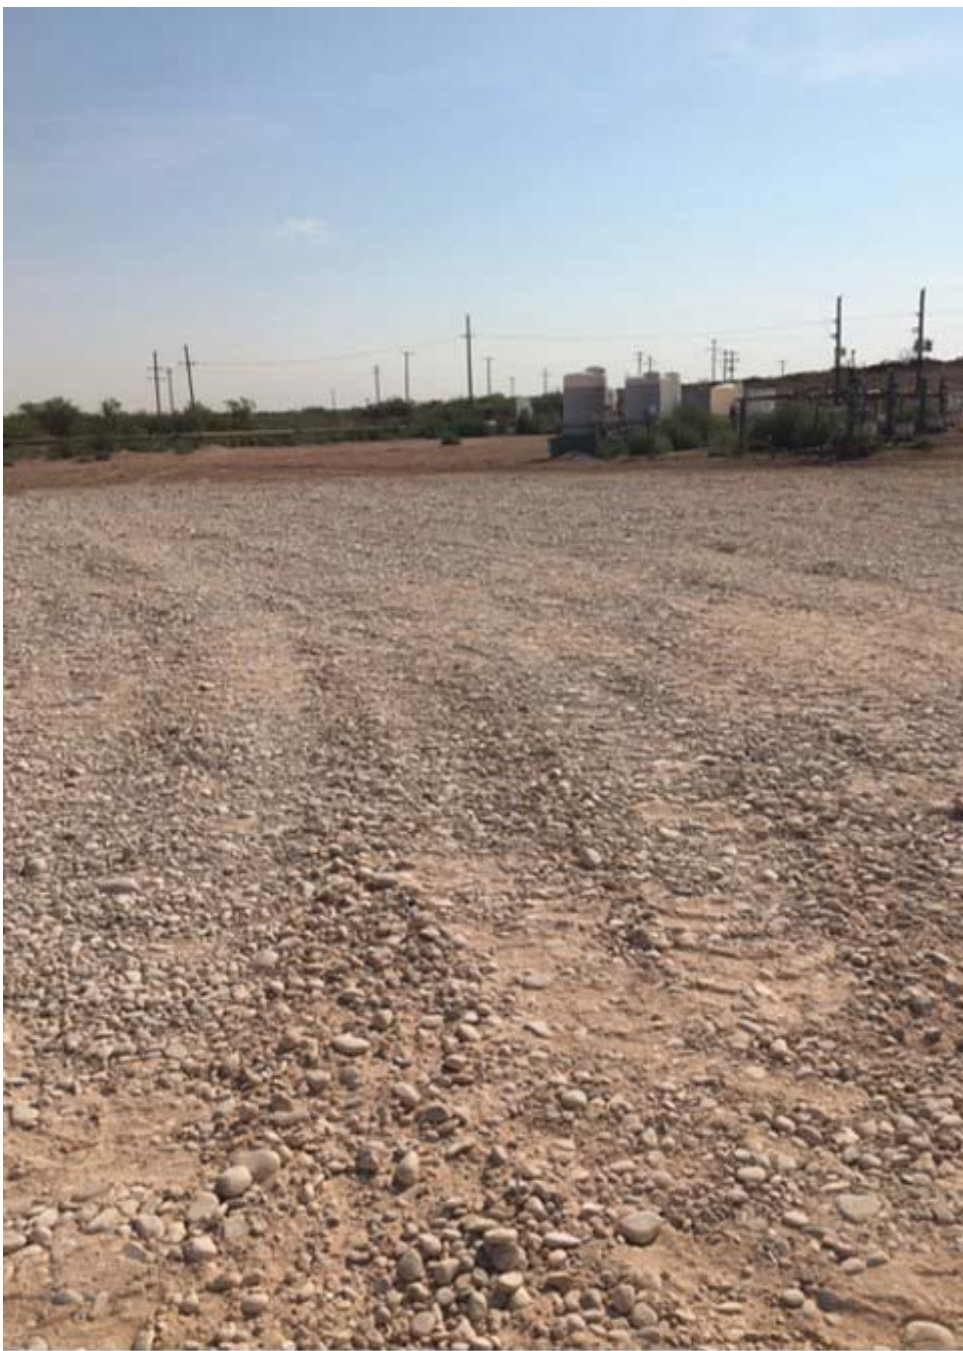
Initial C-141	signed and included	
C-141, page 6	signed and included	
Site Diagram	Google Earth map with excavation depths & confirmation sample points	
Pictures	Remediation photos	
Lab Summary/Analysis	Confirmation lab summary/analysis report for 8/10/20	
Depth to Groundwater	USGS Info

Remediation Parameters:	Excavated the leak areas SP1 and SP2 to a depth of 1 foot. Excavated SP3 to a depth of 2 feet, and SP4 to a depth of 3 feet. Collected bottom and sidewall confirmation samples every 50 feet. The entire site was backfilled with clean soil.
Remediation Activities:	7-28-20 through 8-18-20
