Remediation and Closure Report

Cooter 16 State 1H Battery
Eddy County, New Mexico
2RP-5572

Subject: **Remediation and Closure Report**
Cooter 16 State 1H Battery
Eddy County, New Mexico
2RP-5572

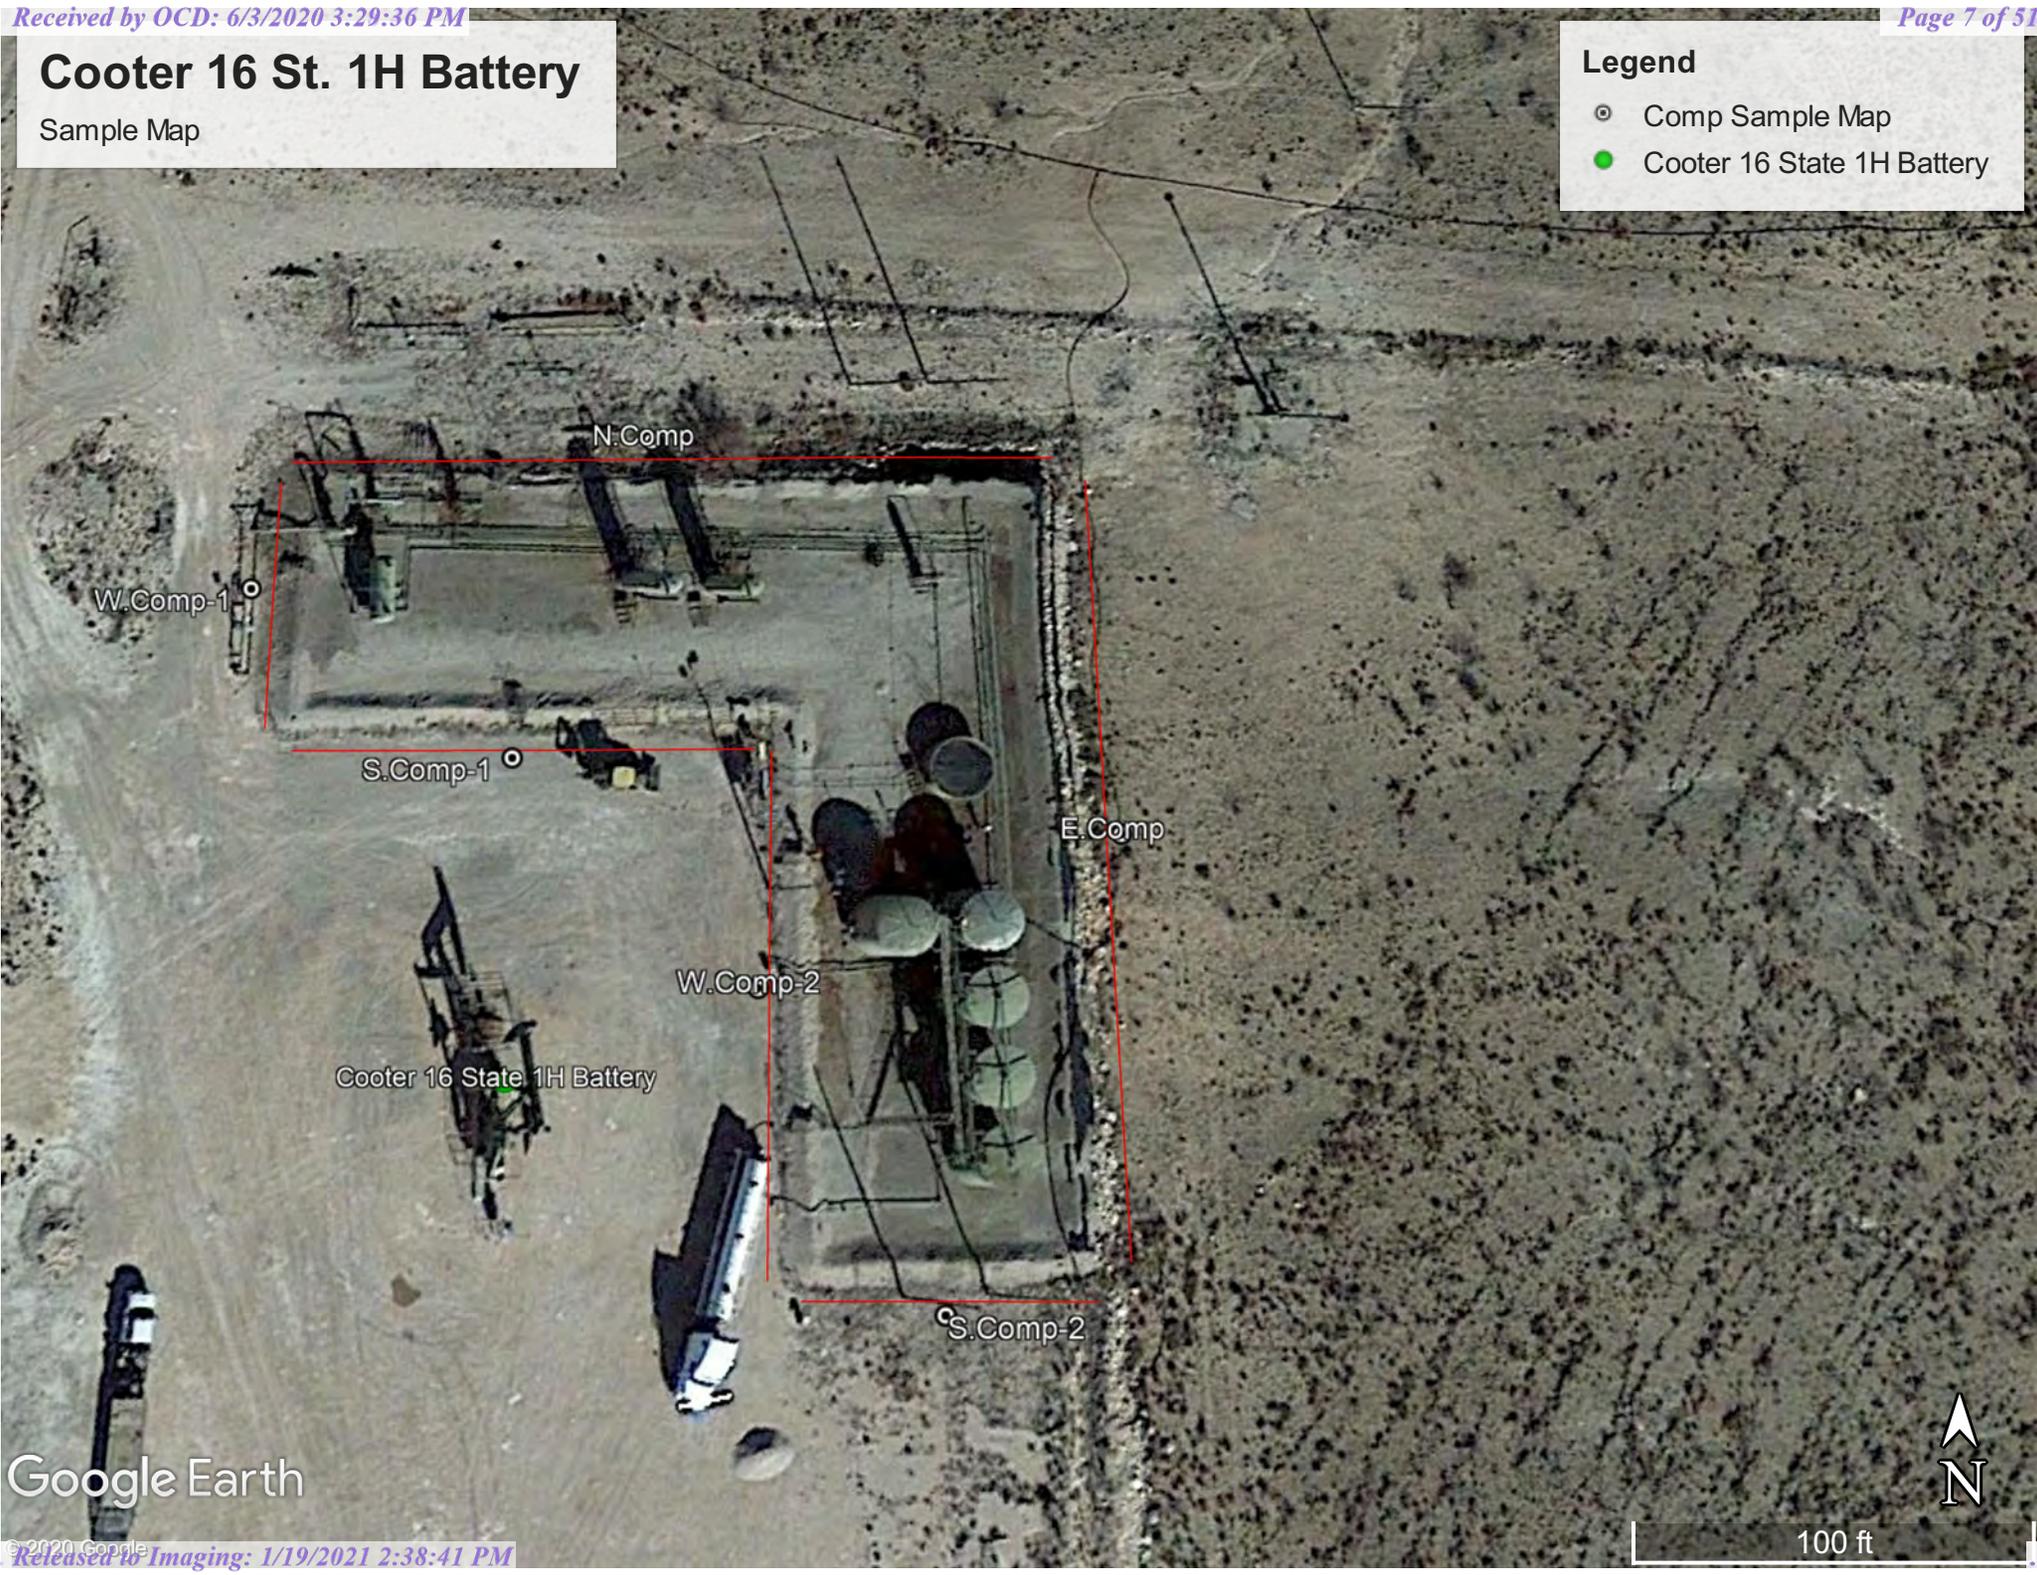
- Comp Sample Map
- Cooter 16 State 1H Battery

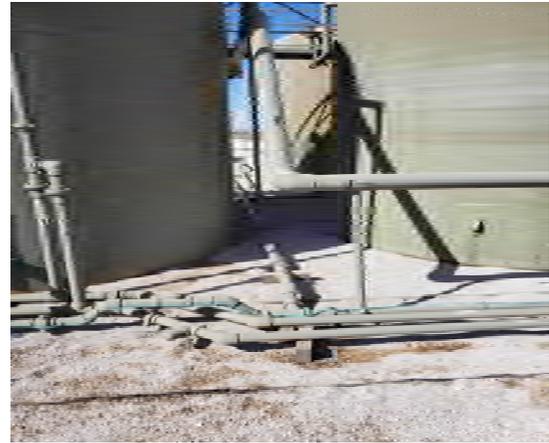
Interior Staining

- Stained Pea gravel was hand excavated from the interior of the lined area.
- No breaches were observed in exposed liner, photo documentation is presented in [Appendix IV](#).
- Fresh Pea gravel was placed in lined area.

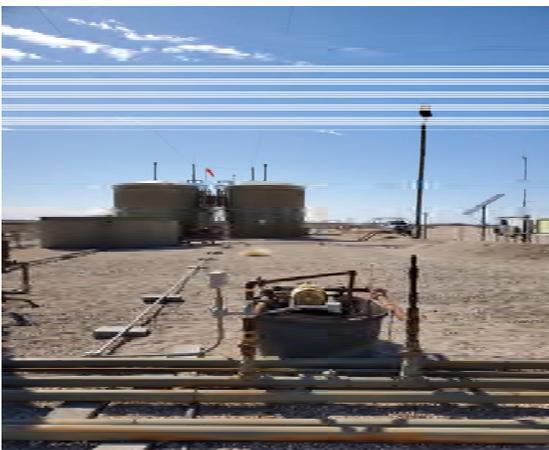
Lined Battery

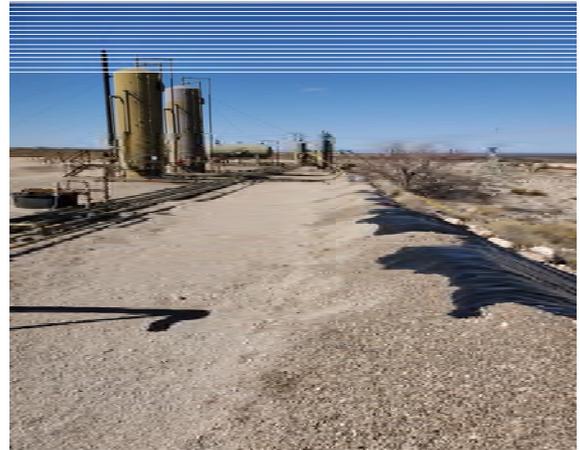
Lined Berm

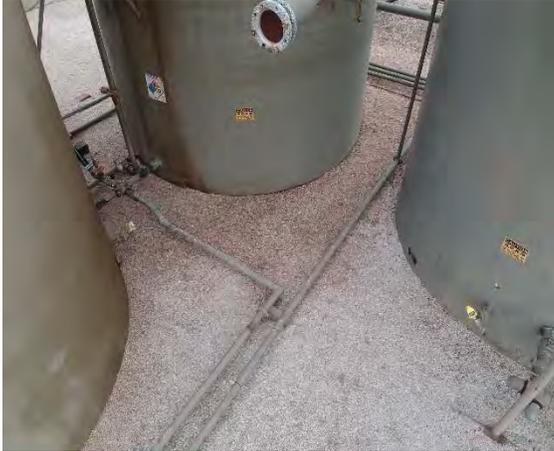
Post clean-up at source

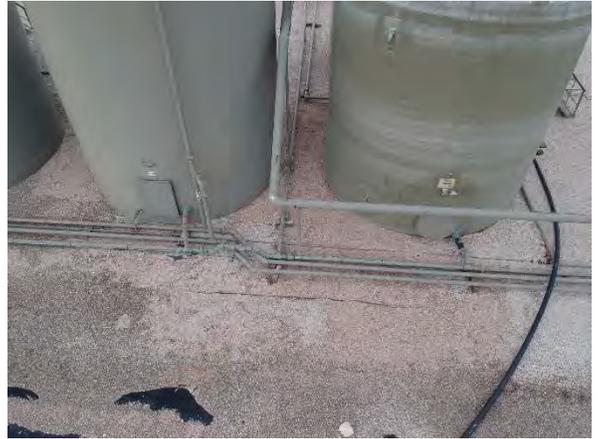
Post removal of staining

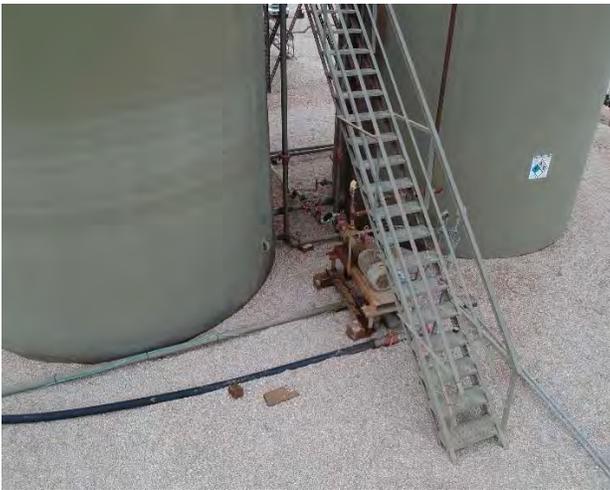
Completion Photo of fresh material

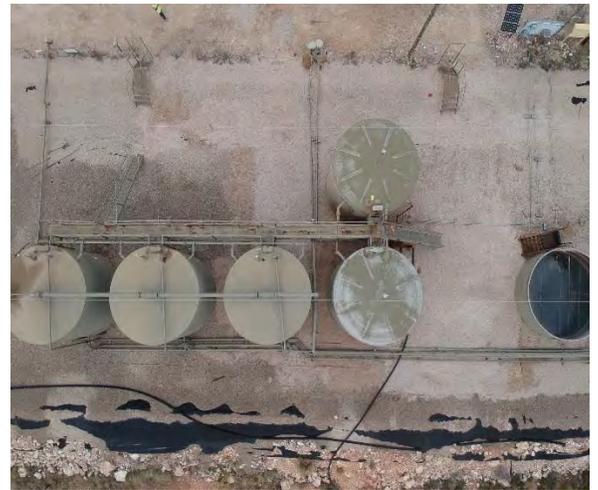
Aerial confirmation of lined containment
