## Remediation and Closure Report

Hackberry 26 Fed Com 1H  
Eddy County, New Mexico  
API # 30-015-43856  
Incident # **Nvv2002839011**

**Rev. October 19 2020**

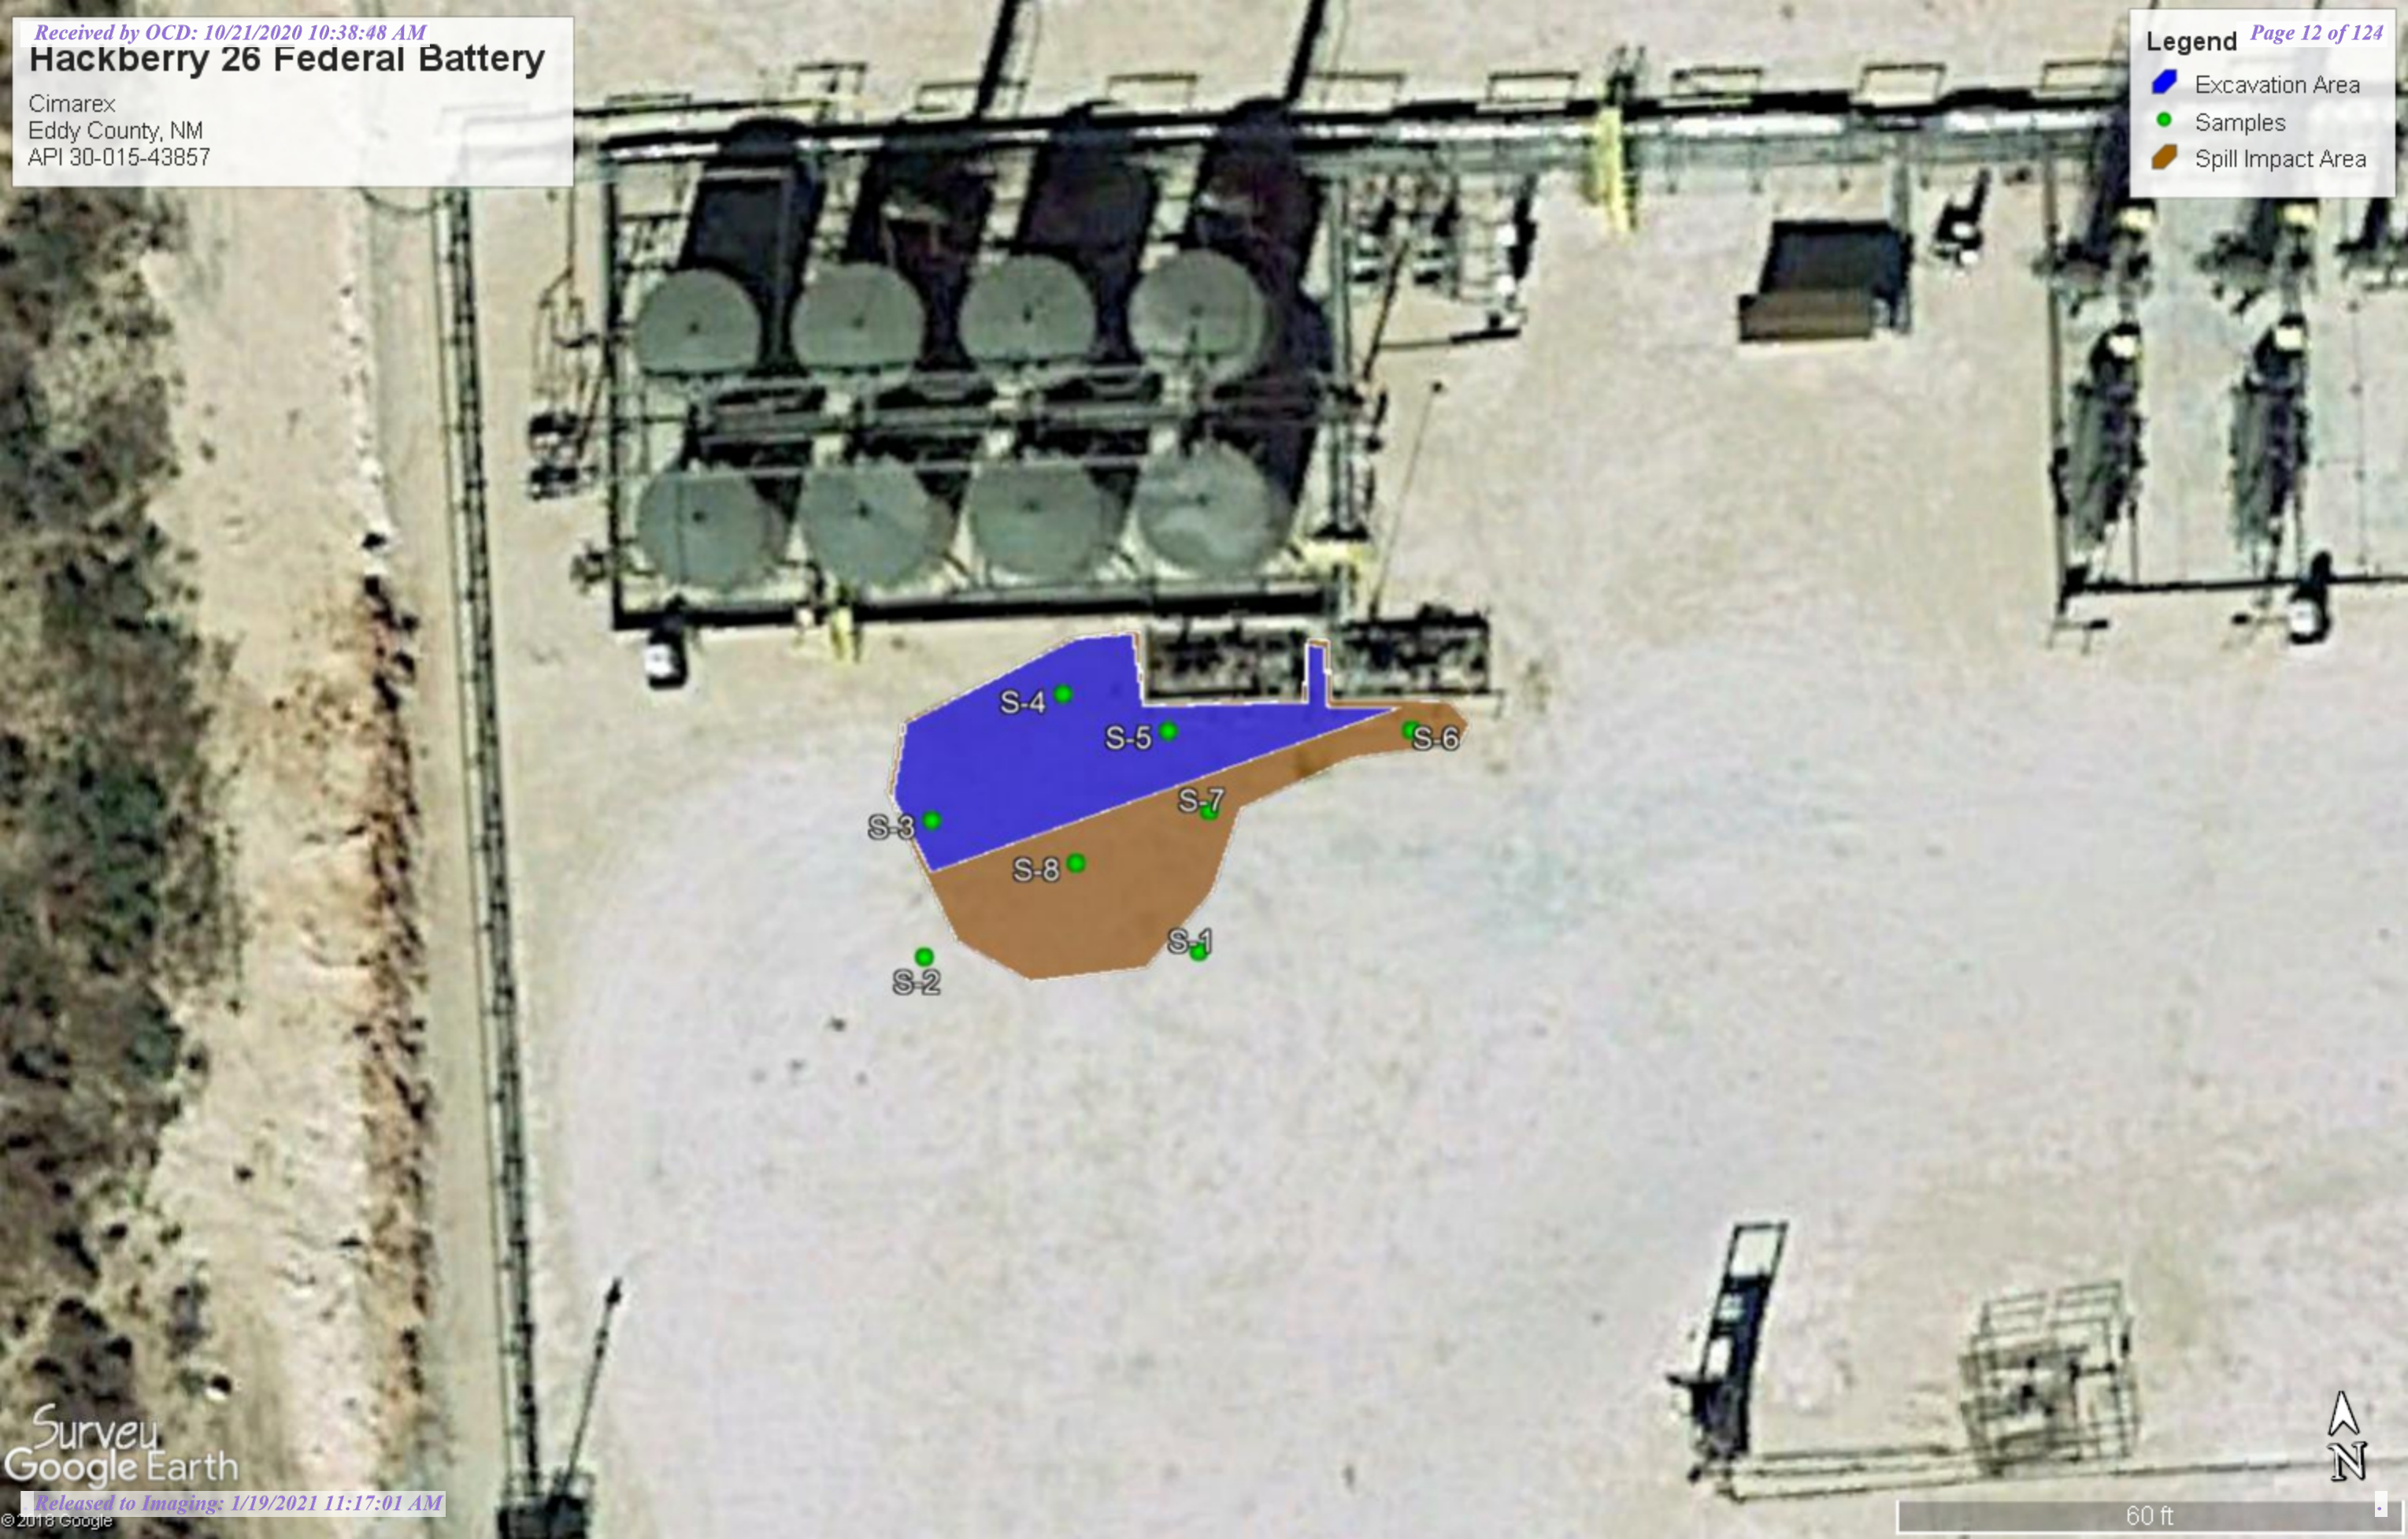
Cimarex Energy Company  
API # 30-015-43856  
Eddy County, NM  
Sample Point Map

Spill Impact Area

- Soil Sample (Discrete)
- Test Trench

On August 07, 2019 Talon mobilized personnel to begin site assessment and soil sampling activities. Grab soil samples were initially collected from the impacted area utilizing a hand auger. All soil samples were properly contained, preserved and Transported to Cardinal Laboratories for analyses of Chloride (SM4500Cl-B), BTEX (8021B), and TPH (8015M). Analytical results from our initial sampling events are presented in the following data table. Initial site assessment sample positions are illustrated on Figure 3, in [Appendix I](#). Complete laboratory reports can be found in [Appendix VI](#).

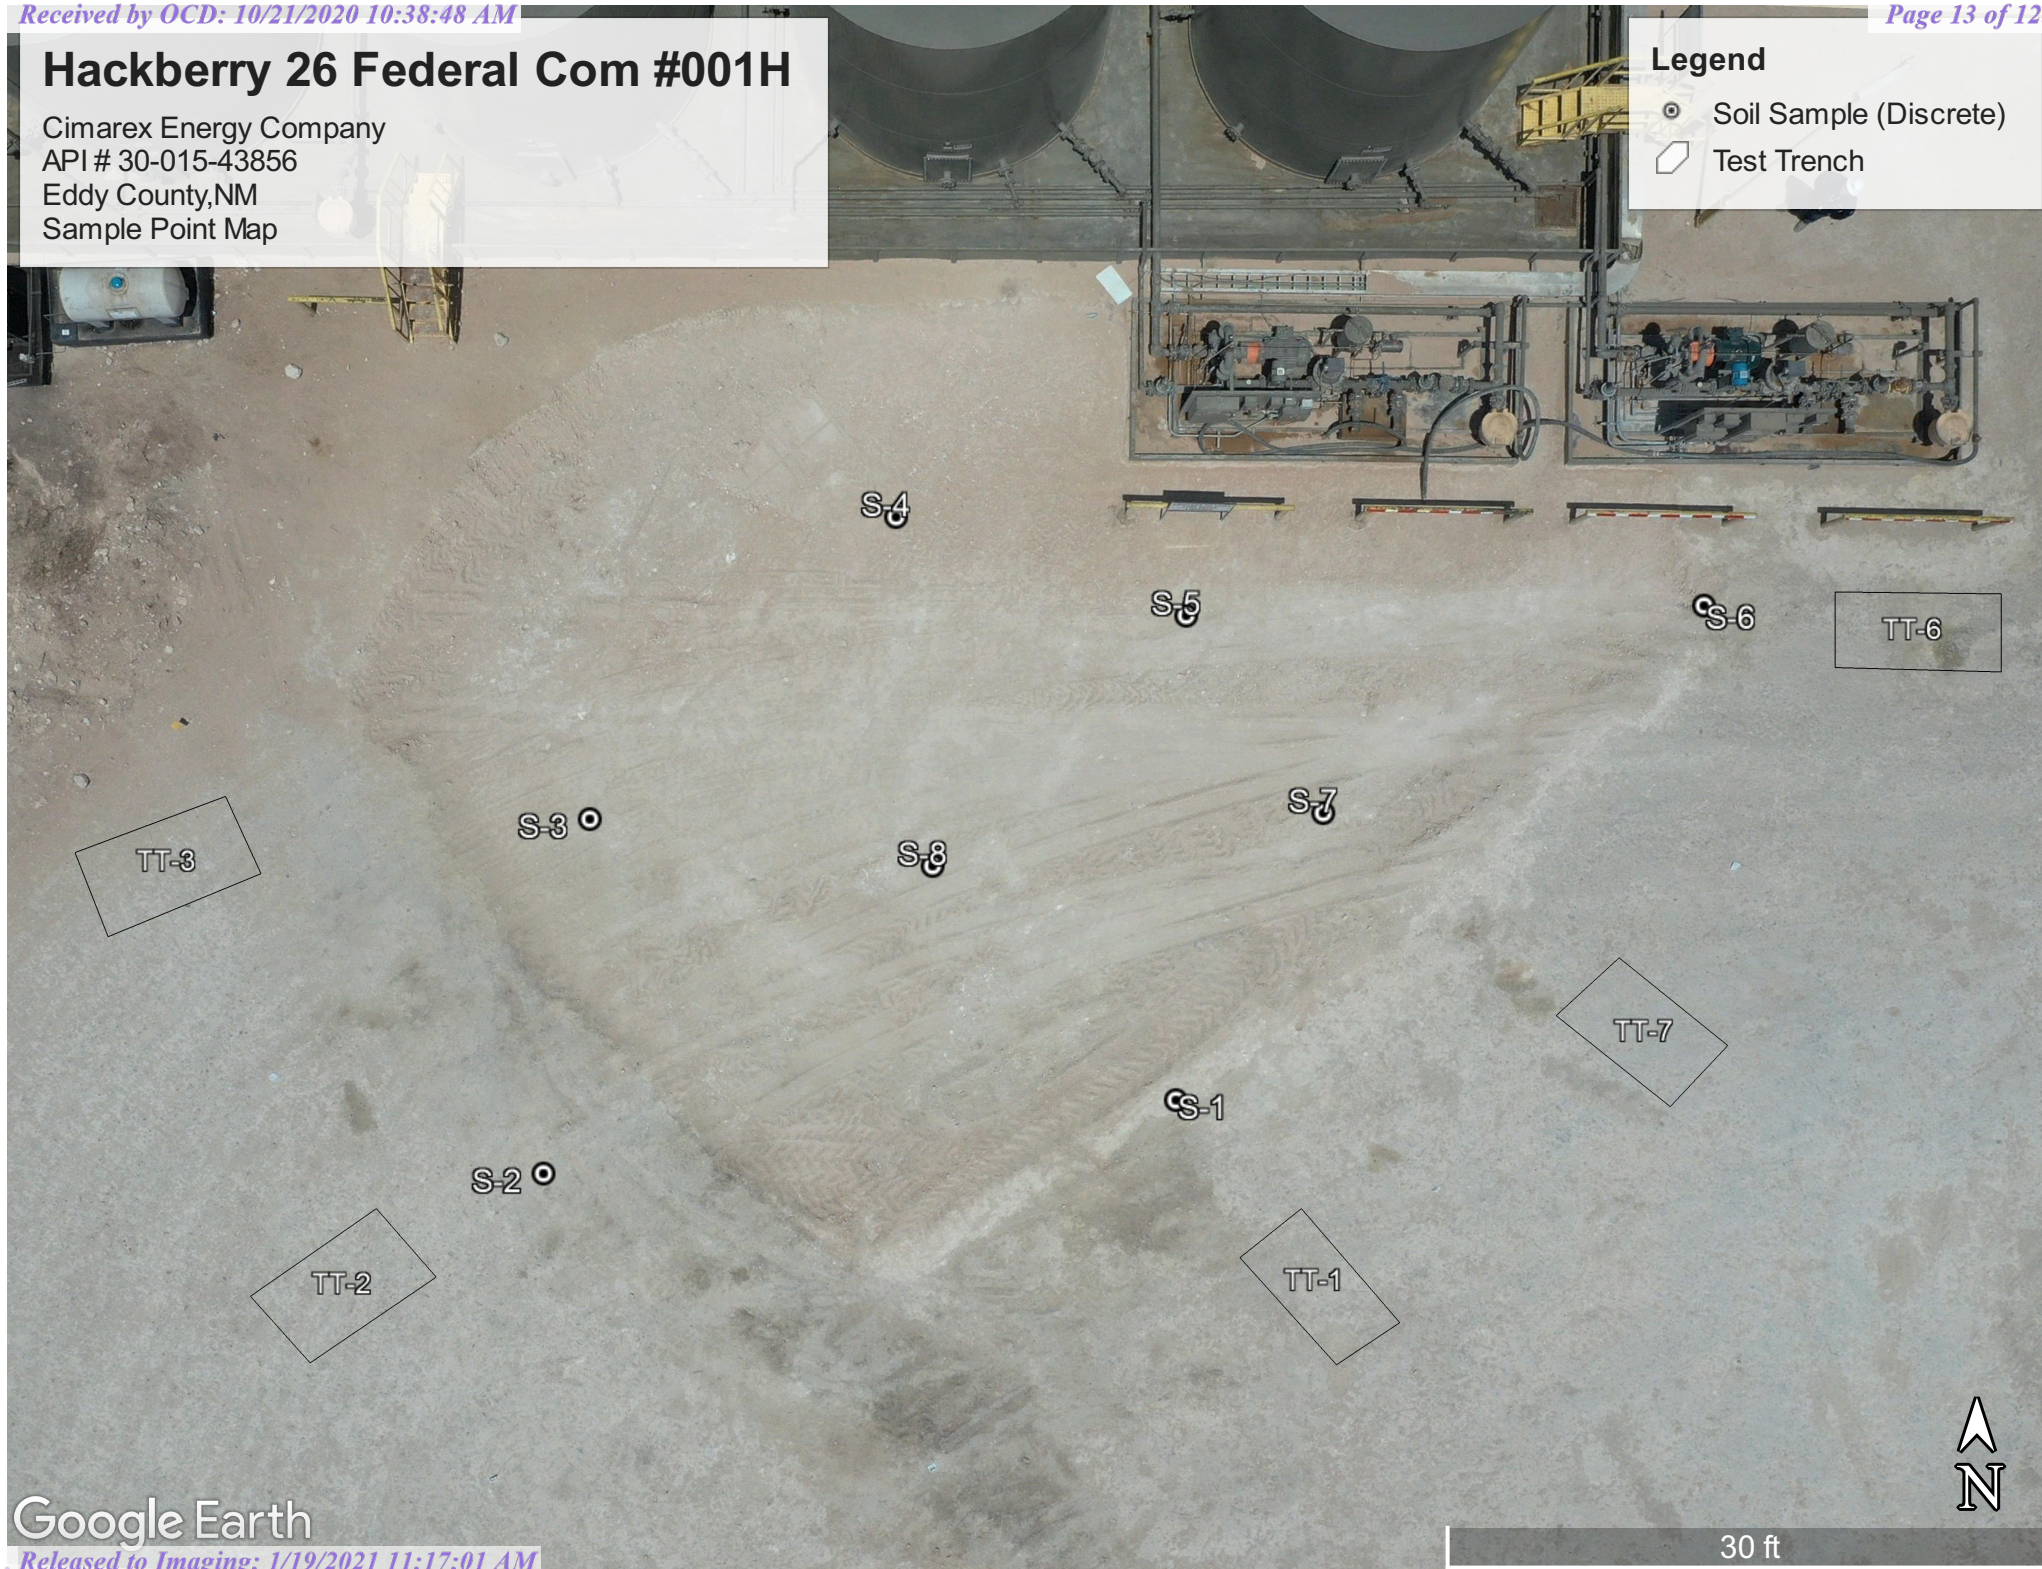
Excavation 0.5 ft.

High Pressure Line

Sample Position

Based on the results of our site assessment and upon client authorization, excavation activities commenced on April 20, 2020. Approximately 0.5' bgs. was excavated throughout the impacted area. Confirmation samples were collected at the base of sidewalls which also serve as bottom confirmation of soil analytes and that NMOCD closure criteria had been met, for the analytes of concern. The results of which can be found in the following data table. Confirmation sample locations and excavation dimensions can be found on Figure 4 in [Appendix I](#). Complete laboratory reports are attached in [Appendix VI](#).
