**Re: Closure Report**  
**Tatanka Federal Com 004H (2.29.20)**  
**Tracking#: NRM2006556242**  
**GPS: 32.0510, -103.3312**  
**Unit Letter P, Section 11, Township 26 South, Range 35 East**  
**Lea County, New Mexico**

COG Operating, LLC (COG) is pleased to submit the following closure report in response to a release that occurred at the Tatanka Federal Com 004H, located in Unit Letter P, Section 11, Township 26 South, Range 35 East, Lea County, New Mexico. The spill site coordinates are 32.0510, -103.3312.

Tatanka Federal Com 4H (2.29.20)

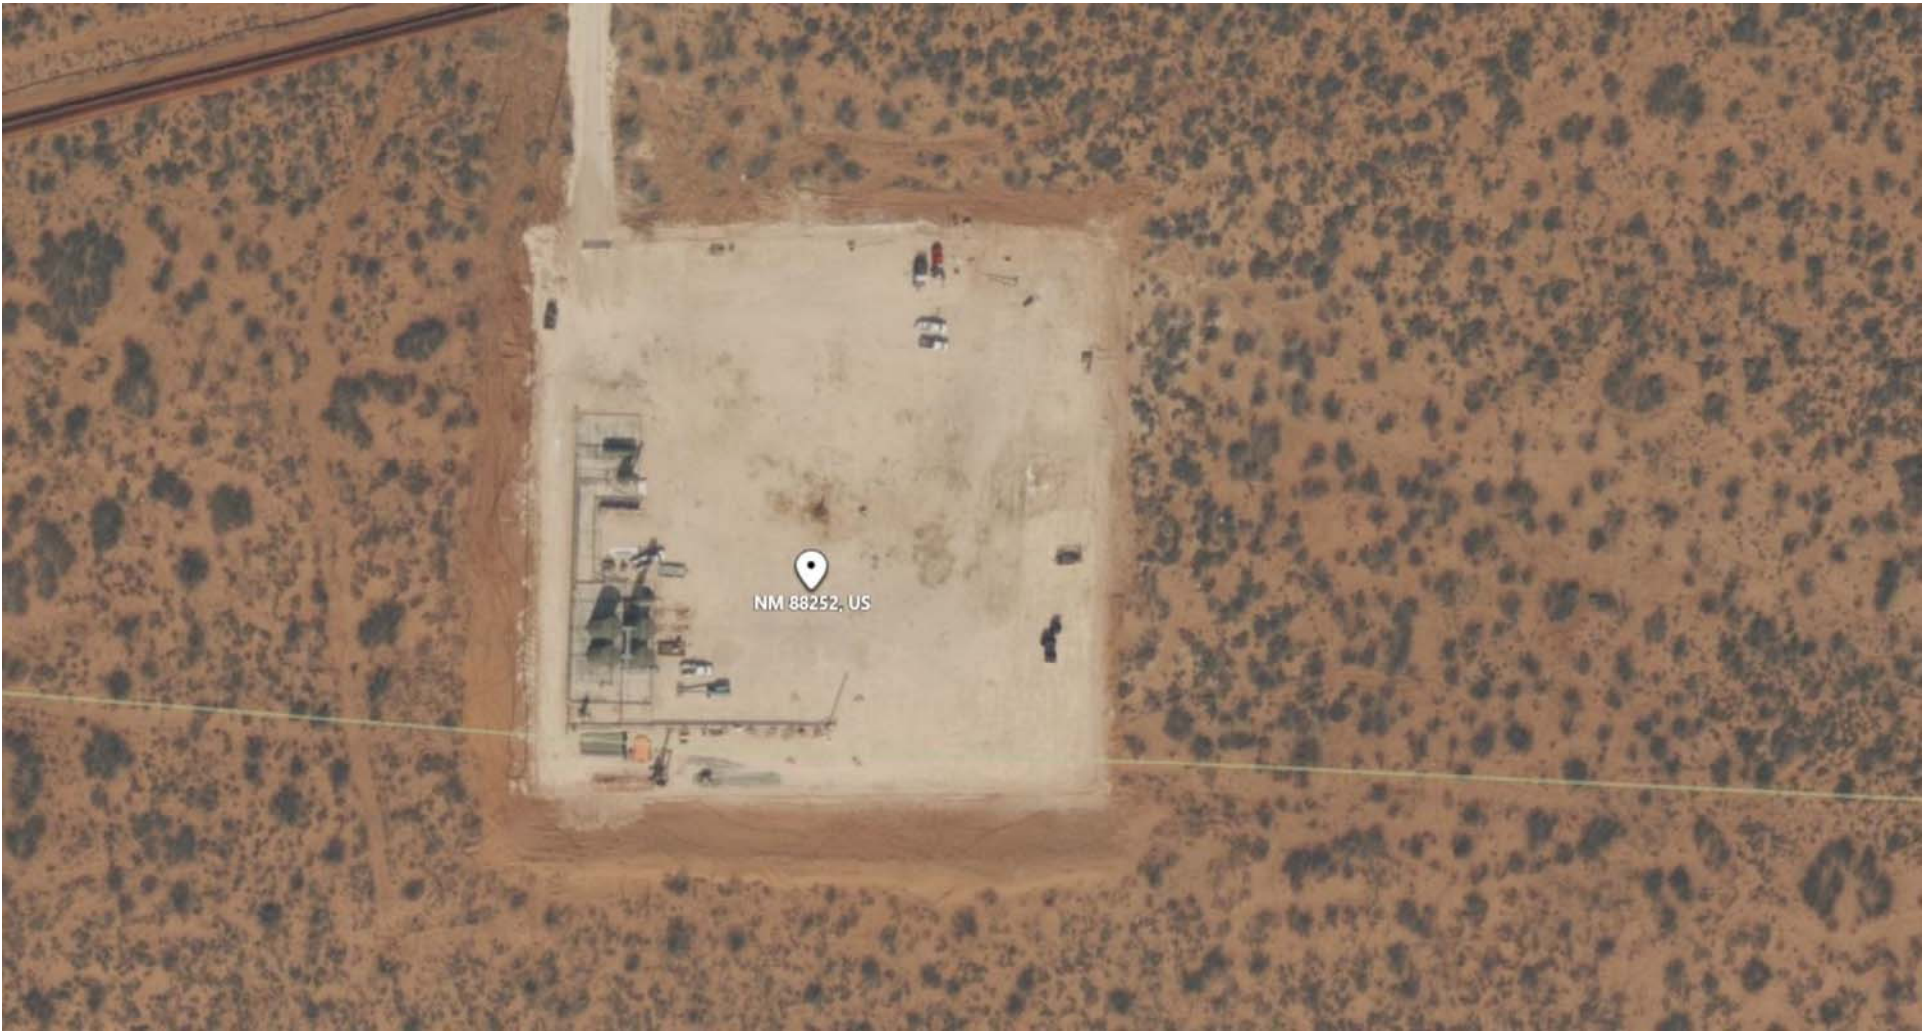
- Three (3) auger holes (AH-1, AH-2, and AH-3) were installed at zero to one (0-1) ft bgs and one to one and a half (1-1.5) bgs to assess and evaluate the release area.
- The sample results are shown in Table 1. The analytical data shows that all samples meets NMOCD closure criteria (NMAC 19.15.29.12(E) Table I).

Auger Holes

AH-3

AH-1

AH-2
