Release Notification

RE: Closure Report
Incident ID: NRM2024553731
AEP #: 08312020-1431-prodops
Location: In ROW SW of MSU 551 Pad

Advance Energy Partners Hat Mesa LLC submits this closure report for the above referenced incident. We ask closure for the regulatory file.

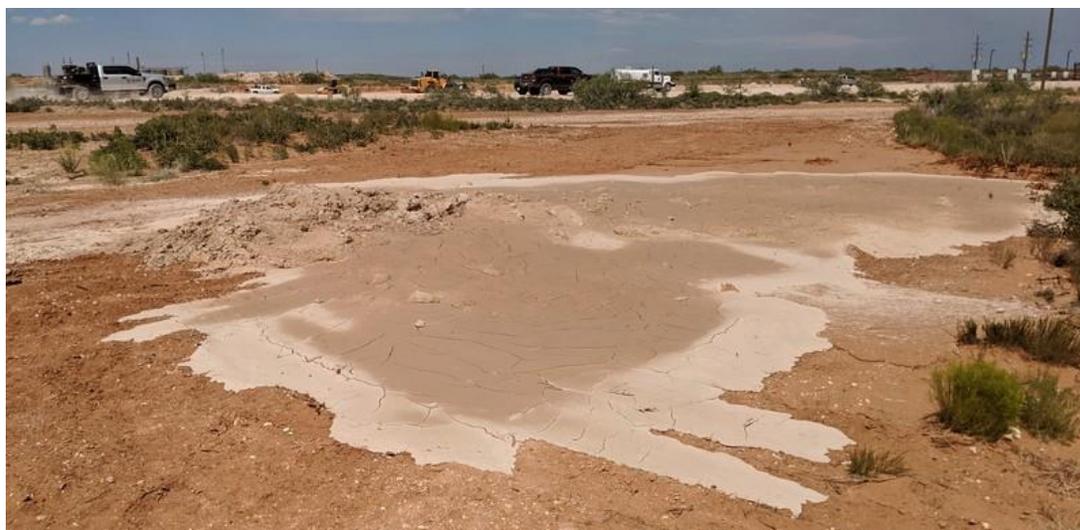
The unauthorized release was discovered on August 31, 2020 in a right-of-way on surface owned by Merchant Livestock. Field investigations suggest that a hydrovac released excavated soil (Figure 1) after performing surface trenching for construction purposes for the installation of flowlines and electrical associated with oil and gas operations. The release extent covered 2,214 square feet. Figure 2 is a representative photo showing the released excavated material (source material) that flowed over the surface.

Figure 1: Photo of release viewing east-northeast from the southwestern extent of the release; along the east-west right-of-way. The Merchant State Unit 551H production pad is visible in photo background. GPS: 32.4409261 N, 103.5498500 W. Date/Time: 2020-08-31 14:29:53.

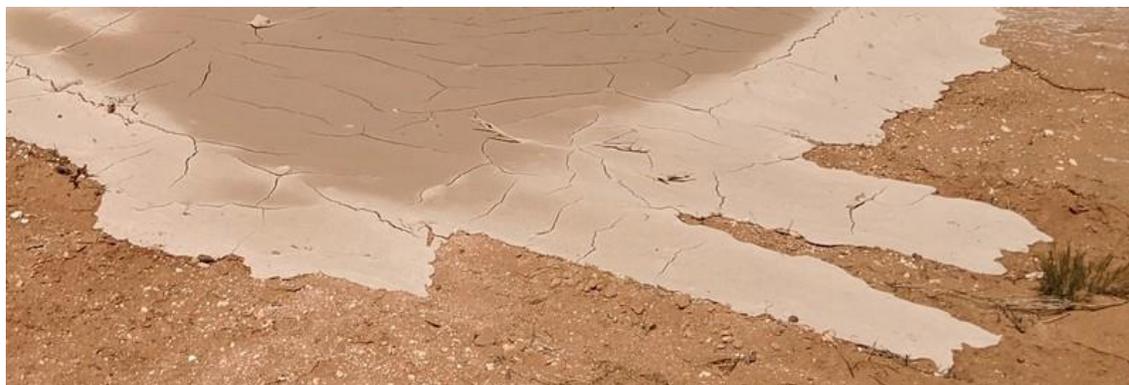
Figure 2: Source material that was released in the right-of-way. GPS: 32.4409261 N, 103.5498500 W. Date/Time: 2020-08-31 14:29:53.

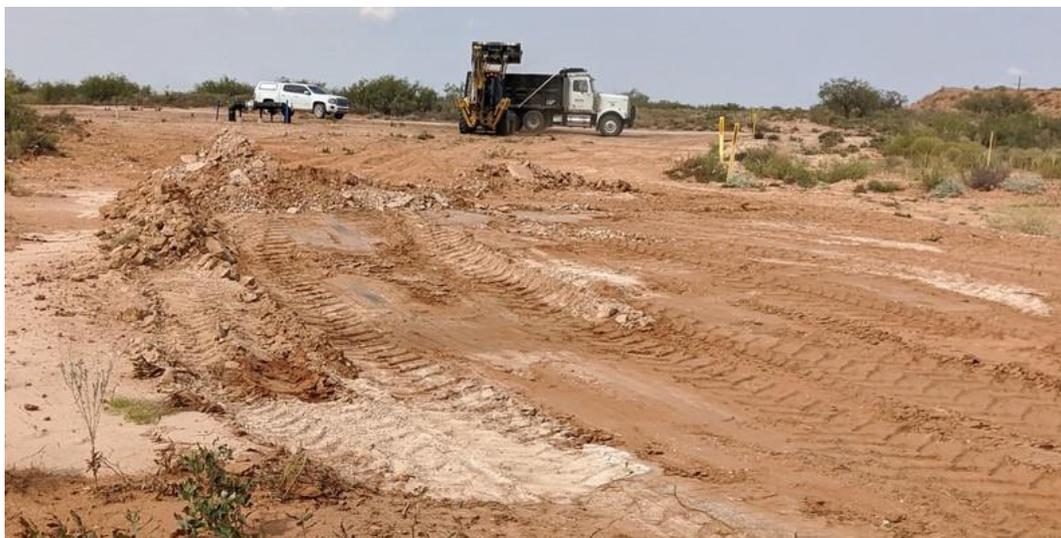
Figure 3: Excavation of source material - hauled off for proper disposal. Photograph is viewing west from eastern release extent. GPS: 32.4409283 N, 103.5496094 W. Date/Time: 2020-09-17 10:25:15

On September 17, 2020; approximately 15 cubic yards of source material was excavated and hauled offsite for proper disposal (Figure 3).

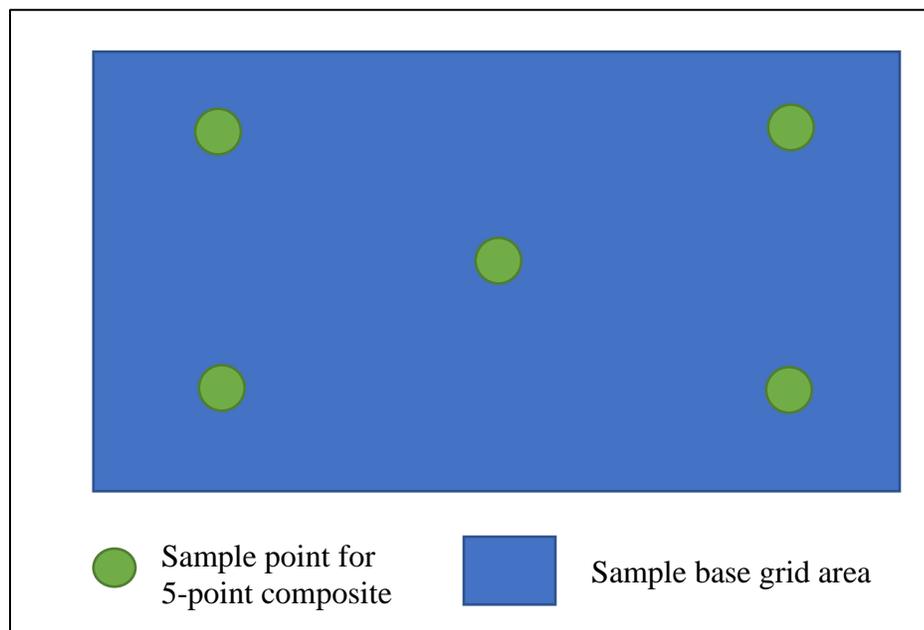
As the source material characterization sample was below the most stringent closure criteria listed in Table 1 of 19.15.29 NMAC, we divided the remediated area into two representative sections for the collection of confirmation samples on September 18, 2020. Confirmation samples were below the most stringent closure criteria listed in Table 1 of 19.15.29 NMAC. Plate 1 shows the location of confirmation samples (B-01 and B-02). Each confirmation sample represents a 5-point composite sample as represented in Figure 4.

Figure 4: Example of 5-point sample base grid for composite sampling.

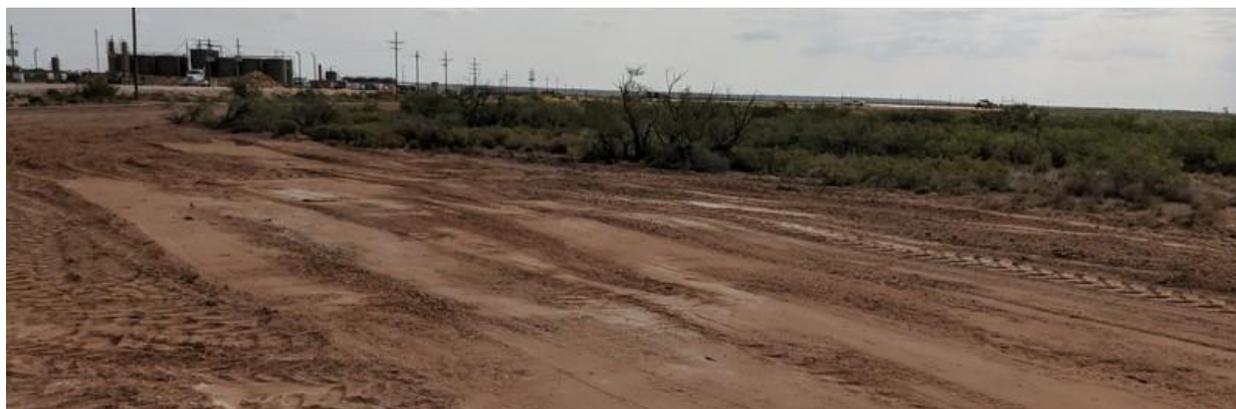
Figure 5: Restored right-of-way surface. Viewing northeast toward the Merchant State Unit 551H production pad.
GPS: 32.4409950 N, 103.5497922 W. Date/Time: 2020-09-17 10:40:52.

The surface was restored per 19.15.29.13 NMAC (Figure 5) as a right-of-way easement.

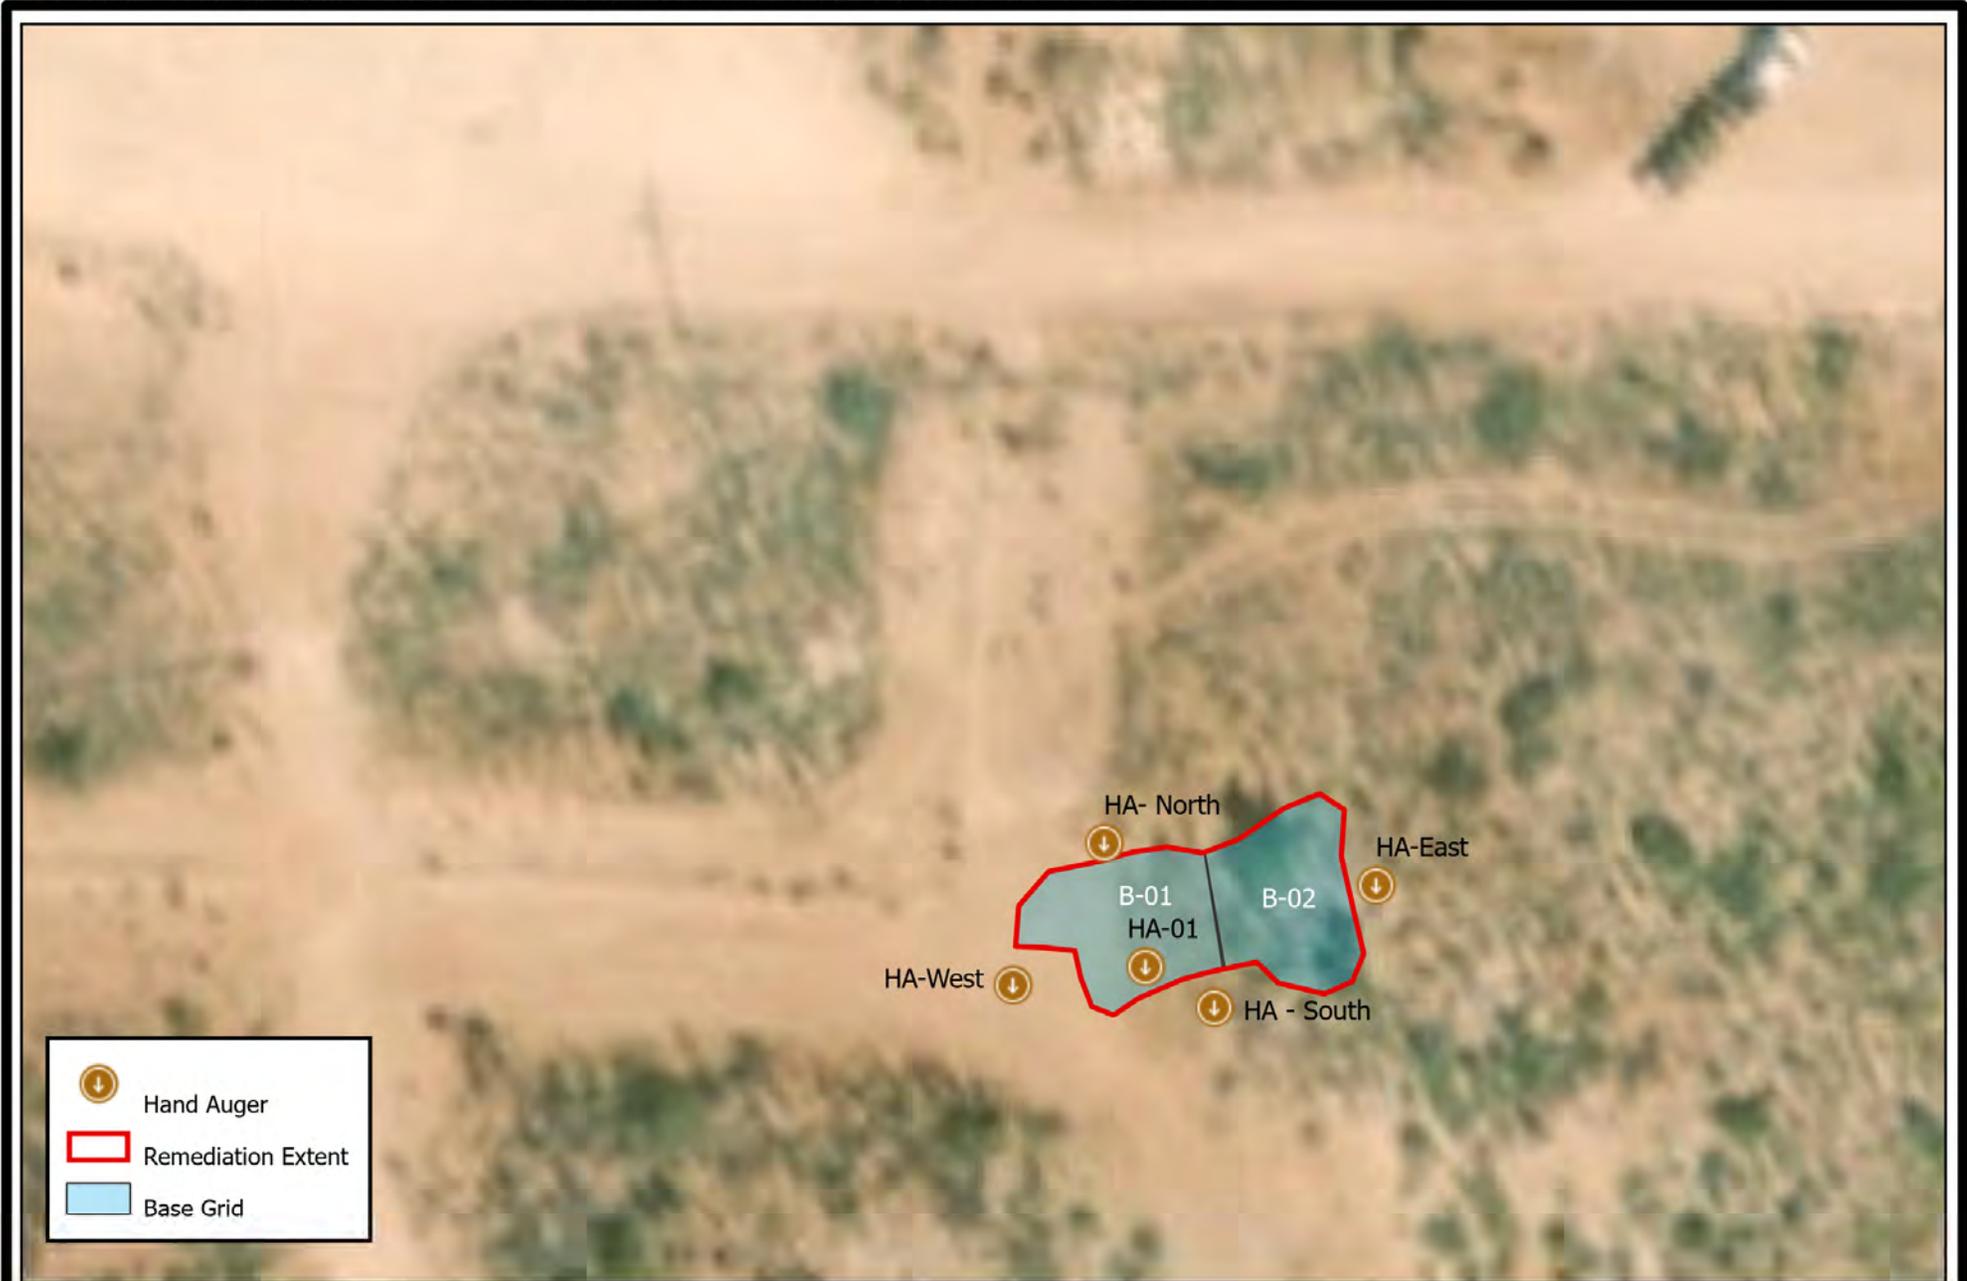
Plate 01

Hand Auger
	Remediation Extent
	Base Grid

Site Map
