Site Assessment Report and Proposed Remediation Workplan

Targa Midstream Services, LLC

Bagley 7-Inch

NMOCD Reference No. nRM2022554489

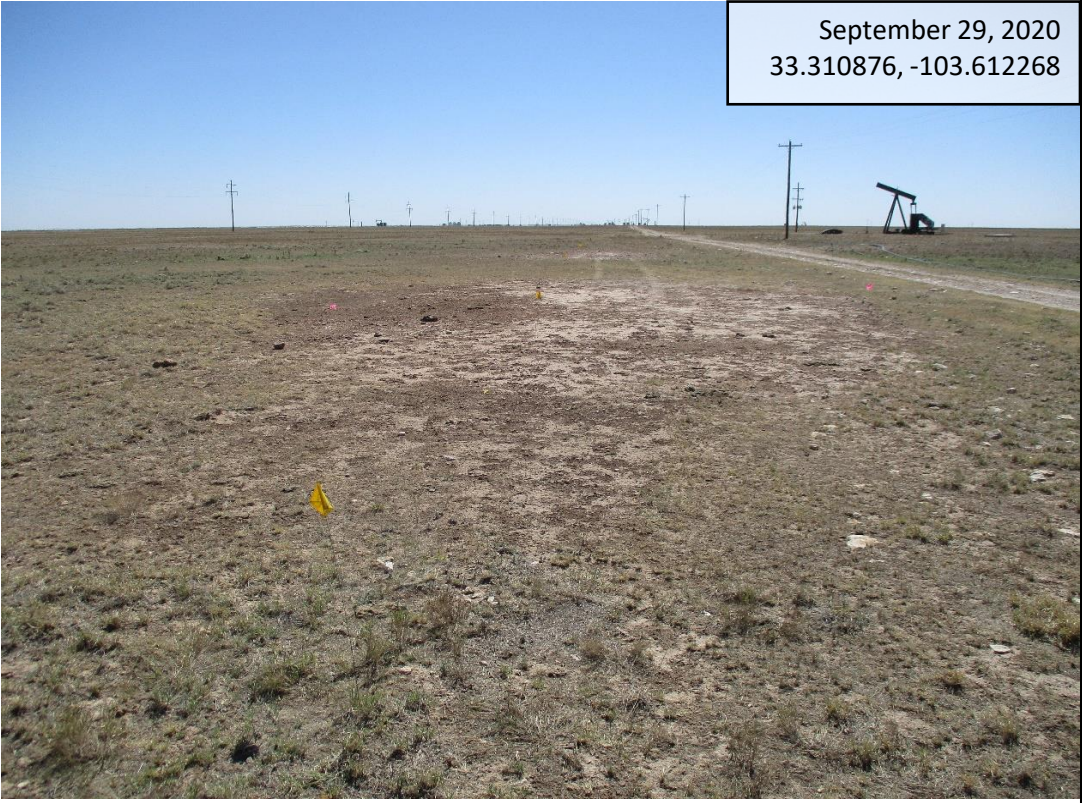
Photo Number: 1

September 29, 2020 33.310876, -103.612268
Photo Direction: South		
Photo Description: Impacted surface area.

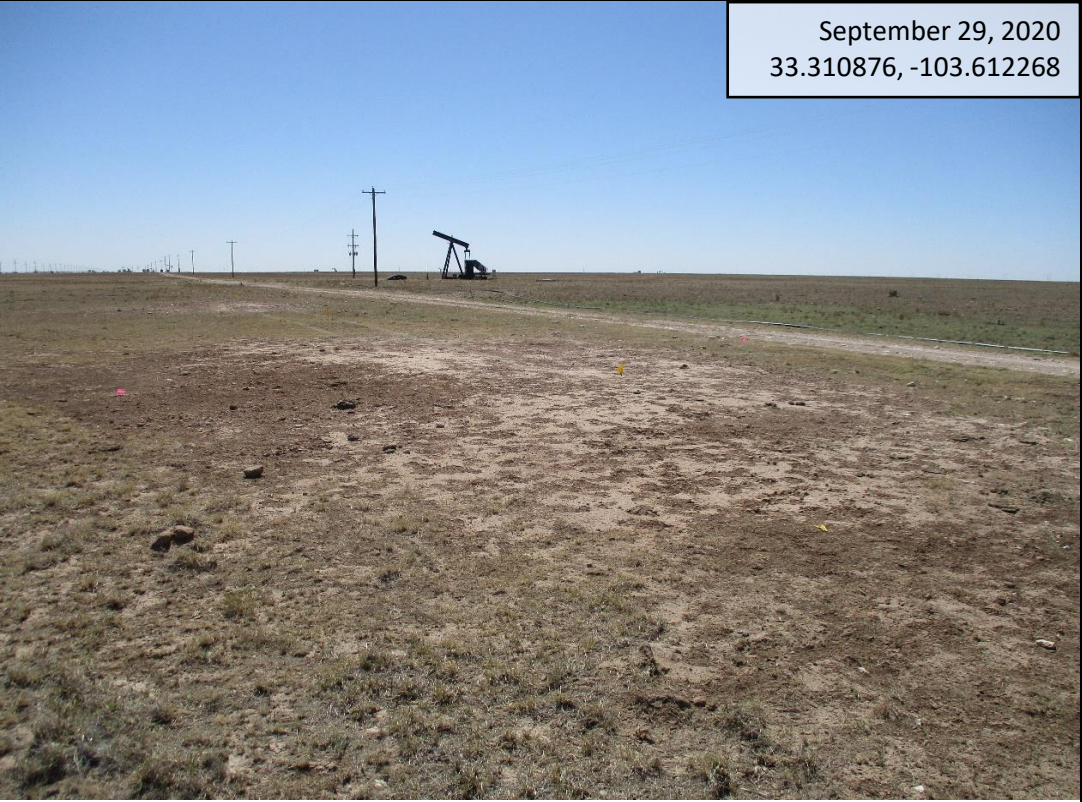
Photo Number: 2

September 29, 2020 33.310876, -103.612268
Photo Direction: Southwest		
Photo Description: Impacted surface area.

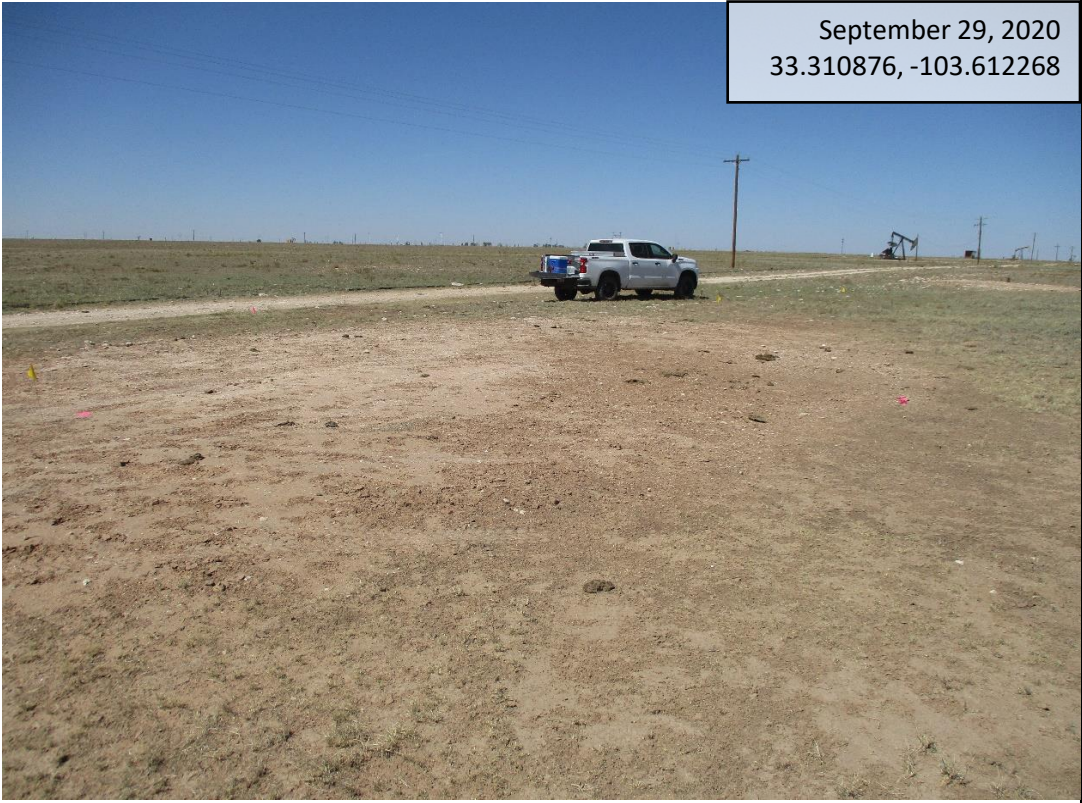
Photo Number: 3

<p>September 29, 2020 33.310876, -103.612268</p>
Photo Direction: Northwest	
Photo Description: Impacted surface area.

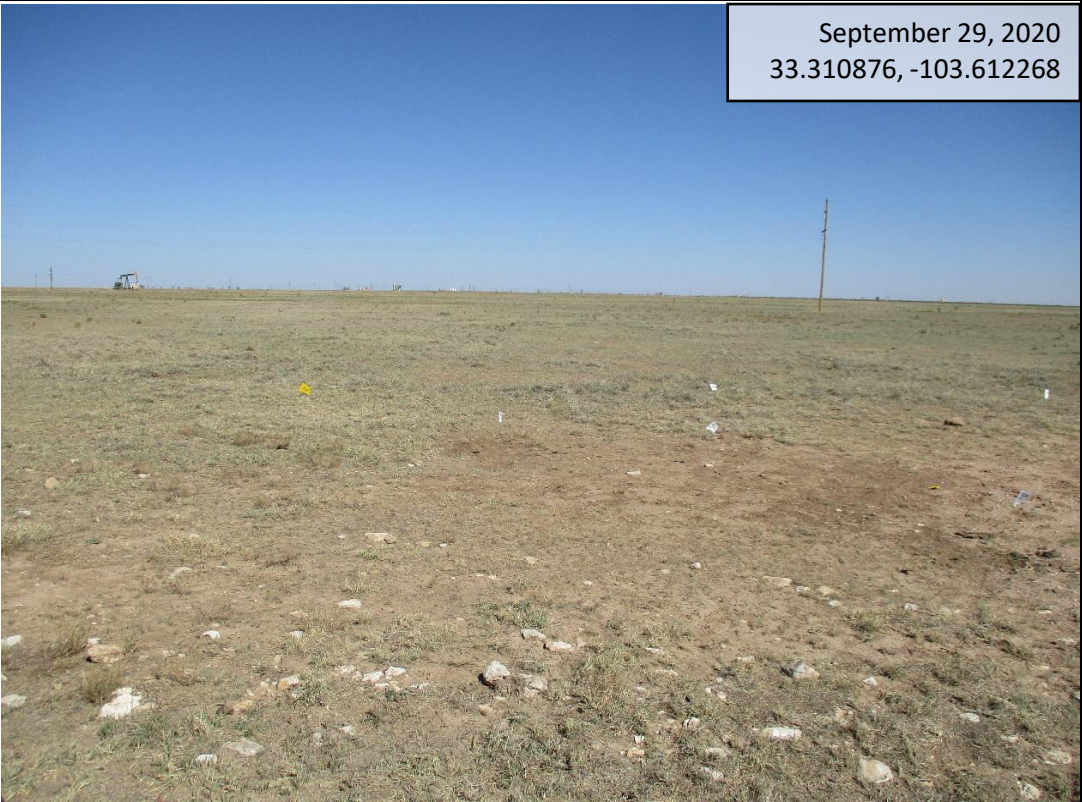
Photo Number: 4

<p>September 29, 2020 33.310876, -103.612268</p>
Photo Direction: East	
Photo Description: Impacted surface area.
