Closure Report

Incident ID: NAB1831944630

Site Name:	Pure Gold B Federal 4
Company:	Oxy, Permian
Legal Description:	U/L P, Section 20, T23S, R31E
County:	Eddy County, NM
GPS Coordinates:	N 32.28413 W -103.79363

Oxy Pure Gold B Federal 4

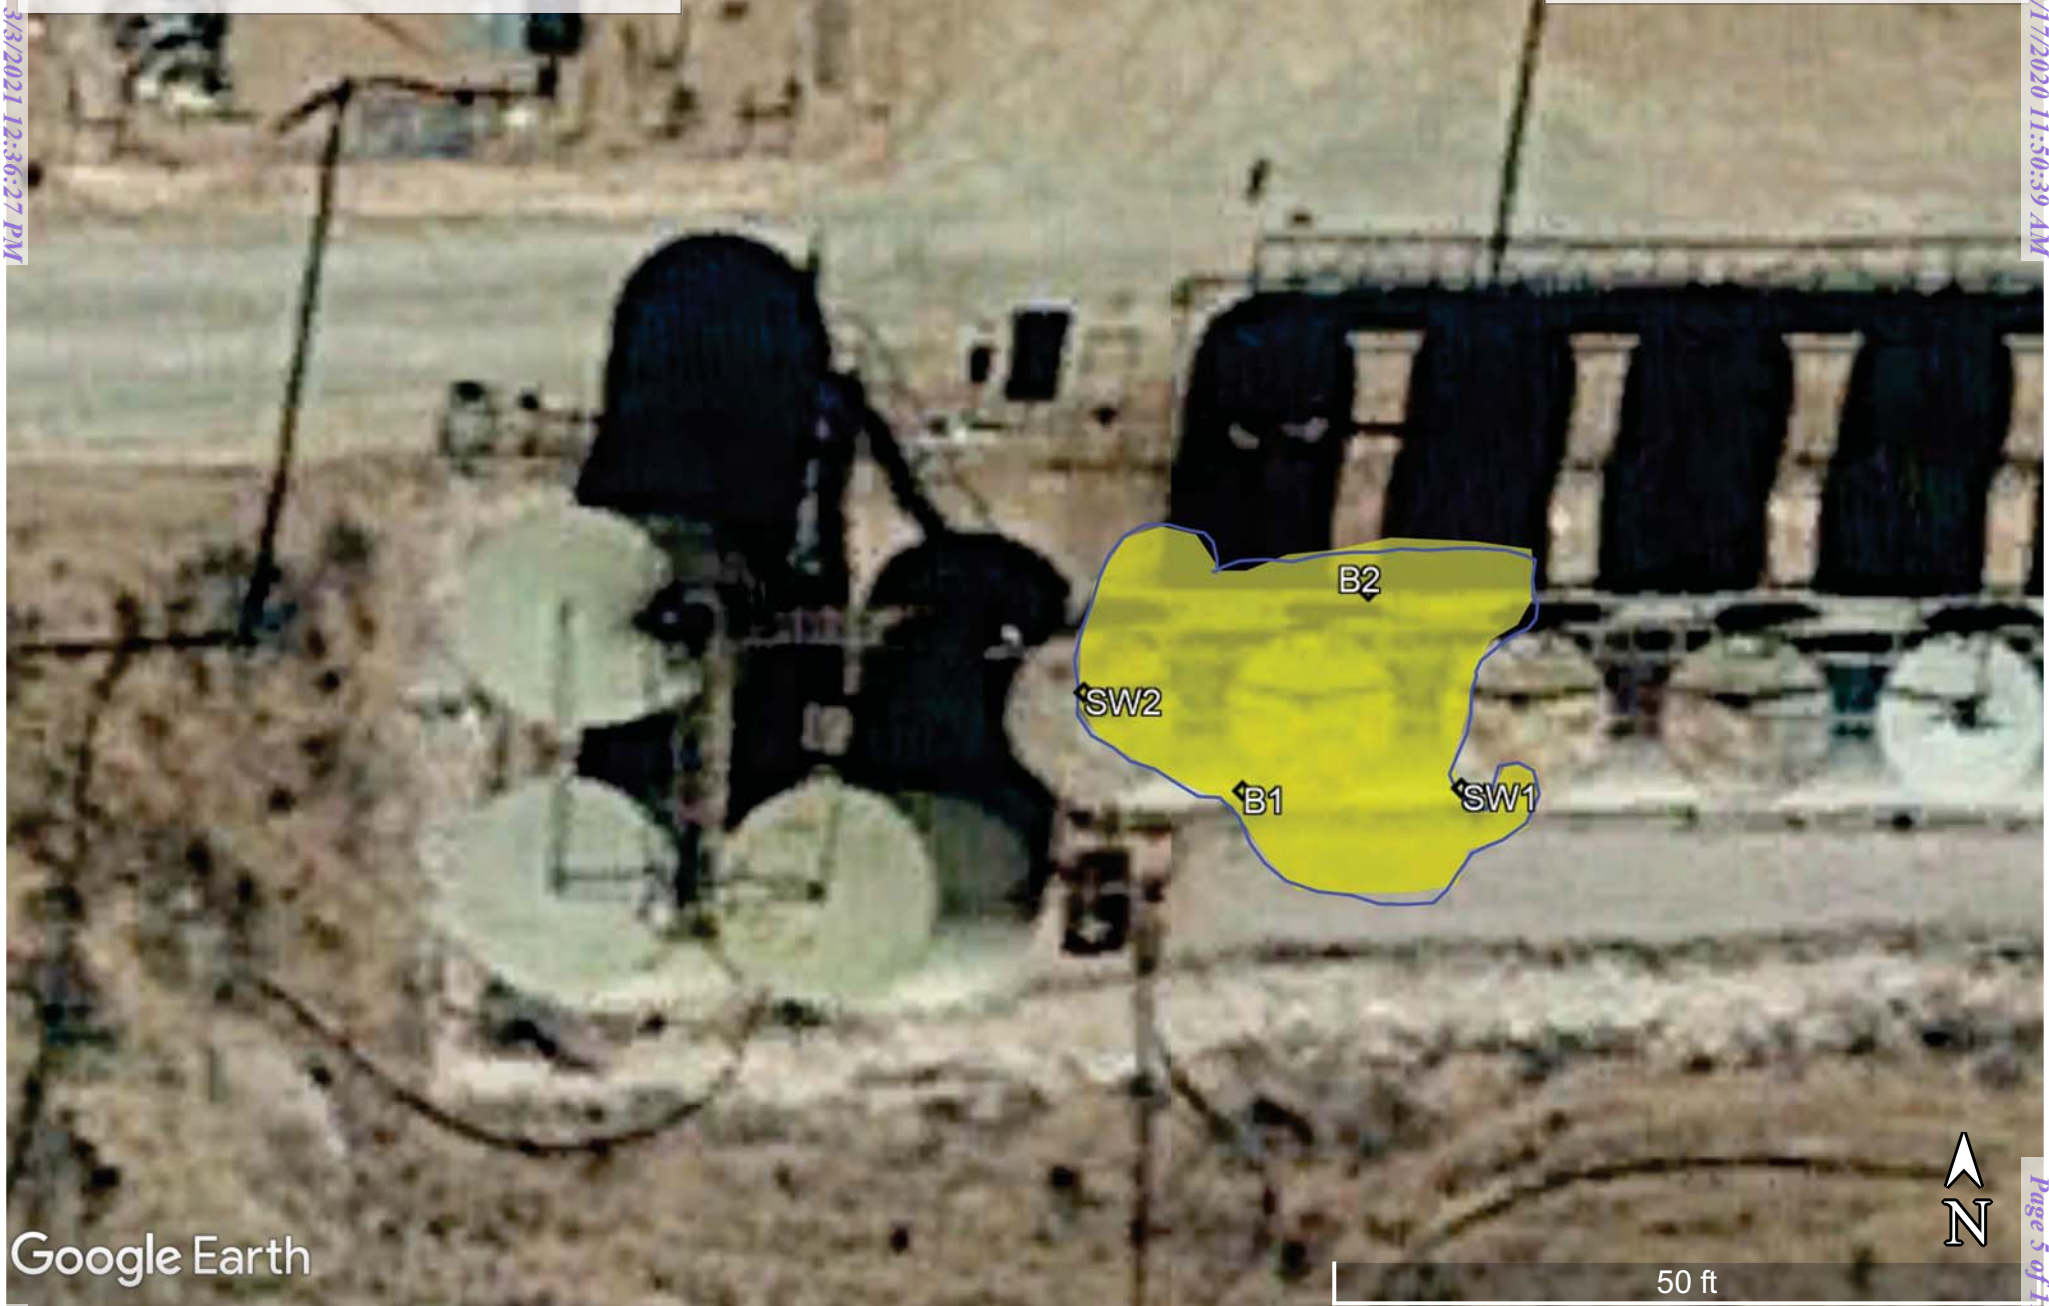
Leak Date: 10-17-2018
Eddy County, NM
API: 30-015-27238
Incident ID: PAB1831944349

6 inch Excavation
-

Confirmation Sample Points
-

Leak Area

Remediation Parameters:	Entire leak area has been excavated to a depth of 6 inches. Bottom confirmation samples were collected every 50 feet. The entire site was then backfilled with clean soil.
Remediation Activities:	10/9/20 to 11/12/20
