Final Closure Report

**Grizzly Operating, LLC
Abo Pump Station B-6
Lea County, New Mexico
Unit Letter "B", Section 6, Township 17 South, Range 37 East
Latitude 32.86986 North, Longitude 103.289134 West
NMOCD Incident # nOY1814332779
1RP-5073**

September 2020

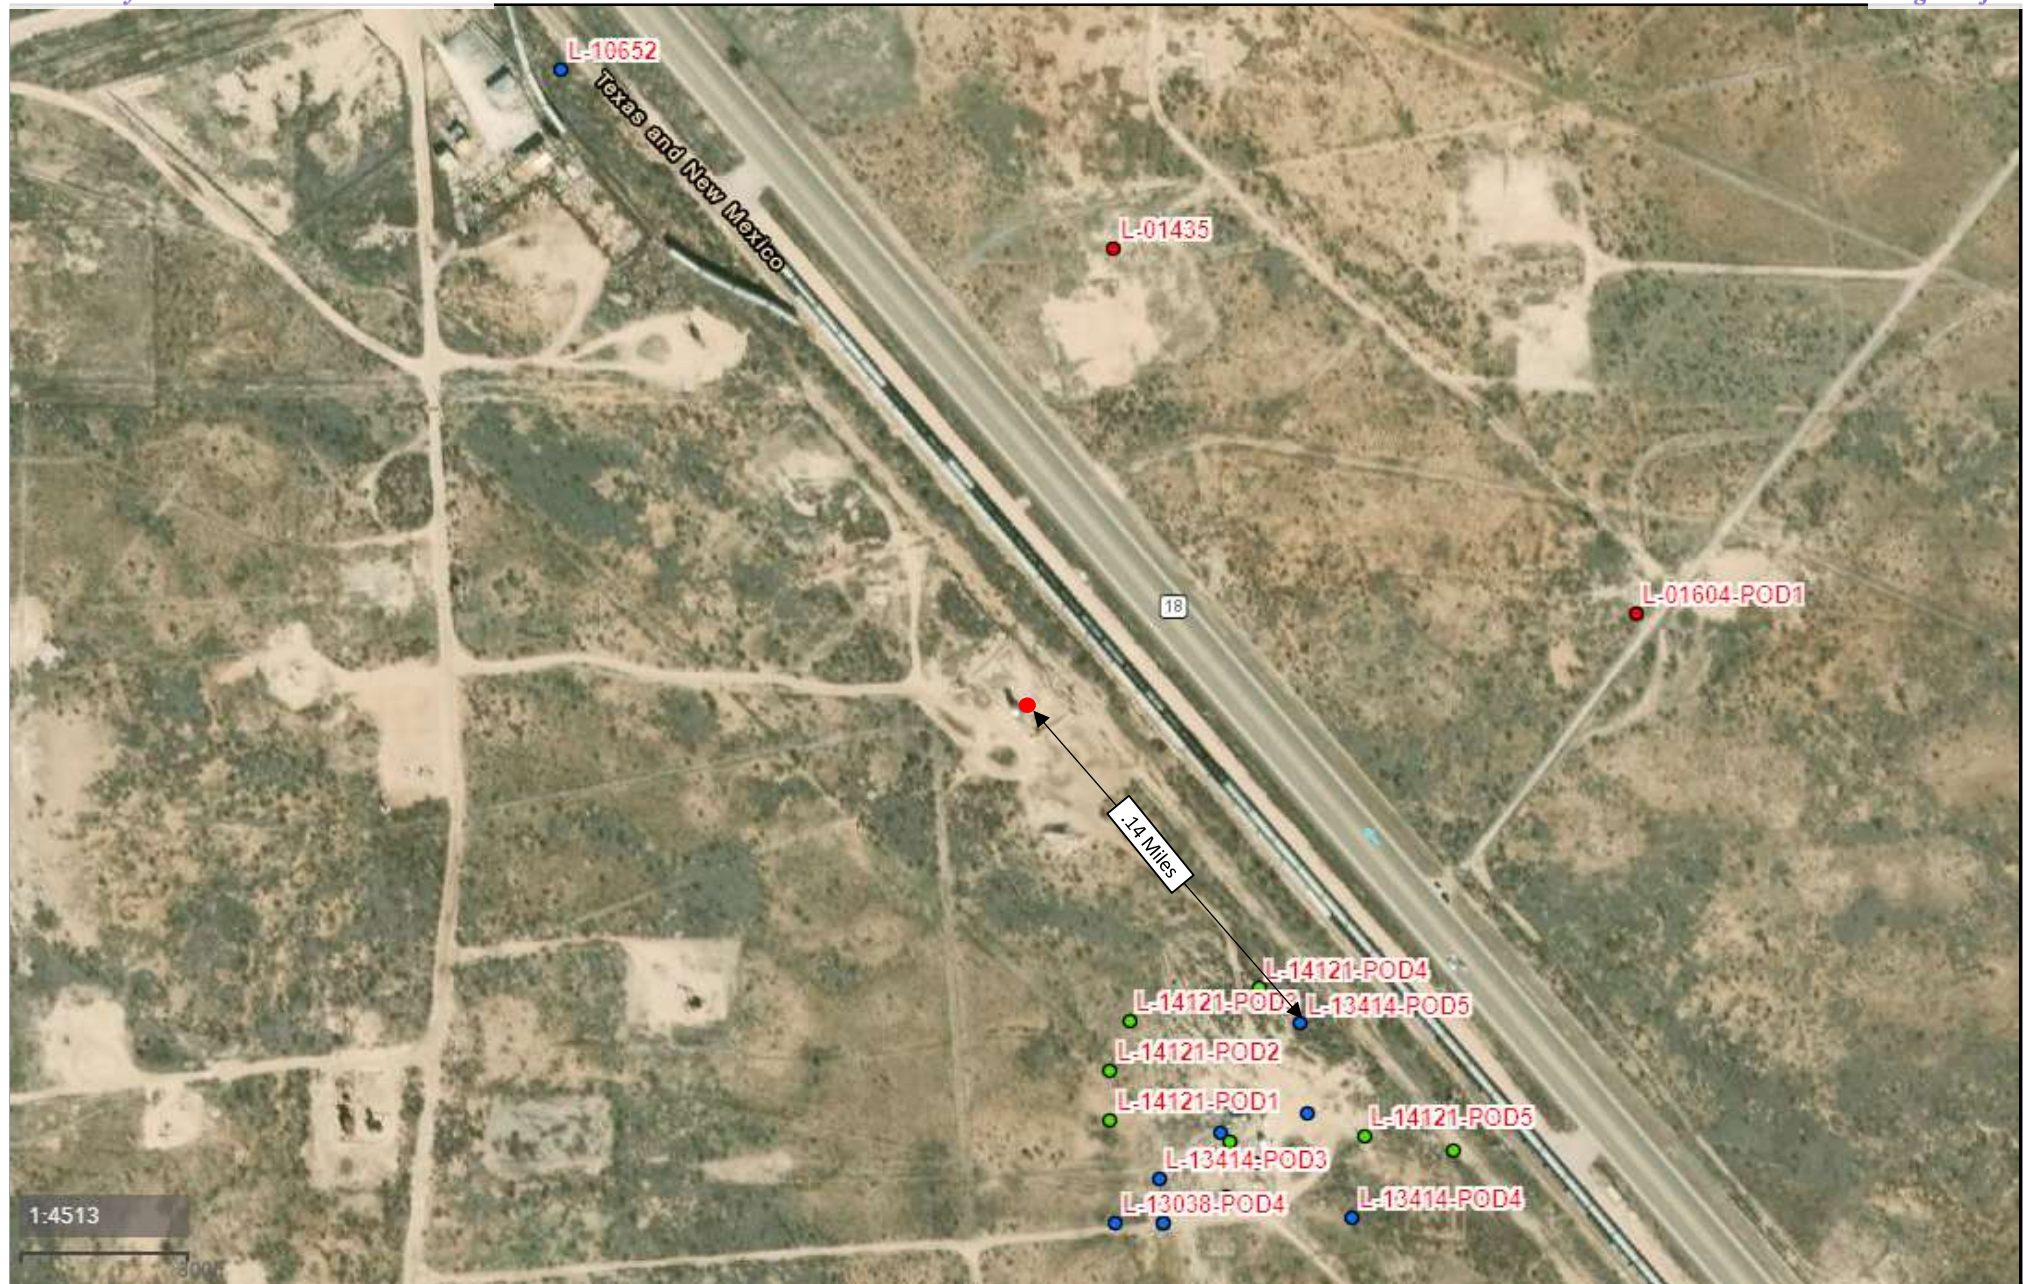
**Figure 2**

OSE POD Locations Map
 Grizzly Operating, LLC
 Abo Pump Station B-6
 GPS: 32.86986, -103.289134
 Lea County

A search of the New Mexico Office of the State Engineer (NMOSE) and United States Geological Survey (USGS) groundwater databases was completed in an effort to determine the horizontal distance to known water sources within a half mile radius of the Release Site. Approximate depth to groundwater was determined using maintained and published water well data. Karst mapping indicates the site is not located in a Karst designated area. Depth to groundwater information is provided as Attachment II and the results are depicted on Figures 2 & 3.

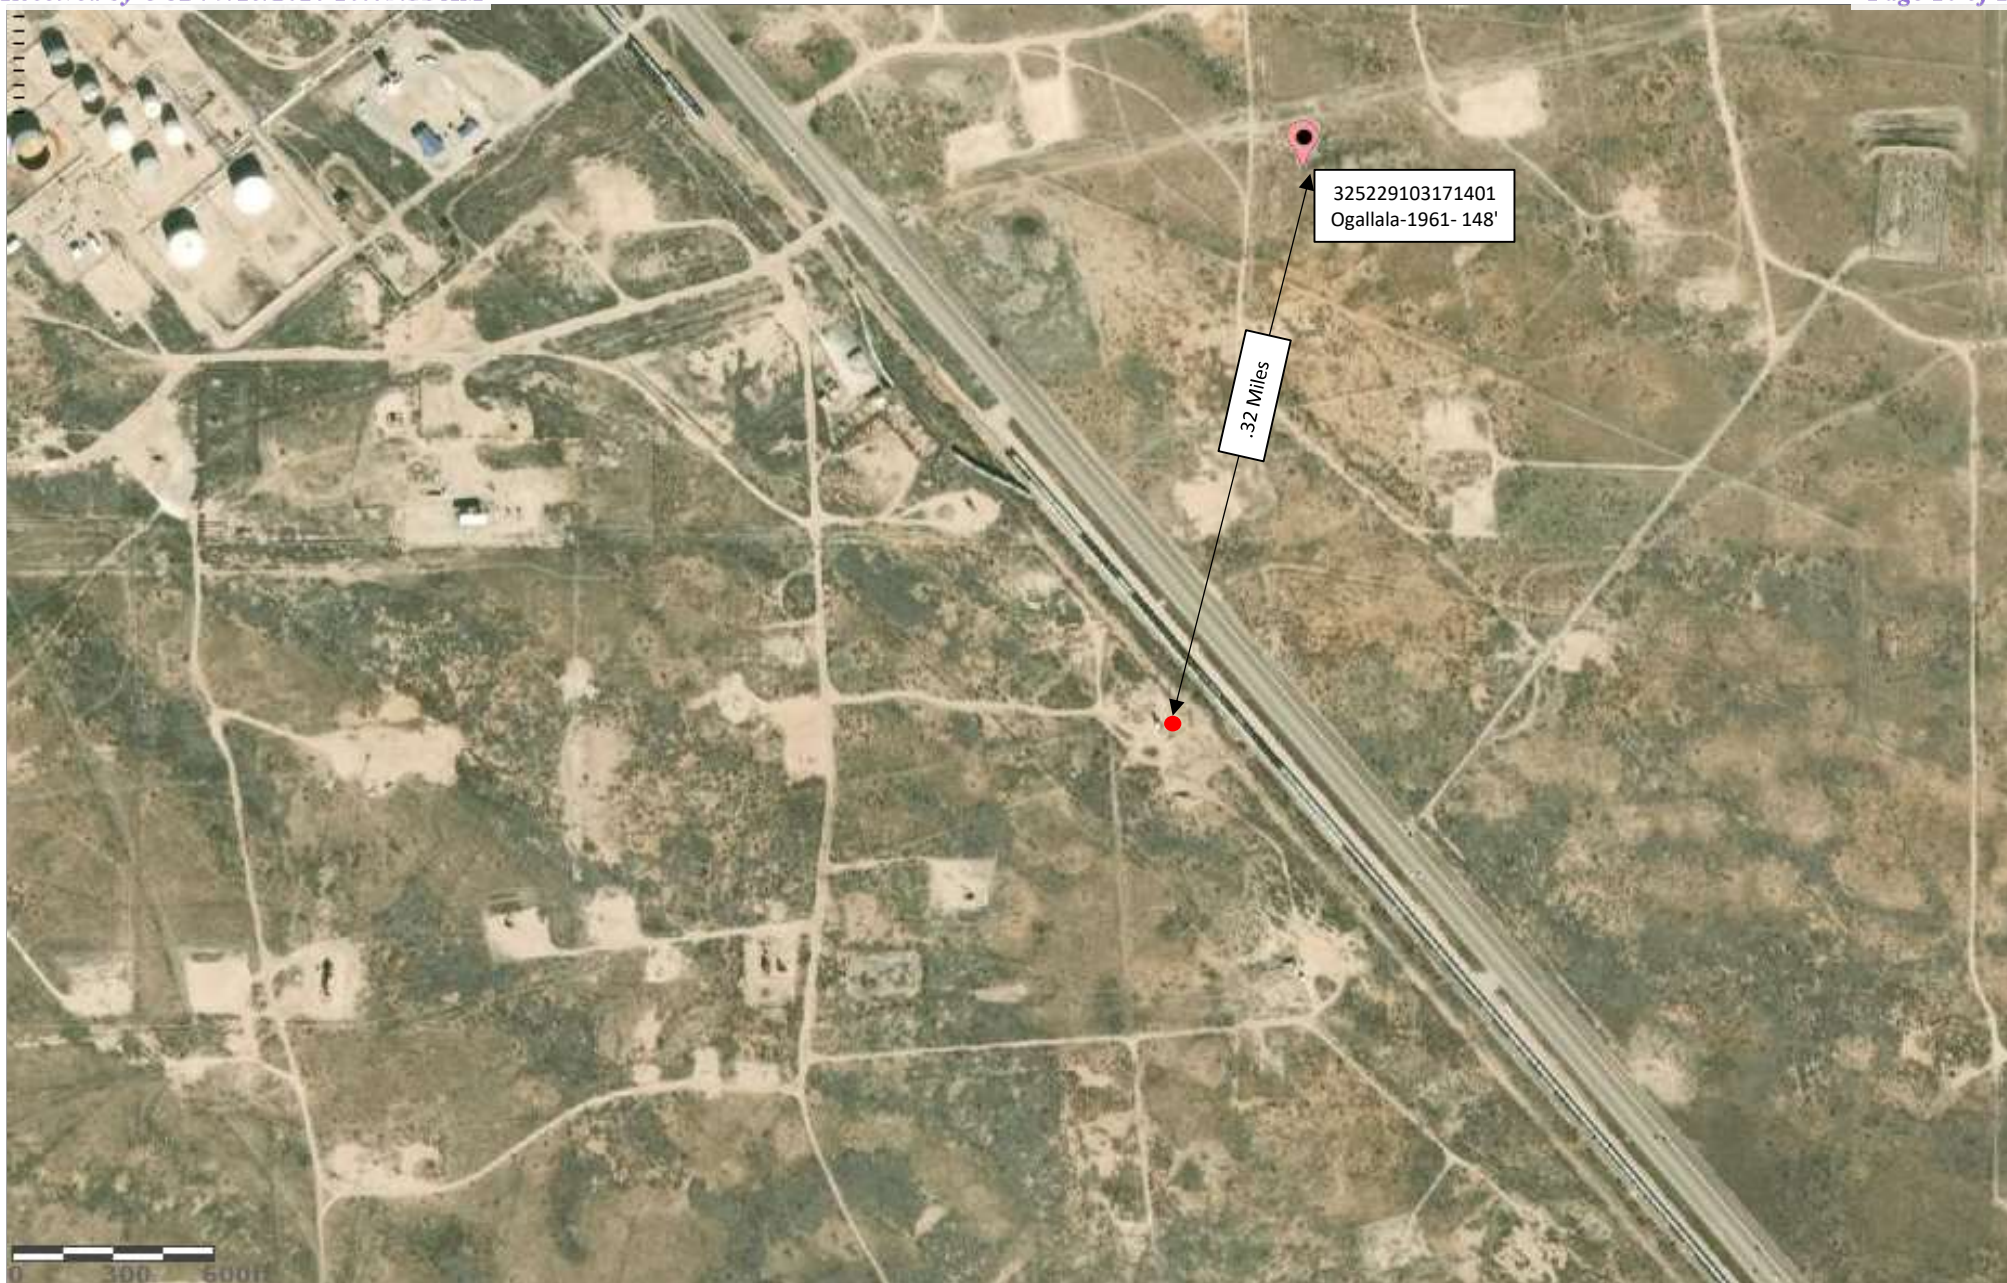
**Figure 3**

USGS Well Locations Map
Grizzly Operating, LLC
Abo Pump Station B-6
GPS: 32.86986, -103.289134
Lea County

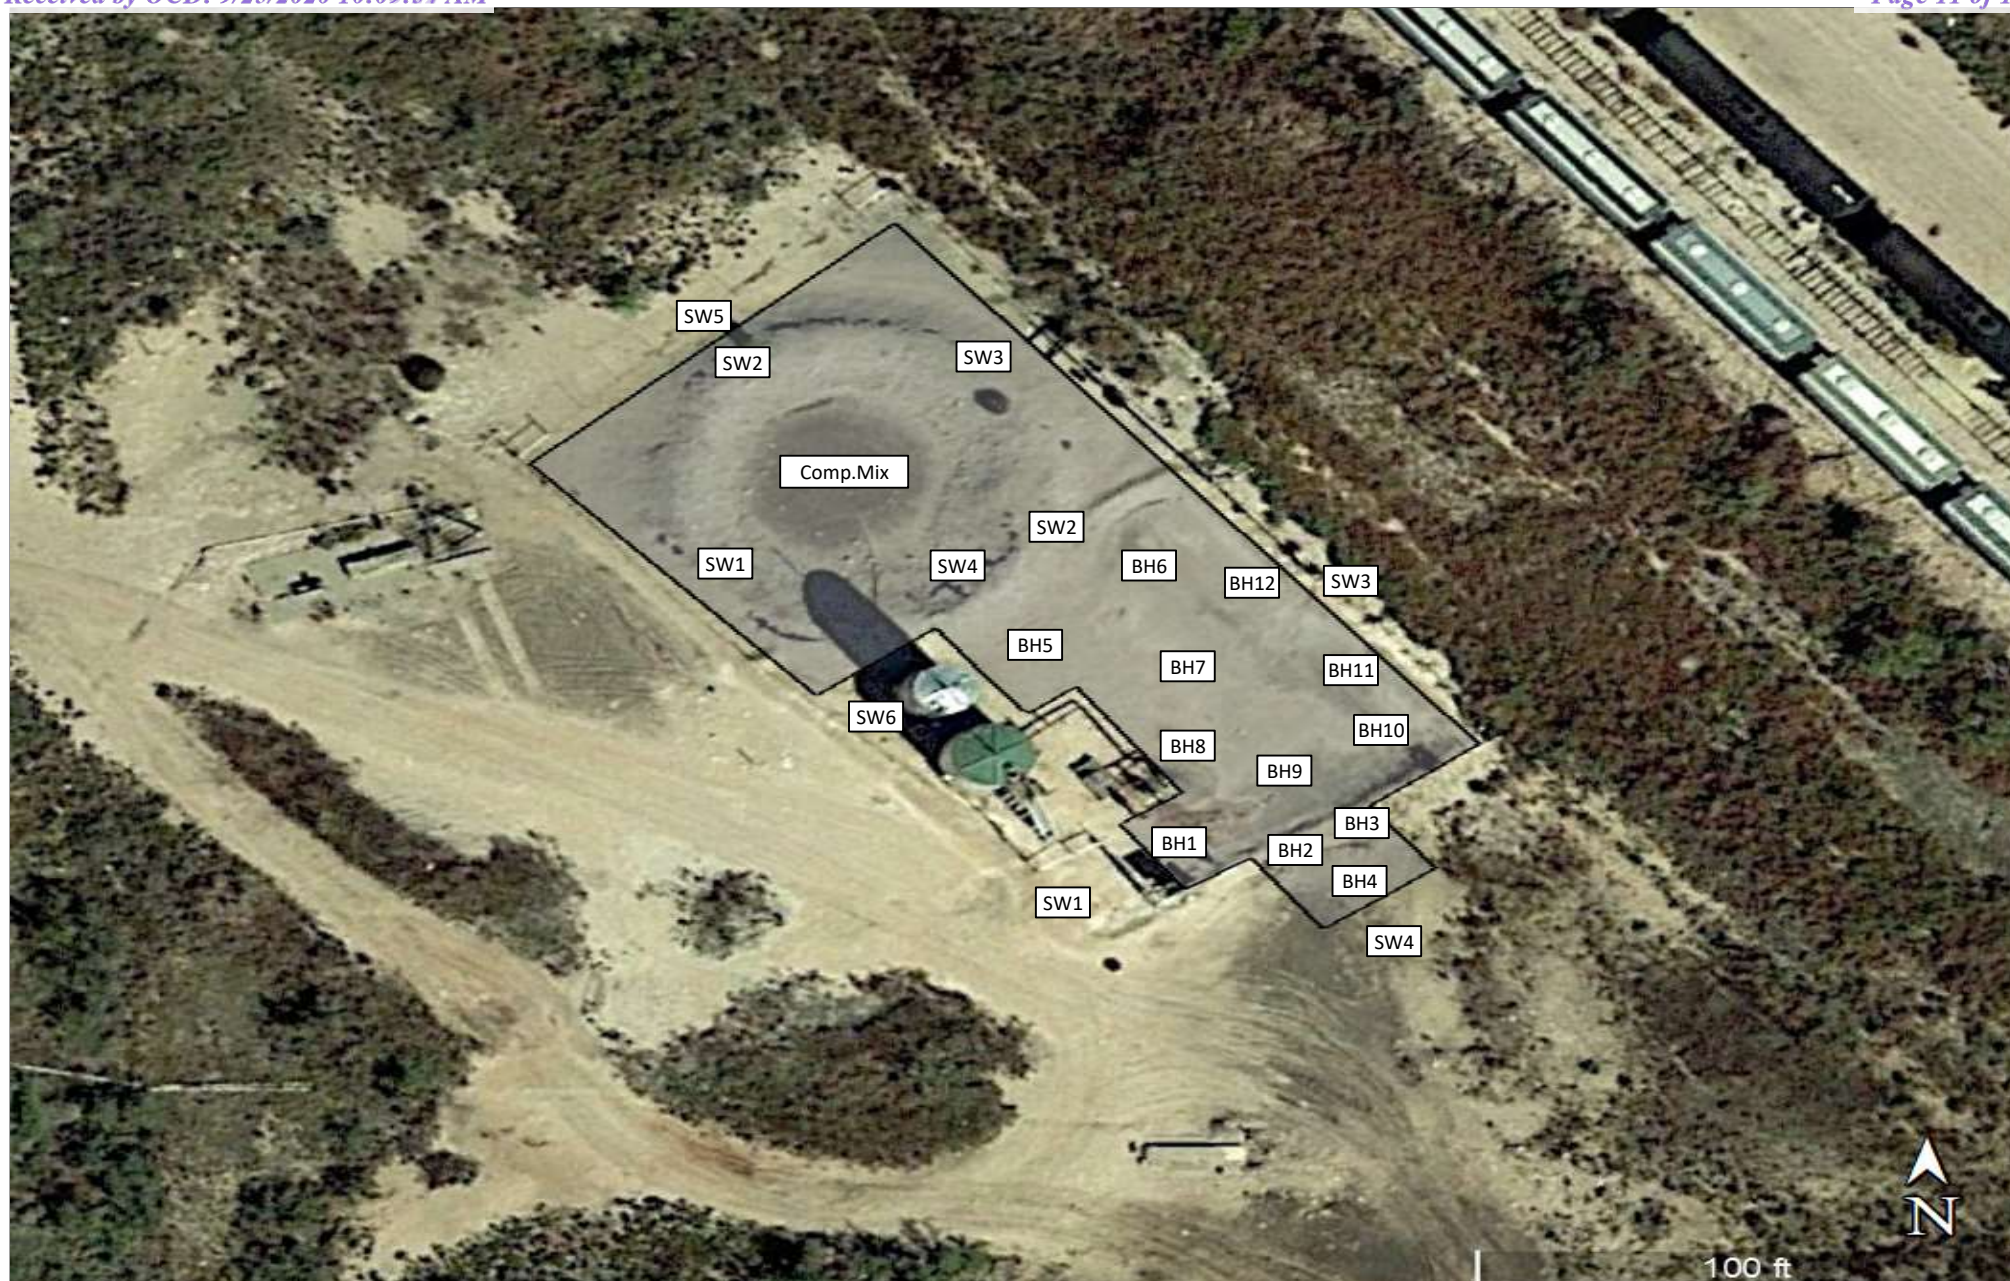
**Figure 4**

Excavation Sample Location Map
 Grizzly Operating, LLC
 Abo Pump Station B-6
 GPS: 32.86986, -103.289134
 Lea County

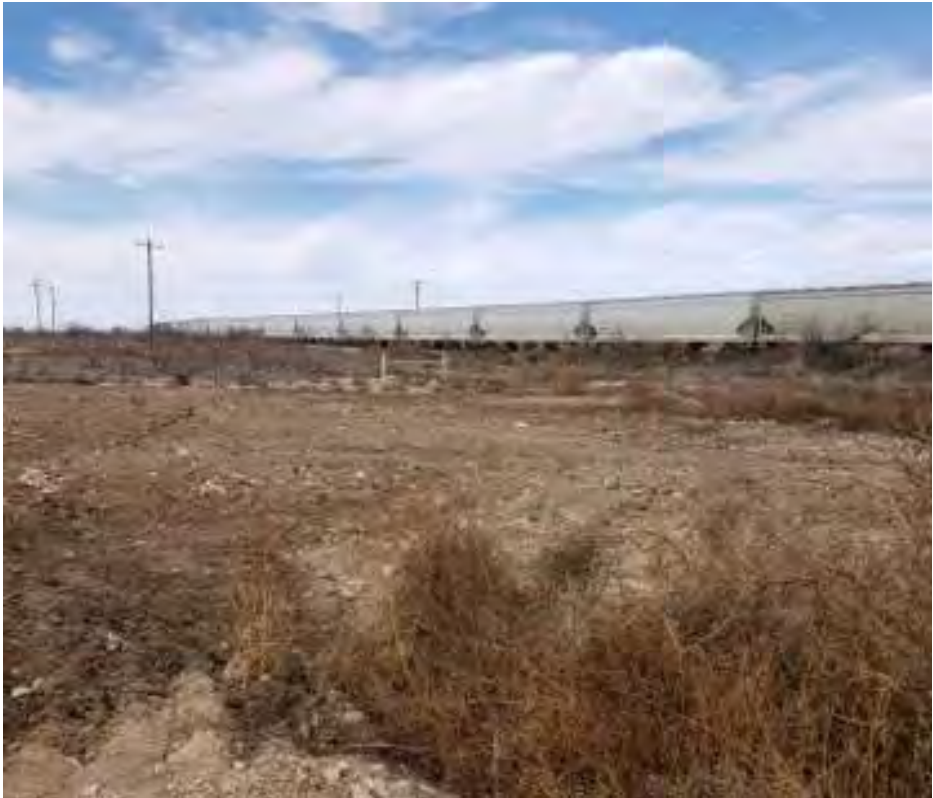
Photo 2

Direction Northwest	
Description Remediation activities

On November 19, 2019, remediation activities commenced on location. In accordance with the approved work plan, impacted soil was excavated to approximately two (2) feet bgs. Excavated soil was stockpiled on site, then transported to an NMOCD approved disposal facility.

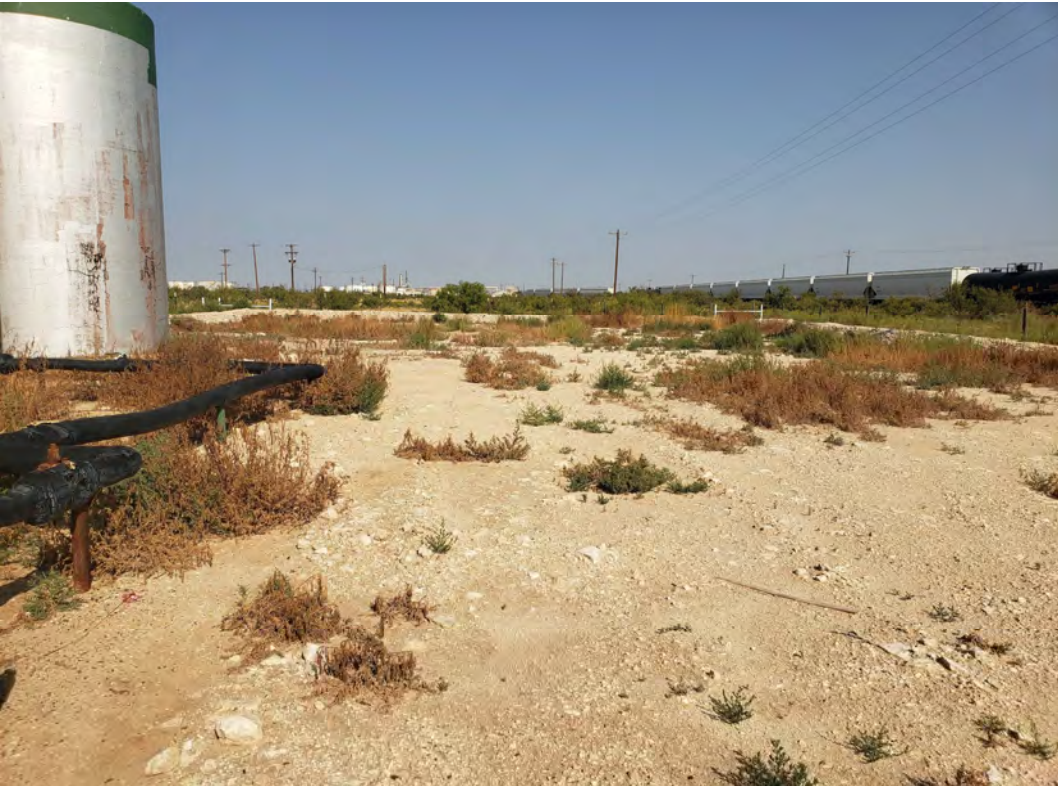
Photo 8

Direction Northwest	
Description Backfilled - area had been sprayed for weed control

The excavation was backfilled with clean, non-impacted, like material and replaced to the near original relative positions. The affected areas were contoured to achieve erosion control and preserve surface water flow. And as the release occurred on an active well pad, no seeding will be required.
