**HRL**  
**COMPLIANCE**  
**SOLUTIONS**

September 24, 2020

**Subject:       Site Characterization, Remediation, and Closure Report**  
**Cochiti 28 Federal #1 SWD (May 2018)**  
**2RP-4753**  
**Eddy County, New Mexico**

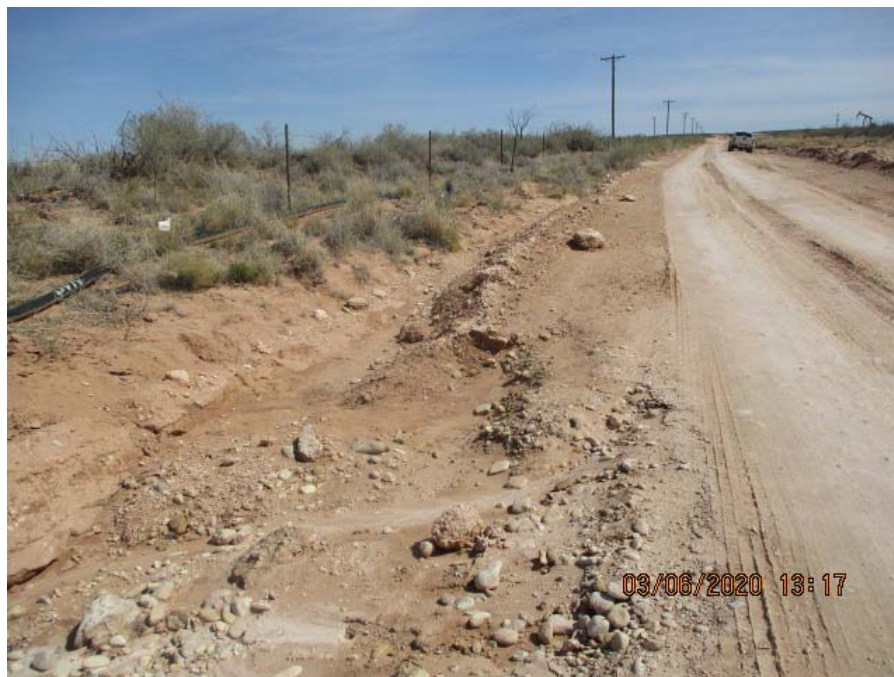
View of the  
impacted area  
prior to  
excavation; view  
to the southeast

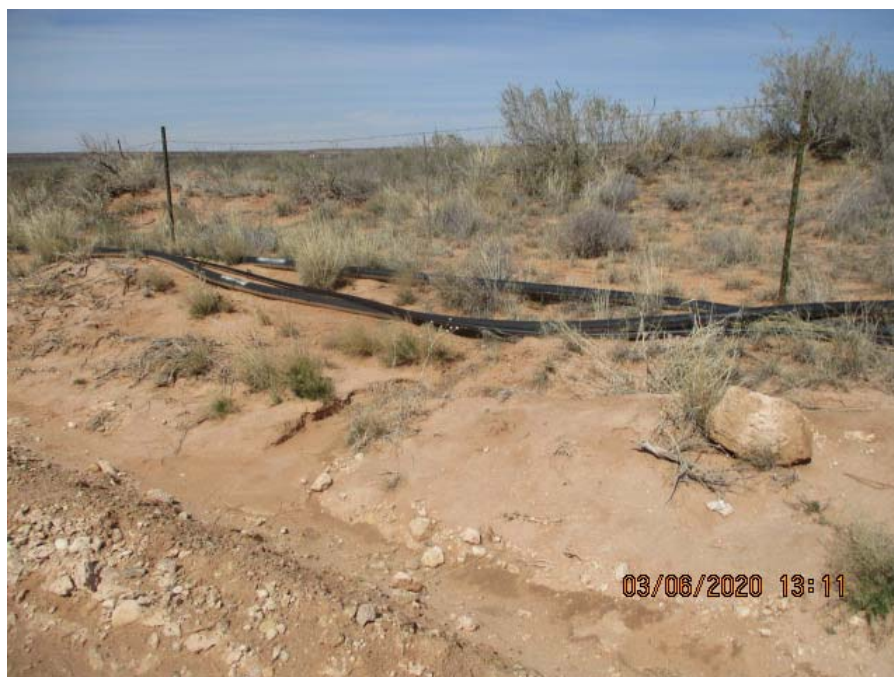
View of the  
impacted area  
prior to  
excavation; view  
to the  
north/northwest

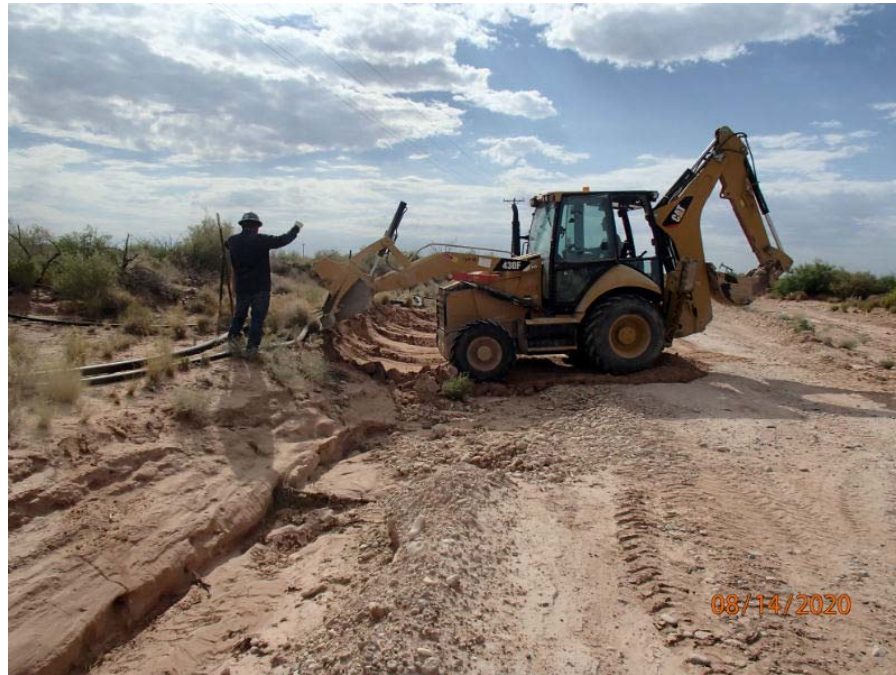
Excavating  
impacted soil,  
view to the  
southeast

On August 14, 2020, HRL mobilized to the site with its excavation subcontractor Halo Services to excavate the impacted soil. Impacted soil was removed from the bar ditch along the north/northeast side of the lease road. Approximately 120-square feet of soil to a depth of approximately six inches bgs was removed from the Site for off-site disposal at a NMOCD approved facility (Attachment D, Soil Disposal Manifests). Following excavation, HRL collected two confirmation soil samples from the Site (Figure 4). Sample results confirmed the soil remaining in the ground has less than 600 mg/kg chloride (Table 2, Attachment E). The excavated area was graded to and contoured to blend with the adjacent topographic surface, achieve erosion control, long-term stability, and preservation of surface water flow patterns.

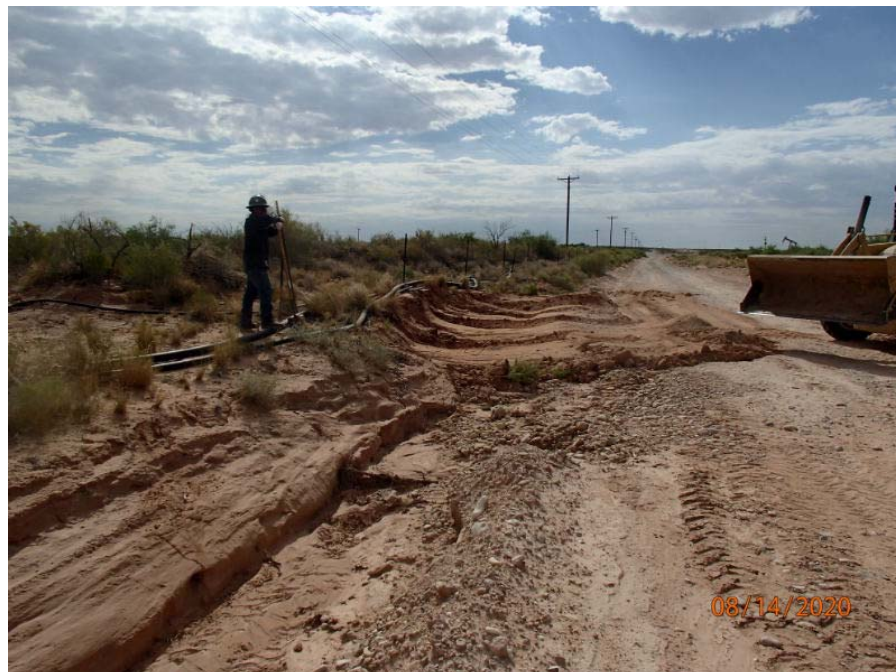
Matching the  
excavated area  
to the same  
grade as the  
adjacent area,  
view to the  
southeast

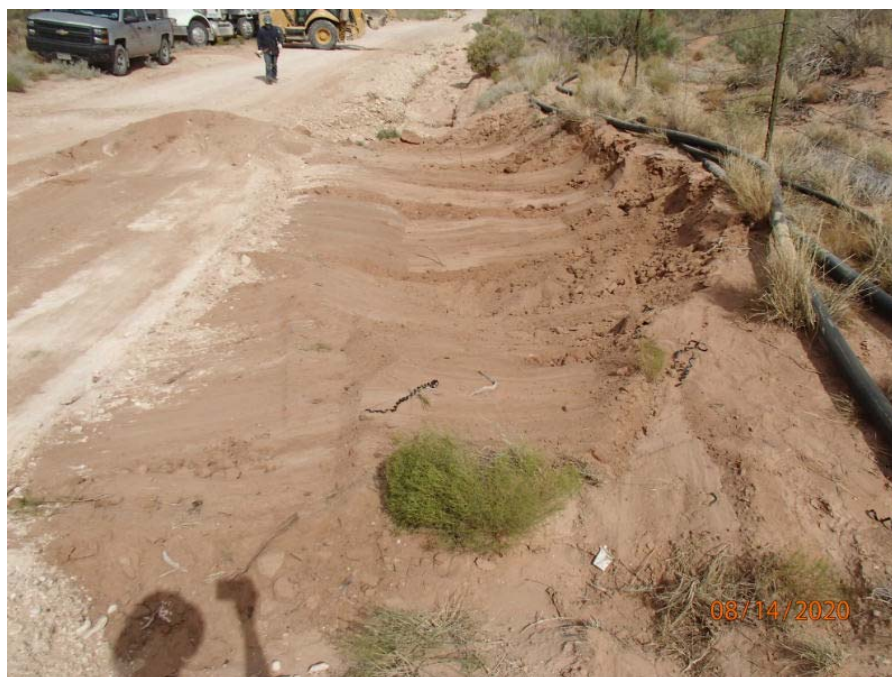
View of the  
excavated area,  
view to the  
north/northwest

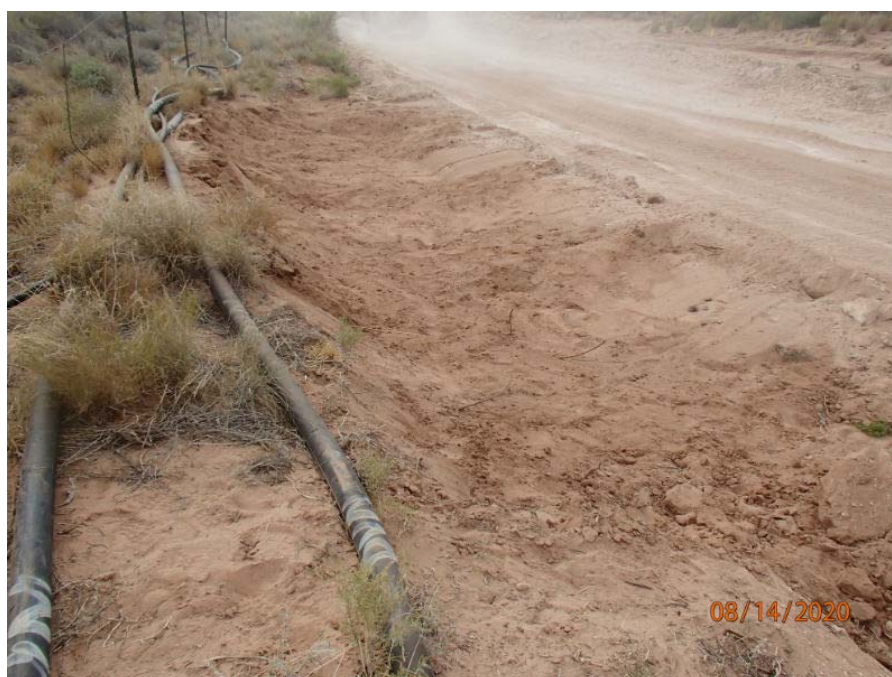
View of the  
complete  
excavated area  
after matching  
to surrounding  
topography,  
view to the  
southeast

The disturbed area will be reseeded with the Bureau of Land Management (BLM) seed mixture for sandy sites. This seed mixture includes:
