DELINEATION/REMEDIATION WORKPLAN

OXY – FOXGLOVE 29 6H (Leak Date: 7/14/20)

Incident Reference #: NRM2022460278

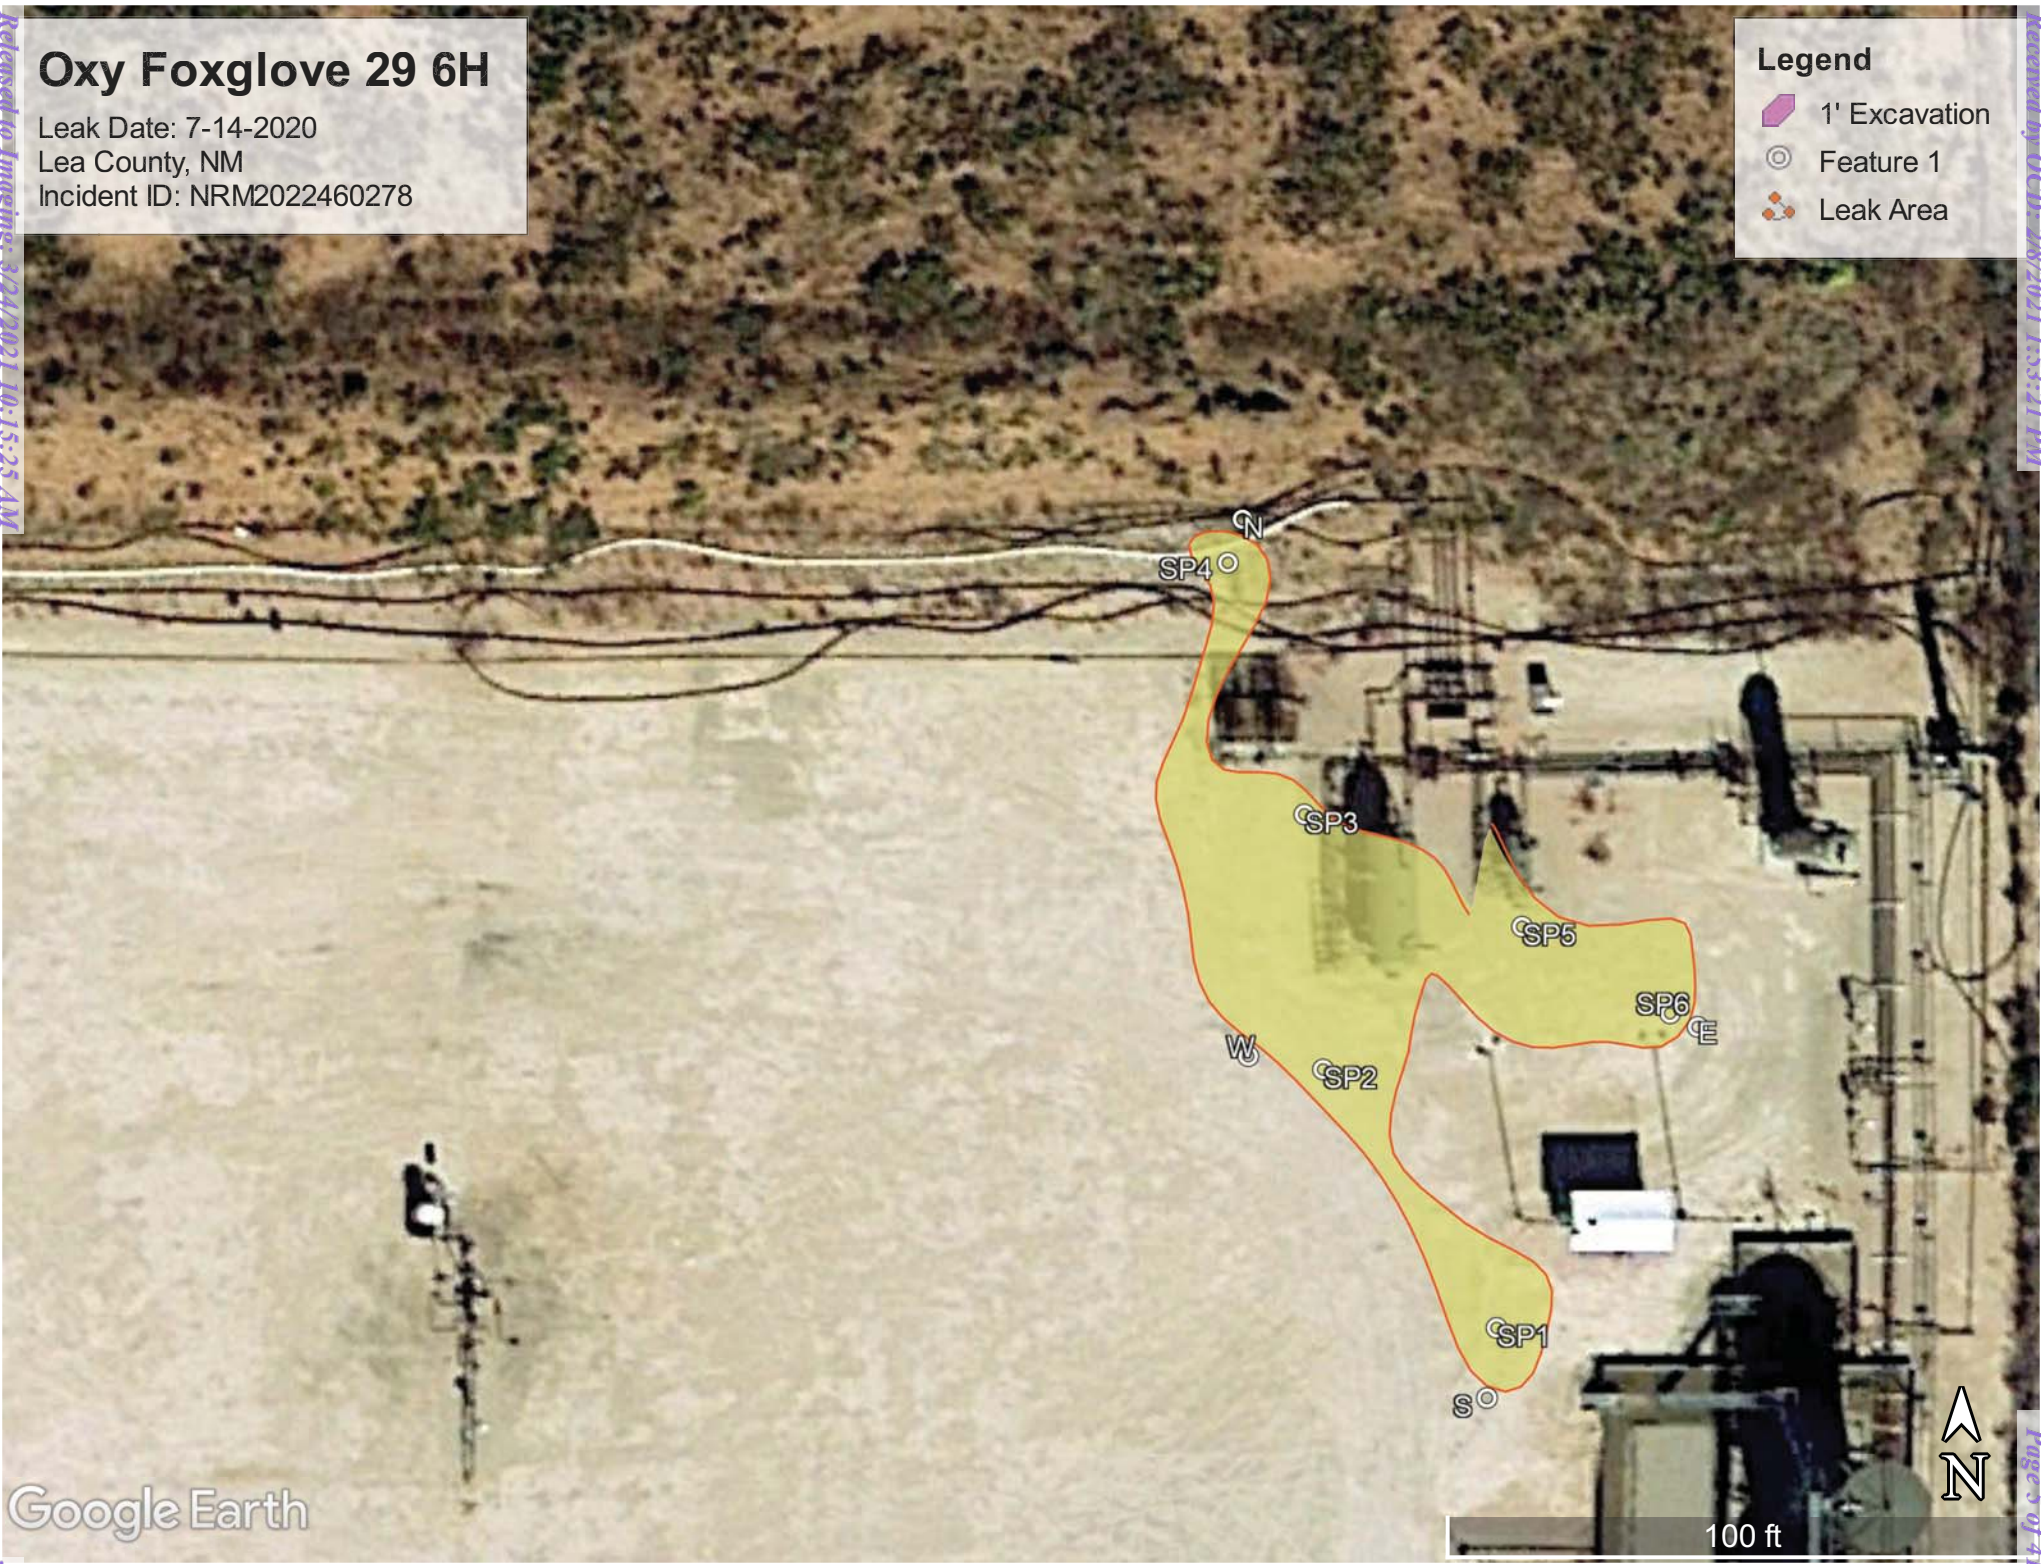
Oxy Foxglove 29 6H

OXY will excavate the spill area as depicted on the following site diagram.

The entire leak area (yellow shade on diagram) will be excavated to a depth of 1 foot.

OXY will collect sidewall and confirmation samples every 200 square feet. The estimated amount of soil to be excavated is 137 cubic yards. The remediation will be completed within 90 days of approval.

- 1' Excavation
- Feature 1
- Leak Area

Sample points

SP1, N 32.28201 W 103.59063

SP2, N 32.28213 W 103.59072

SP3, N 32.28224 W 103.59073

SP4, N 32.28236 W 103.59077

SP5, N 32.28219 W 103.59061

SP6, N 32.28215 W 103.59053
