**Re: Site Assessment and Closure Report
Hawkeye 7 Federal #1
API No. 30-025-00892
GPS: Latitude 32.66946 Longitude -103.81169
UL "M", Sec. 07, T19S, R32E
Eddy County, NM
NMOCD Ref. No. 1RP-4986**

Pima Environmental Services, LLC (Pima) has been contracted by Devon Energy Production Company (Devon) to perform a spill assessment, site remediation and has prepared this Closure Report for a produced water release that occurred at the Hawkeye 7 Fed 1 (Hawkeye). The initial C-141 was submitted on February 23, 2018 (Appendix C). This incident was assigned 1RP-4986, Incident ID NOY1806632744, by the New Mexico Oil Conservation Division (NMOCD).

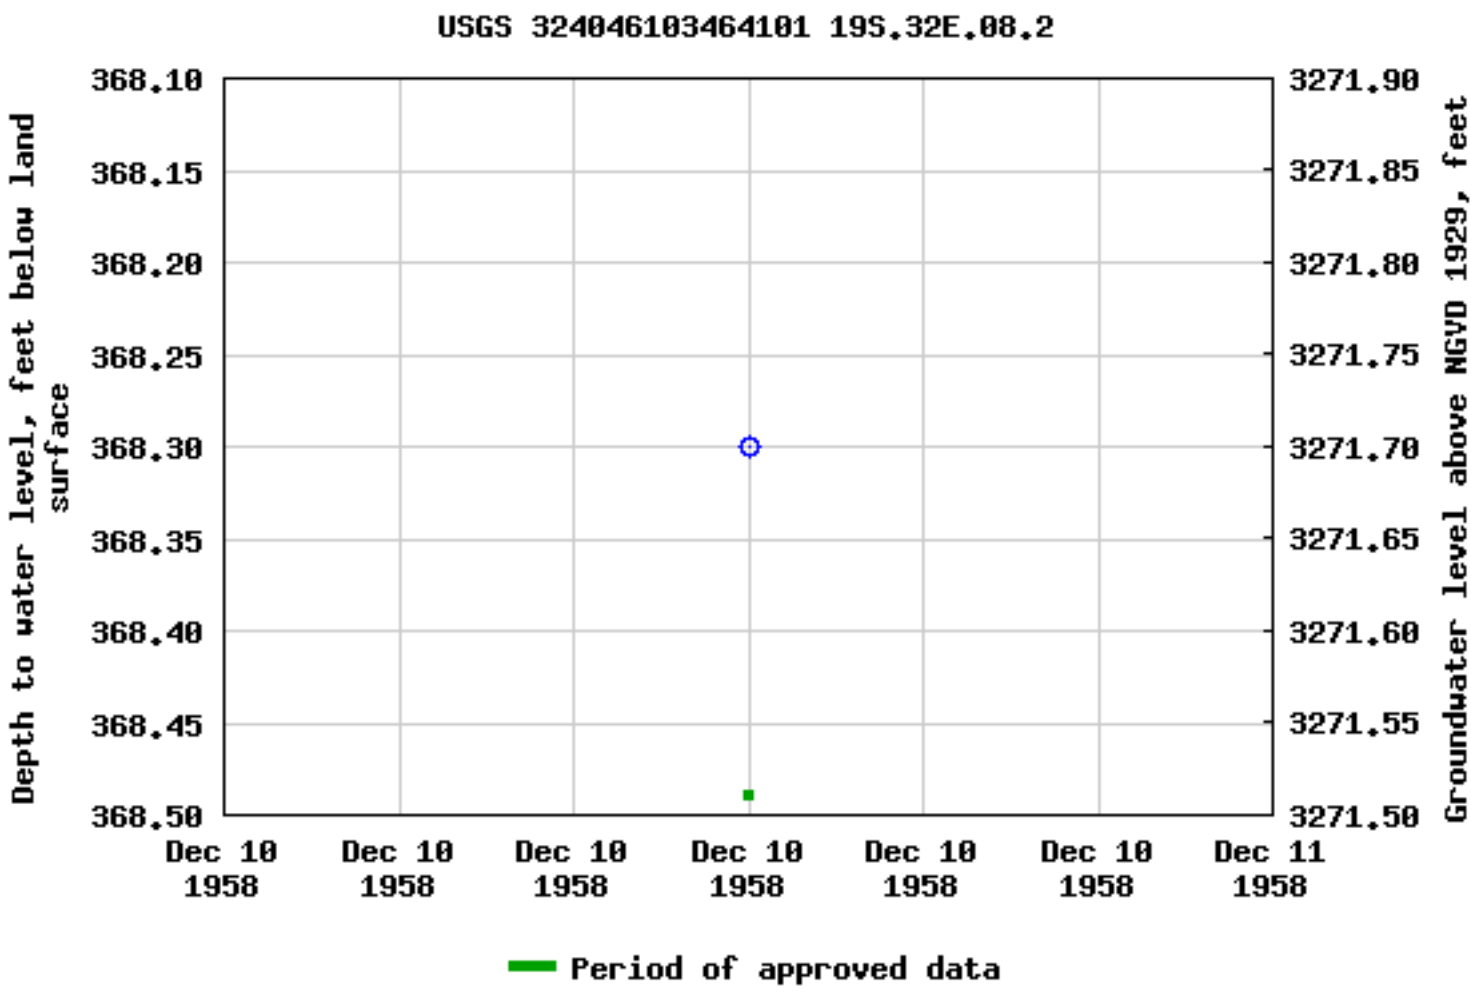
Graph of data

Breaks in the plot represent a gap of at least one year between field measurements.
[Download a presentation-quality graph](#)

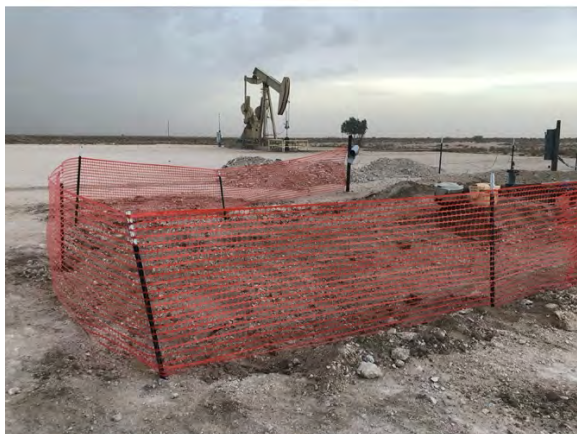
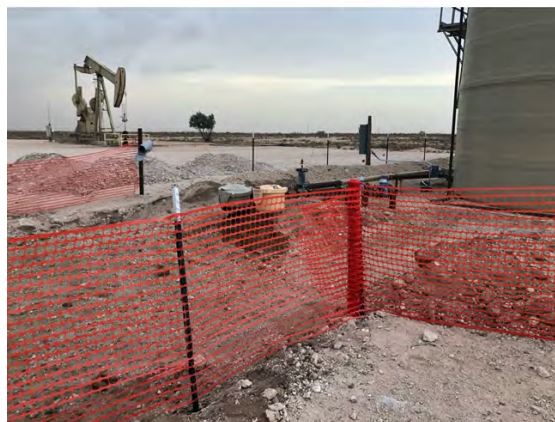
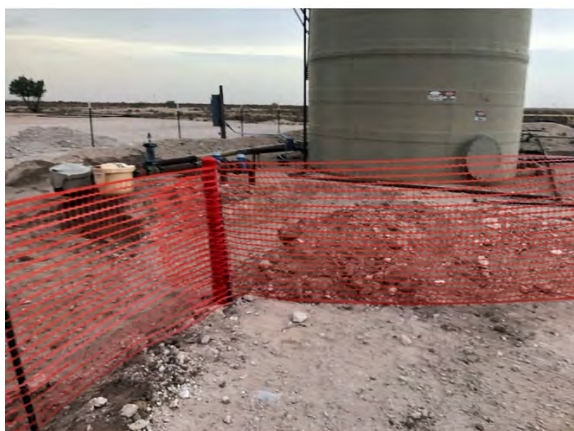
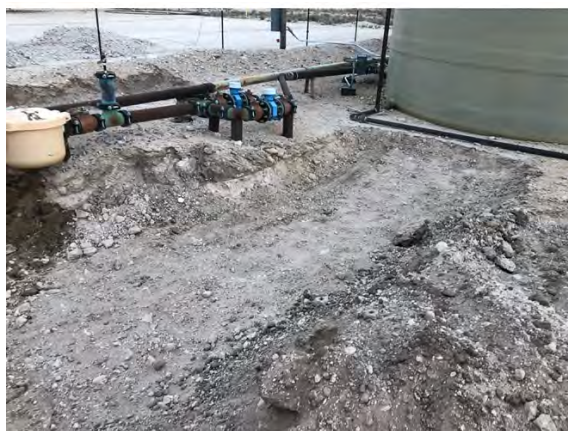
Excavation

On September 4, 2020, Pima mobilized personnel and equipment to conduct remedial activities. The area in the vicinity of S-3 was excavated to a depth of 1.0-foot below grade surface (BGS). The excavation extended 10-feet by 30-feet horizontally away from the center of the initial sample point. Sidewall and bottom confirmation samples were obtained, and the laboratory results can be found in the following data table.

Based on the results, Pima returned to the site to continue excavating from the west side, removing another 1.0-foot BGS from the excavation's bottom. Composite confirmation samples were again obtained to ensure the contamination was removed. The laboratory results can be found in the following data table.
