Re: Site Remediation and Closure Report
Arcturus 18 Federal #1H
API No. 30-015-38237
GPS: Latitude 32.6665878 Longitude -103.9007874
UL "A", Sec. 18, T19S, R31E
Eddy County, NM
NMOCD Ref. No. 2RP-3979; 2RP-5348

Pima Environmental Services, LLC (Pima) has been contracted by Devon Energy Production Company (Devon) to perform a spill assessment and to perform remediation activities for an oil release that occurred at the Arcturus 18 Fed #1H (Arcturus). The initial C-141 for this incident was submitted on 11-8-16 (Appendix C). This incident was assigned 2RP-3979, Incident ID NAB1631440104, by the New Mexico Oil Conservation Division (NMOCD). The initial C-141 for the incident given 2RP-5348 was submitted on 4-1-19 and was assigned Incident ID NAB1909944395.

Closure Request

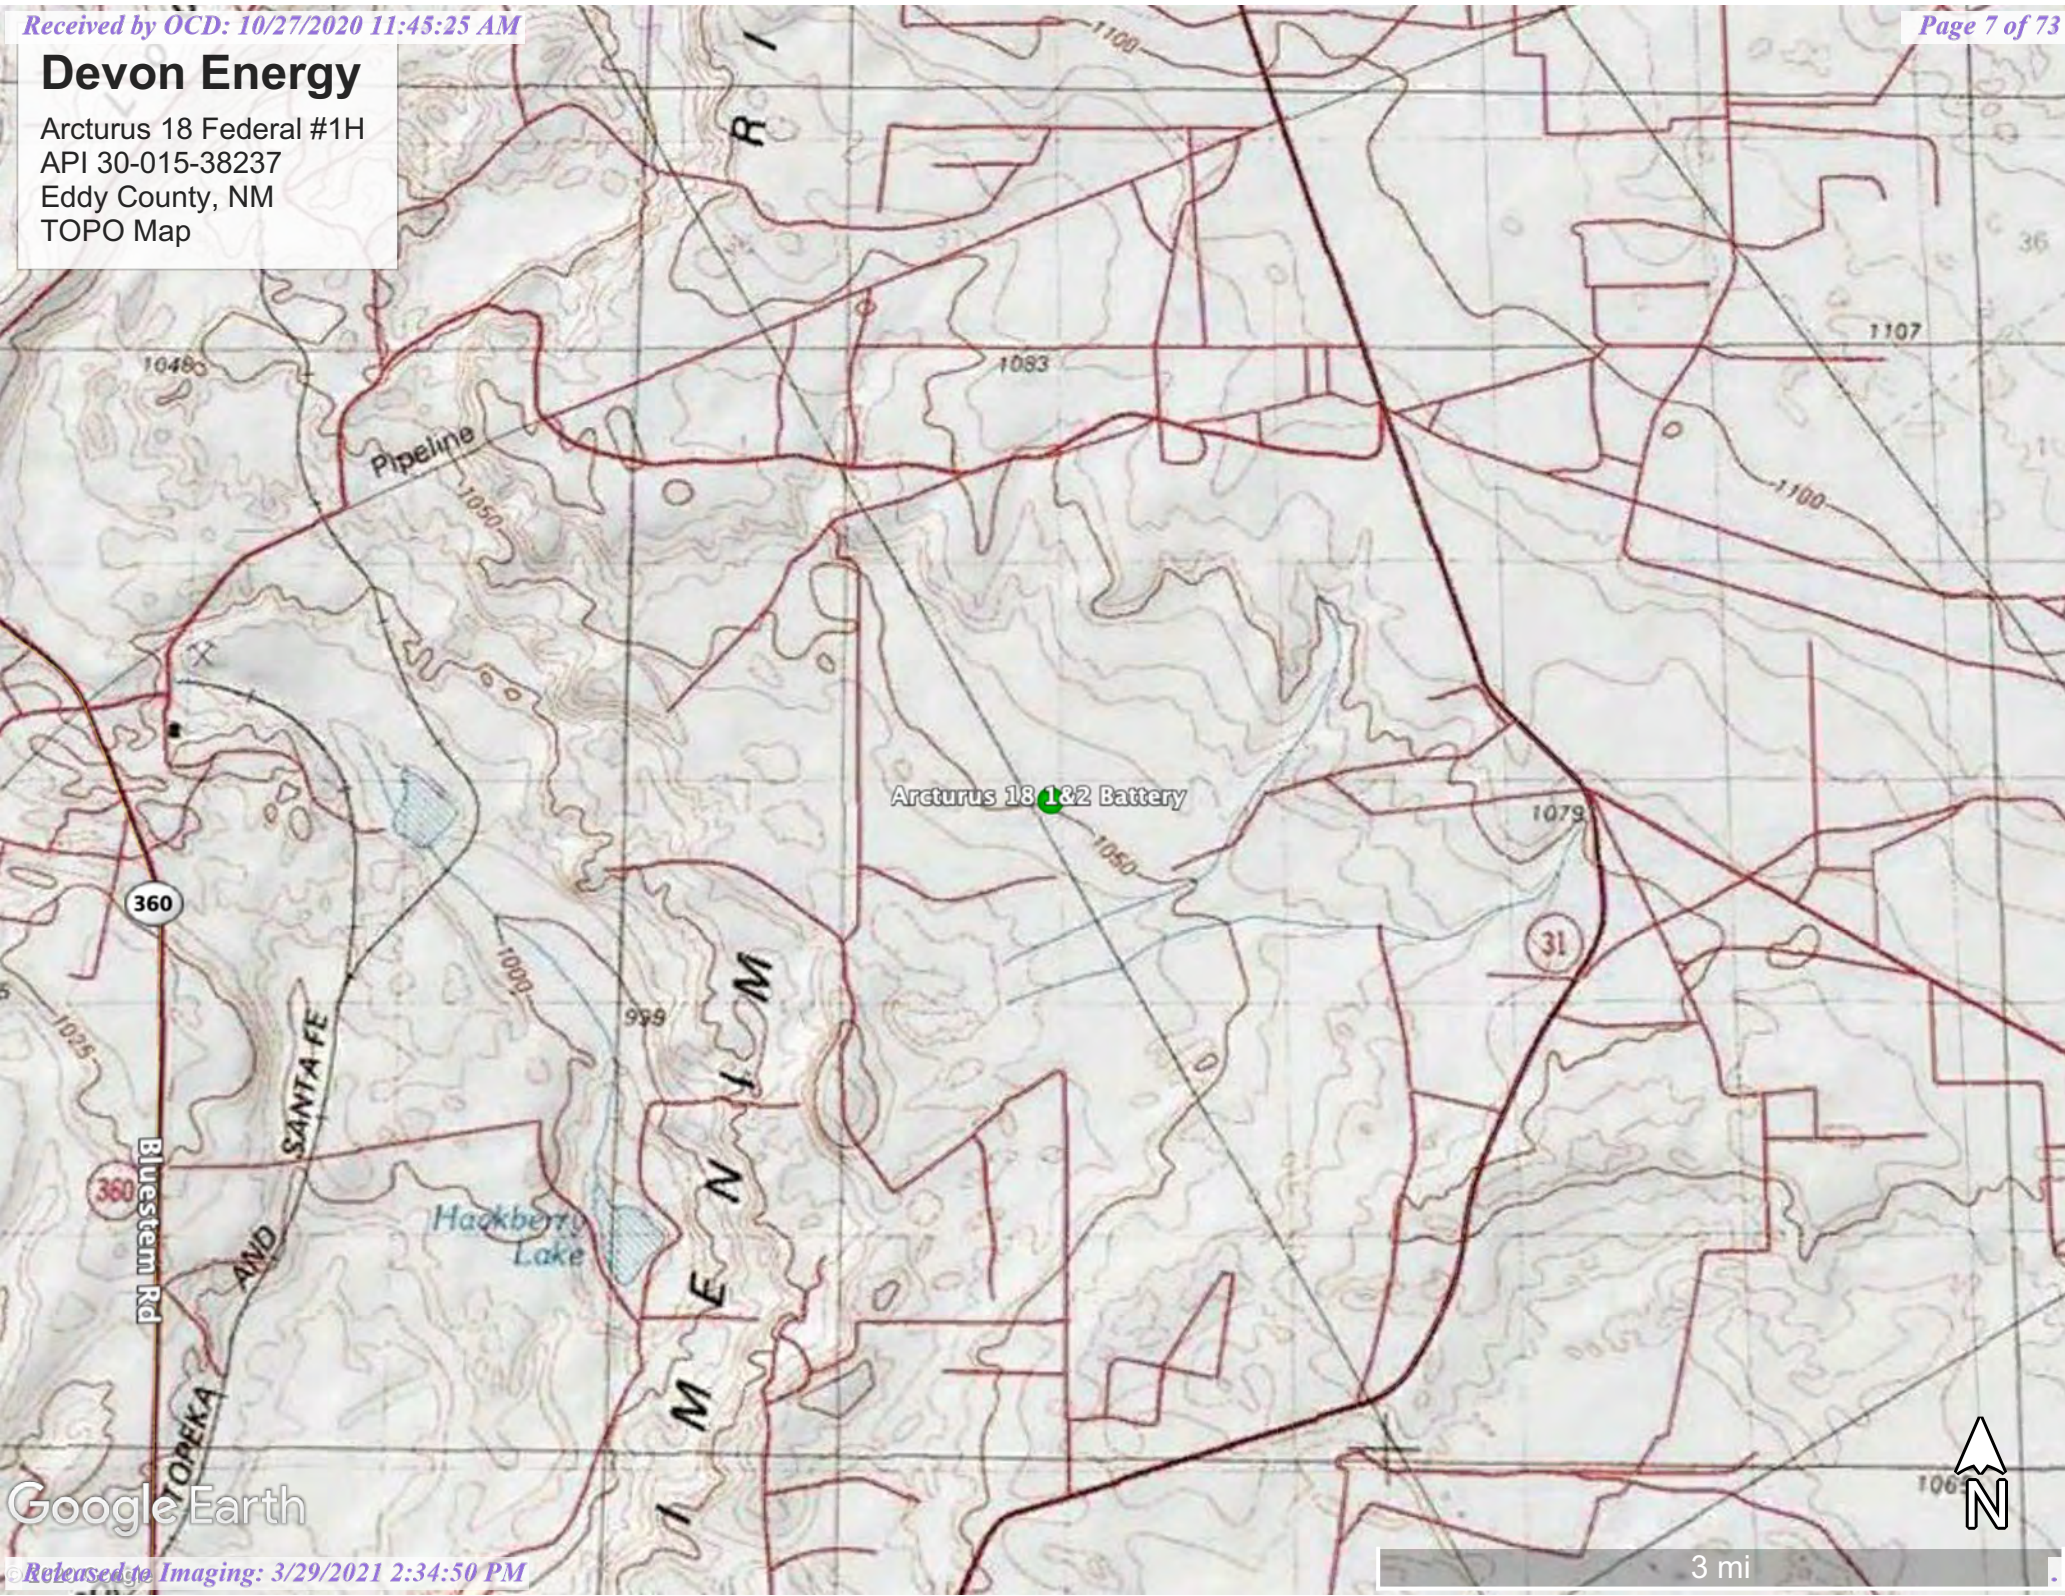
Arcturus 18 Federal #1H
API 30-015-38237
Eddy County, NM
TOPO Map

Reference Figure 2 for a TOPO Map.

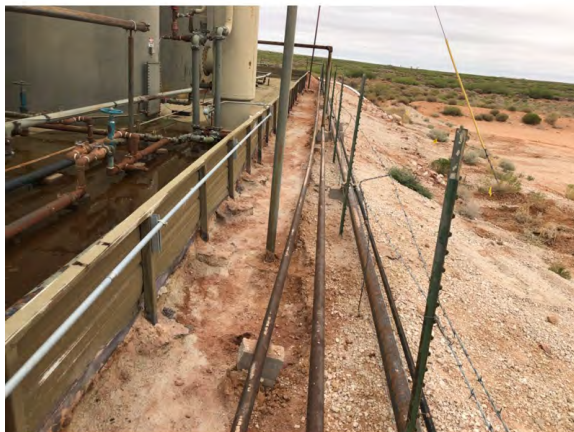
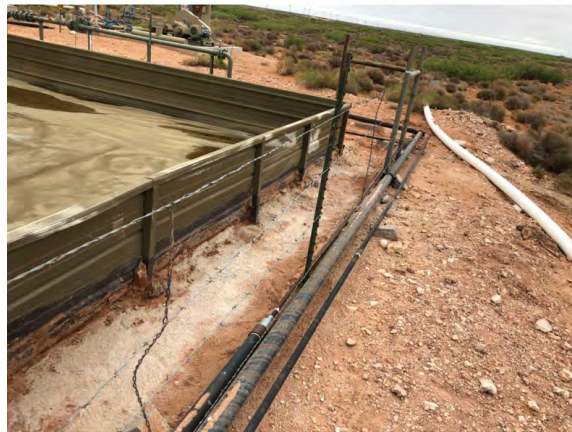
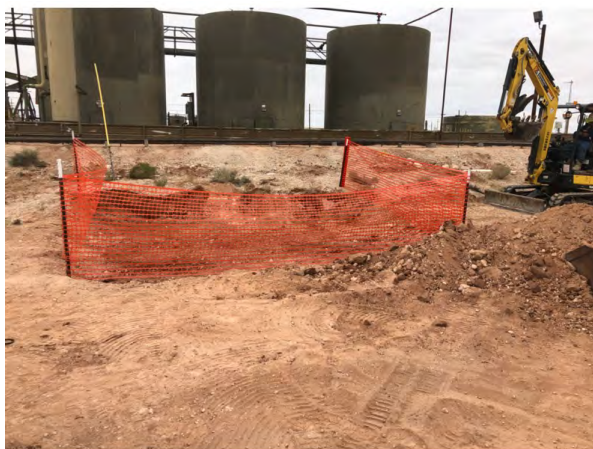
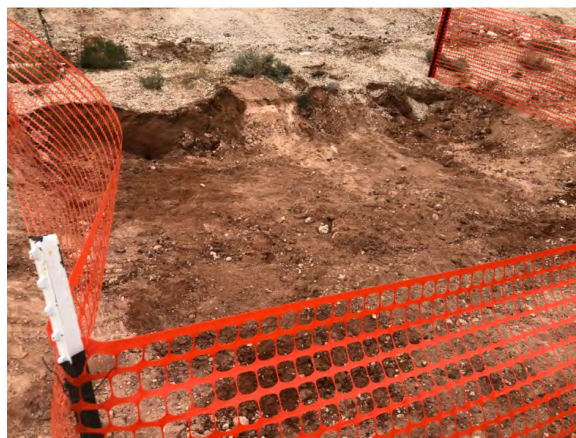
EXCAVATION

On September 9, 2020, Pima mobilized personnel and equipment to conduct remedial activities. The vicinity of the south and west sides of the containment was excavated to a depth of 0.5-foot-deep and extended horizontally from the containment 3-feet. Confirmation bottom and sidewall composite samples were obtained to ensure that the contamination's vertical and horizontal extents had been removed. Each composite sample was representative of no more than 200 square feet. The laboratory results of this sampling event can be found in the following data table.

The contaminated material was transported to Lea Land, an NMOCD approved disposal site. The excavation was then backfilled with clean like material, machine compacted, and contoured to match the surrounding terrain.
