## Release Notification

| Site Name | Peashooter 6" Pipeline | Site Type | Gathering Pipeline |

### **Peashooter 6" Leak**

Enterprise Field Services, LLC  
 Closure Report  
 Peashooter 6" Leak  
 February 26, 2021

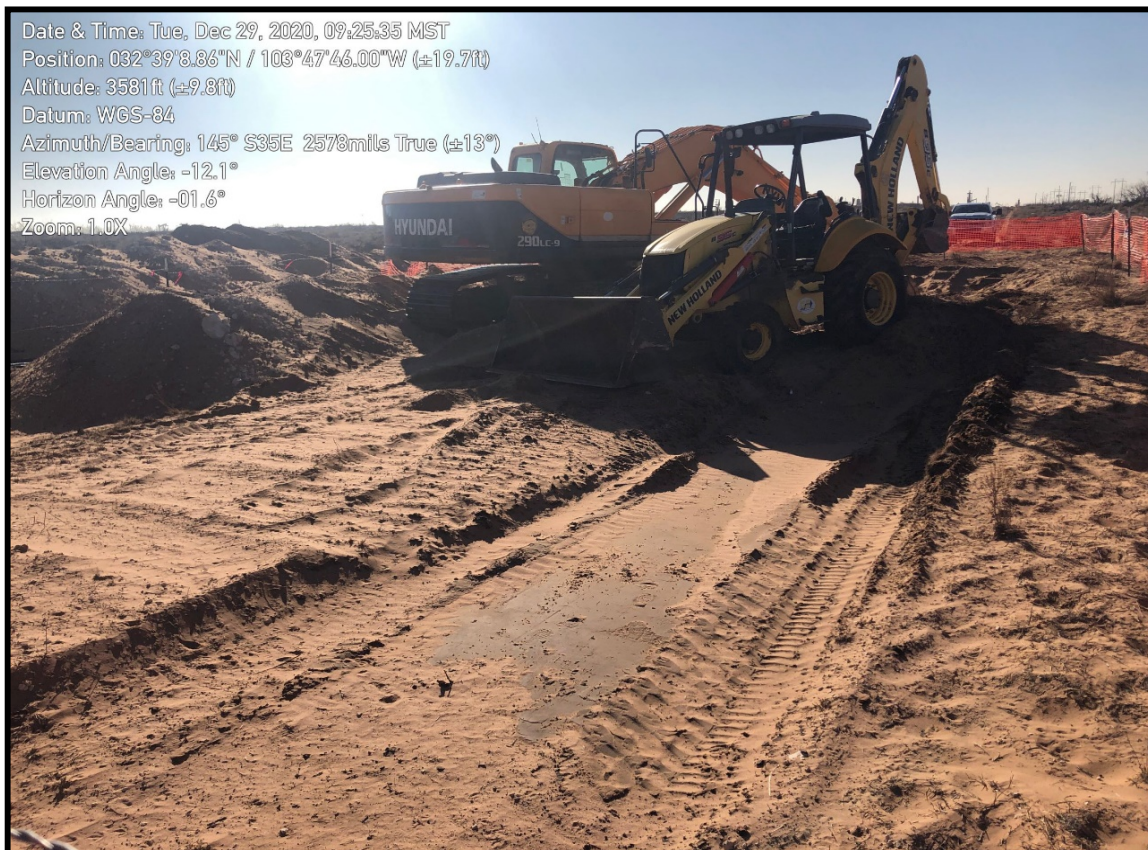
View of surficial staining during excavation activities, facing southeast.

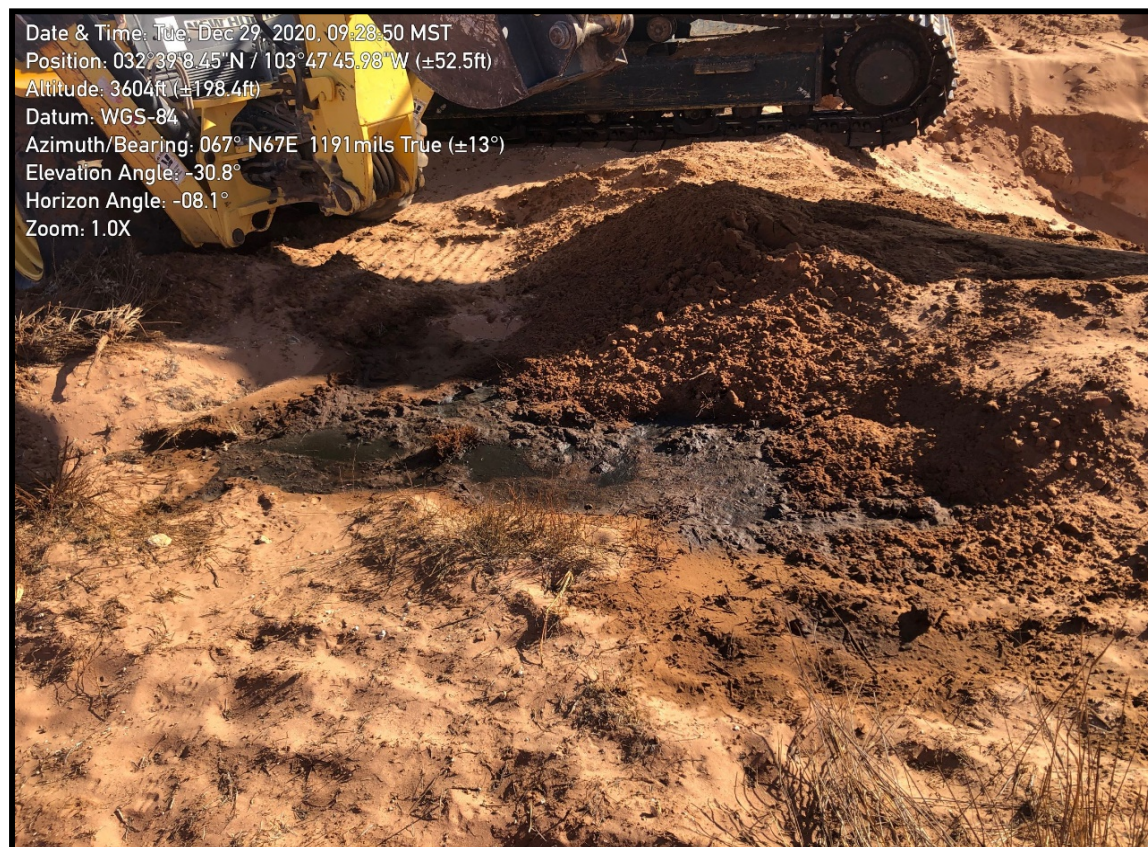
View of surficial staining during excavation activities, facing northeast.

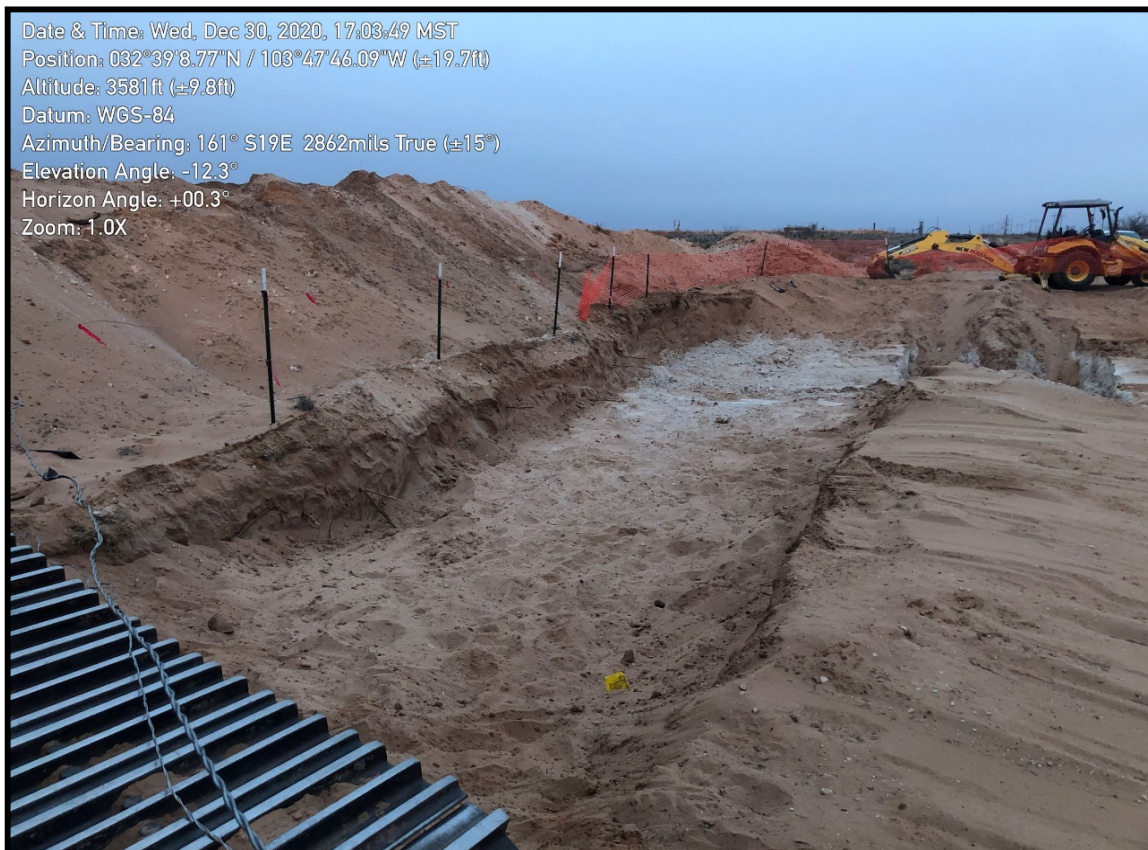
View of Reclamation Soil Excavation area during excavation activities, facing southeast.

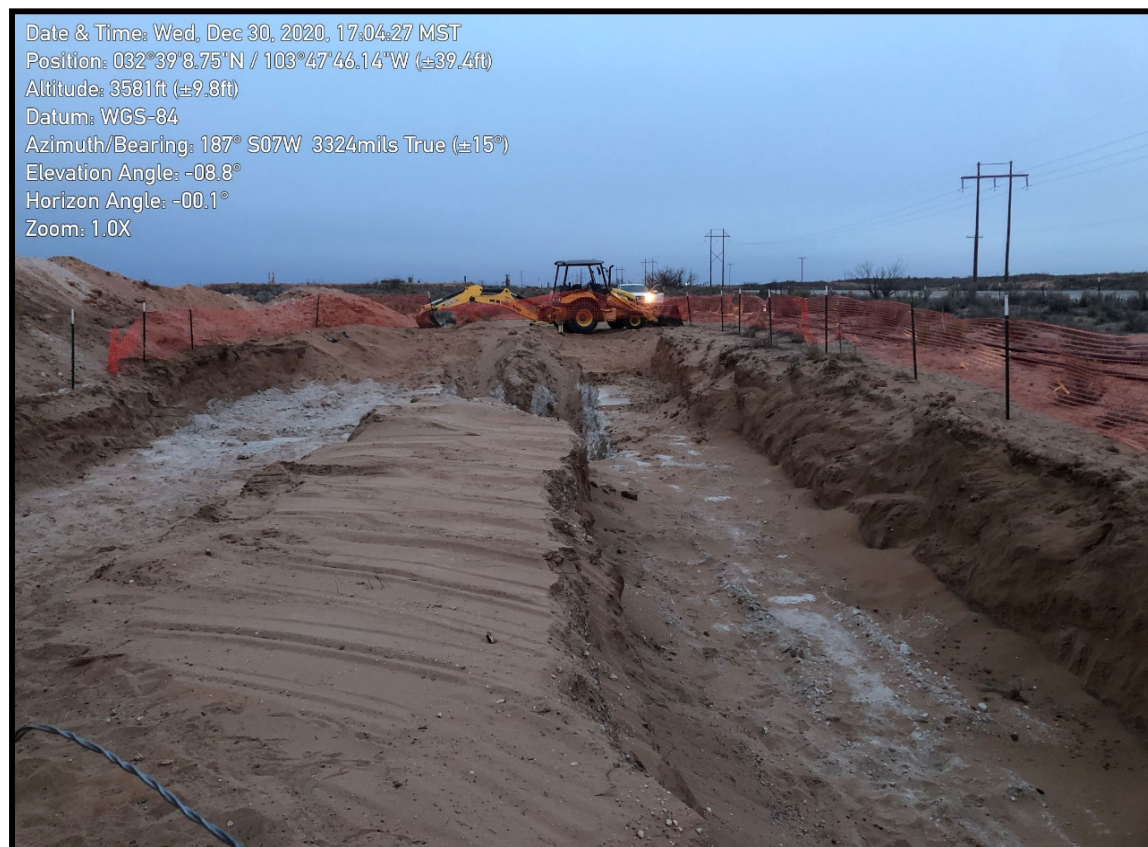
View of Reclamation Soil Excavation area during excavation activities, facing south.

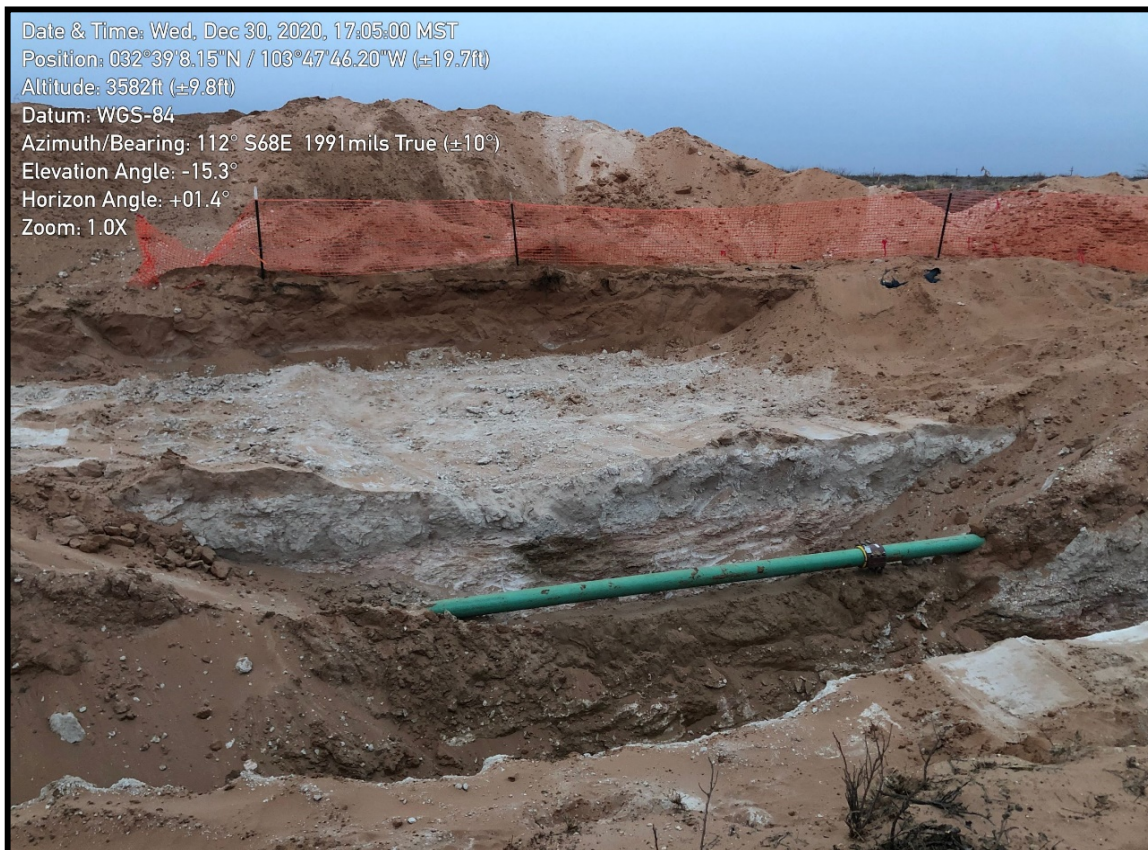
View of pipeline with clamp during excavation activities, facing southeast.

On December 17, 2020, a leak was reported due to possible corrosion along Line ID 2012-3. Approximately 10 bbls of natural gas liquids were released and the gas loss was reported at 38 MSCF. The line was isolated and blown down for repair, with a clamp attached to stop further leaks.

On January 20, 2021, another leak was discovered five (5) feet north of the original release. The pinhole leak was clamped, and the impacted soil was excavated. Based on the laboratory analytical results for CS-19 and CS-21, and the new leak, additional excavation was completed. Ensolum arrived on-Site and collected the composite soil samples CS-19, CS-21, CS-22, and CS-23 from the excavated area at depths ranging from zero (0) to five (5) feet bgs. The composite soil samples exhibited results below the applicable NMOCD Closure Criteria.

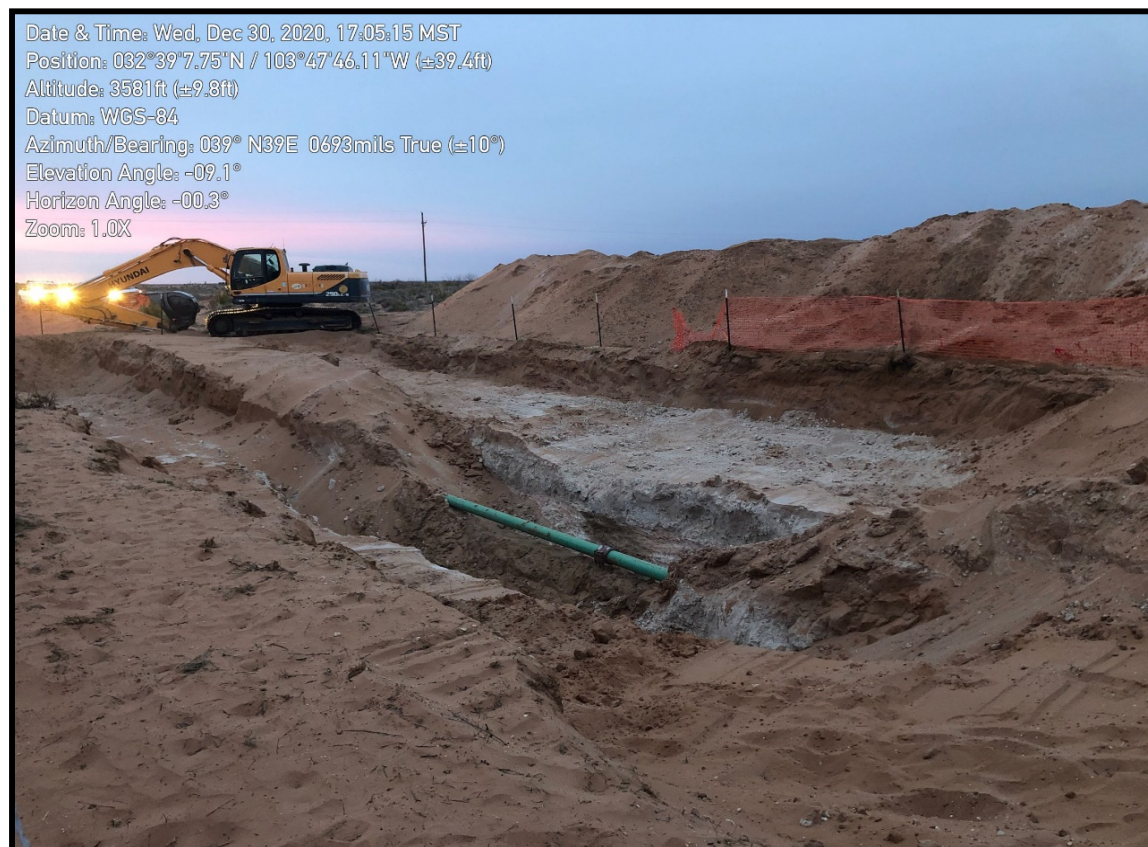
View of entire excavation site during excavation activities, facing northeast.

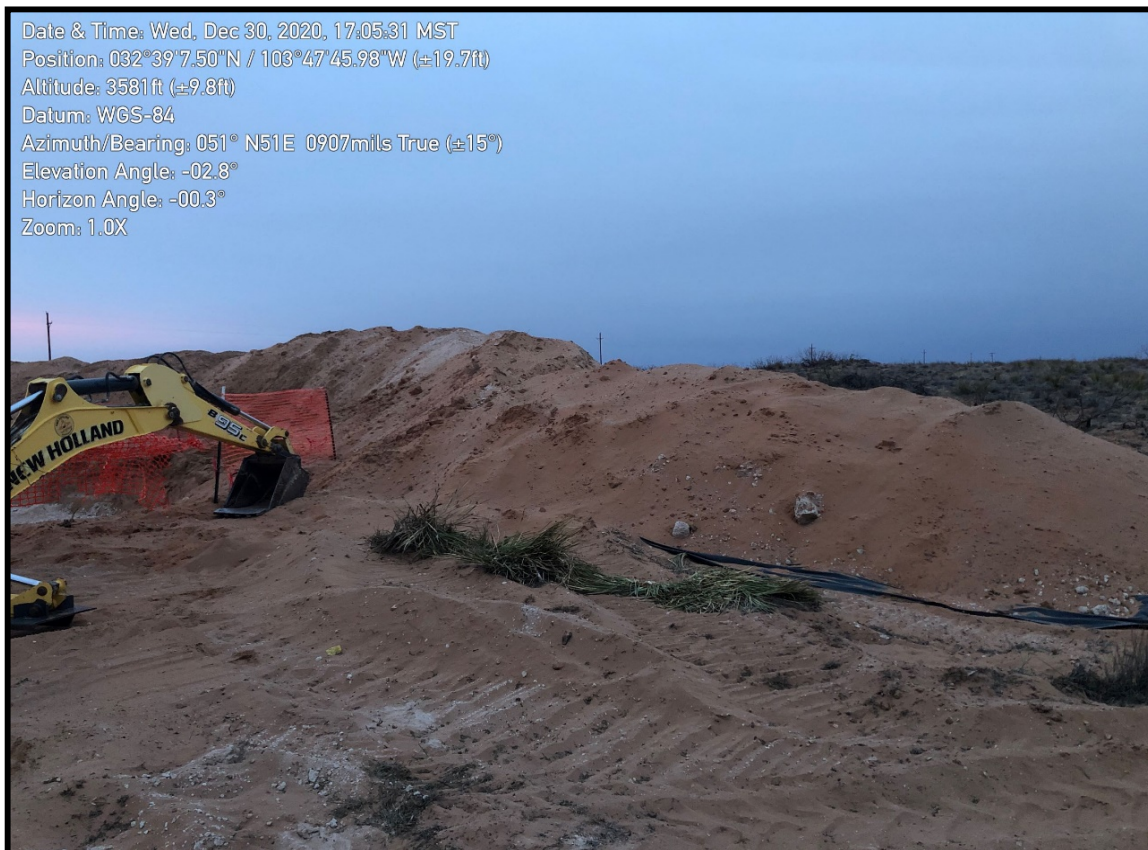
View of STP-4 during excavation activities, facing northeast.

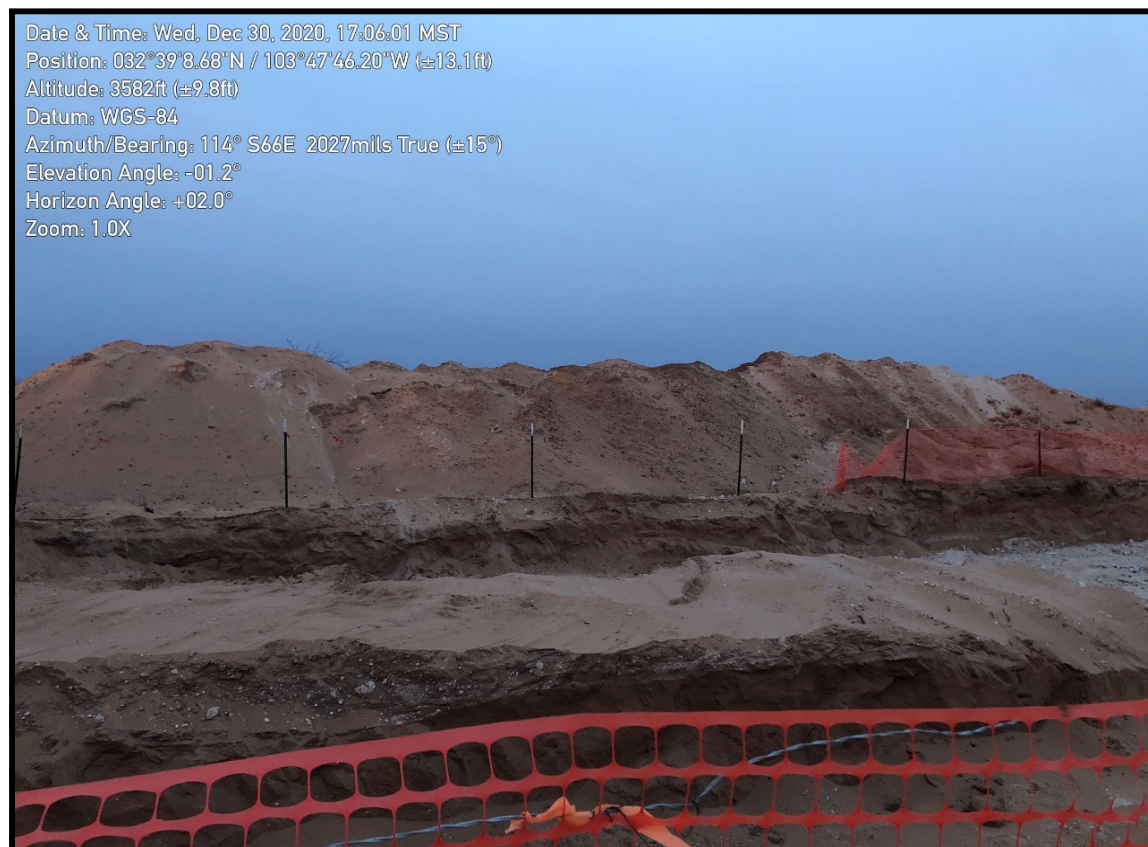
View of STP-2 and STP-3 during excavation activities, facing southeast.
