Vertex Project #: 19E-00575-011

Spill Closure Report: Cockburn Fed #002
Unit M, Section 10, Township 18 South, Range 33 East
County: Lea
API 30-025-36282
Incident Tracking Number: NAB1908655364

Prepared For: Devon Energy Production Company
6488 Seven Rivers Highway
Artesia, New Mexico 88210

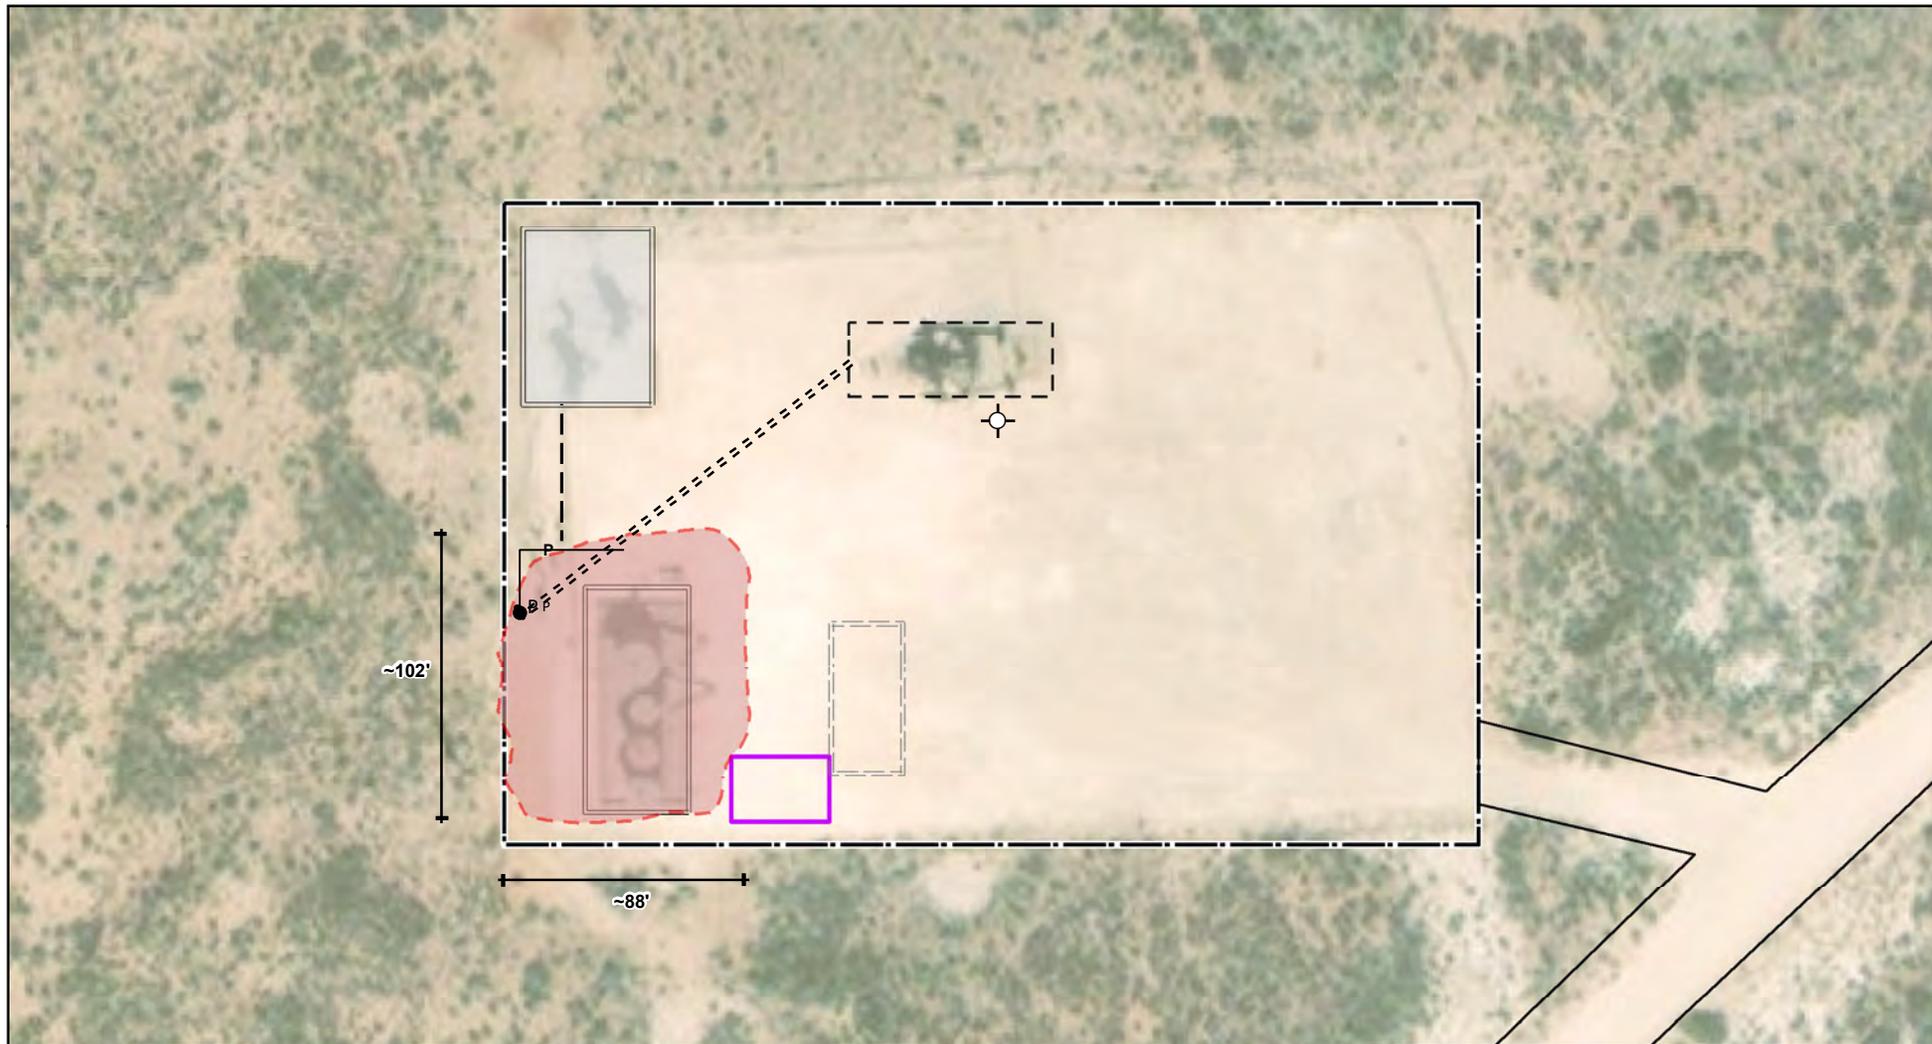
Attachment 2 (Figure 1).

An initial spill inspection, completed by Vertex on May 3, 2019, identified and mapped the boundaries of the release (Attachment 2 – Figure 1). The impacted area was determined to be approximately 88 feet wide and 102 feet long; the total affected area was determined to be approximately 7,805 square feet. On May 5, 2020, the burned tanks and damaged equipment were removed from the location. Remediation fieldwork was conducted at Cockburn between May 6 and May 9, 2019, with a Vertex environmental technician on-site to guide excavation of contaminated material using field screening methods. The Daily Field Reports (DFRs) and field screening data associated with the remediation fieldwork are included in Attachment 4.

- Power Pole
- Wellhead
- Aboveground Pipeline
- Electrical Conduit
- Power Line
- Access Road
- Approximate Lease Boundary
- Approximate Spill Extent (~ 7,805 sq. ft.)
- Contamination Pile
- Pumpjack
- Tank Battery Secondary Containment
- Tanks Removed from Containment
- Treater Secondary Containment

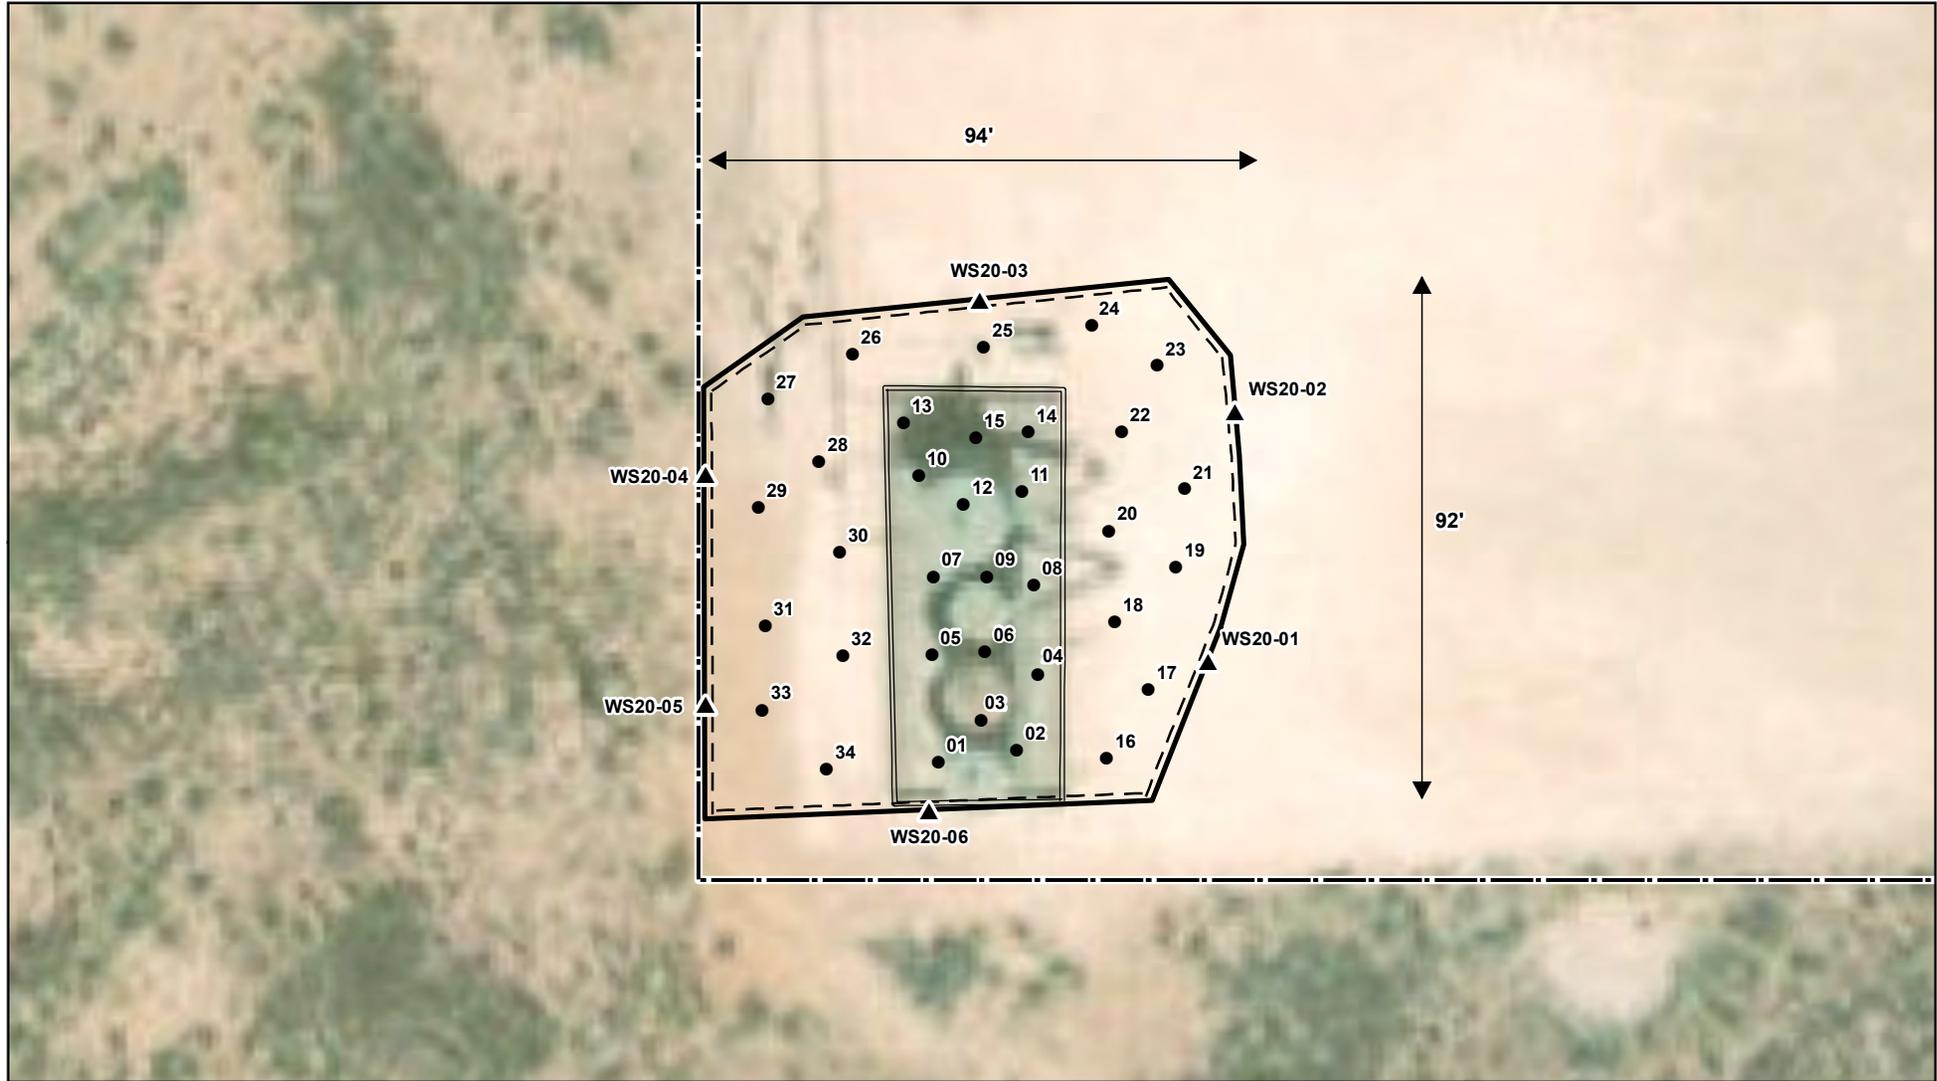
Document Path: G:\I-Projects\US PROJECTS\Devon Energy Corporation\19E-00575011 - Cockburn Federal 002\2nd Event (Aug 2020)\Figure 2 Confirmatory Schematic (Cockburn Federal 002).mxd

To aid in the process of re-building the tank battery and getting Cockburn back in production, initial confirmatory sampling for the portion of the excavation where the containment and new tank battery were to be re-built was conducted on May 9, 2019. Several of these initial confirmatory samples did not meet closure criteria as outlined in Table 1. On May 11, 2019, additional excavation was completed, and the failed confirmatory samples re-collected. Initial confirmatory sampling analytical data are summarized in Table 2 (Attachment 5). Laboratory data reports and chain of custody forms are included in Attachment 6.

- Base Sample Labels prefixed "BS20-, TP20-, or SS20-"
- ▲ Wall Sample
- ▭ Excavation (~ 7,801 sq. ft.)
- ▭ Containment
- ▭ Approximate Lease Boundary

Vertex recommends no additional remediation action to address the release at Cockburn. Laboratory analyses of the confirmatory samples showed constituent of concern concentration levels below NM OCD closure criteria for areas where depth to groundwater is less than 50 feet, or undetermined. There are no anticipated risks to human, ecological or hydrological receptors associated with the release site.

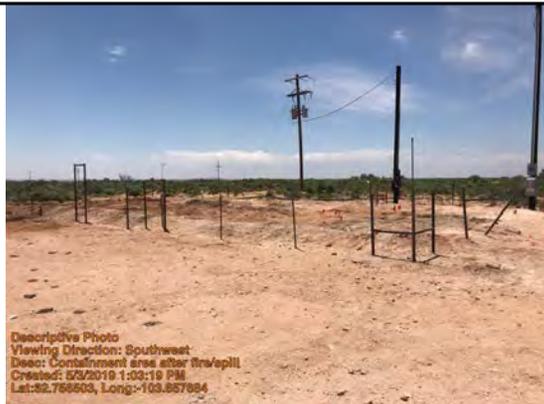
Descriptive Photo
Viewing Direction: Southwest
Desc: Containment area after fire/spill
Created: 5/3/2019 1:03:19 PM
Lat:32.756603, Long:-103.657894

Containment area after fire/spill

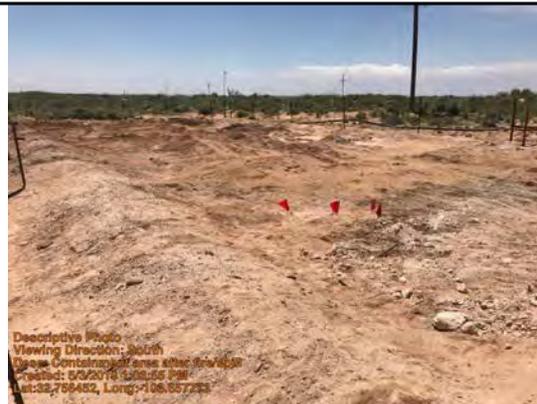
Descriptive Photo
Viewing Direction: South
Desc: Containment area after fire/spill
Created: 5/3/2019 1:03:55 PM
Lat:32.756482, Long:-103.657233

Containment area after fire/spill

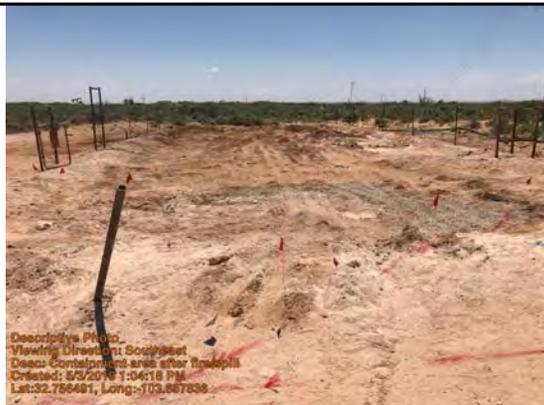
Descriptive Photo
Viewing Direction: Southeast
Desc: Containment area after fire/spill
Created: 5/3/2019 1:04:18 PM
Lat:32.756481, Long:-103.657838

Containment area after fire/spill

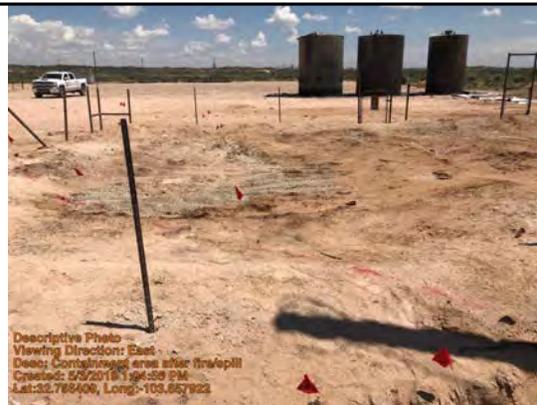
Descriptive Photo
Viewing Direction: East
Desc: Containment area after fire/spill
Created: 5/3/2019 1:04:59 PM
Lat:32.756406, Long:-103.657922

Containment area after fire/spill

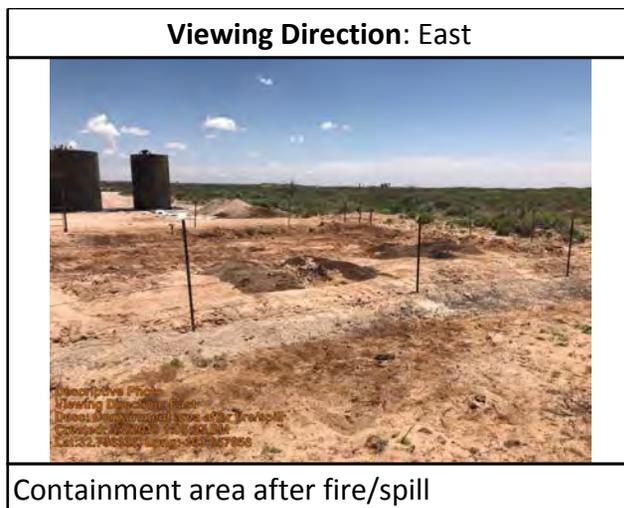
Containment area after fire/spill

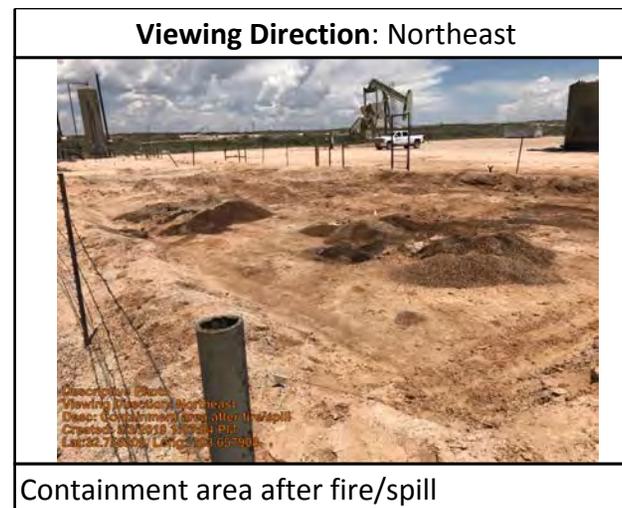
Containment area after fire/spill

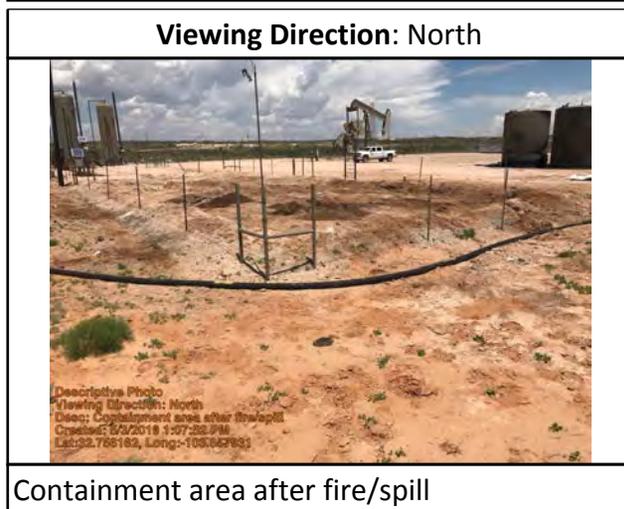
Containment area after fire/spill

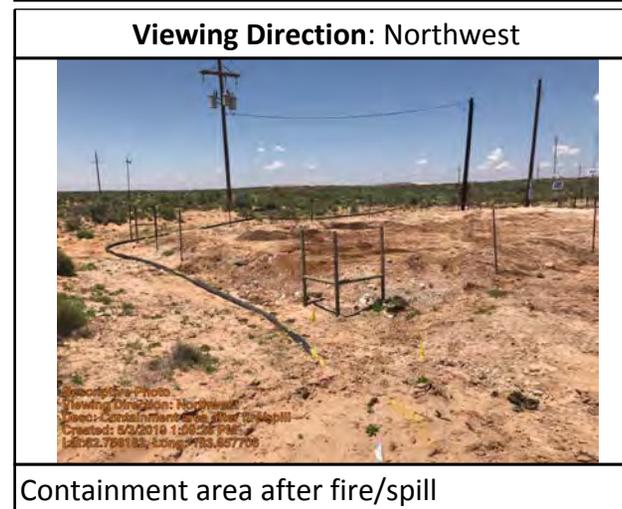
Containment area after fire/spill

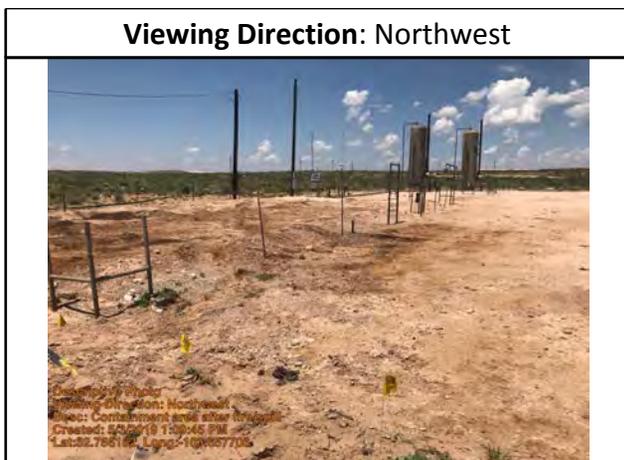
Containment area after fire/spill

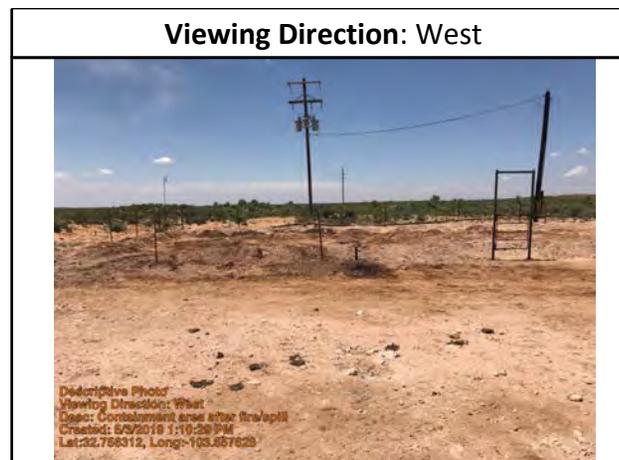
Containment area after fire/spill

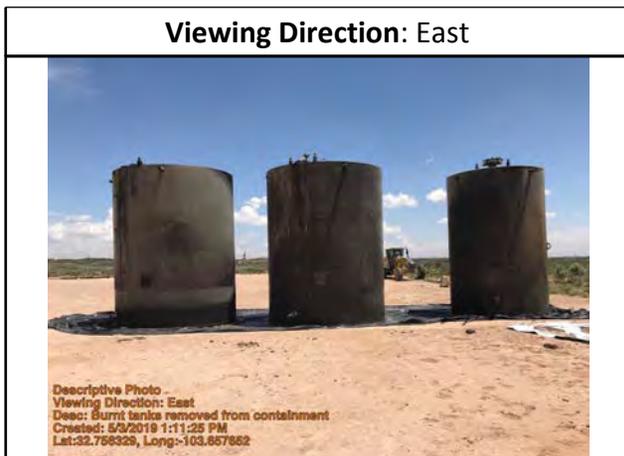
Burnt tanks removed from containment

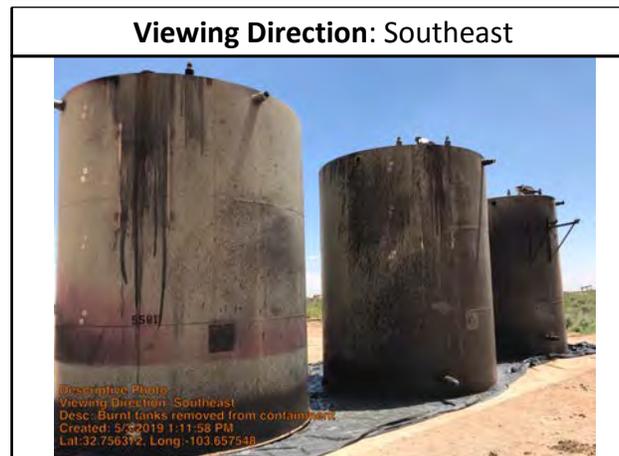
Burnt tanks removed from containment

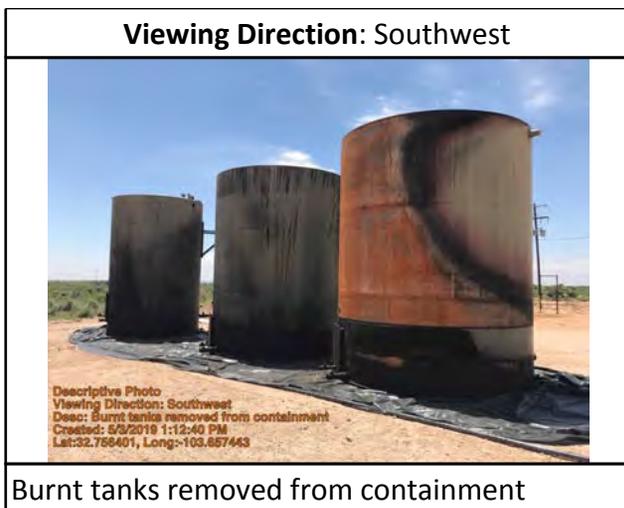
Burnt tanks removed from containment

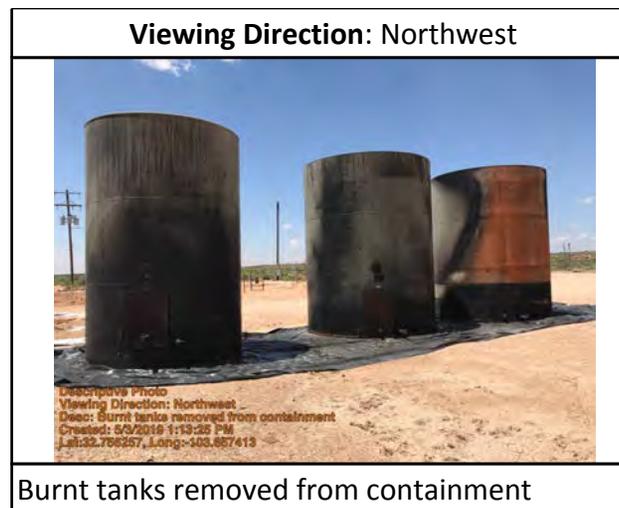
Burnt tanks removed from containment

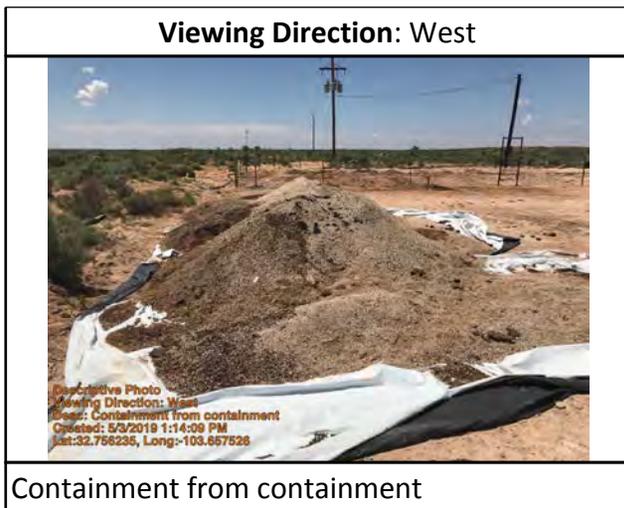
Containment from containment

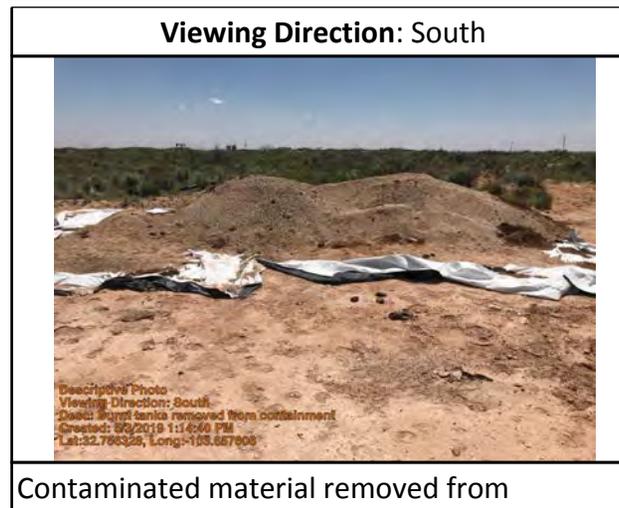
Contaminated material removed from containment

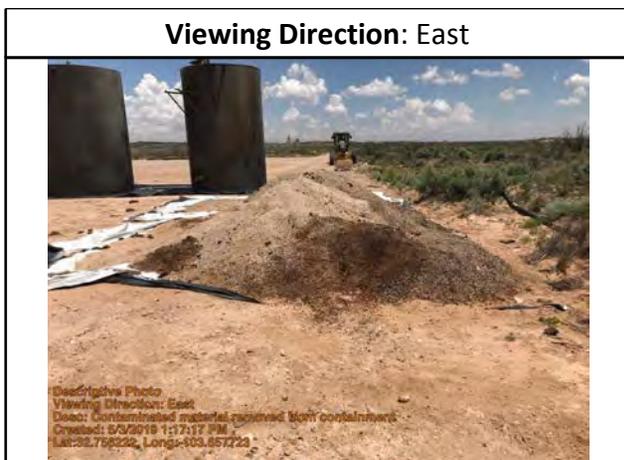
Contaminated material removed from containment

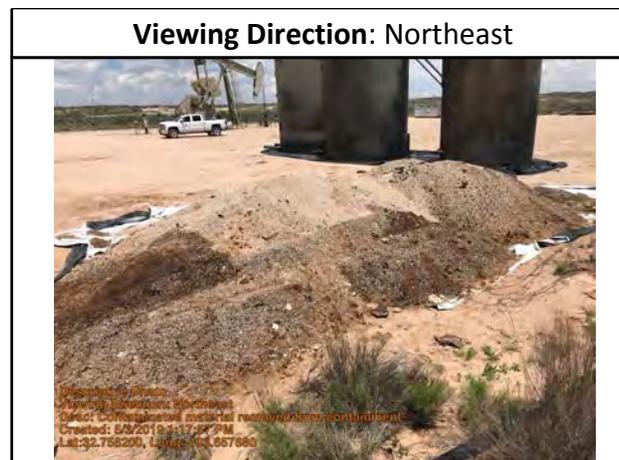
Contaminated material removed from containment

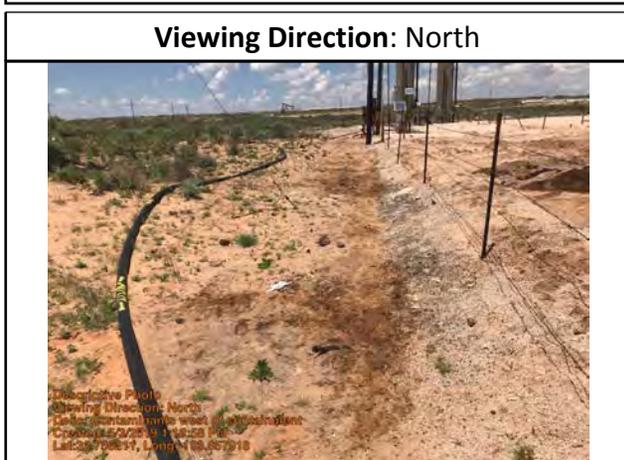
Contaminants west of containment

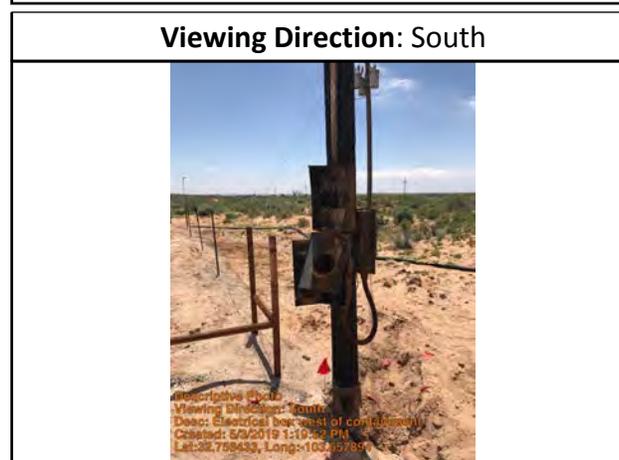
Electrical box west of containment

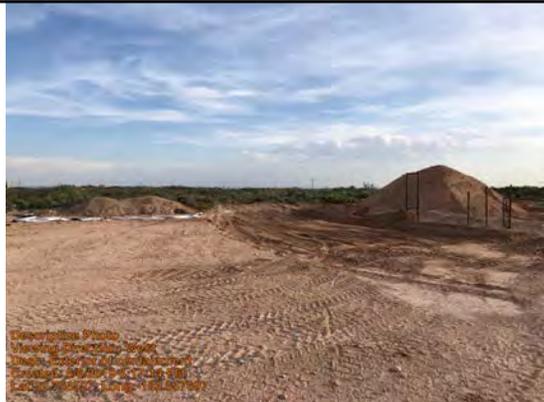
Descriptive Photo
Viewing Direction: West
Event: Exterior of containment
Created: 2020/05/18 01:24 PM
Lat: 32.98211, Long: -104.69732

Exterior of containment

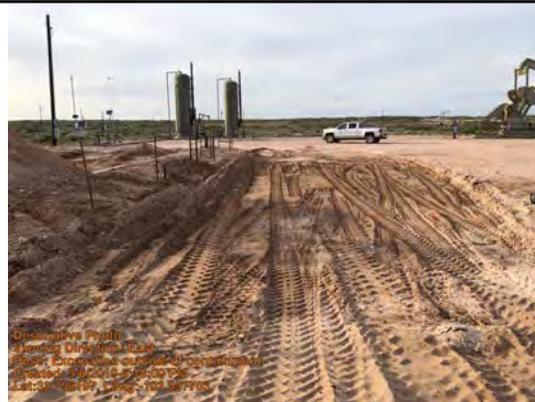
Descriptive Photo
Viewing Direction: East
Event: Excavation outside of containment
Created: 2020/05/18 01:24 PM
Lat: 32.98211, Long: -104.69732

Excavation outside of containment

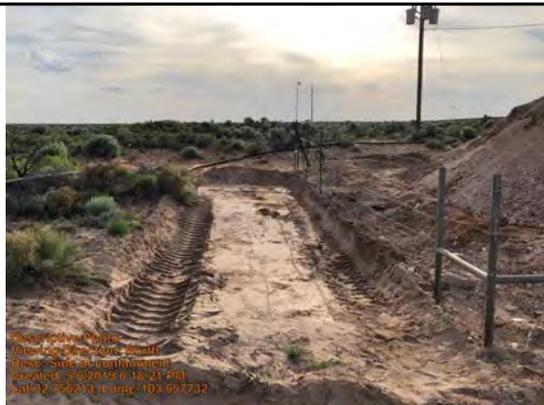
Descriptive Photo
Viewing Direction: North
Event: Side of containment
Created: 2020/05/18 01:24 PM
Lat: 32.98211, Long: -104.69732

Side of containment

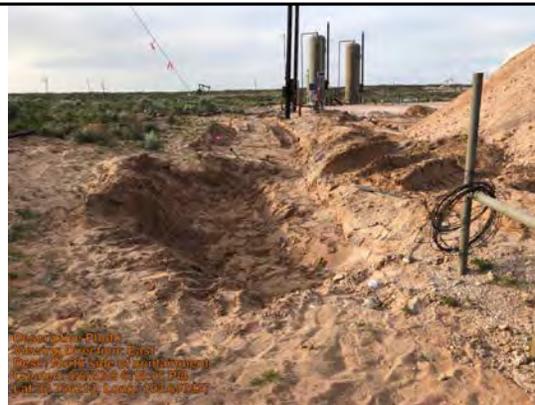
Descriptive Photo
Viewing Direction: East
Event: North side of containment
Created: 2020/05/18 01:24 PM
Lat: 32.98211, Long: -104.69732

North side of containment

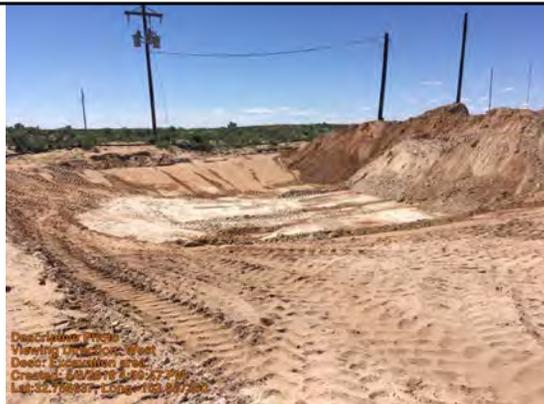
Description: Photo
Viewing Direction: West
Date: Excavation area
Created: 5/8/2019 5:59:17 PM
Lat:32.758337, Long:-103.657345

Excavation area

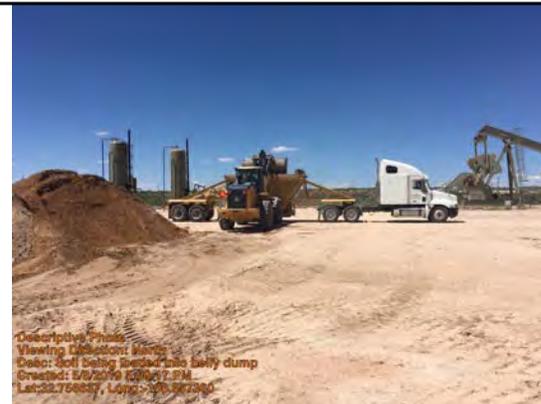
Description: Photo
Viewing Direction: North
Date: Soil being loaded into belly dump
Created: 5/8/2019 5:59:17 PM
Lat:32.758337, Long:-103.657345

Soil being loaded into belly dump

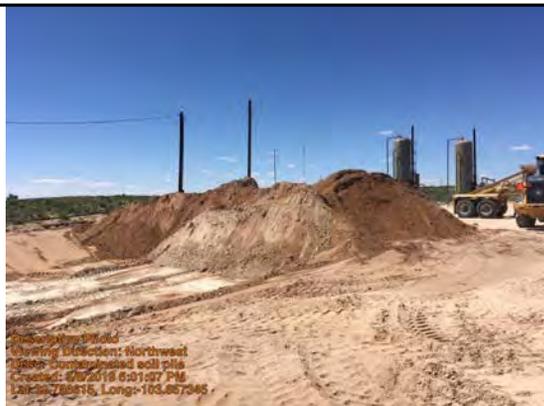
Description: Photo
Viewing Direction: Northwest
Date: Contaminated soil pile
Created: 5/8/2019 6:31:37 PM
Lat:32.758315, Long:-103.657345

Contaminated soil pile

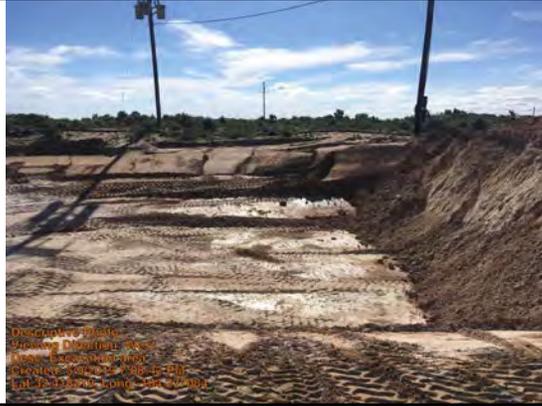
Excavation area

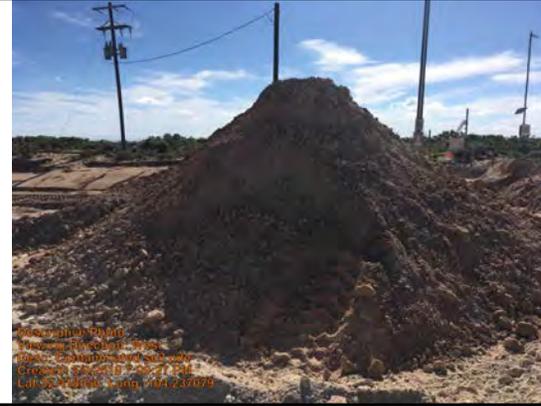
Contaminated soil pile

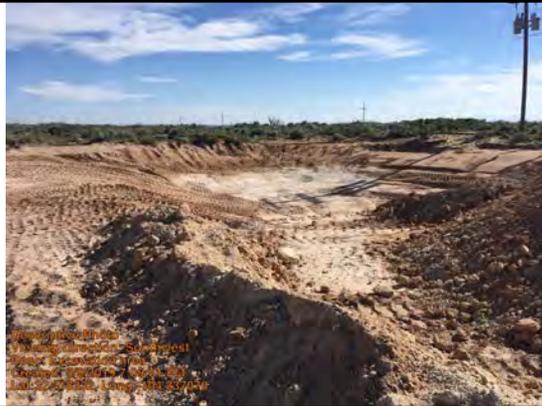
Excavation area

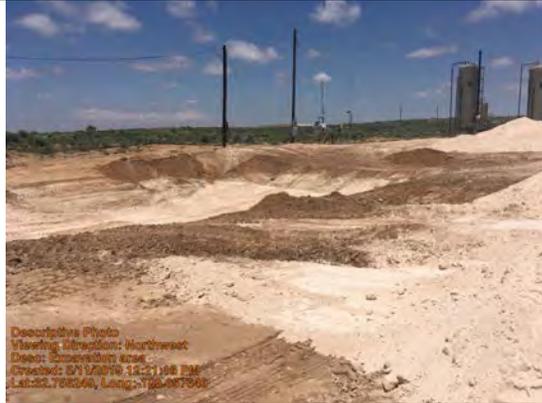
Excavation area

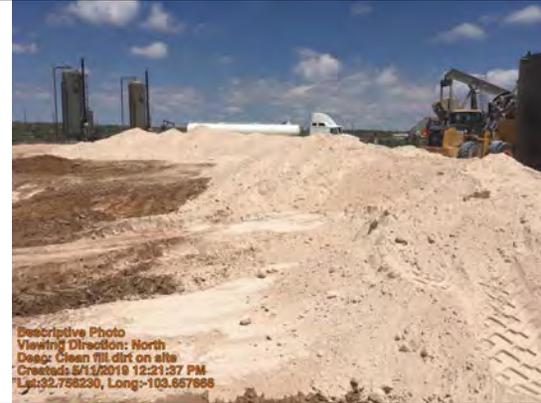
Clean fill dirt on site
