## Release Notification

Site Name PLU 442-443	Site Type Tank Battery
Date Release Discovered 10/8/2020	API# (if applicable)

Cause of Release Water dump line plugged with scale causing the flare scrubber to fill with fluid and flow out of the flare stack. Evidence was found indicating a small fire that extinguished itself below the flare. A third party contractor has been retained for remediation activities.

PHOTOGRAPHIC LOG		
XTO Energy, Inc.	Poker Lake Unit 442-443 Eddy County, New Mexico	NRM2030234533

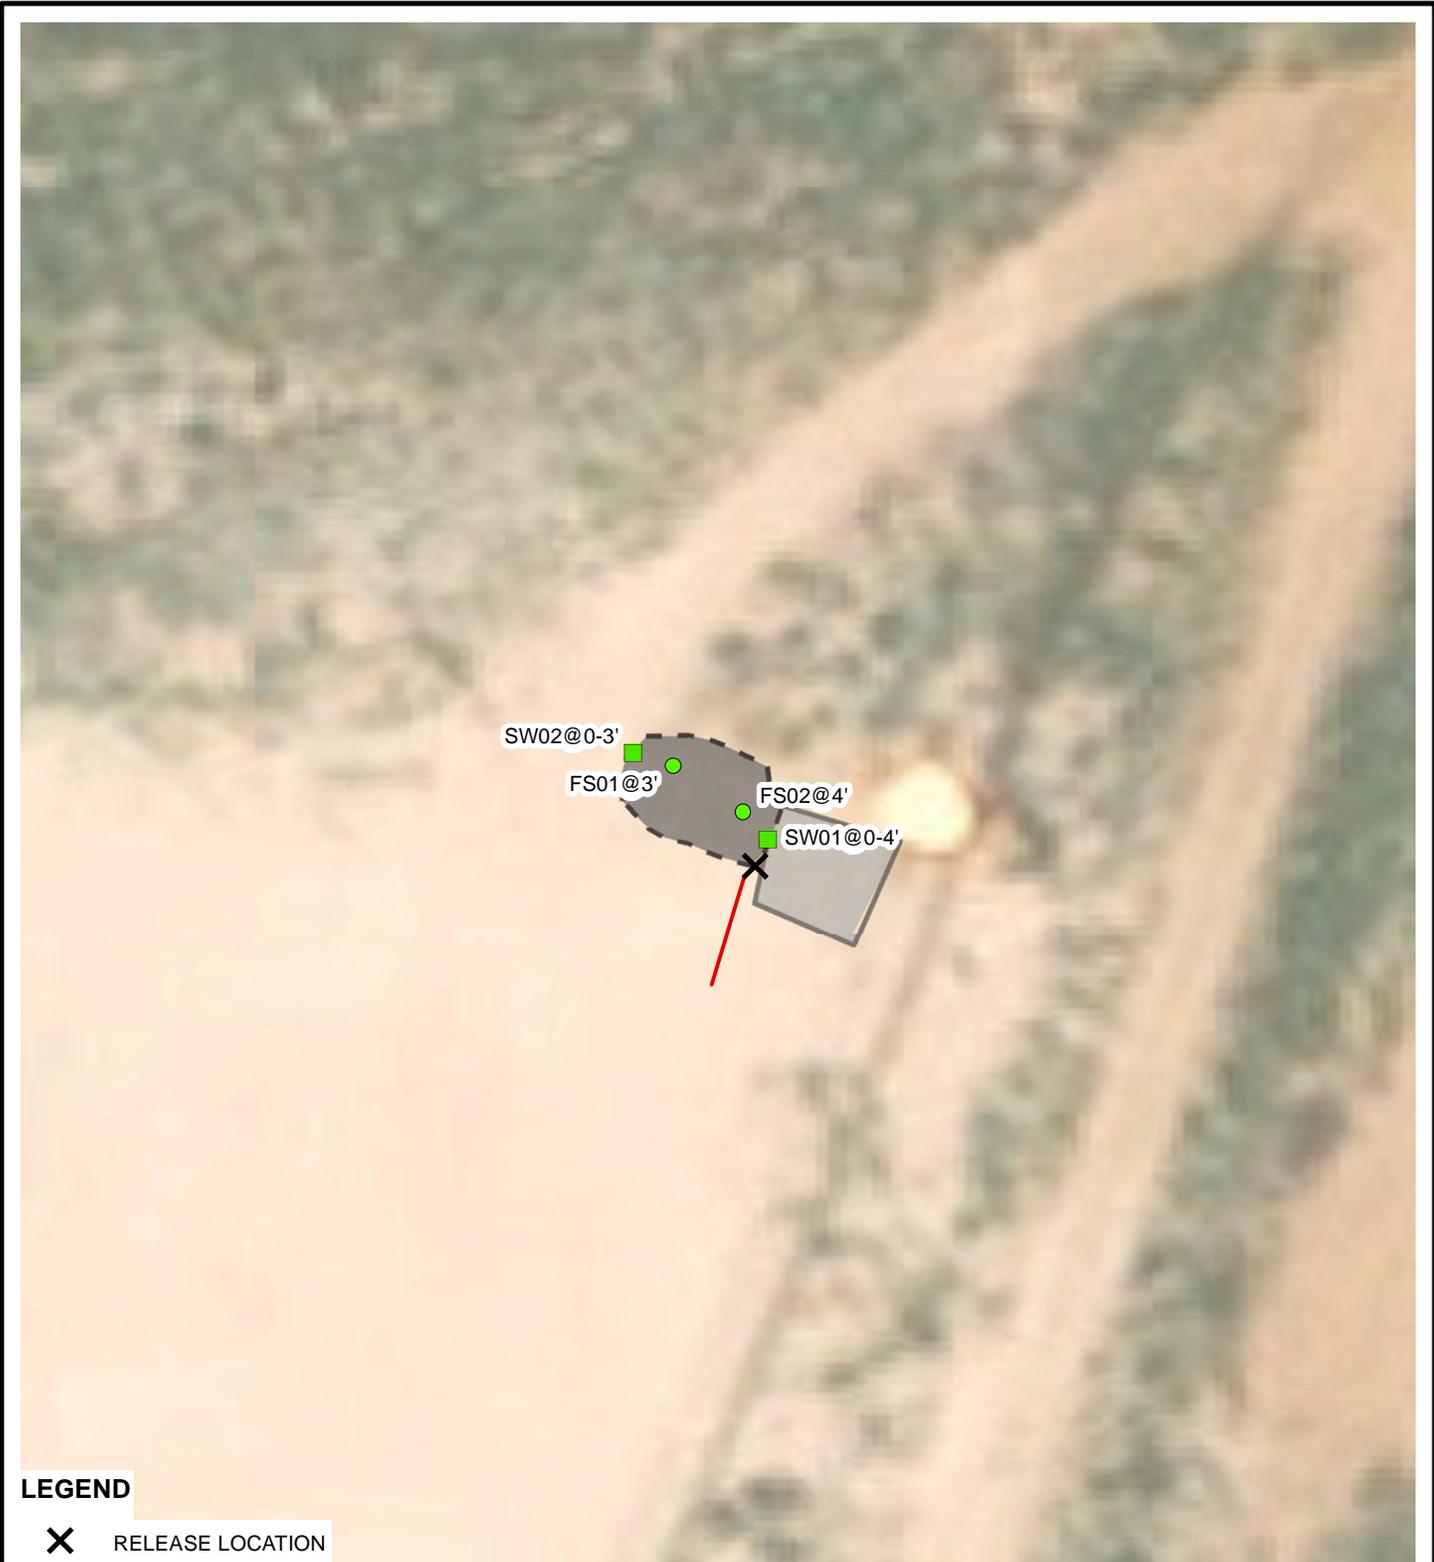
**FIGURE 2**  
**PRELIMINARY SOIL SAMPLE LOCATIONS**  
 PLU 442-443  
 UNIT B SEC 30 T24S R30E  
 EDDY COUNTY, NEW MEXICO  
 XTO ENERGY, INC.

Laboratory analytical results for preliminary soil sample SS01 and SS02 indicated that TPH-GRO, TPH-DRO and TPH concentrations exceeded the Closure Criteria. Based on visible staining in the release area, elevated field screening results, and laboratory analytical results for the preliminary soil samples, excavation activities were warranted.

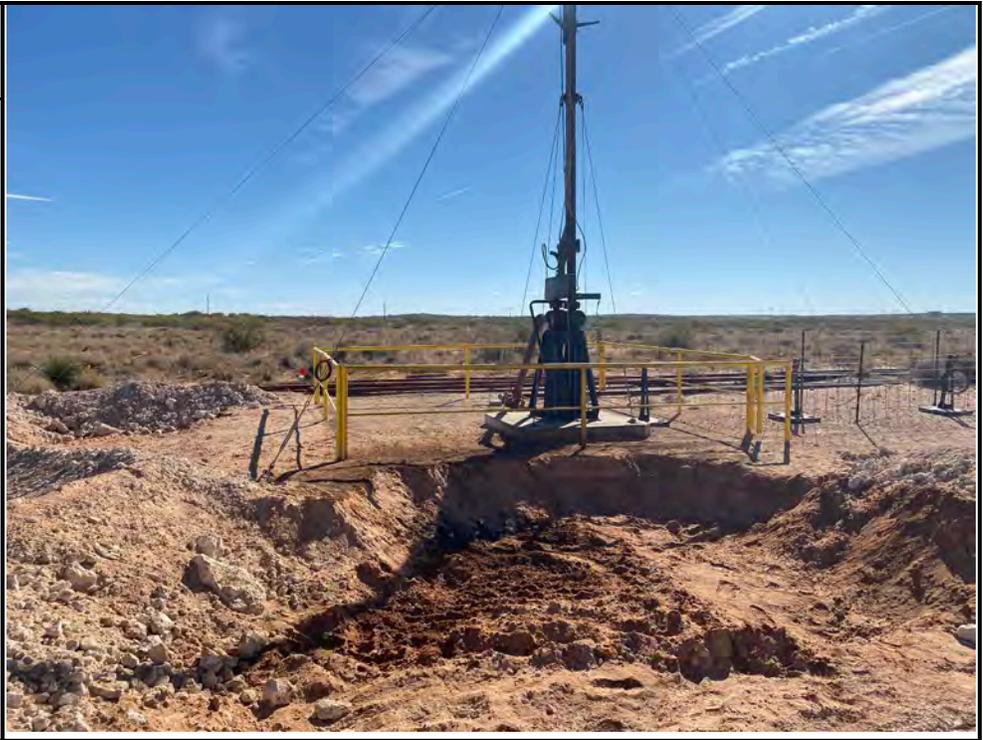
Photo No.	Date
1	November 3, 2020

View of staining around flare stack facing East.

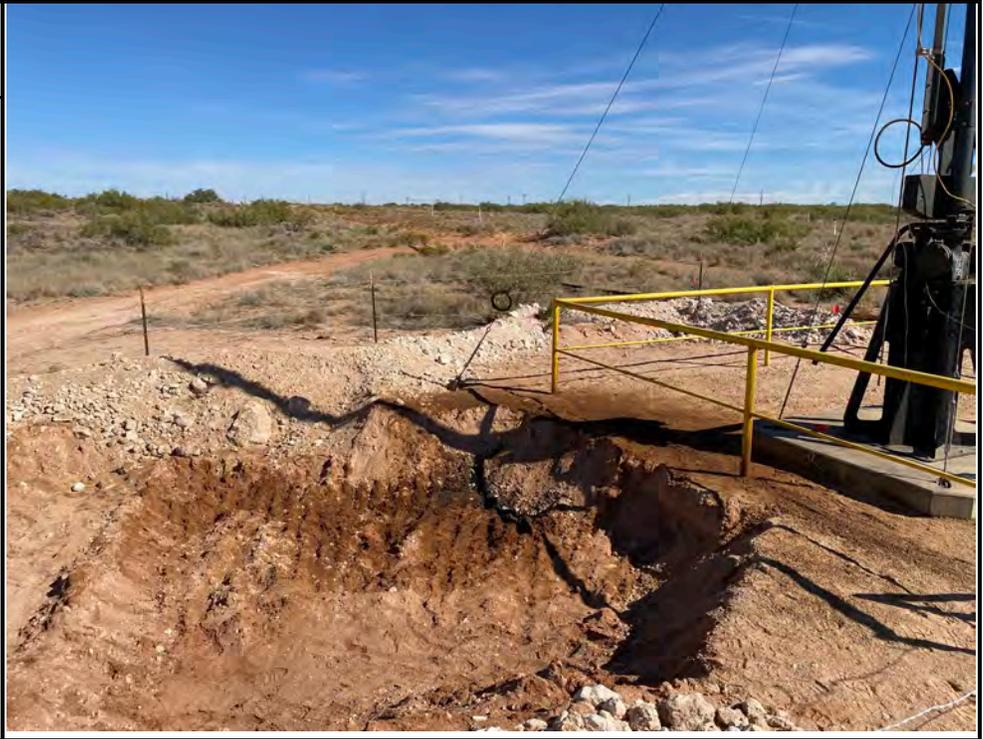
Photo No.	Date
2	November 3, 2020

View of staining around flare stack facing North.

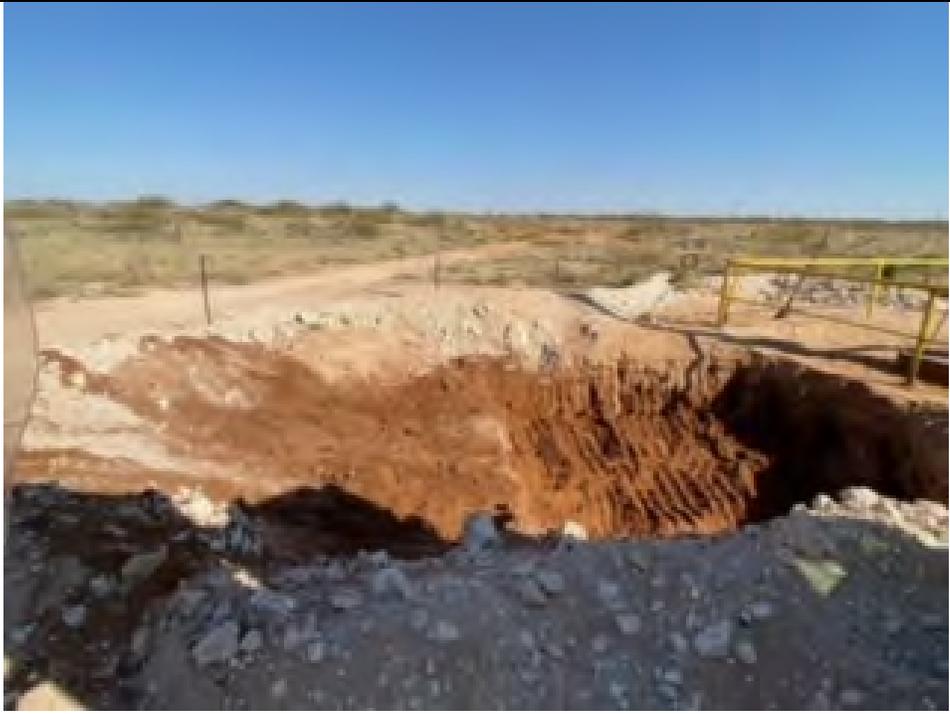
Photo No.	Date	
3	November 19, 2020	
View of excavation facing North

The excavation area totaled approximately 308 square feet. A total of approximately 17 cubic yards of impacted soil was removed during the excavation activities. The impacted soil was transported and properly disposed of at the R360 Facility in Hobbs, New Mexico. After completion of confirmation sampling, the excavation was secured with fencing. The area north of the flare stack will be reseeded and backfilled with material purchased locally and recontour the Site to match pre-existing site conditions.

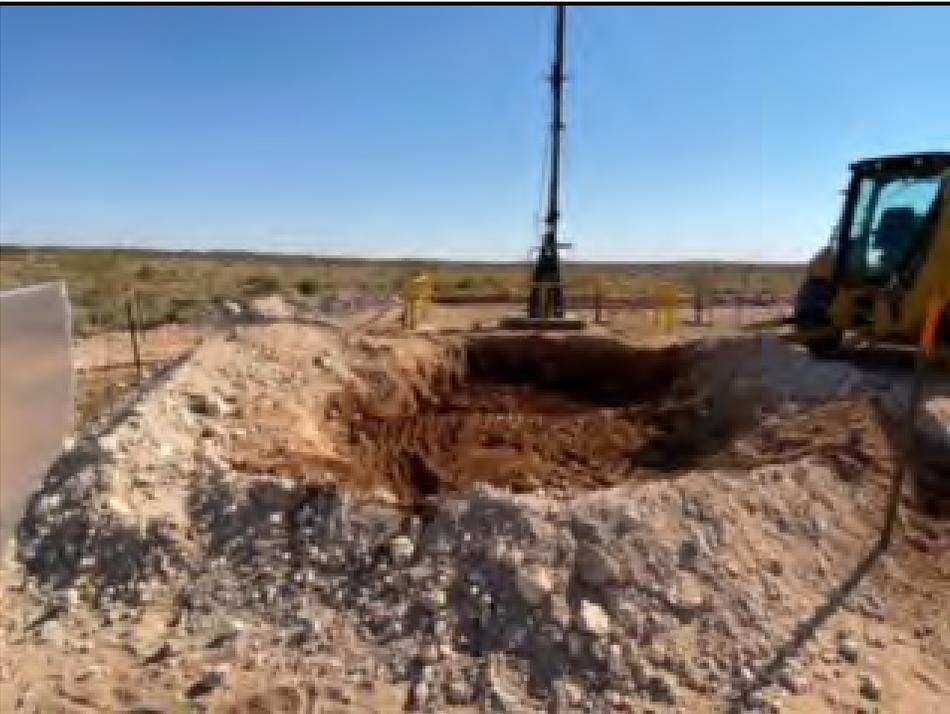
Photo No.	Date	
4	November 19, 2020	
View of excavation facing East.

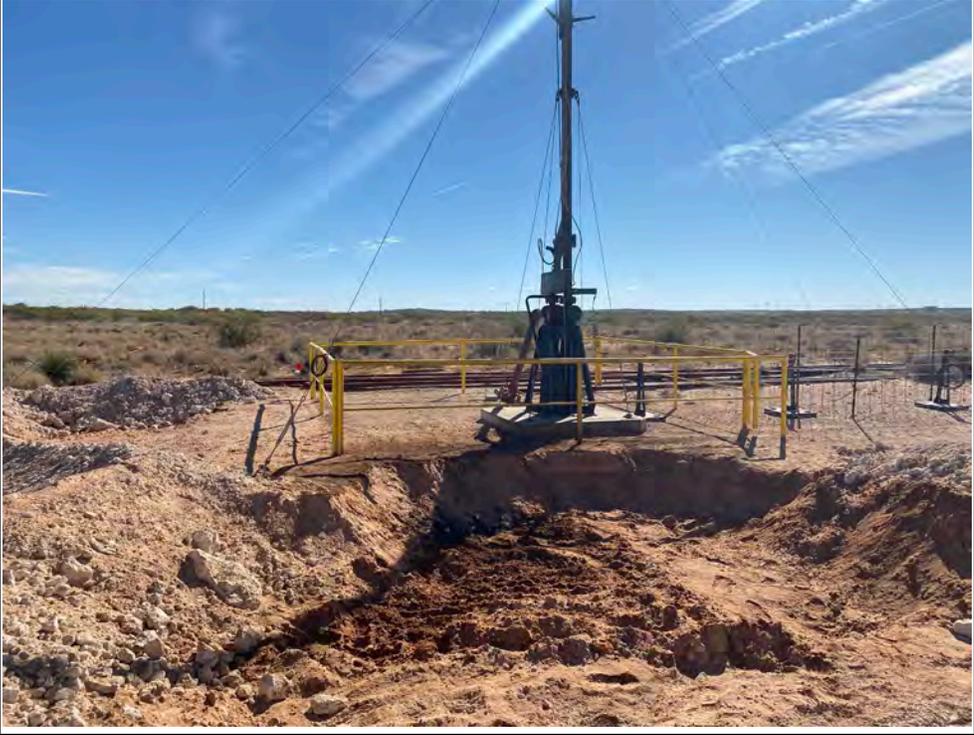
Photo No.	Date	
1	November 3, 2020	
View of staining around flare stack facing East.

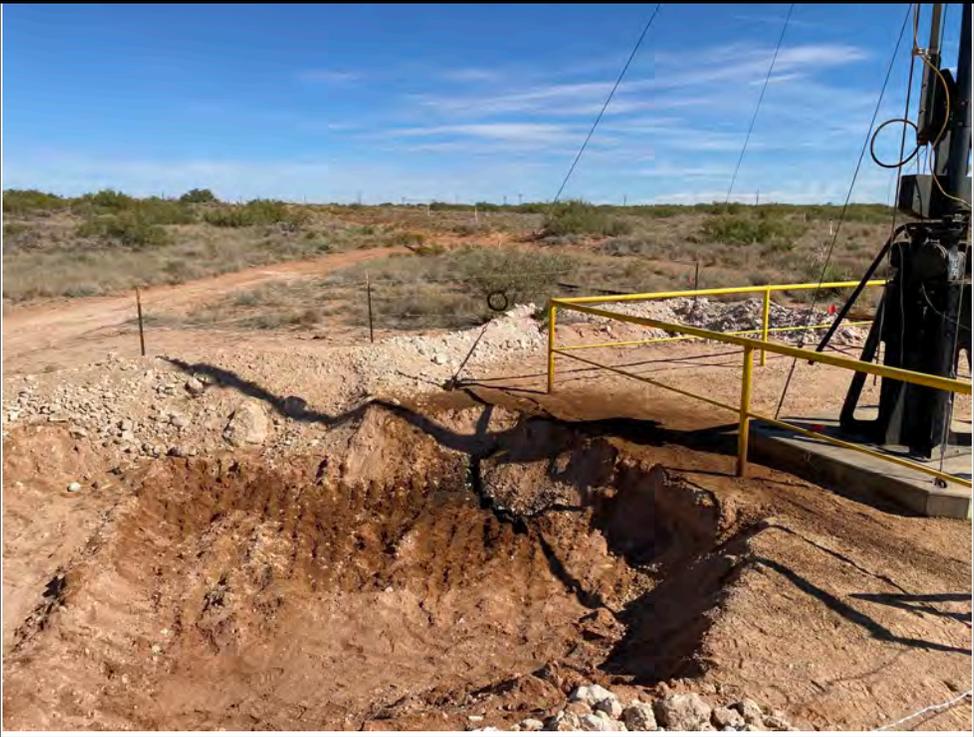
Photo No.	Date	
2	November 3, 2020	
View of staining around flare stack facing North.

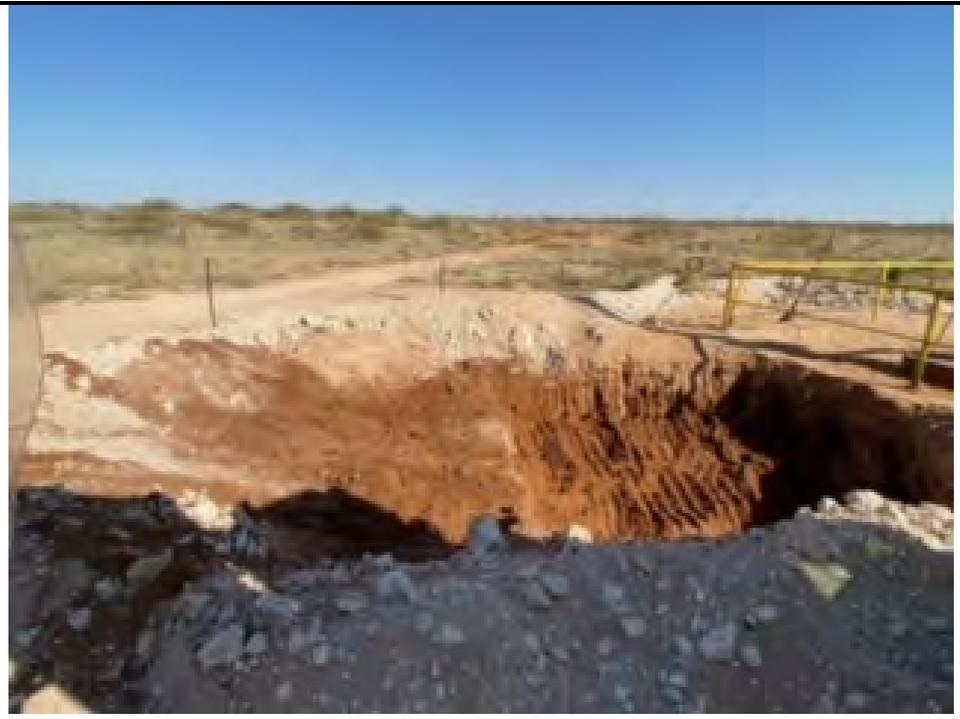
<b>Photo No.</b>	<b>Date</b>
3	November 19, 2020

View of excavation facing North

The excavation area totaled approximately 308 square feet. A total of approximately 17 cubic yards of impacted soil was removed during the excavation activities. The impacted soil was transported and properly disposed of at the R360 Facility in Hobbs, New Mexico. After completion of confirmation sampling, the excavation was secured with fencing. The area north of the flare stack will be reseeded and backfilled with material purchased locally and recontour the Site to match pre-existing site conditions.

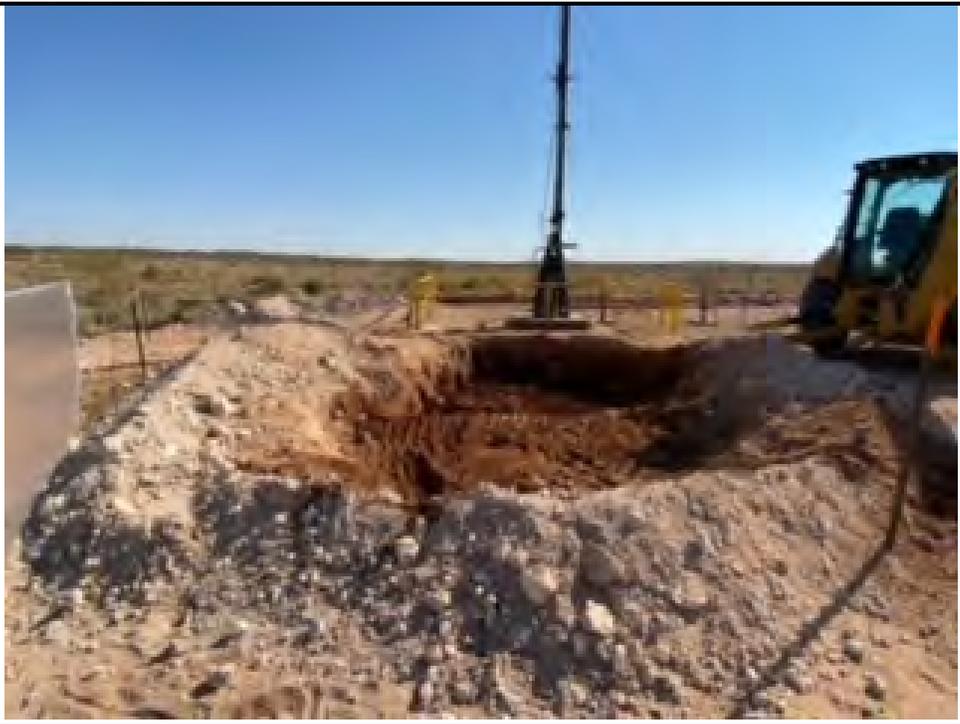
<b>Photo No.</b>	<b>Date</b>
4	November 19, 2020

View of excavation facing East.
