Cimarex – Crawford 27 26 Fee 15H  
Closure Report

## CLOSURE REPORT

Cimarex Energy Company  
Crawford 27 26 Fee 15H  
Eddy County, New Mexico  
Unit Letter "L", Section 27, Township 24 South, Range 26 East  
Latitude 32.187833, Longitude -104.288333  
nRM2033557420  
February 2021

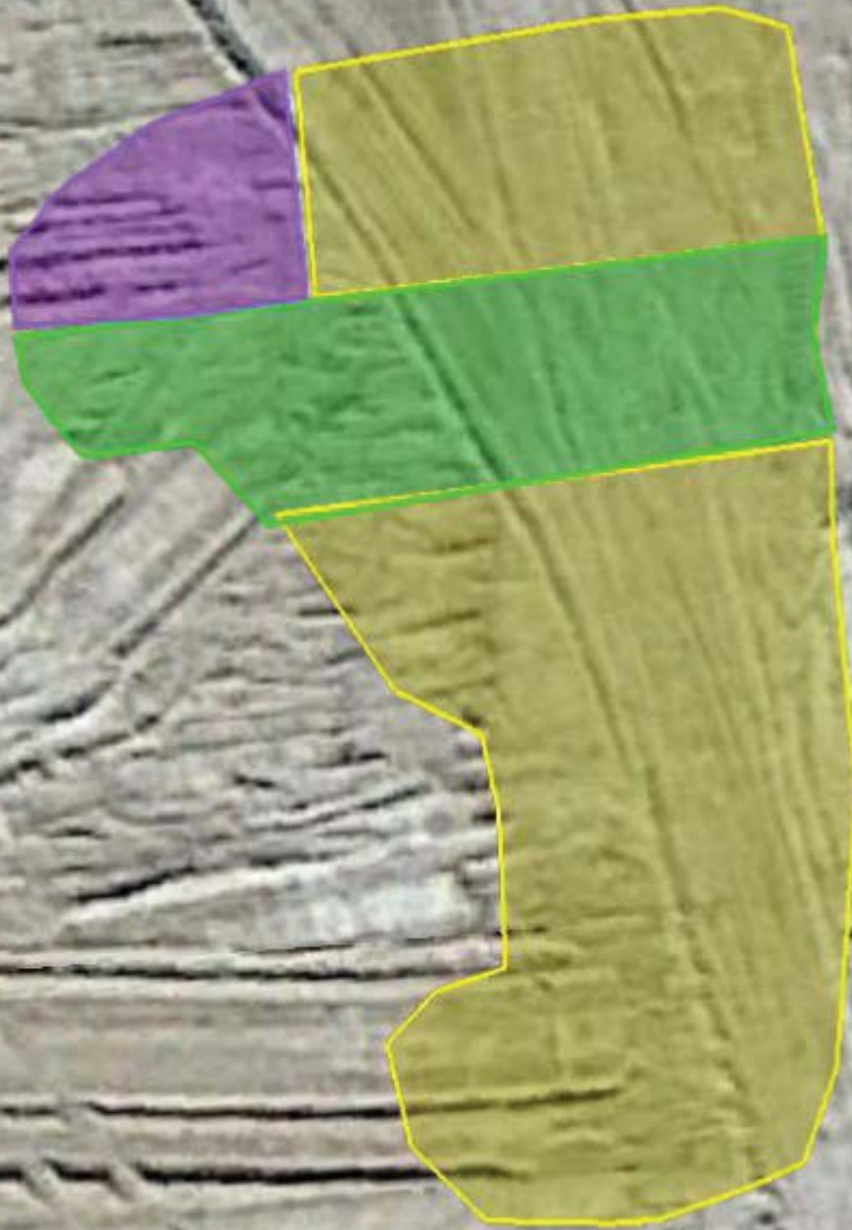
- Excavated bottom confirmation sample (CS)
- Release Footprint
- Side Wall confirmation sample (SW)

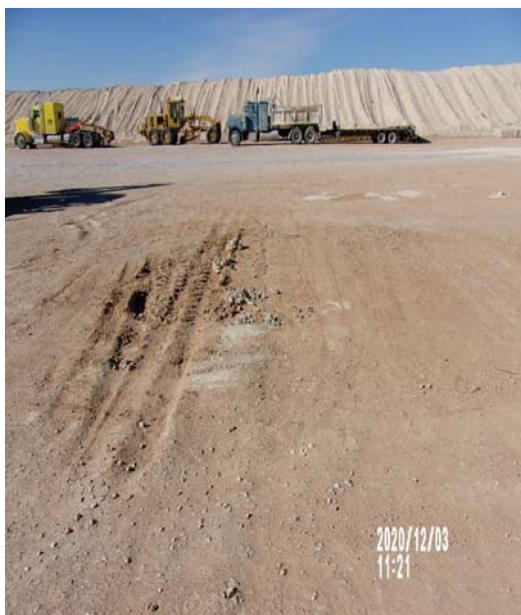
On December 3, 2020, ASSI personnel performed a site inspection in response to a release of seventy-five (75) barrels (bbls) of produced water. The cause of the release was due to a failure of the secondary containment which caused the release to occur directly on to the ground. Seventy-four (74) bbls of produced water were recovered. ASSI determined the release footprint was approximately six thousand two-hundred (6200) square feet of production pad.

View West – Origin of spill. Release caused by open frac tank valves and a failed liner at an adjacent containment.

After the frac job completed, several 8" and 4" valves were found with no caps and had dripped onto lined containment. Select Water Transfer rigged down their manifold onto the containment but failed to put the straps back on that hold the liner to the muscle wall. The wind blew the loose containment down causing 1 barrel of 50/50 blend (50% fresh water and 50% produced water) to spill onto the well pad. A vacuum truck recovered 74 barrels 50/50 blend water from the lined containment. Once the frac equipment is removed, the impacted soils will be removed, disposed of at an approved E&P waste site and the area will be delineated.

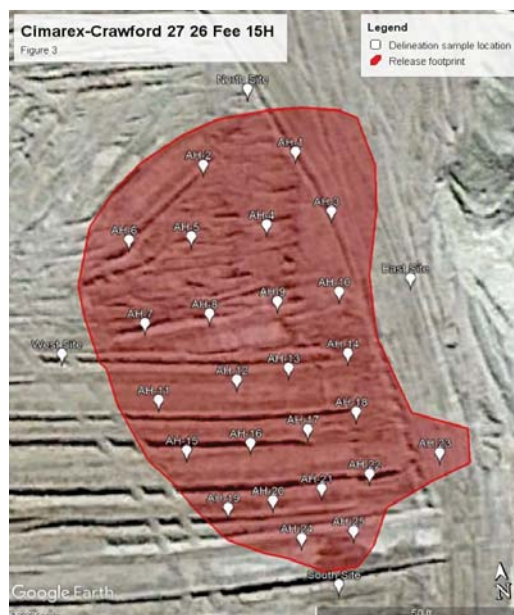
Delineation sample locations within the release footprint.

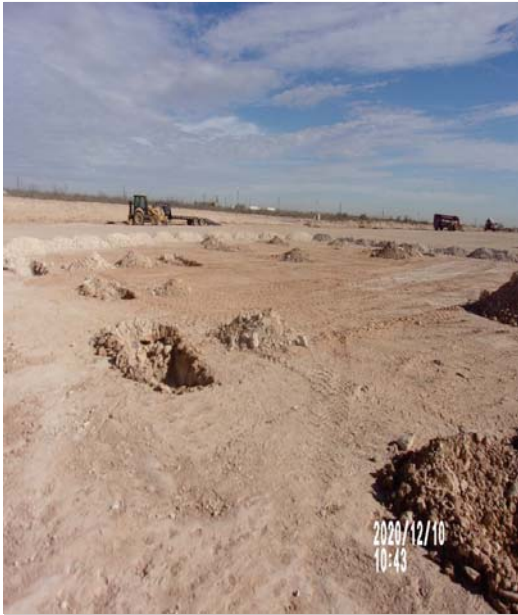
View Northeast – Delineation sample locations within the release footprint (i.e., Auger Holes 1 thru 10).

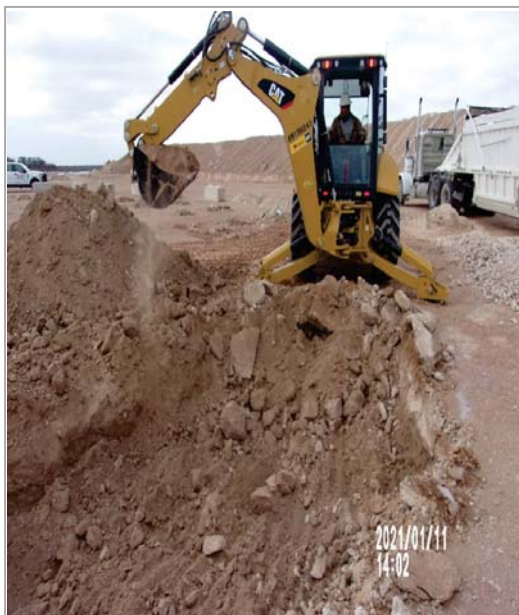
View Southwest – Impacted material excavated to 2 ft bgs being exported offsite to a Cimarex approved disposal.

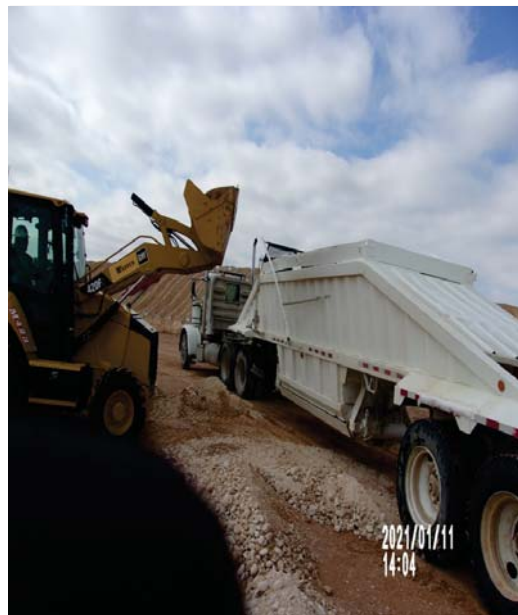
View Southwest – Impacted material excavated to 2 ft bgs being exported offsite to a Cimarex approved disposal.

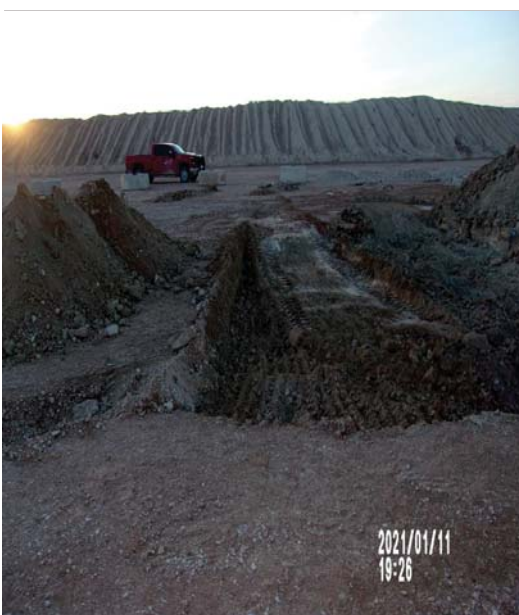
View West – Impacted material excavated to 2 ft bgs to be exported offsite to a Cimarex approved disposal.

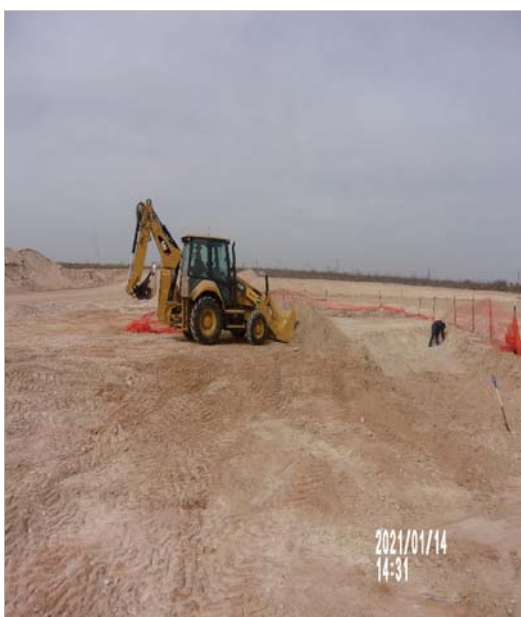
View North – Excavation of impacted material ongoing.

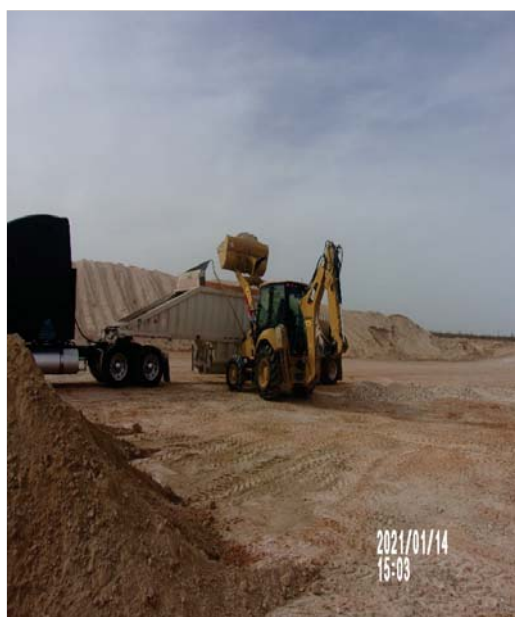
View Northwest – Excavated impacted material being loaded for export offsite to a Cimarex approved disposal.

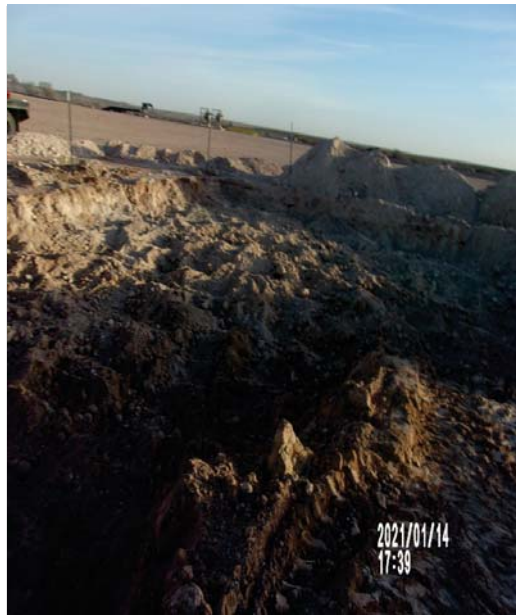
View Southeast – Excavation of impacted material ongoing.
