Re: Remediation Activities and Closure Report
Turquoise PWU 27 #1H
API No. 30-015-38333
GPS: Latitude 32.6362 Longitude -104.0703
UL "D", Sec. 27, T19S, R29E
Eddy County, NM
NMOCD Ref. ID. NAB1908046533, NRM2030058093

Pima Environmental Services, LLC (Pima) has been contracted by Devon Energy Production Company (Devon) to perform a spill assessment, site remediation and has prepared this Closure Report for two produced water releases that occurred at the Turquoise PWU 27 #1H (Turquoise). The first initial C-141 was submitted on March 14, 2019 (Appendix C). This incident was assigned 2RP-5316, Incident ID NAB1908046533, by the New Mexico Oil Conservation Division (NMOCD). The second C-141 was submitted on October 21, 2020 and was assigned Incident ID NRM2030058093, by the NMOCD.

Turquoise PWU 27 #1H
API 30-015-38333
Eddy County, NM
Site Map

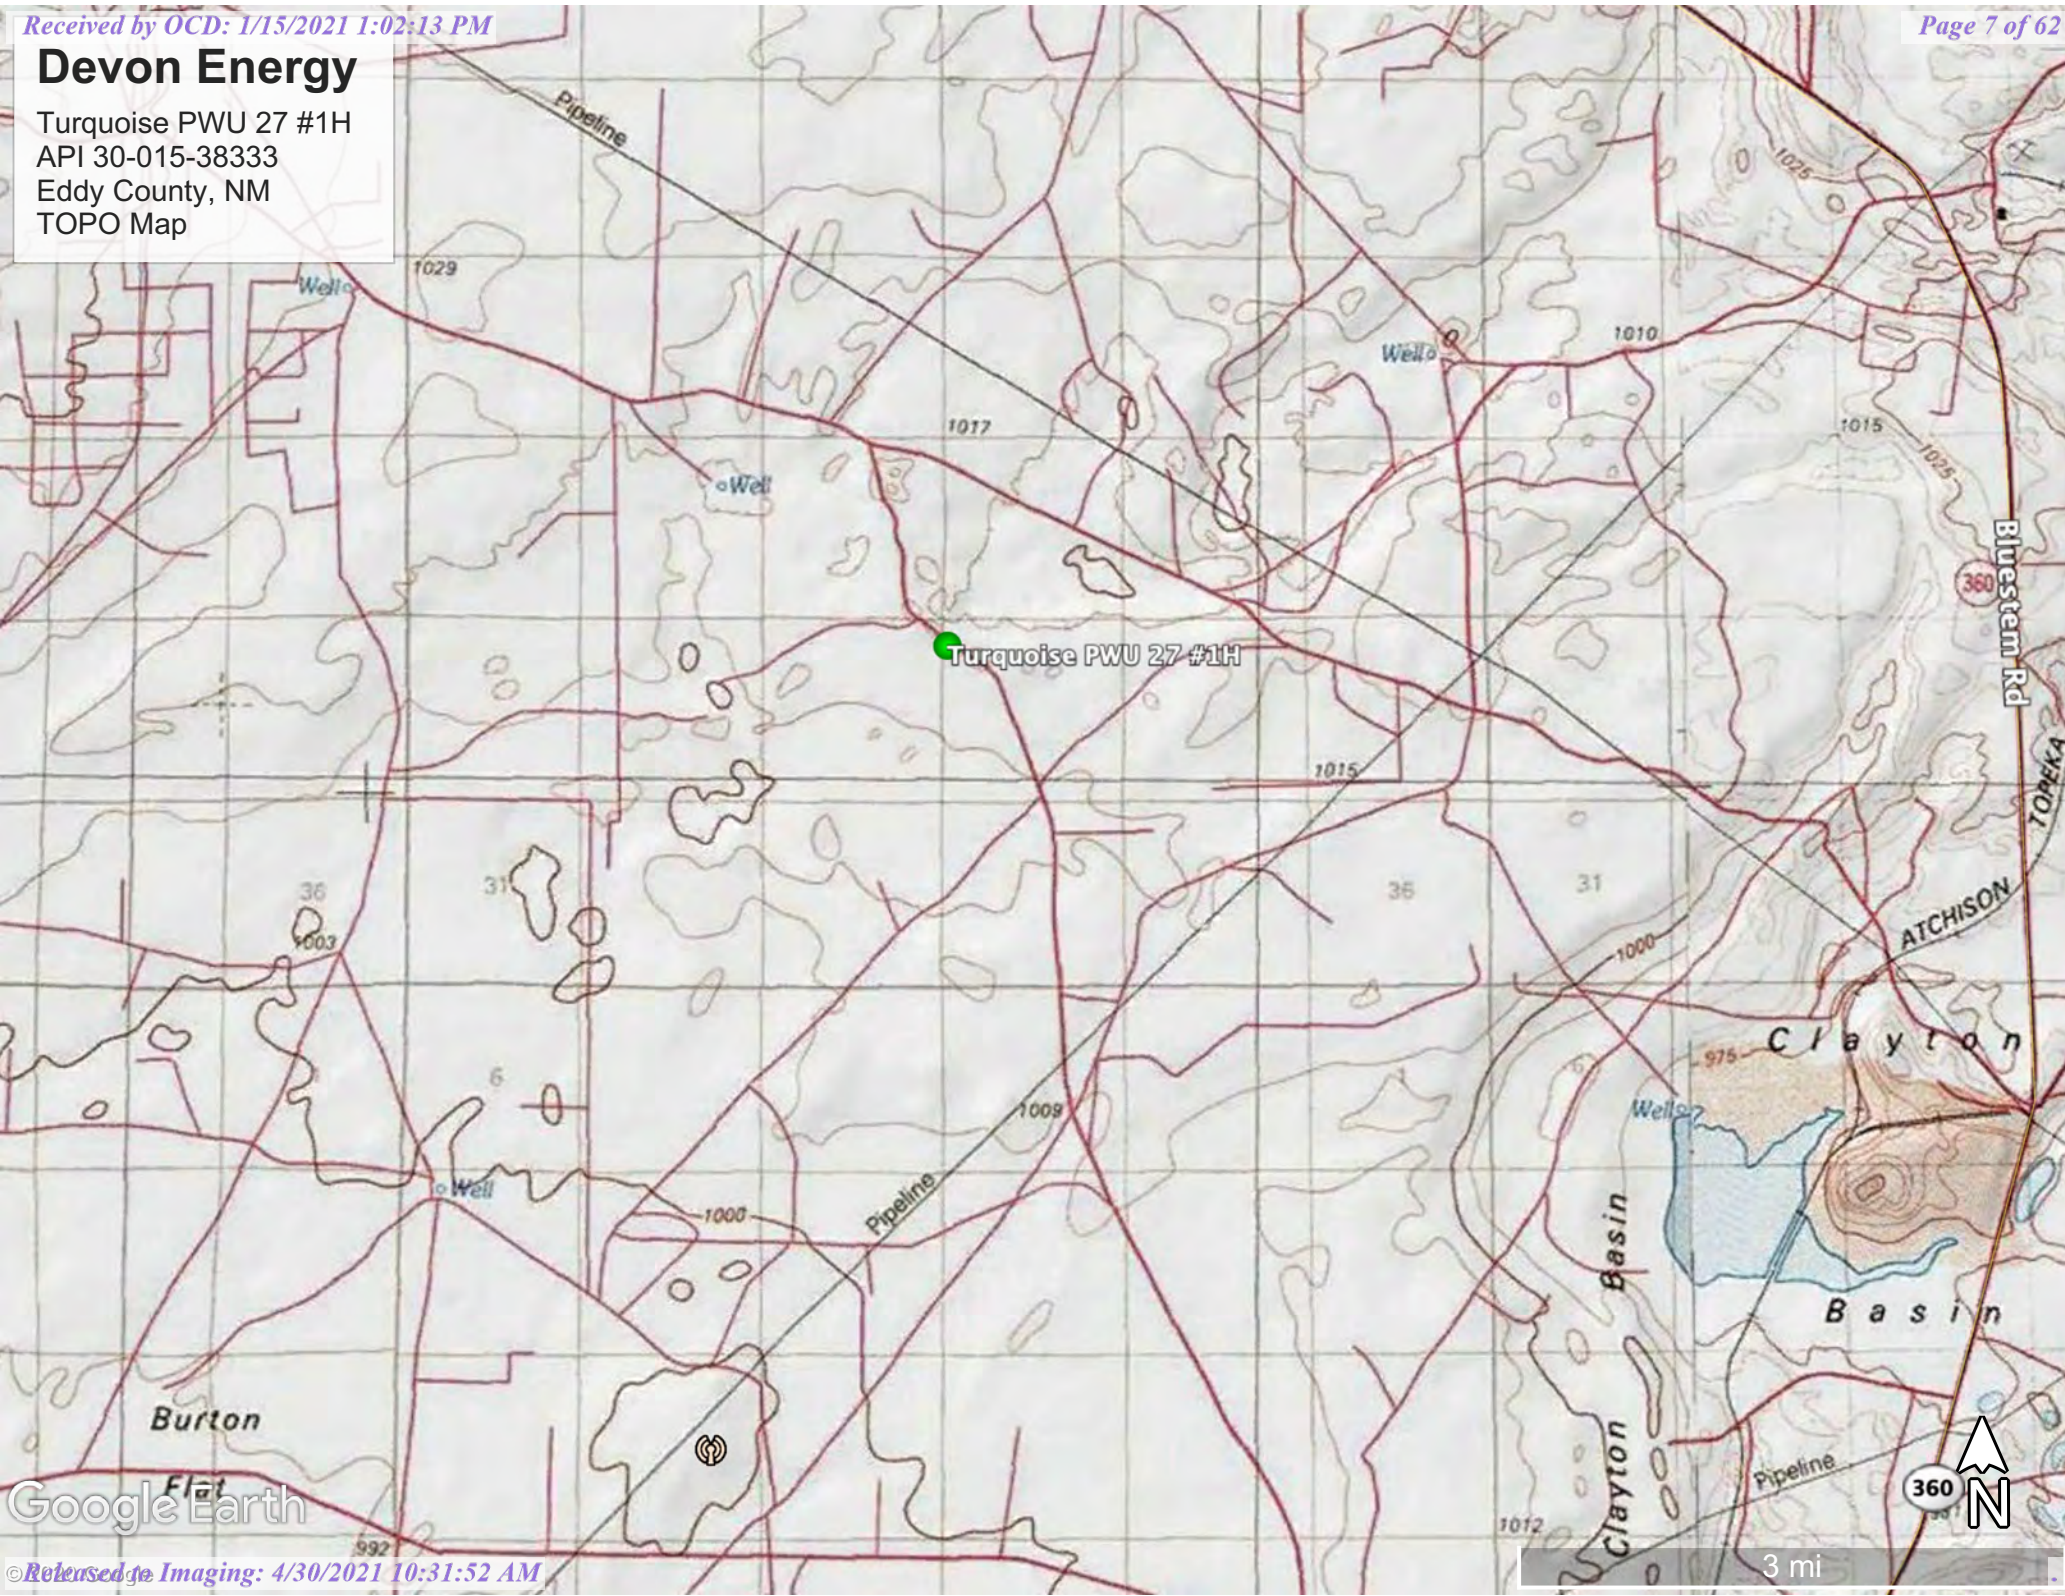
Turquoise PWU 27 #1H
API 30-015-38333
Eddy County, NM
TOPO Map

Reference Figure 2 for a TOPO Map.

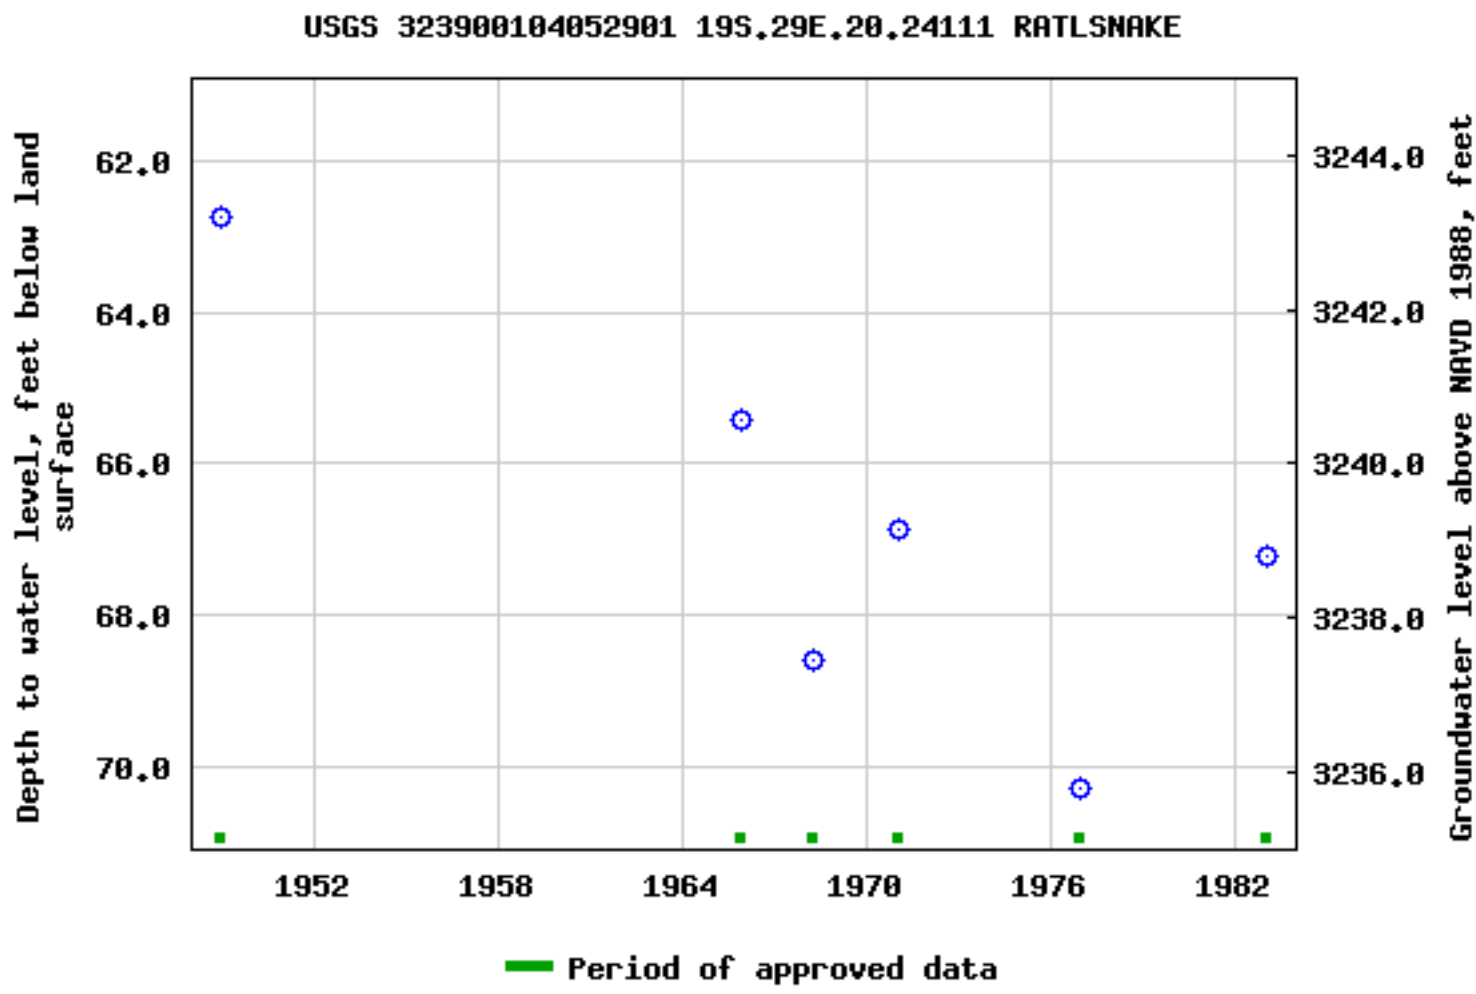
USGS 323900104052901 19S.29E.20.24111 RATLSNAKE

Eddy County, New Mexico
Hydrologic Unit Code 13060011
Latitude 32°39'00", Longitude 104°05'29" NAD27
Land-surface elevation 3,306 feet above NAVD88
This well is completed in the Rustler Formation (312RSLR) local aquifer.

Breaks in the plot represent a gap of at least one year between field measurements.
[Download a presentation-quality graph](#)

According to the New Mexico Office of the State Engineer, depth to the nearest groundwater in this area is 60 feet below grade surface (BGS). According to the United States Geological Survey (USGS), the nearest groundwater is 65 feet BGS. The closest waterway and is a Playa located approximately 4.57 miles to the southeast of this location. See Appendix A for the referenced Surface Water Map.

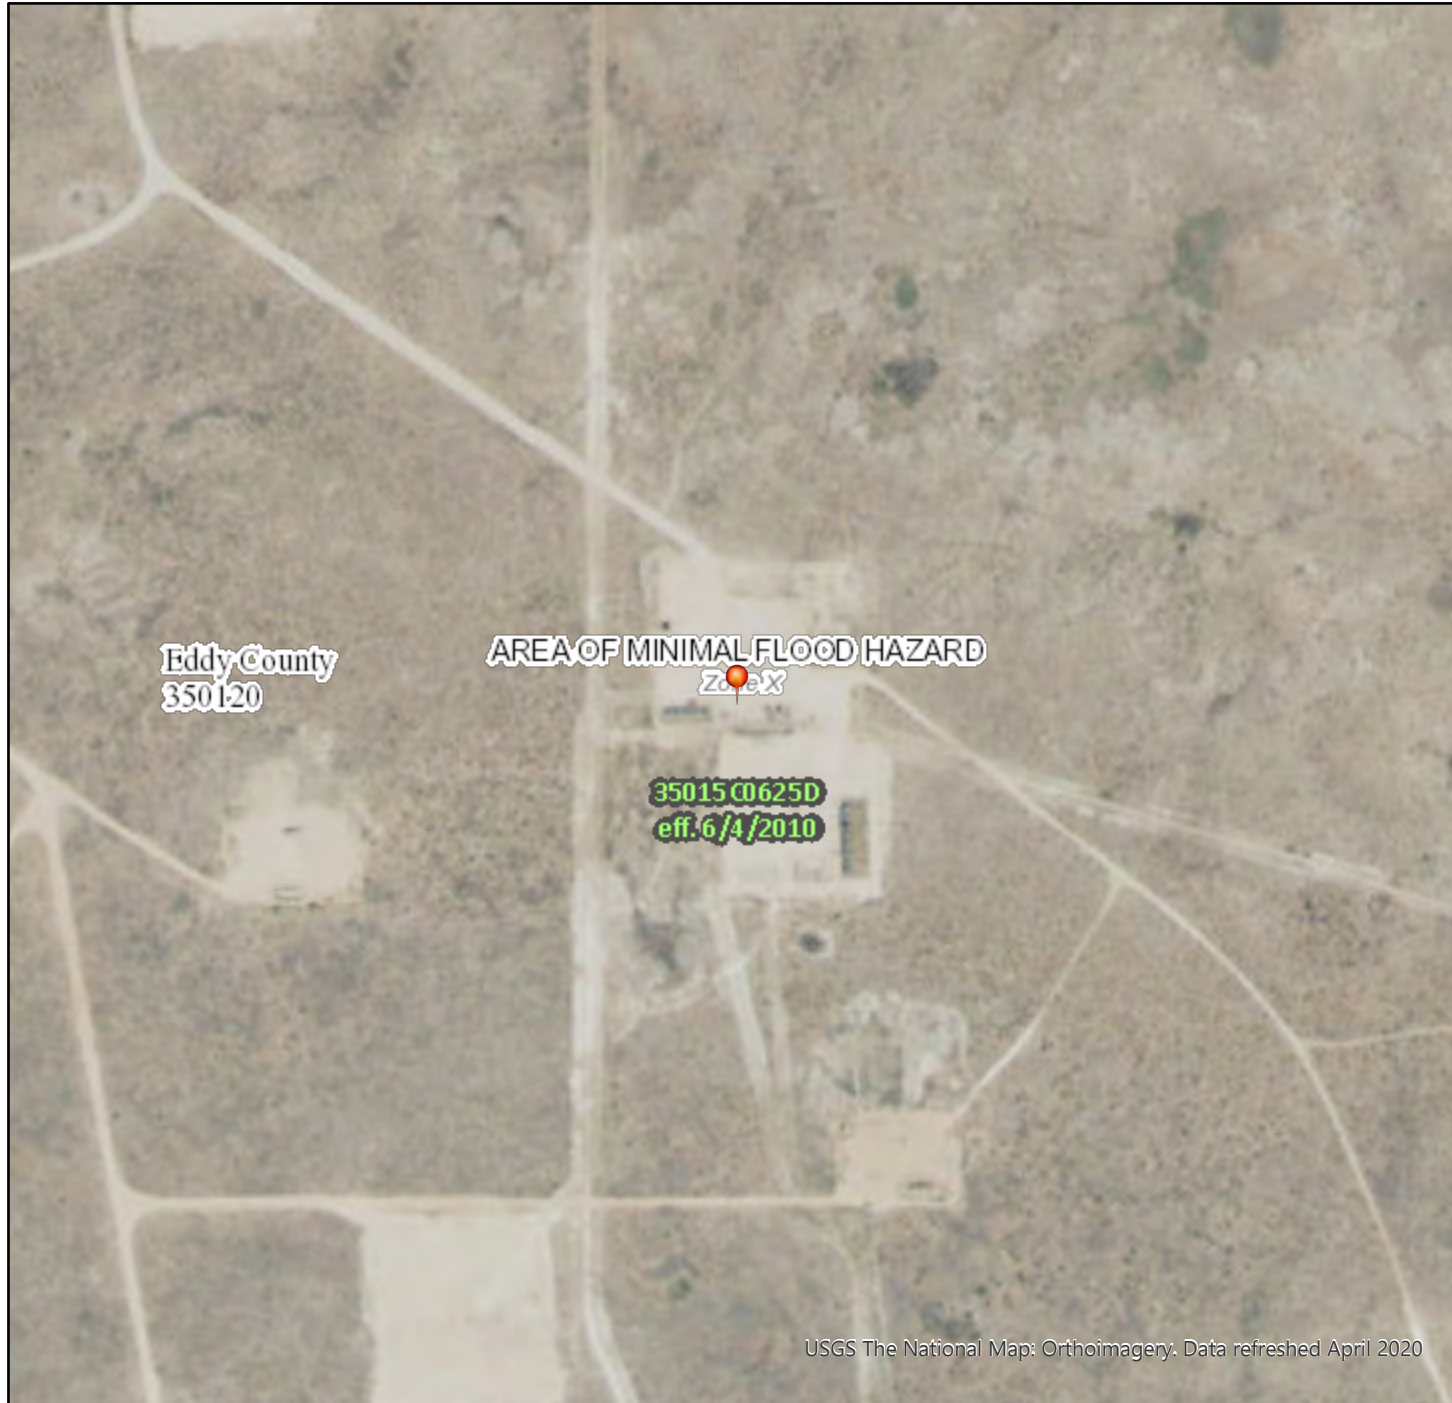
National Flood Hazard Layer FIRMette

The flood hazard information is derived directly from the authoritative NFHL web services provided by FEMA. This map was exported on **8/6/2020 at 12:24 PM** and does not reflect changes or amendments subsequent to this date and time. The NFHL and effective information may change or become superseded by new data over time.

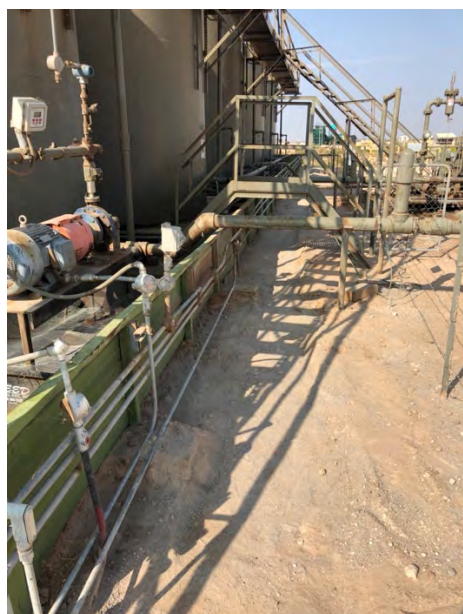
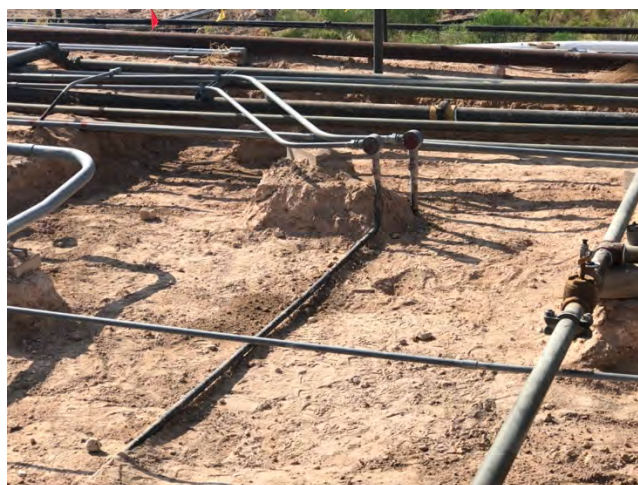
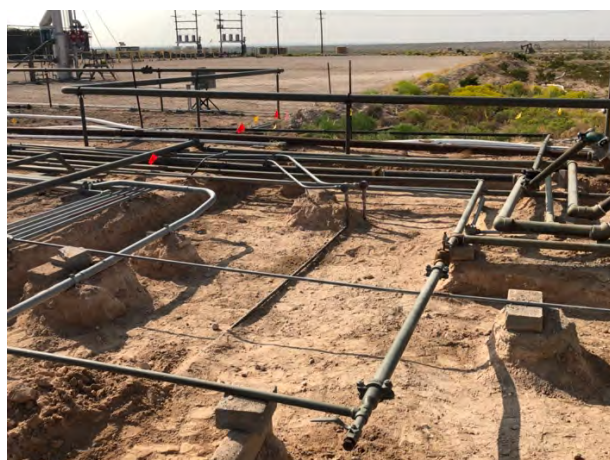
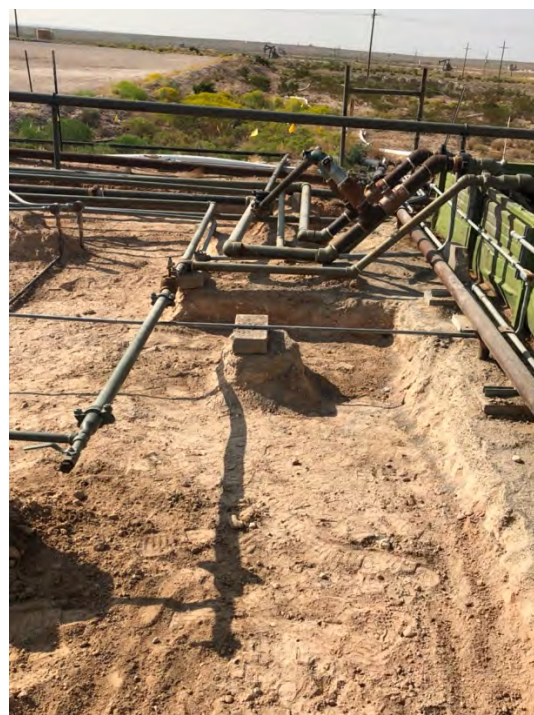
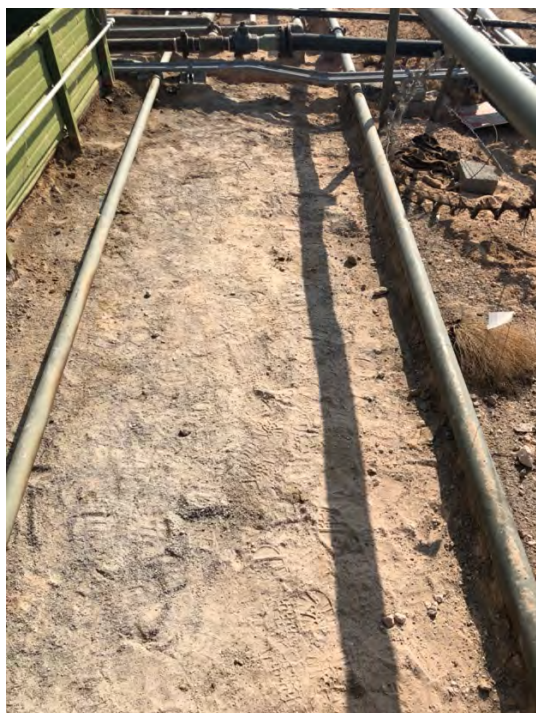
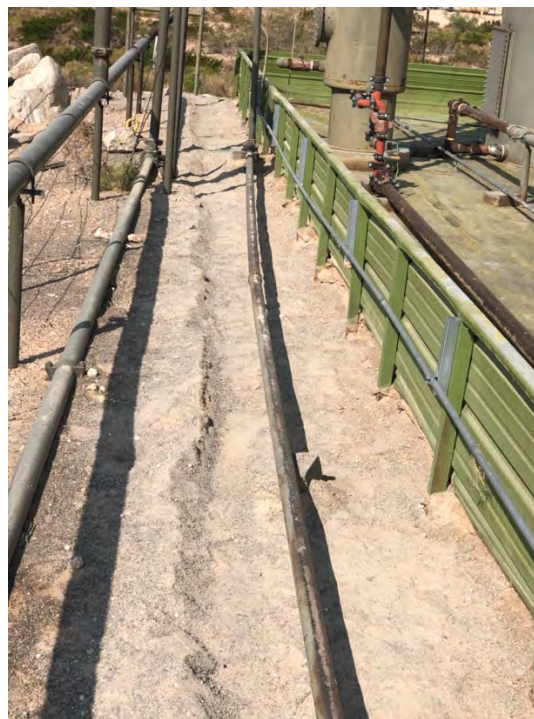
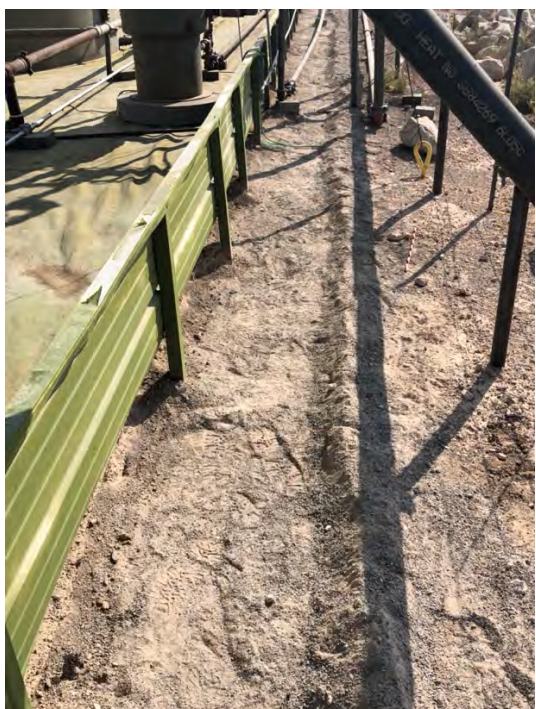
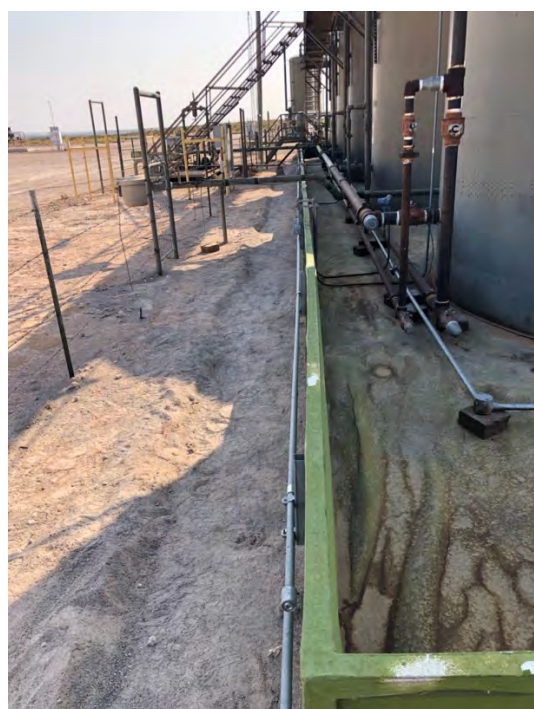
Photographic Documentation Excavation

On September 17, 2020, Pima mobilized personnel and equipment to conduct remedial activities. The area outside the containment was excavated to a depth of 0.5-foot below grade surface (BGS) and 3-feet horizontally away from the containment wall. Sidewall and bottom confirmation samples were obtained, and the laboratory results can be found in the following data table.

The final sample results were below NMOCD Closure Criteria 19.15.29 NMAC. Based on these findings, no further remediation activities were needed at this location. The excavation was backfilled with clean, like material, the area was then contoured to match the surrounding area.

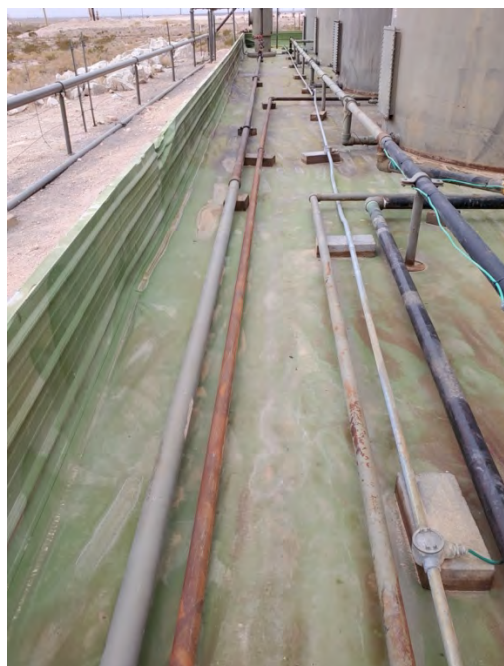
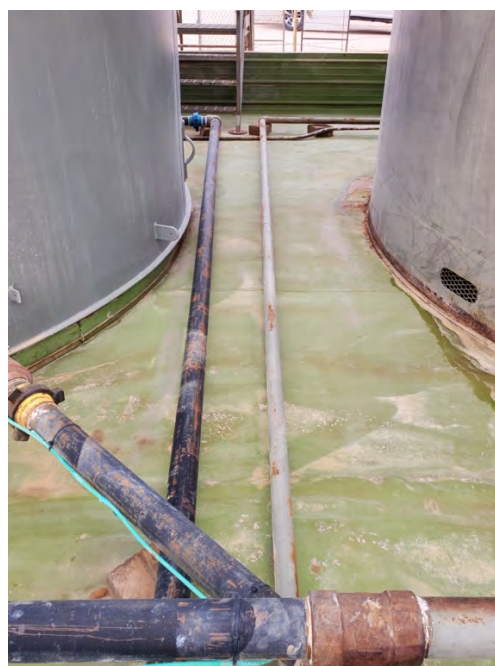
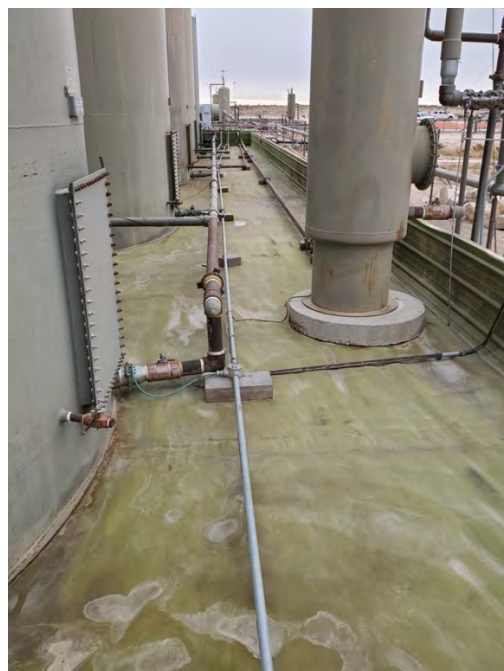
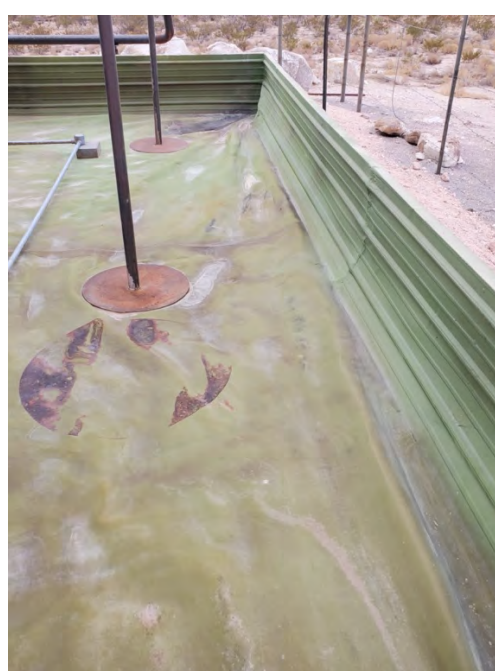
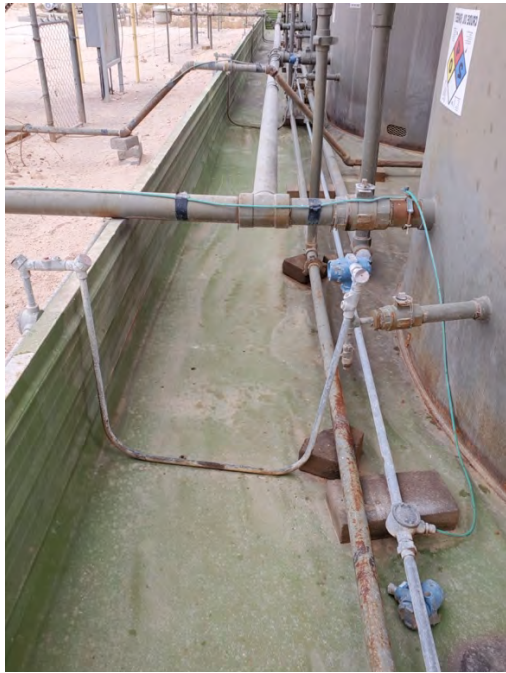
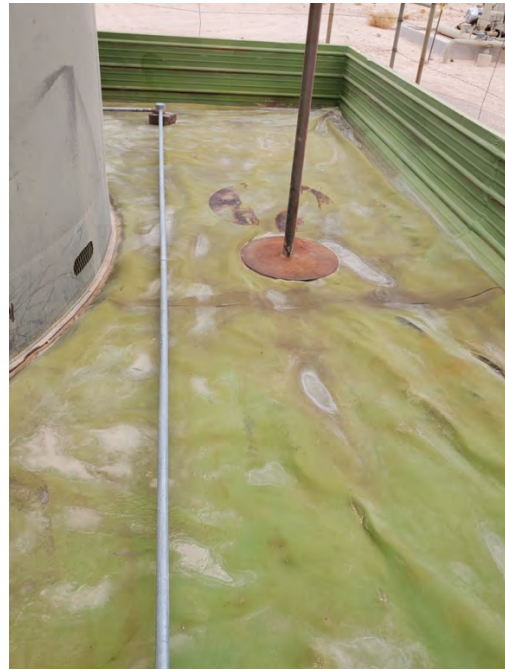
Liner Photos

On December 20, 2020, Pima returned to this site and conducted a liner inspection. The inspection found no loss of integrity in the liner. A liner inspection for and photos of the liner are attached in Appendix E.

Visualization	Yes	No	Comments
Is there a tear in the liner?		x	
Are there holes in the liner?		x	
Is the liner retaining any fluids?		x	
Does the liner have integrity to contain a leak?		x
