RE: Remediation and Closure Report – East Pecos Federal Com 22 #0006H  
API # 30-015-42281  
NMOCD Remediation Case # 2RP-4577

## **Remediation and Closure Report**

East Pecos Federal Com 22 #006H  
API # 30-015-42281 \* 2RP-4577  
Talon Project No. 702331.001.01

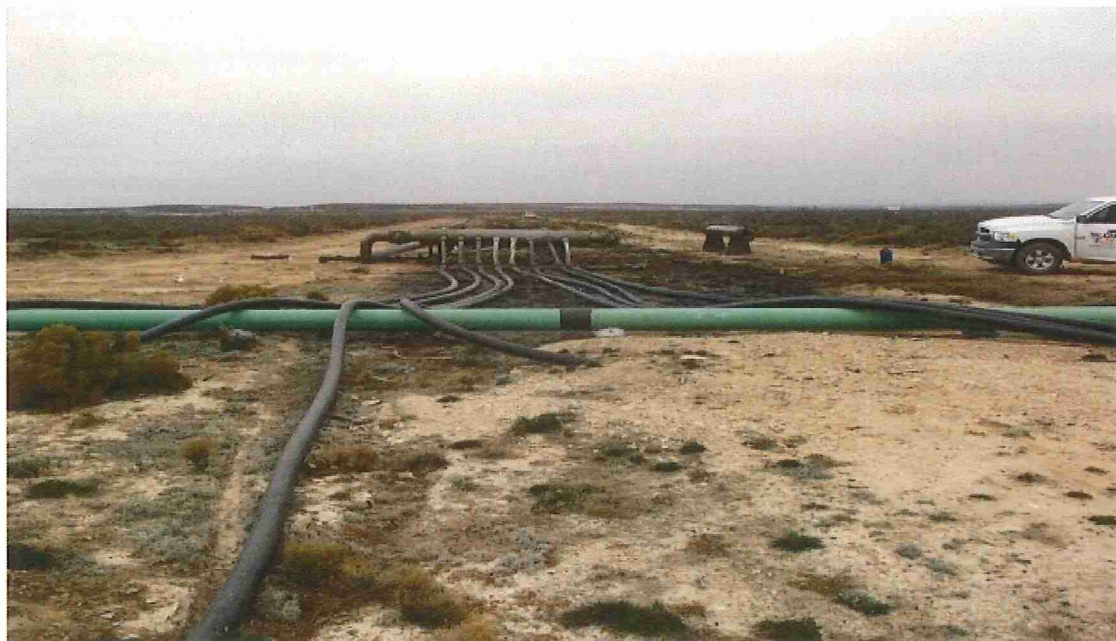
Release Point facing southward

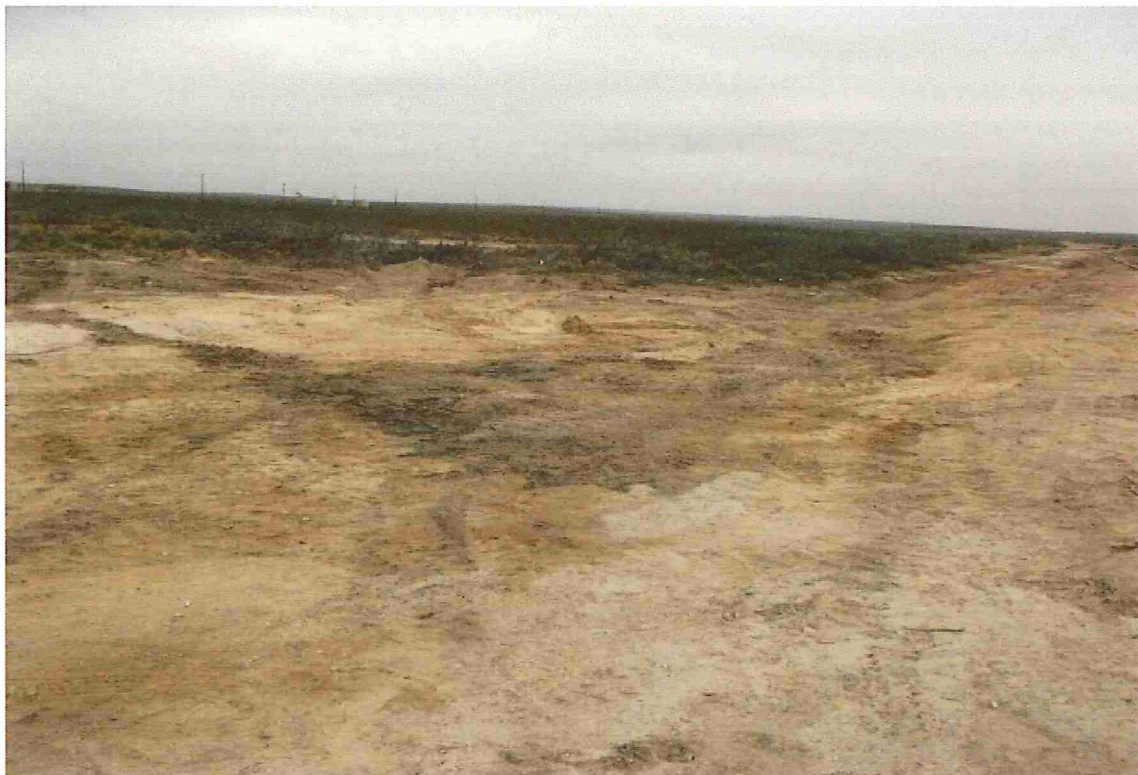
Flow path westward view

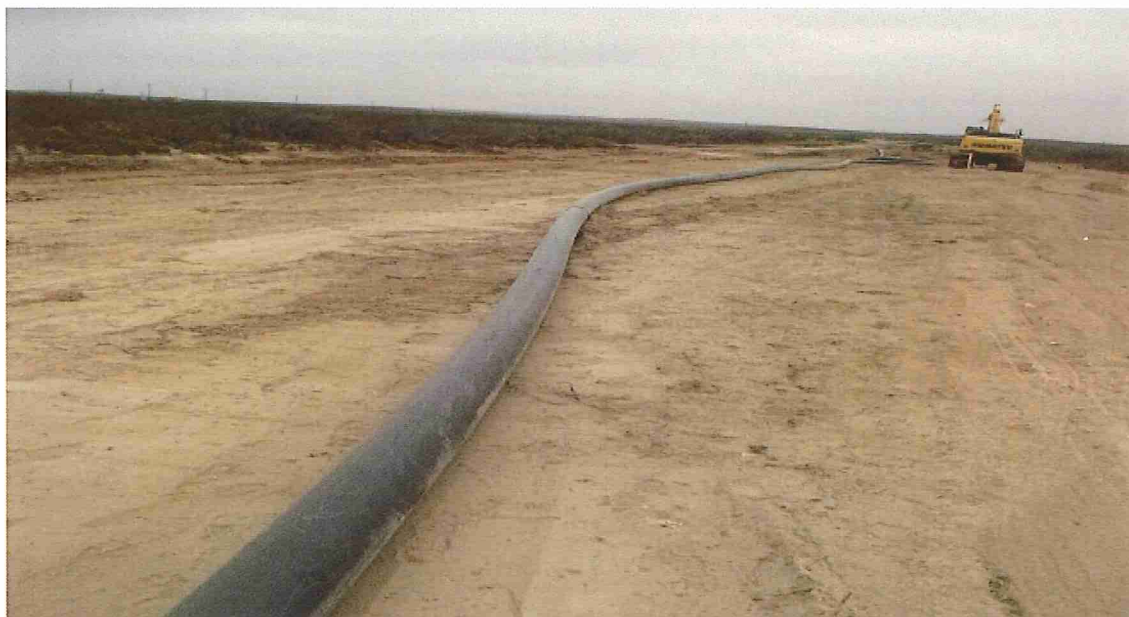
Flow path westward view
