**RE: Termination Request**

**Rice Operating Company – BD SWD System**

**BD P-17 vent (1R426-132): UL/P, Sec. 17, T21S, R37E**

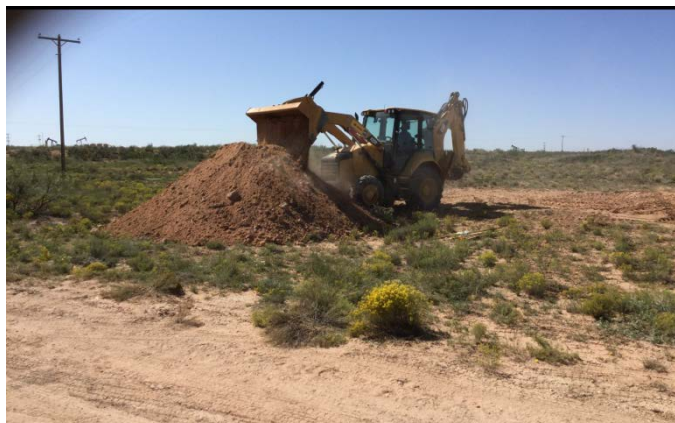
Began excavating, facing southeast 10/16/2019

In order to inhibit the downward migration of residual constituents through the vadose zone, ROC excavated a 57x32-ft area to a depth of 4.5 ft bgs. A representative composite sample was collected from the 4-walls and was analyzed by a commercial laboratory for chloride and hydrocarbon. The composite sample resulted in a chloride concentration of 336 mg/kg, GRO/DRO/EXT-DRO concentrations below detectable limit, and BTEX concentrations below detectable limit. A total of 348 cubic yards of excavated soil were taken to a NMOCD approved facility for disposal. Four representative samples were collected from the remaining excavated soil, resulting in a chloride concentration of 144 mg/kg, 160 mg/kg, 112 mg/kg, and 112 mg/kg.

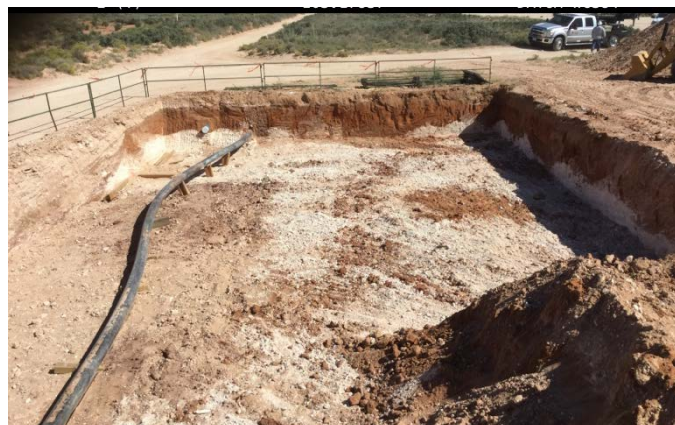
Exposing 8" poly line, facing east 10/21/2019

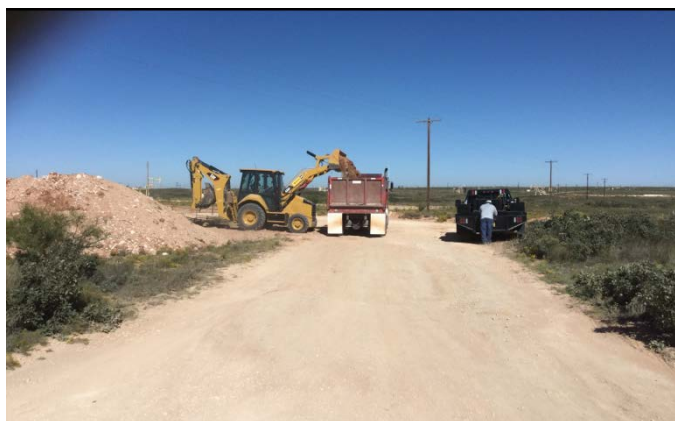
Exporting excavated soil, facing northwest 10/22/2019

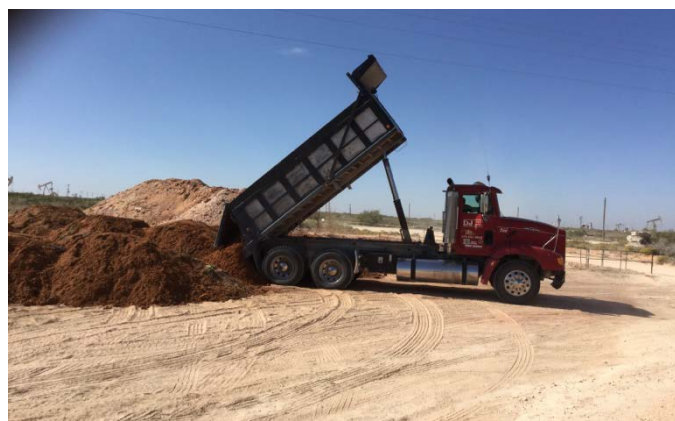
Importing blowsand, facing west 10/28/2019

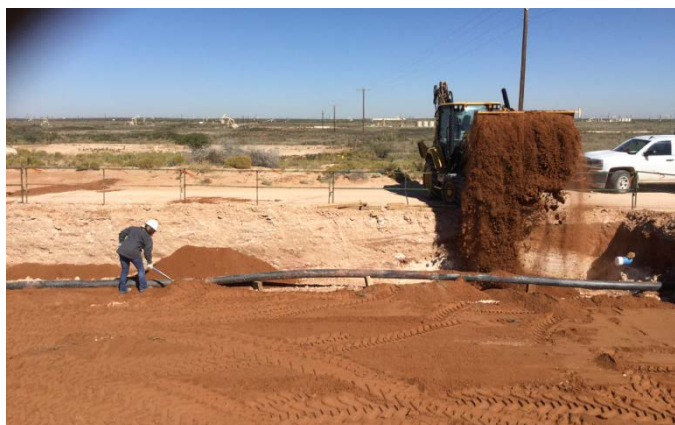
Padding excavation, facing north 10/31/2019

Hydrocarbon concentrations, GRO/DRO/EXT-DRO and BTEX, were below detectable limits in each sample. The top of the liner was padded with imported soil, and the excavation was backfilled to ground surface and contoured to the surrounding area with the clean, excavated soil. A sample of the imported soil was analyzed by a commercial laboratory for chloride resulting in a concentration of 16 mg/kg. The backfilled site was seeded with a blend of native vegetation. Vegetation above the liner will also provide a natural infiltration barrier for the site, since plants capture water through their roots thereby reducing the volume of water moving through the vadose zone.

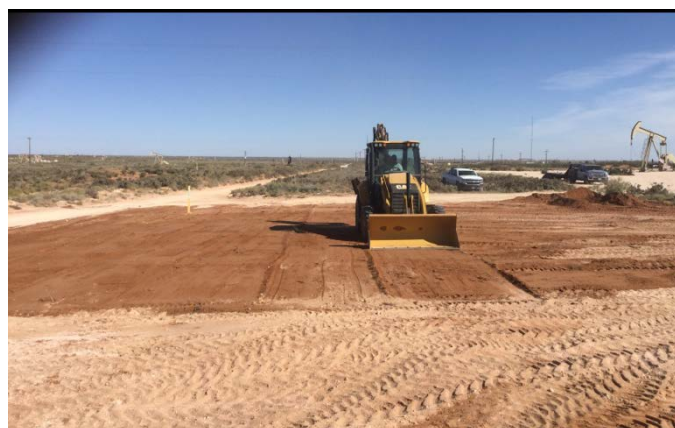
Backfill complete, facing east 11/4/2019

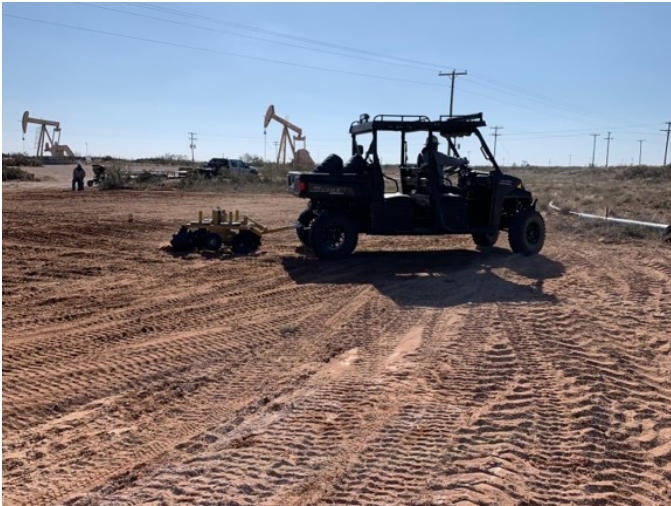
Tilling, facing southeast

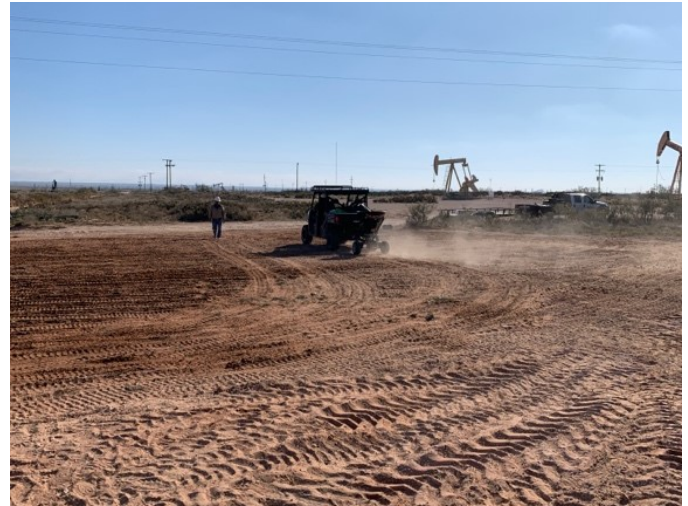
Seeding, facing east

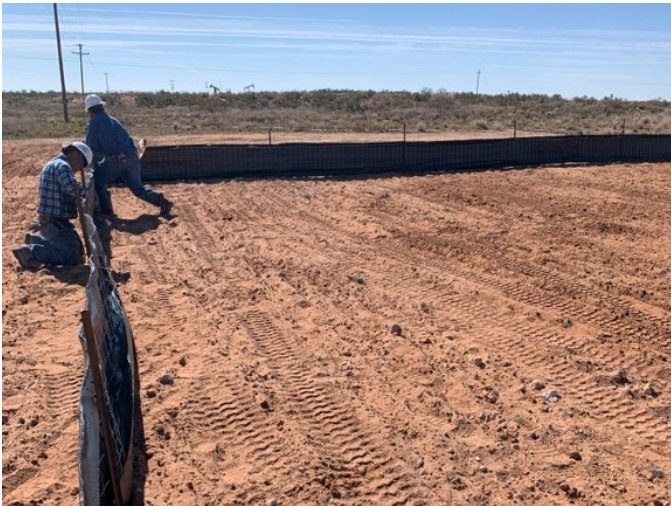
Installing silt net fencing, facing southwest

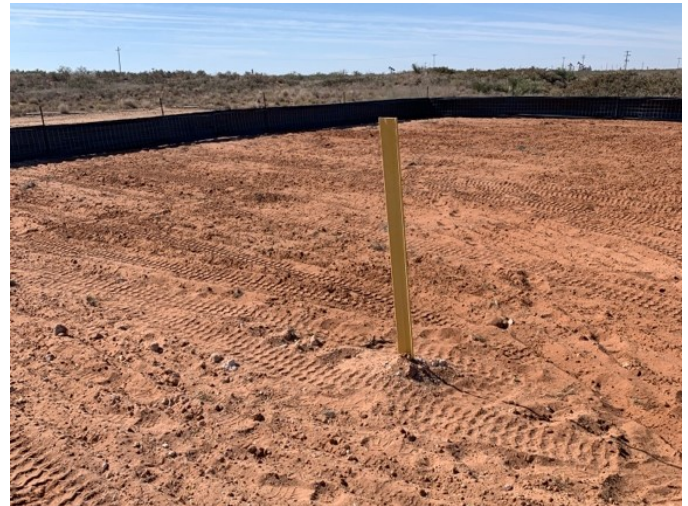
Site complete, facing southwest
