**RE: LINER INSPECTION REPORT  
BELL LAKE 19 CTB 3 (NAPP2104135238)**

Devon Energy  
Bell Lake 19 CTB 3 (NAPP2104135238)

# **Appendix A LINER INSPECTION FORM, FIELD NOTES & PHOTO LOG**

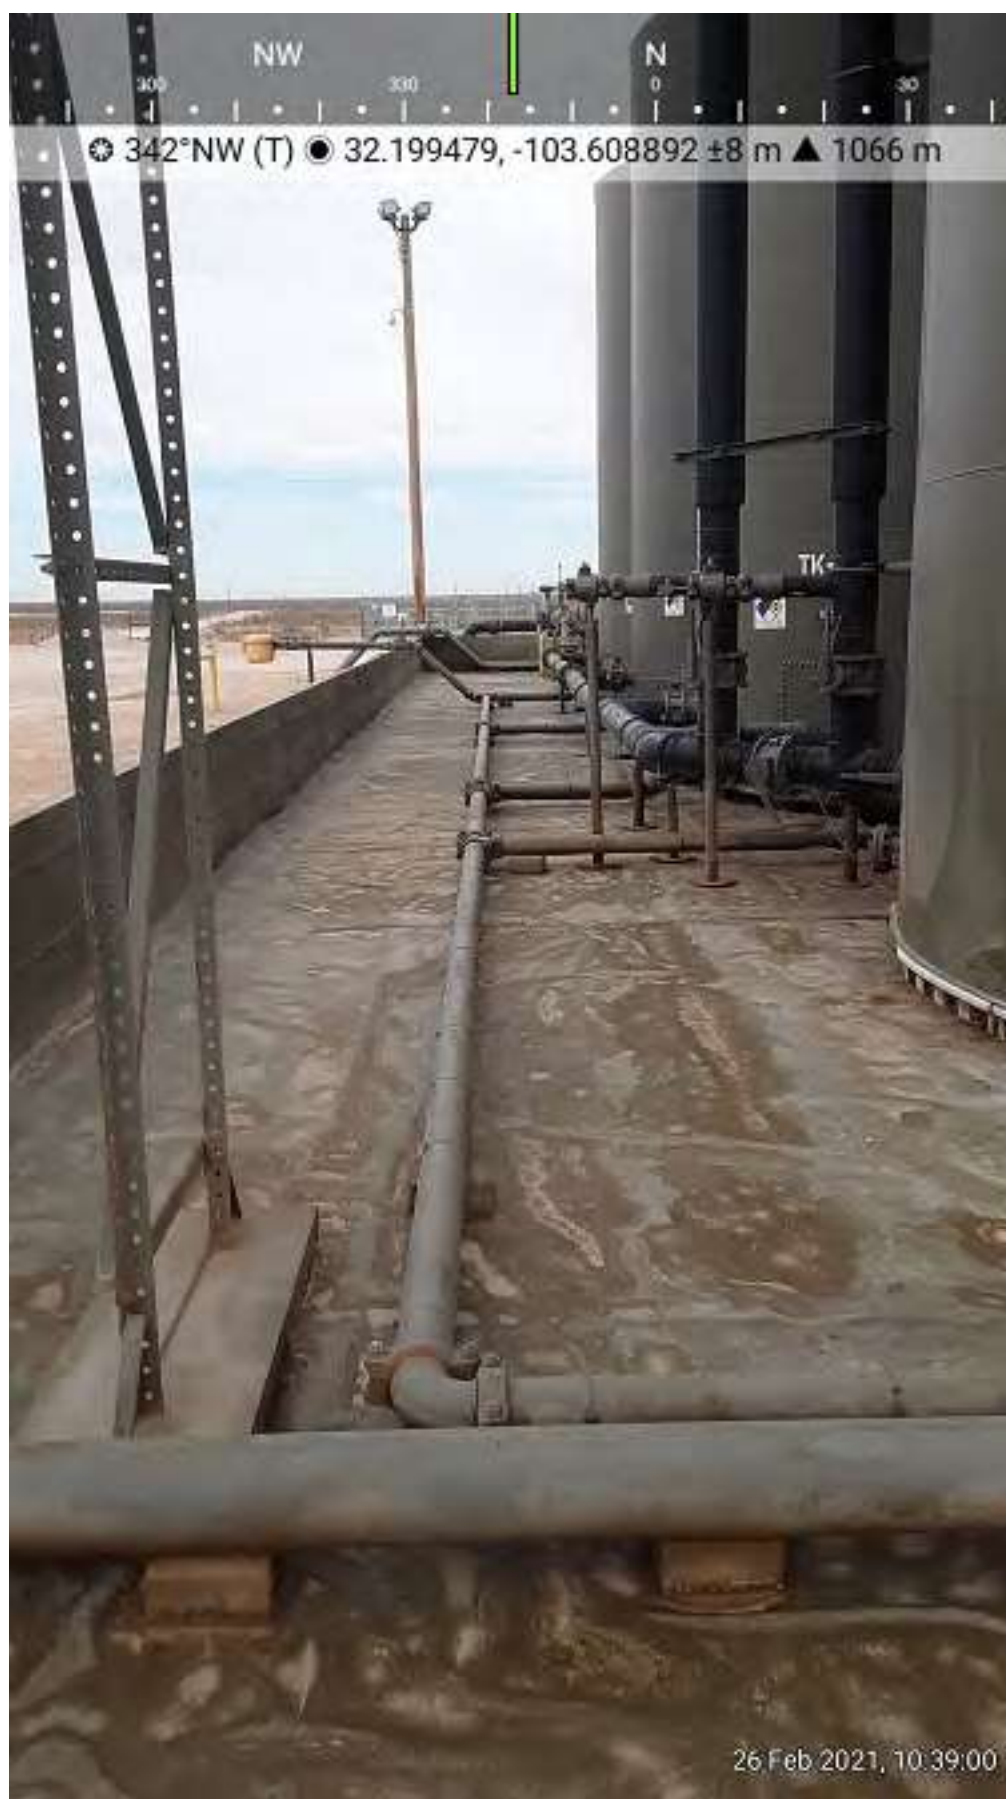
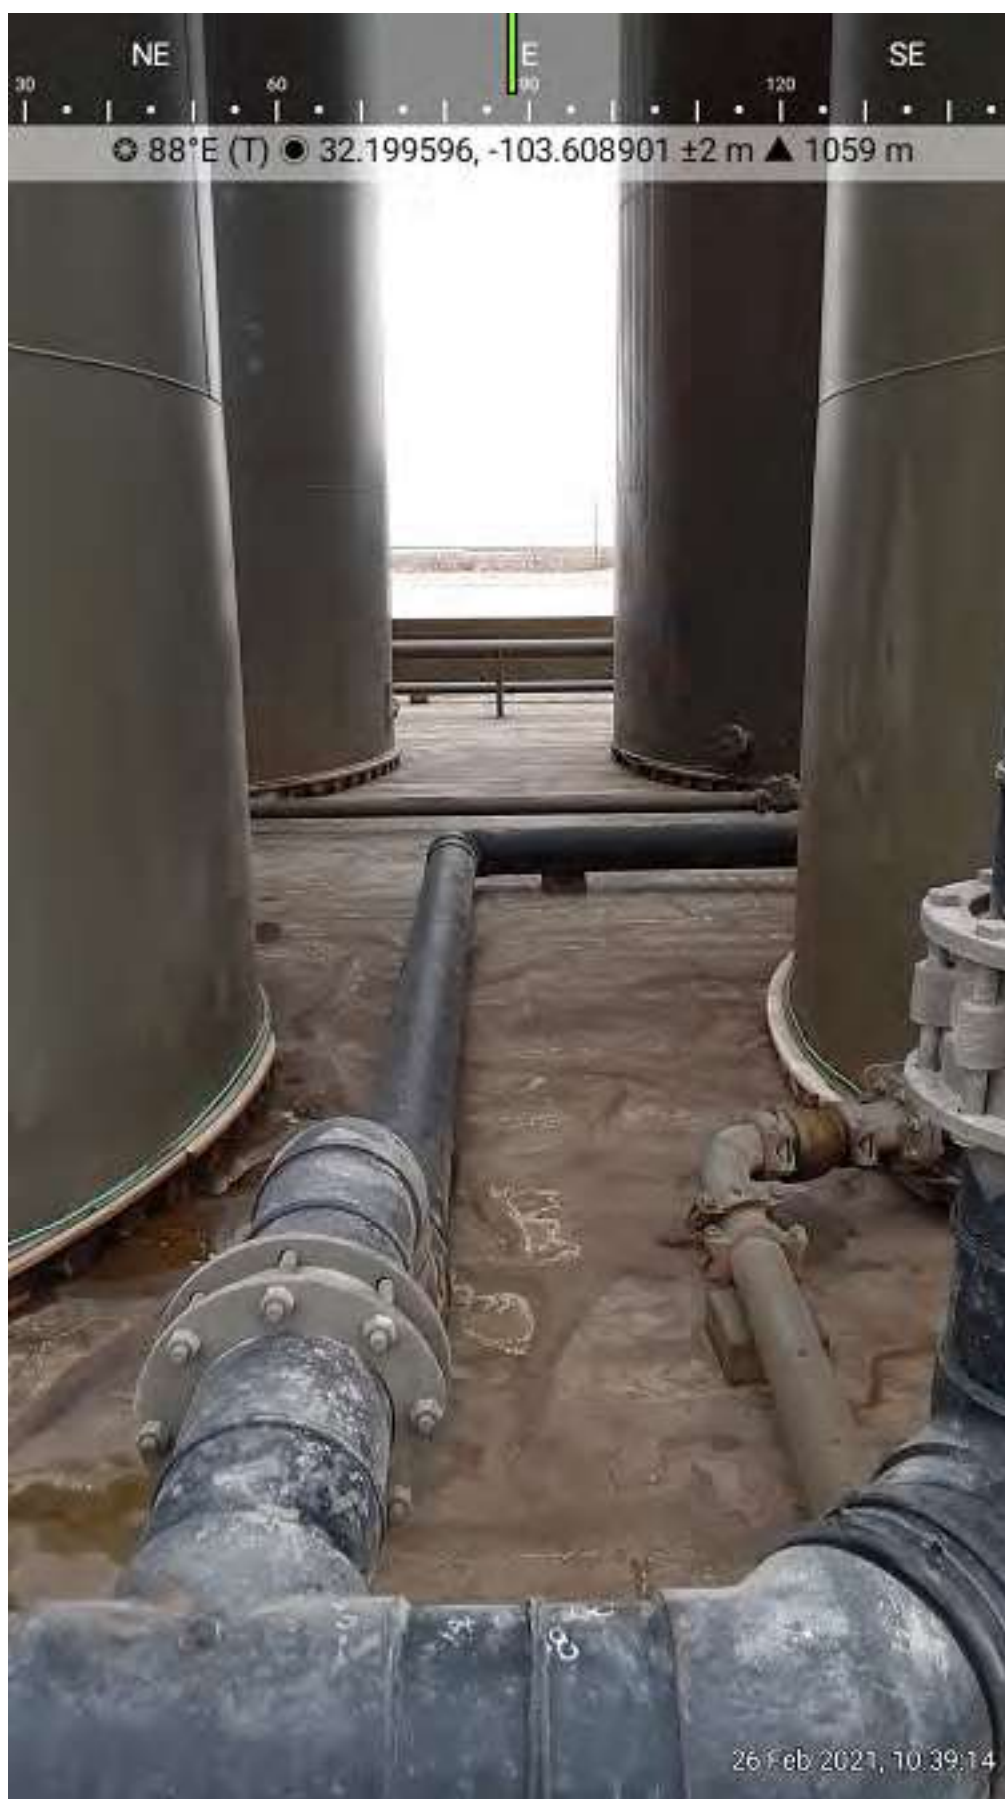
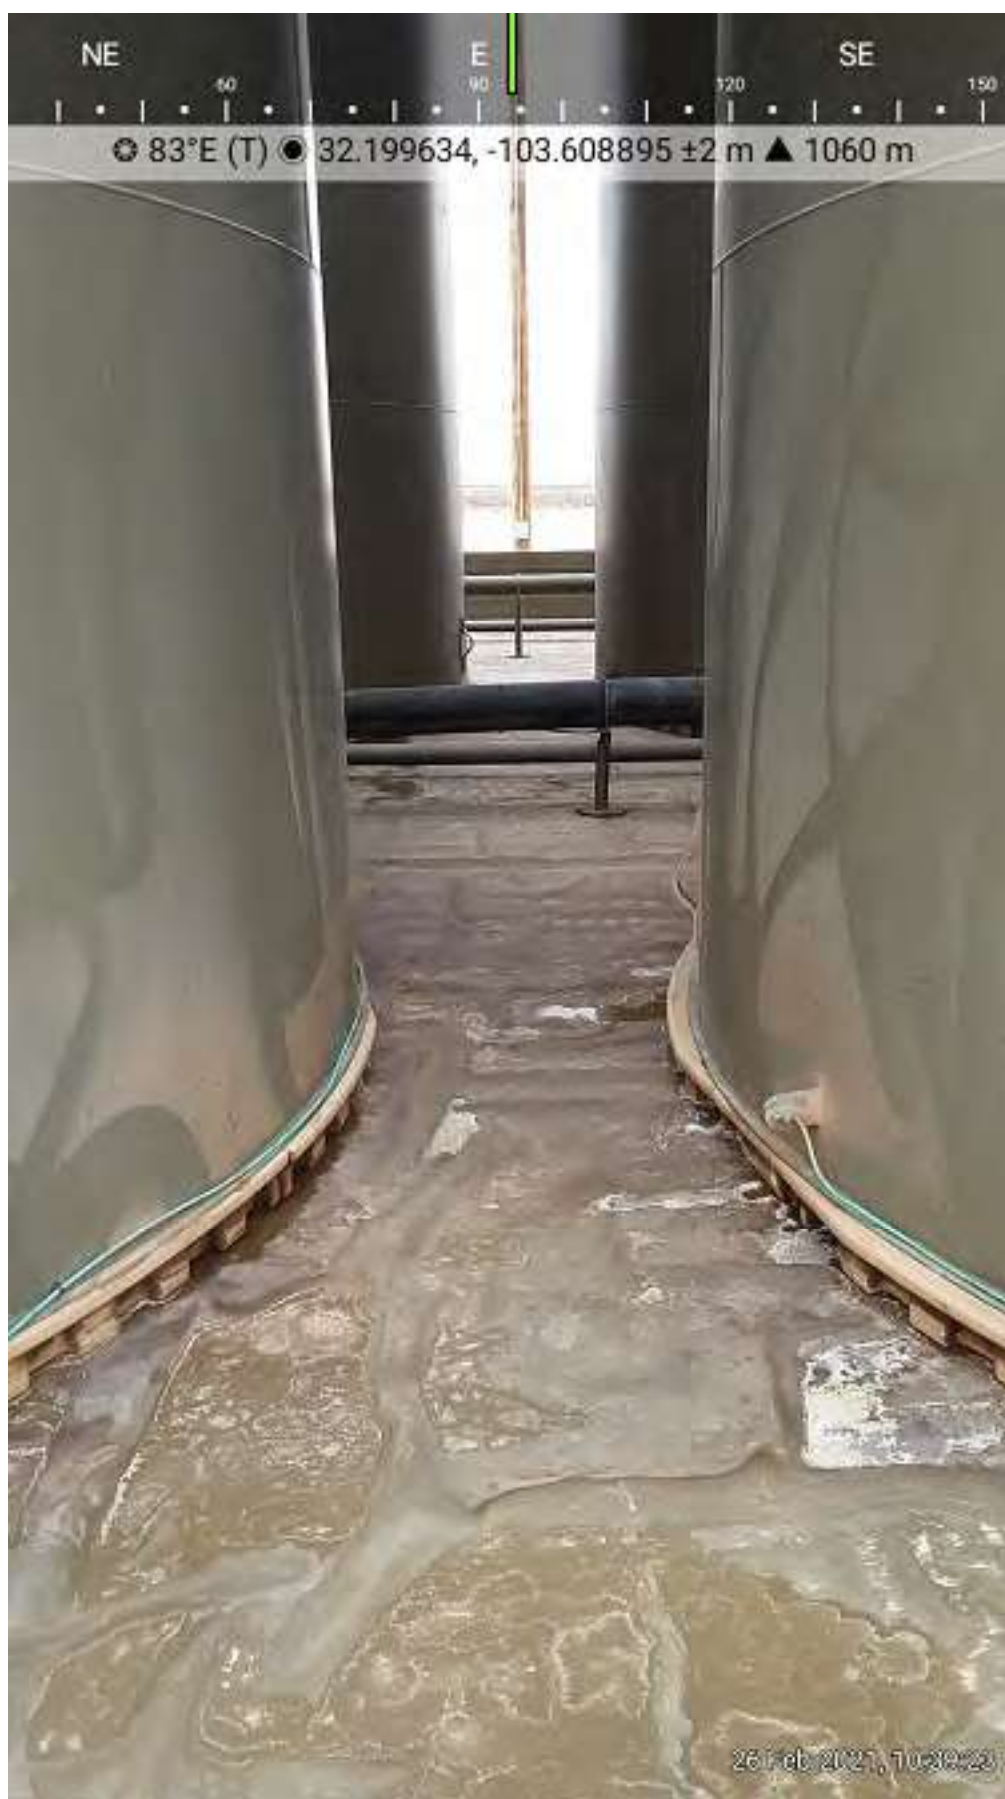
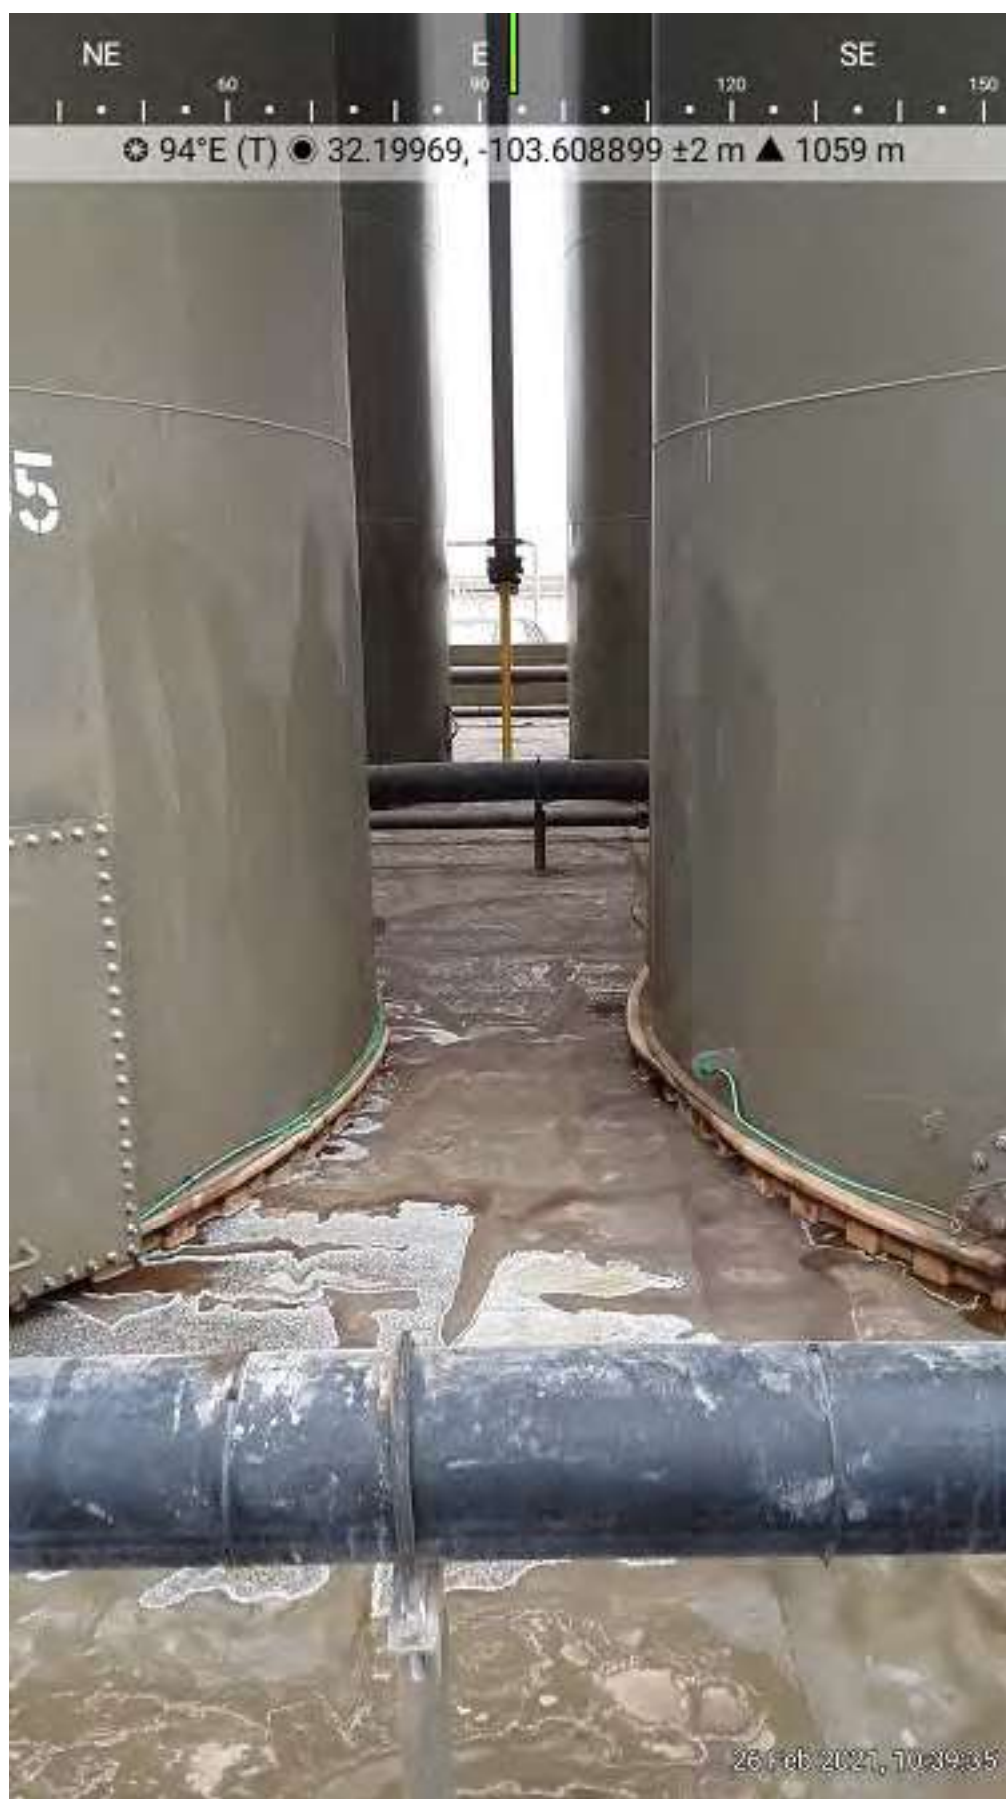
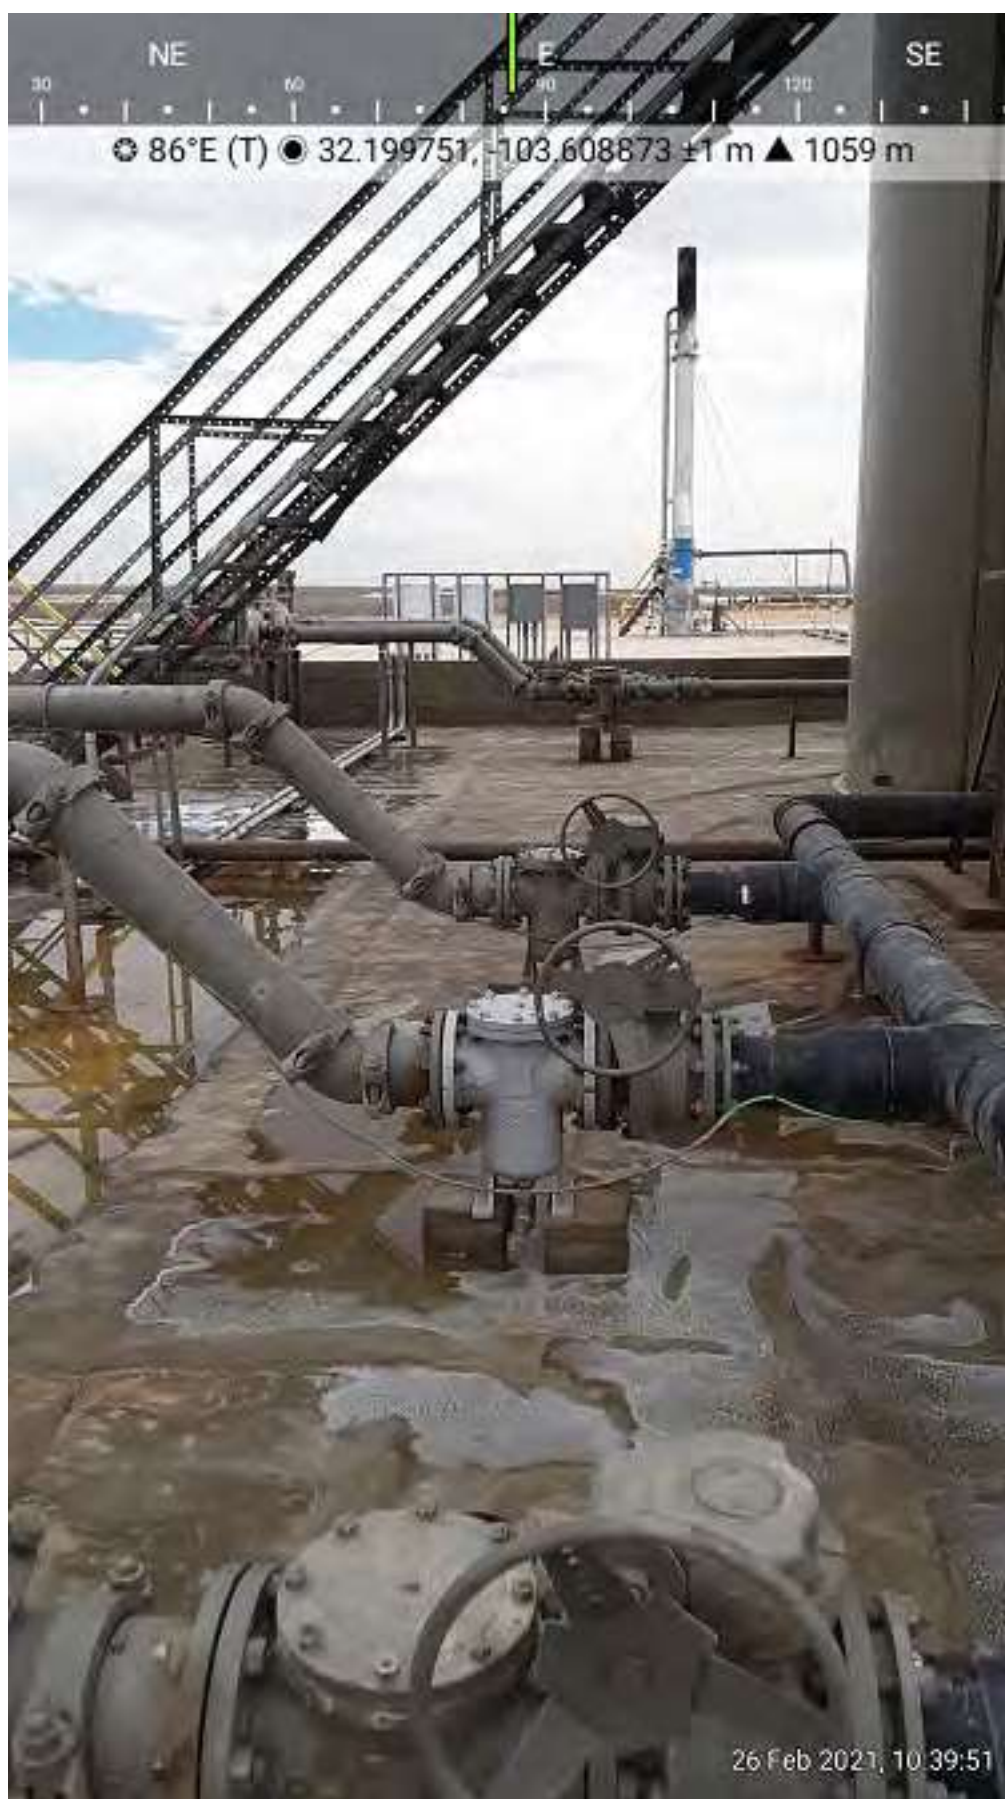
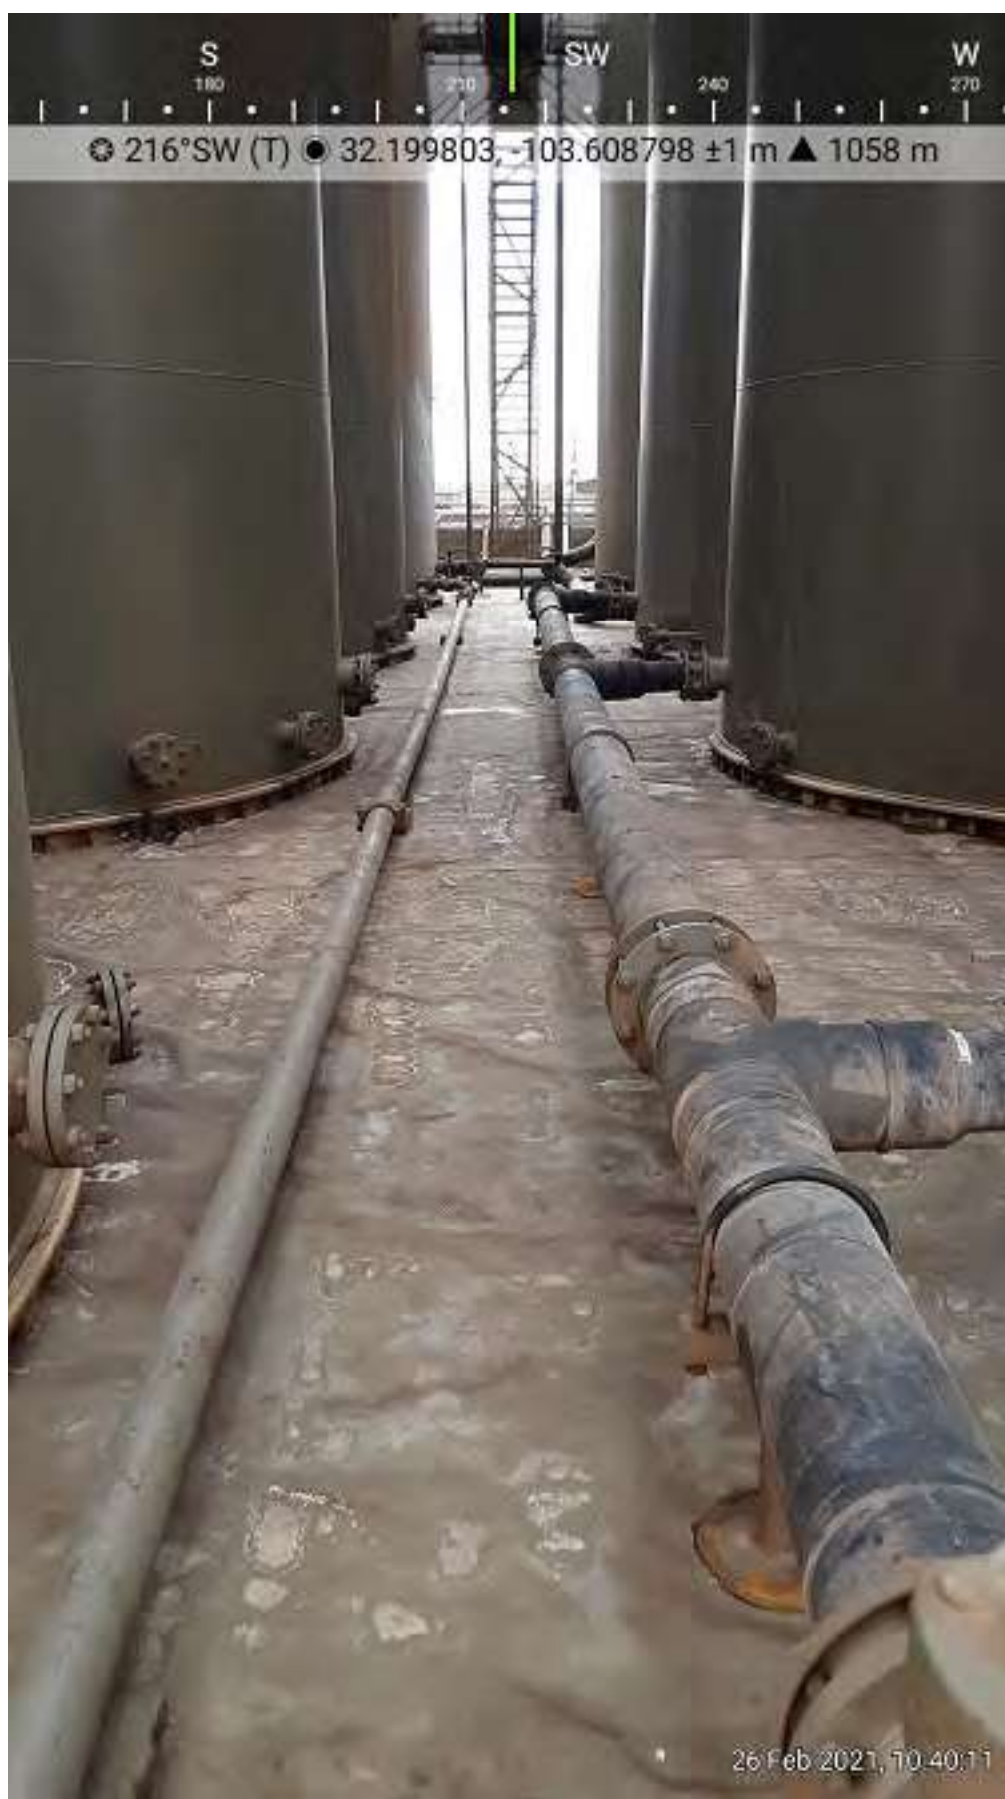
that the release did not occur outside of the lined containment. A photo log and field notes of the inspection is included in Appendix A.

- o Walked to POR and examined it release was fully contained
- o Release did stay in Containment
- o Searched for tears and other potential compromises throughout containment
  - No failures
  - Liner remained intact
  - Verified that outside of containment was not compromised.
- o Took photographs of Containment with GPS coordinates + date/time.
- o Mapped Containment + Photograph location sites.
- o Left Site.

SMA recommends no further action for this release and requests the closure of NAPP2104135238.
