Release Notification

Site Name	PLU Big Sinks 23	Site Type	CTB
Date Release Discovered	11-19-20	API#	(if applicable)

**RE: Closure Request
PLU Big Sinks 23
Incident Number NRM2034929754
Eddy County, New Mexico**

FIGURE 2
DELINEATION SOIL SAMPLE LOCATIONS
PLU BIG SINKS 23
UNIT A SEC 23 T24S R30E
EDDY COUNTY, NEW MEXICO
XTO ENERGY, INC.

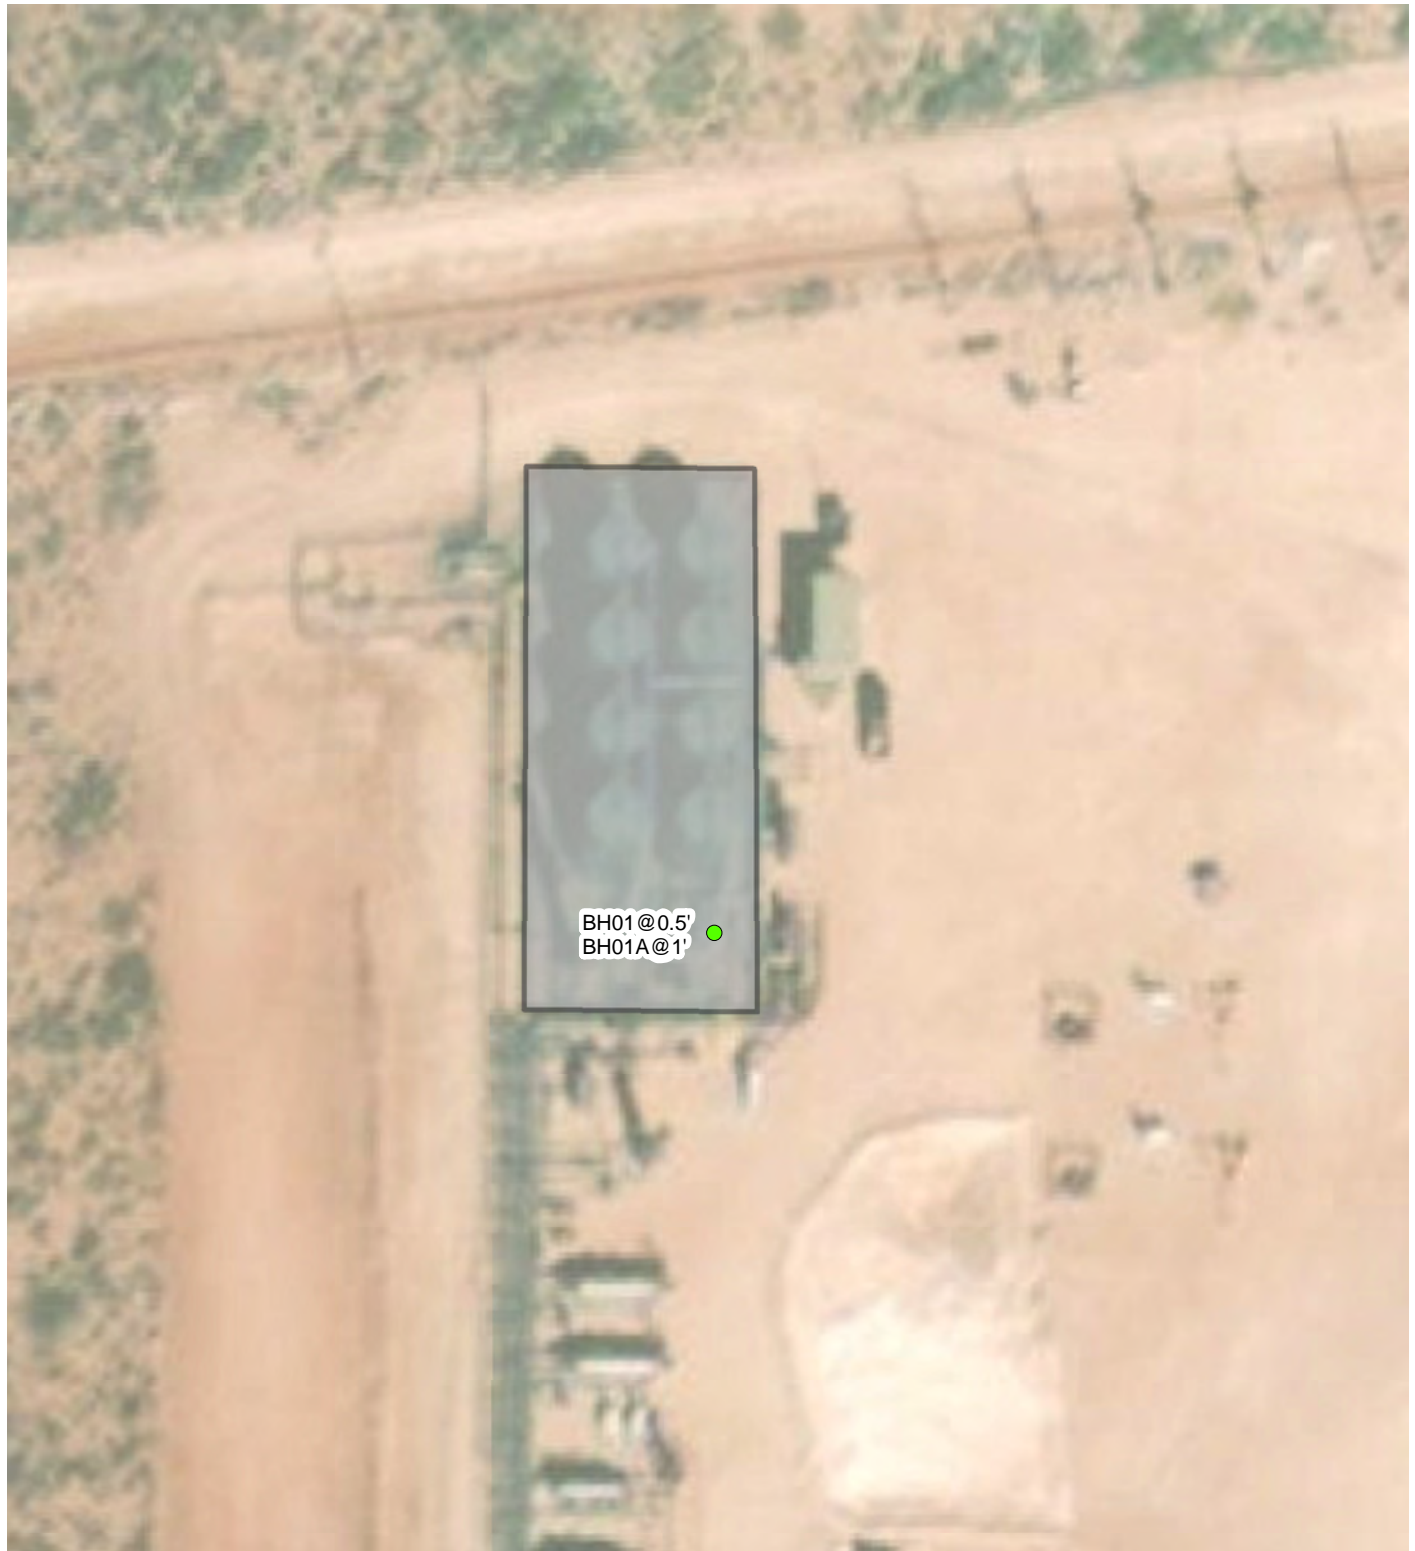
On December 30, 2020, WSP personnel visited the Site to evaluate the release extent based on information provided on the Form C-141 and visual observations. WSP personnel advanced one borehole (BH01) via hand-auger within the breached area identified by XTO during the liner inspection. Two soil samples were collected from borehole BH01 at depths of approximately 0.5 feet and 1-foot bgs. Soil from the borehole was field screened for volatile aromatic hydrocarbons

Following the failed liner integrity inspection at the Site, WSP personnel advanced one borehole (BH01) at the location of the tear in the liner to assess for the presence or absence of soil impacts resulting from the November 19, 2020 produced water release within lined containment. Two delineation soil samples were collected from borehole BH01 at depths of approximately 0.5 feet and 1-foot bgs. Laboratory analytical results for the delineation soil samples indicated that benzene, BTEX, TPH-GRO/TPH-DRO, TPH, and chloride concentrations were compliant with the Closure Criteria. Additionally, delineation soil sample BH01A vertically delineated the release to below the most stringent Closure Criteria. The release was contained laterally by the lined containment and all released fluids were recovered during initial response activities. The tear in the liner was subsequently repaired.

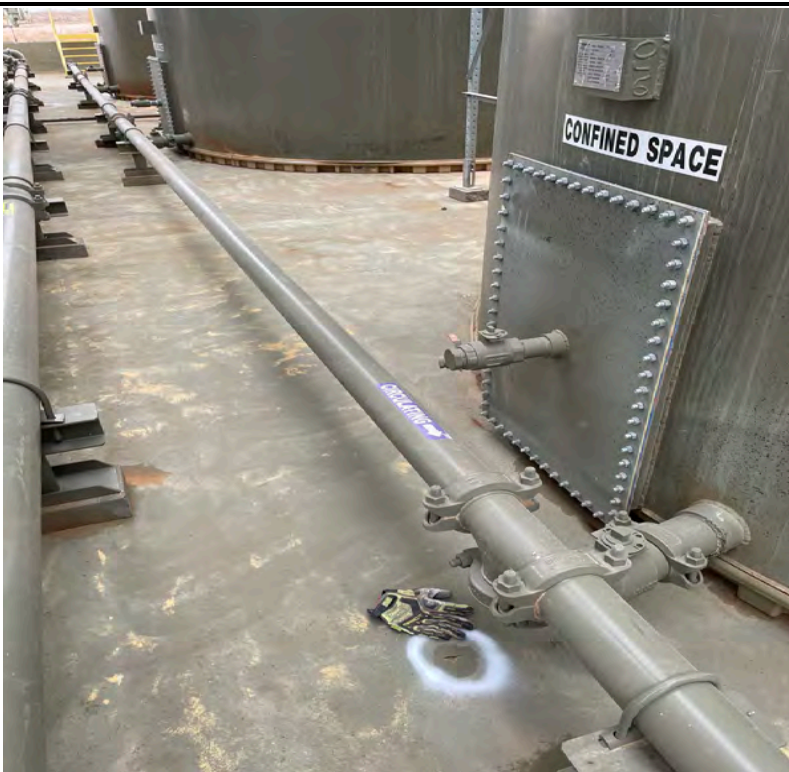
Photo No.	Date	
1	December 30, 2020	
Location of tear in liner and proposed borehole location.

A photograph showing a long, horizontal metal pipe in an industrial setting. A yellow and black impact glove is placed on the ground next to a circular mark on the pipe, indicating the location of a tear in the liner and the proposed borehole location. A 'CONFINED SPACE' warning sign is visible on the wall in the background.

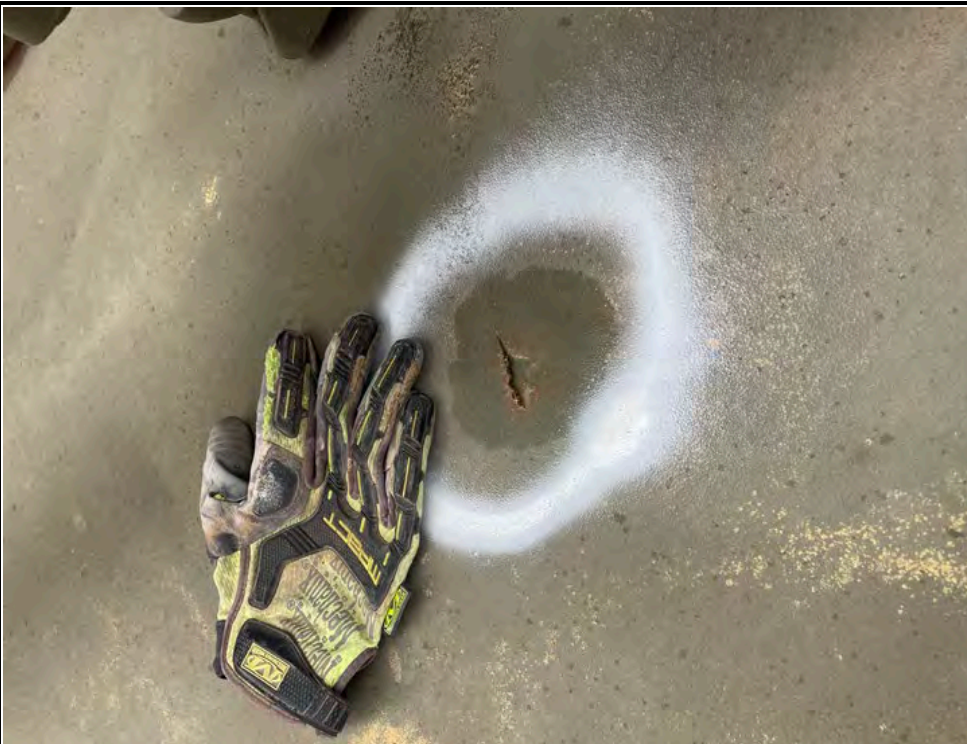
Photo No.	Date	
2	December 30, 2020	
Size of tear in liner, compared to impact gloves

A close-up photograph of a yellow and black impact glove placed next to a circular mark on a metal surface. The mark contains a small, dark, irregular tear in the liner, which is being compared to the size of the glove for scale.
