RE: 1 RP-3381 WBDU 211

**1RP-3381
CLOSURE REPORT
WBDU 211
Brine Water Release
Lea County, New Mexico**

LAI Project No. 19-0112-50

August 30, 2019

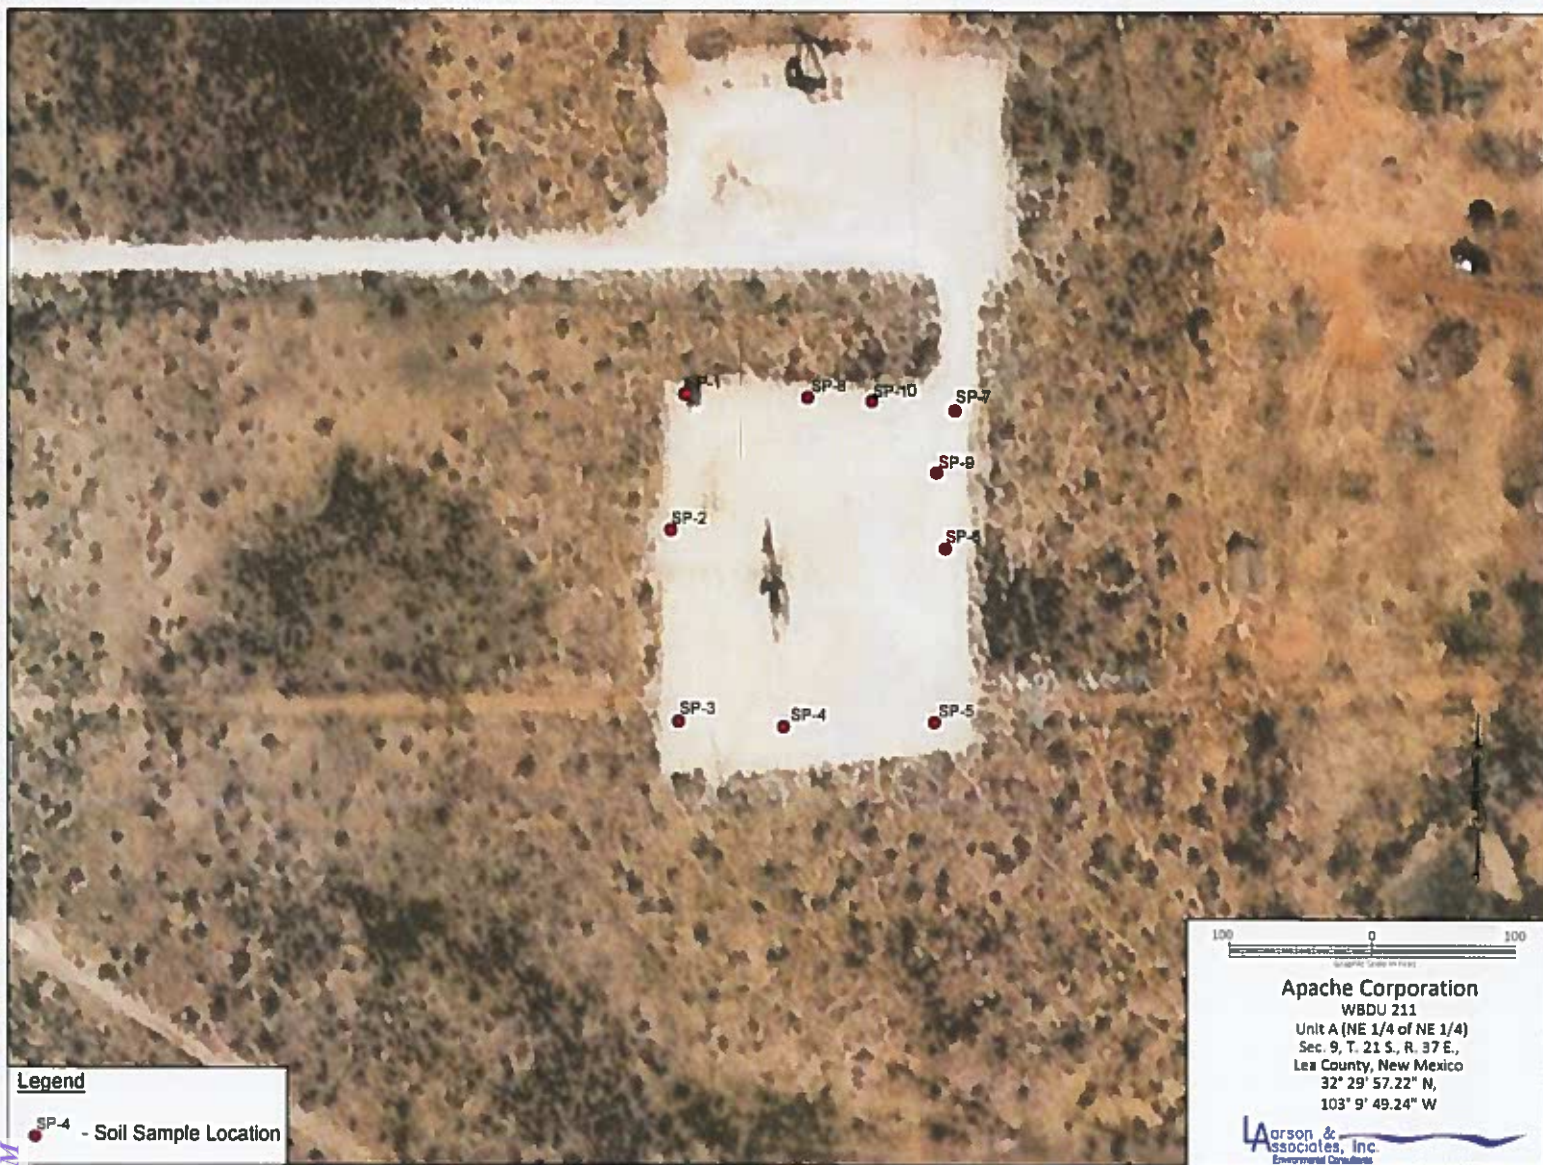
Figure 2 - Aerial Map

On August 5, 2019, Apache personnel used a shovel to collect soil samples at surface and 1 foot below ground surface (bgs). Ten sample locations were evenly spaced within the spill area and labelled SP1

through SP10. Samples were delivered to Cardinal Laboratories in Hobbs, New Mexico, and analyzed for benzene, toluene, ethylbenzene and xylenes (BTEX) by EPA SW-846 Method 8021B, total petroleum hydrocarbons (TPH), including gasoline range organics (C6-C12), diesel range organics (>C12-C28) and oil range organics (>C28-C35) by EPA SW-846 Method 8015M, and chloride by titration method SM4500CL-B. The laboratory reported BTEX, TPH, and chloride below the remediation action levels of 50 mg/Kg, 2,500 mg/Kg, and 10,000 mg/Kg, respectively. Figure 2 presents the soil sampling locations. Appendix B presents the laboratory report. Appendix C presents the site photographs.

Confirmation soil sample concentrations are all below remediation action levels for BTEX, TPH, and chloride therefore, Apache respectfully requests closure for 1RP-3381.
