Release Notification

Site Name PLU Pierce Canyon 28 DTB	Site Type Well Location
Date Release Discovered 11/13/2019	API# (if applicable) 30-015-36830 (PLU CVX JV PC #003H)

**Re: Closure and Deferral Request
Poker Lake Unit Pierce Canyon 28
Incident Numbers/Remediation Permit Number: NRM1931858285 (2RP-5697) and
NCE2002742193
Eddy County, New Mexico**

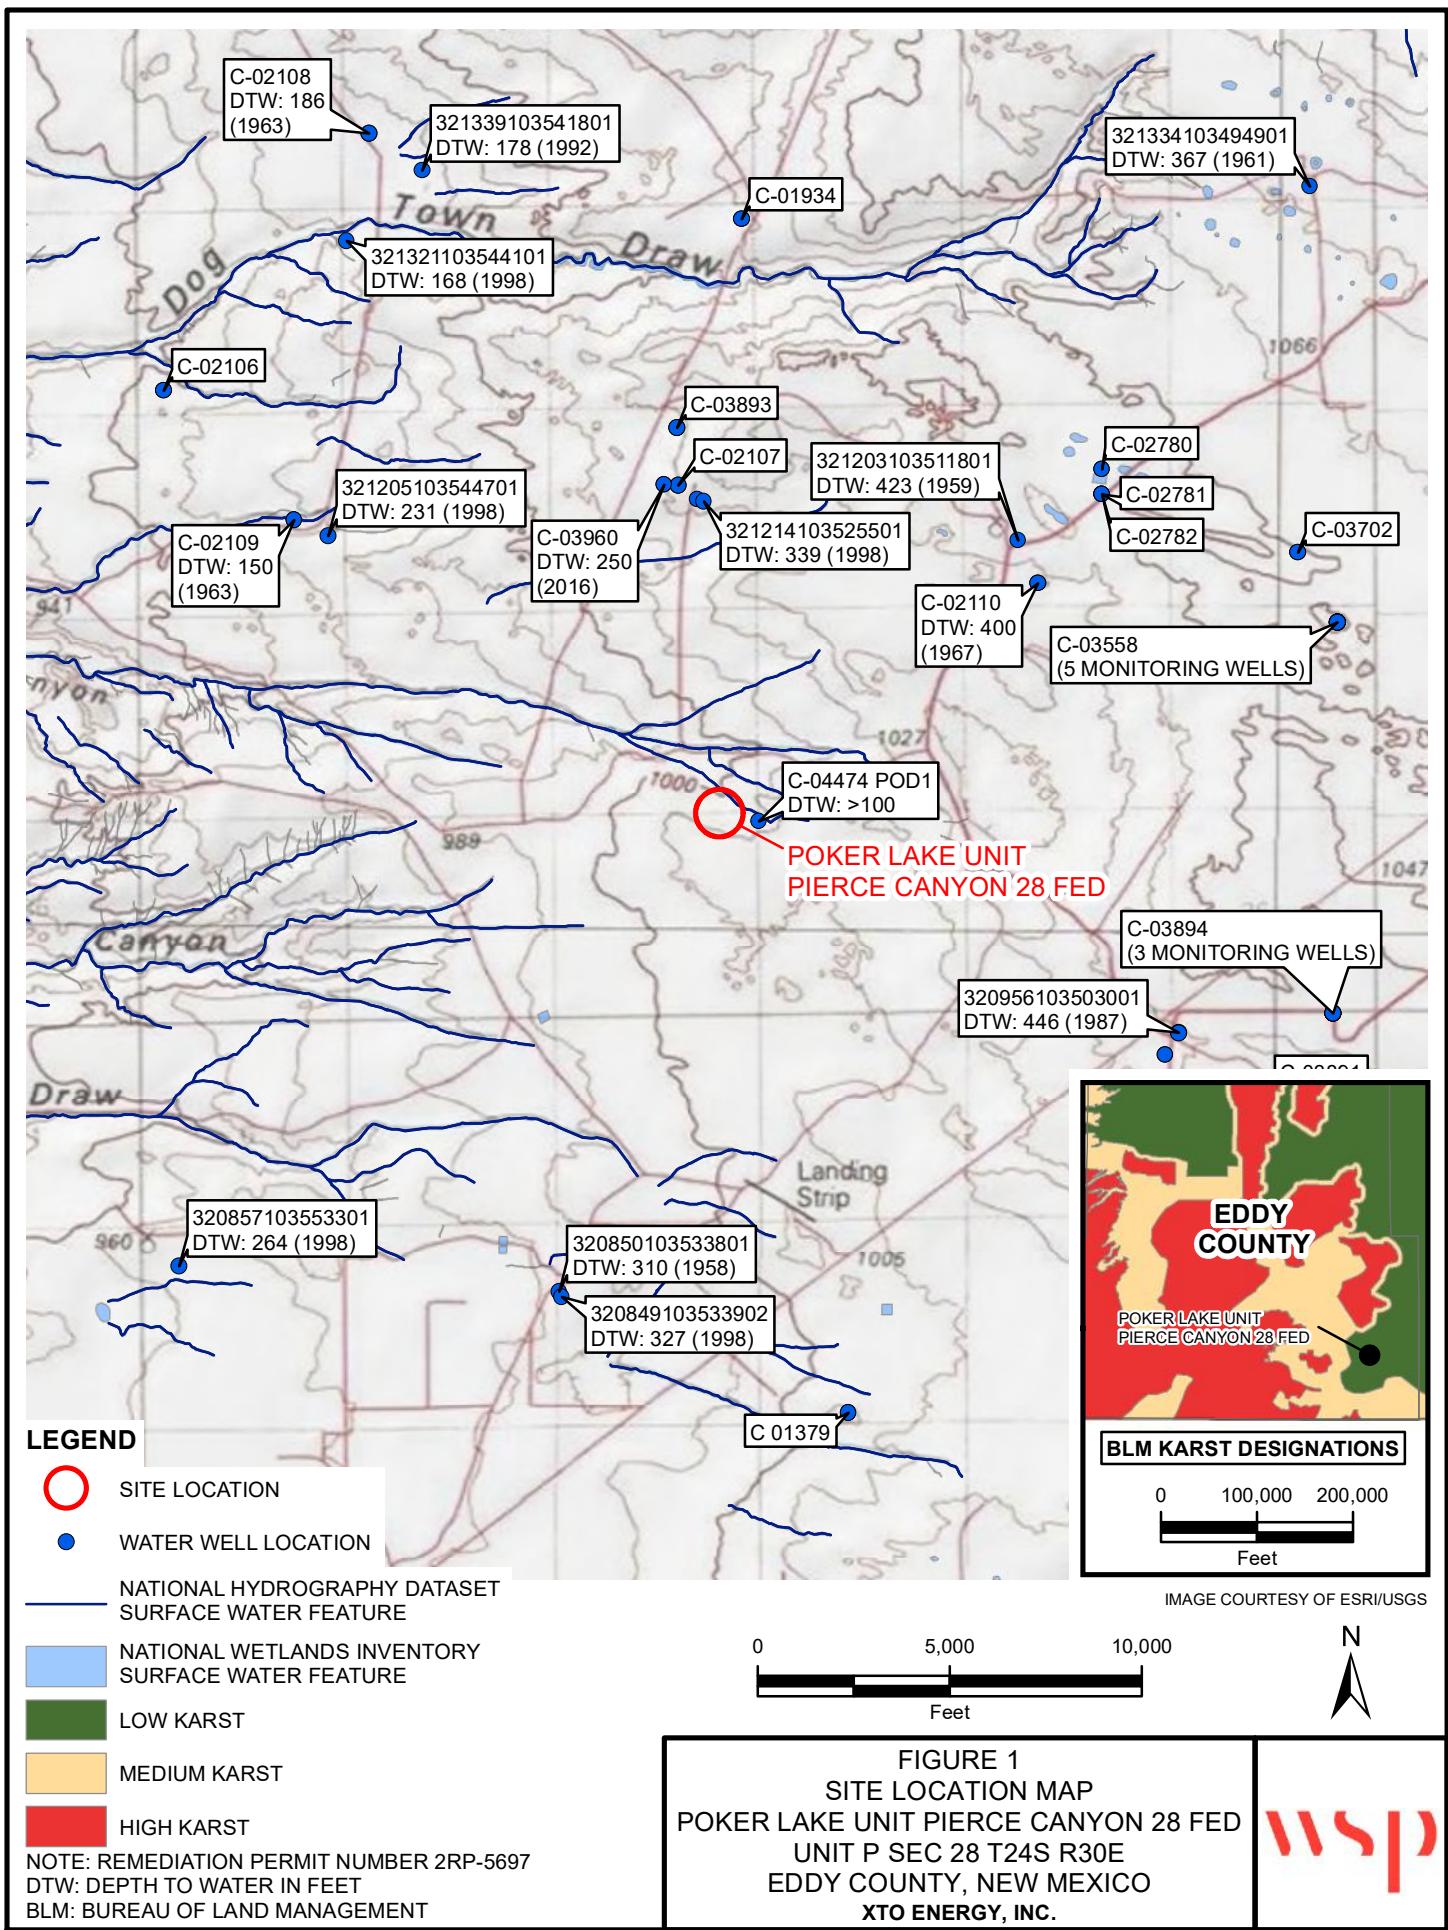
Site receptors are identified on Figure 1.

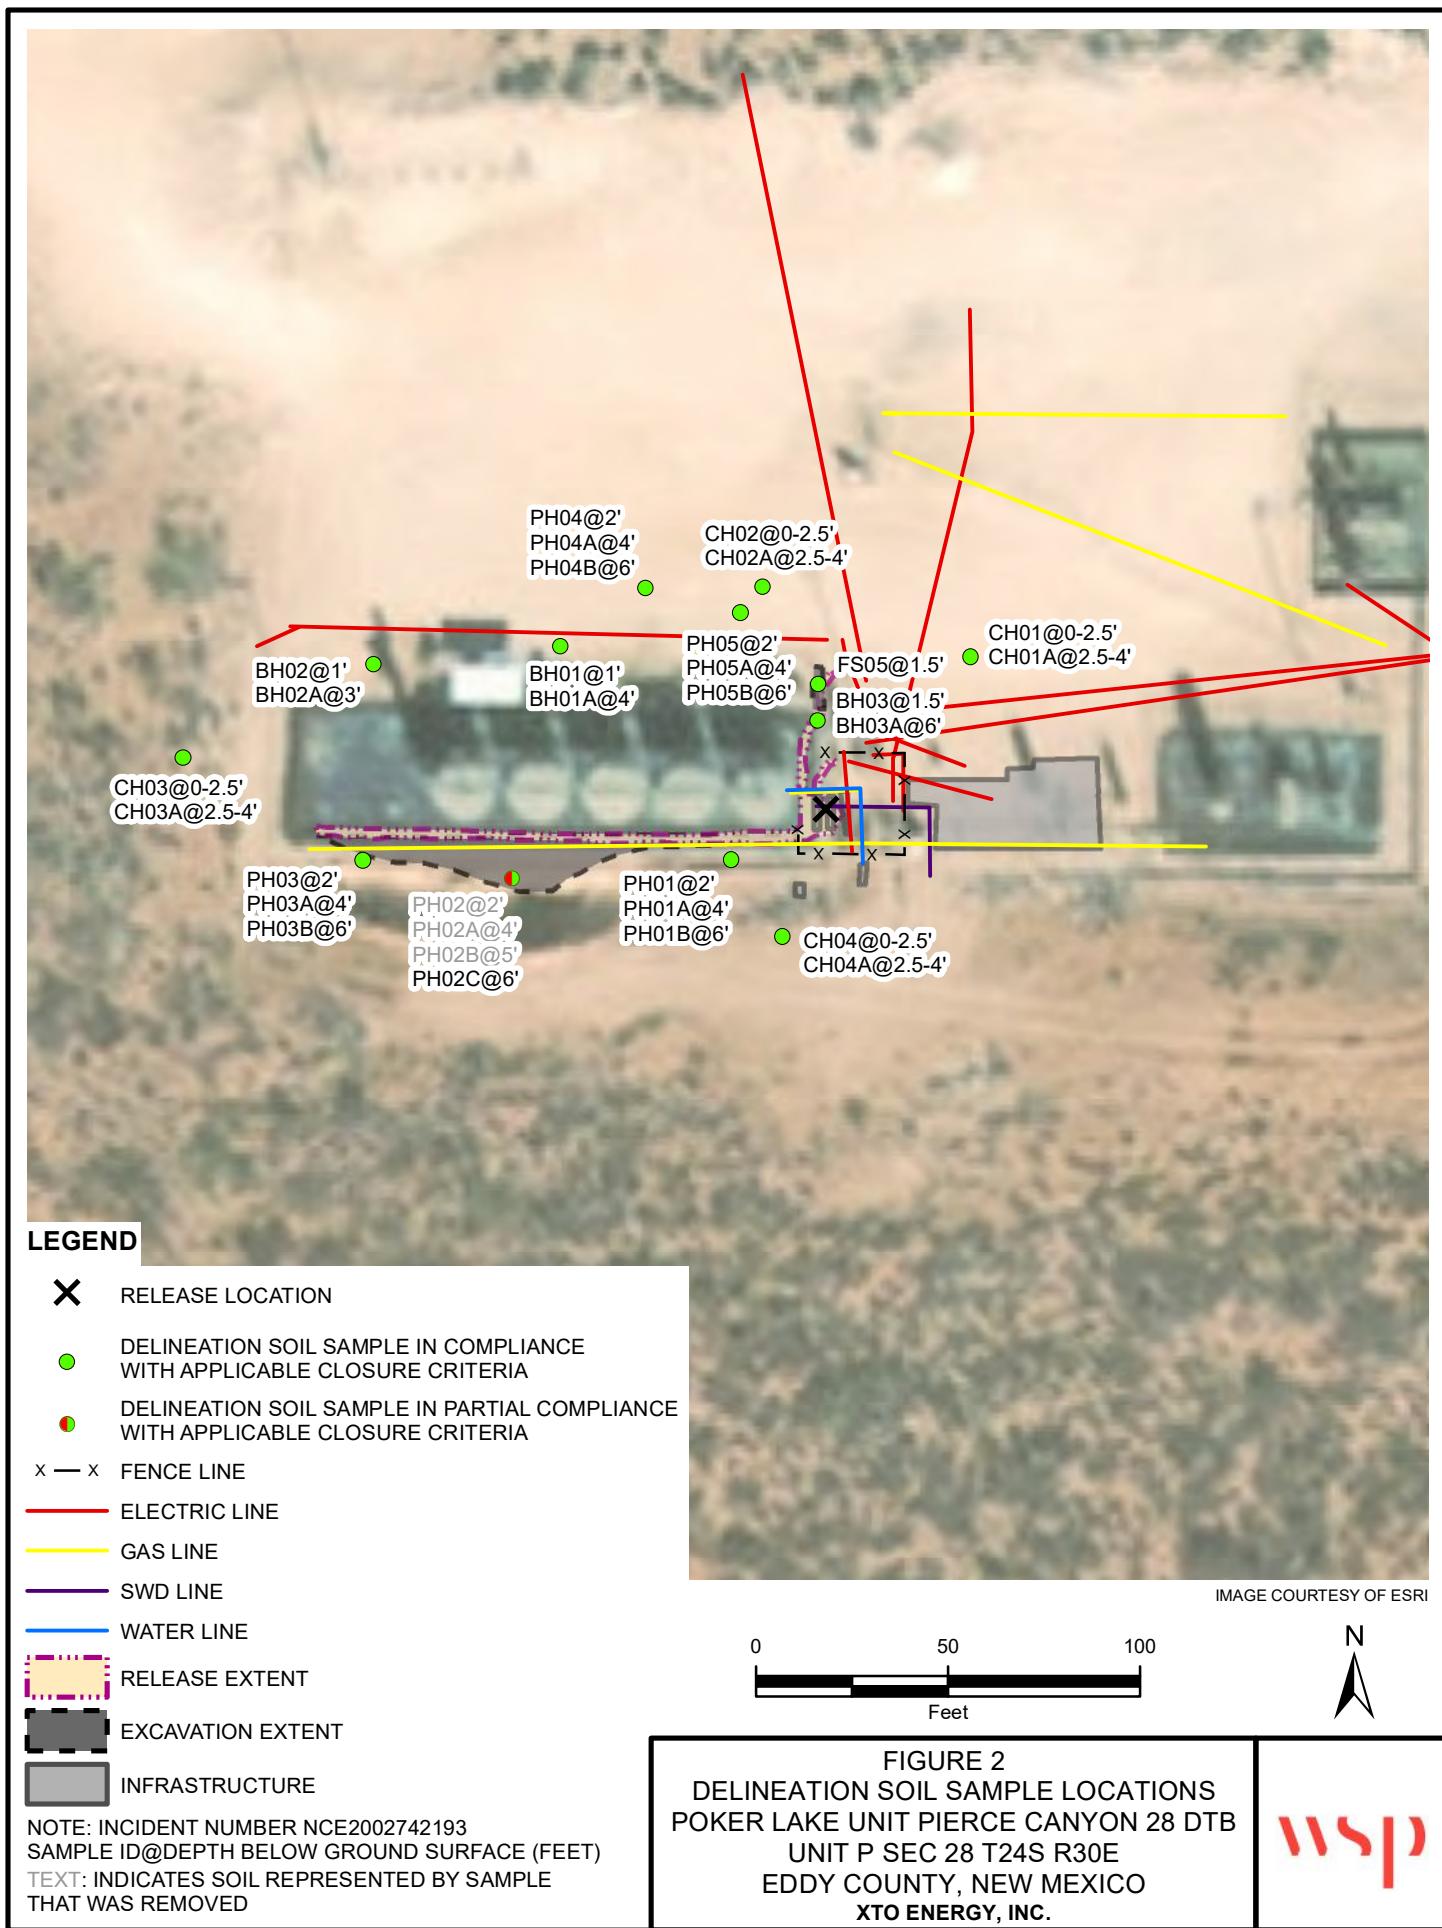
As a condition of the Remediation Work Plan approval, NMOCD requested further sampling of floor sample FS05 to a depth greater than 1-foot bgs to ensure deeper impacted soil was not left in place. On May 4, 2021, WSP personnel returned to the Site to conduct additional sampling in the area of floor sample FS05 to confirm that no residual impacts remained below 1-foot bgs. WSP collected a 5-point composite soil sample (FS05) via hand auger from a depth of 1.5 feet bgs from the original FS05 location. The FS05@1.5' soil sample location is presented on Figure 2.

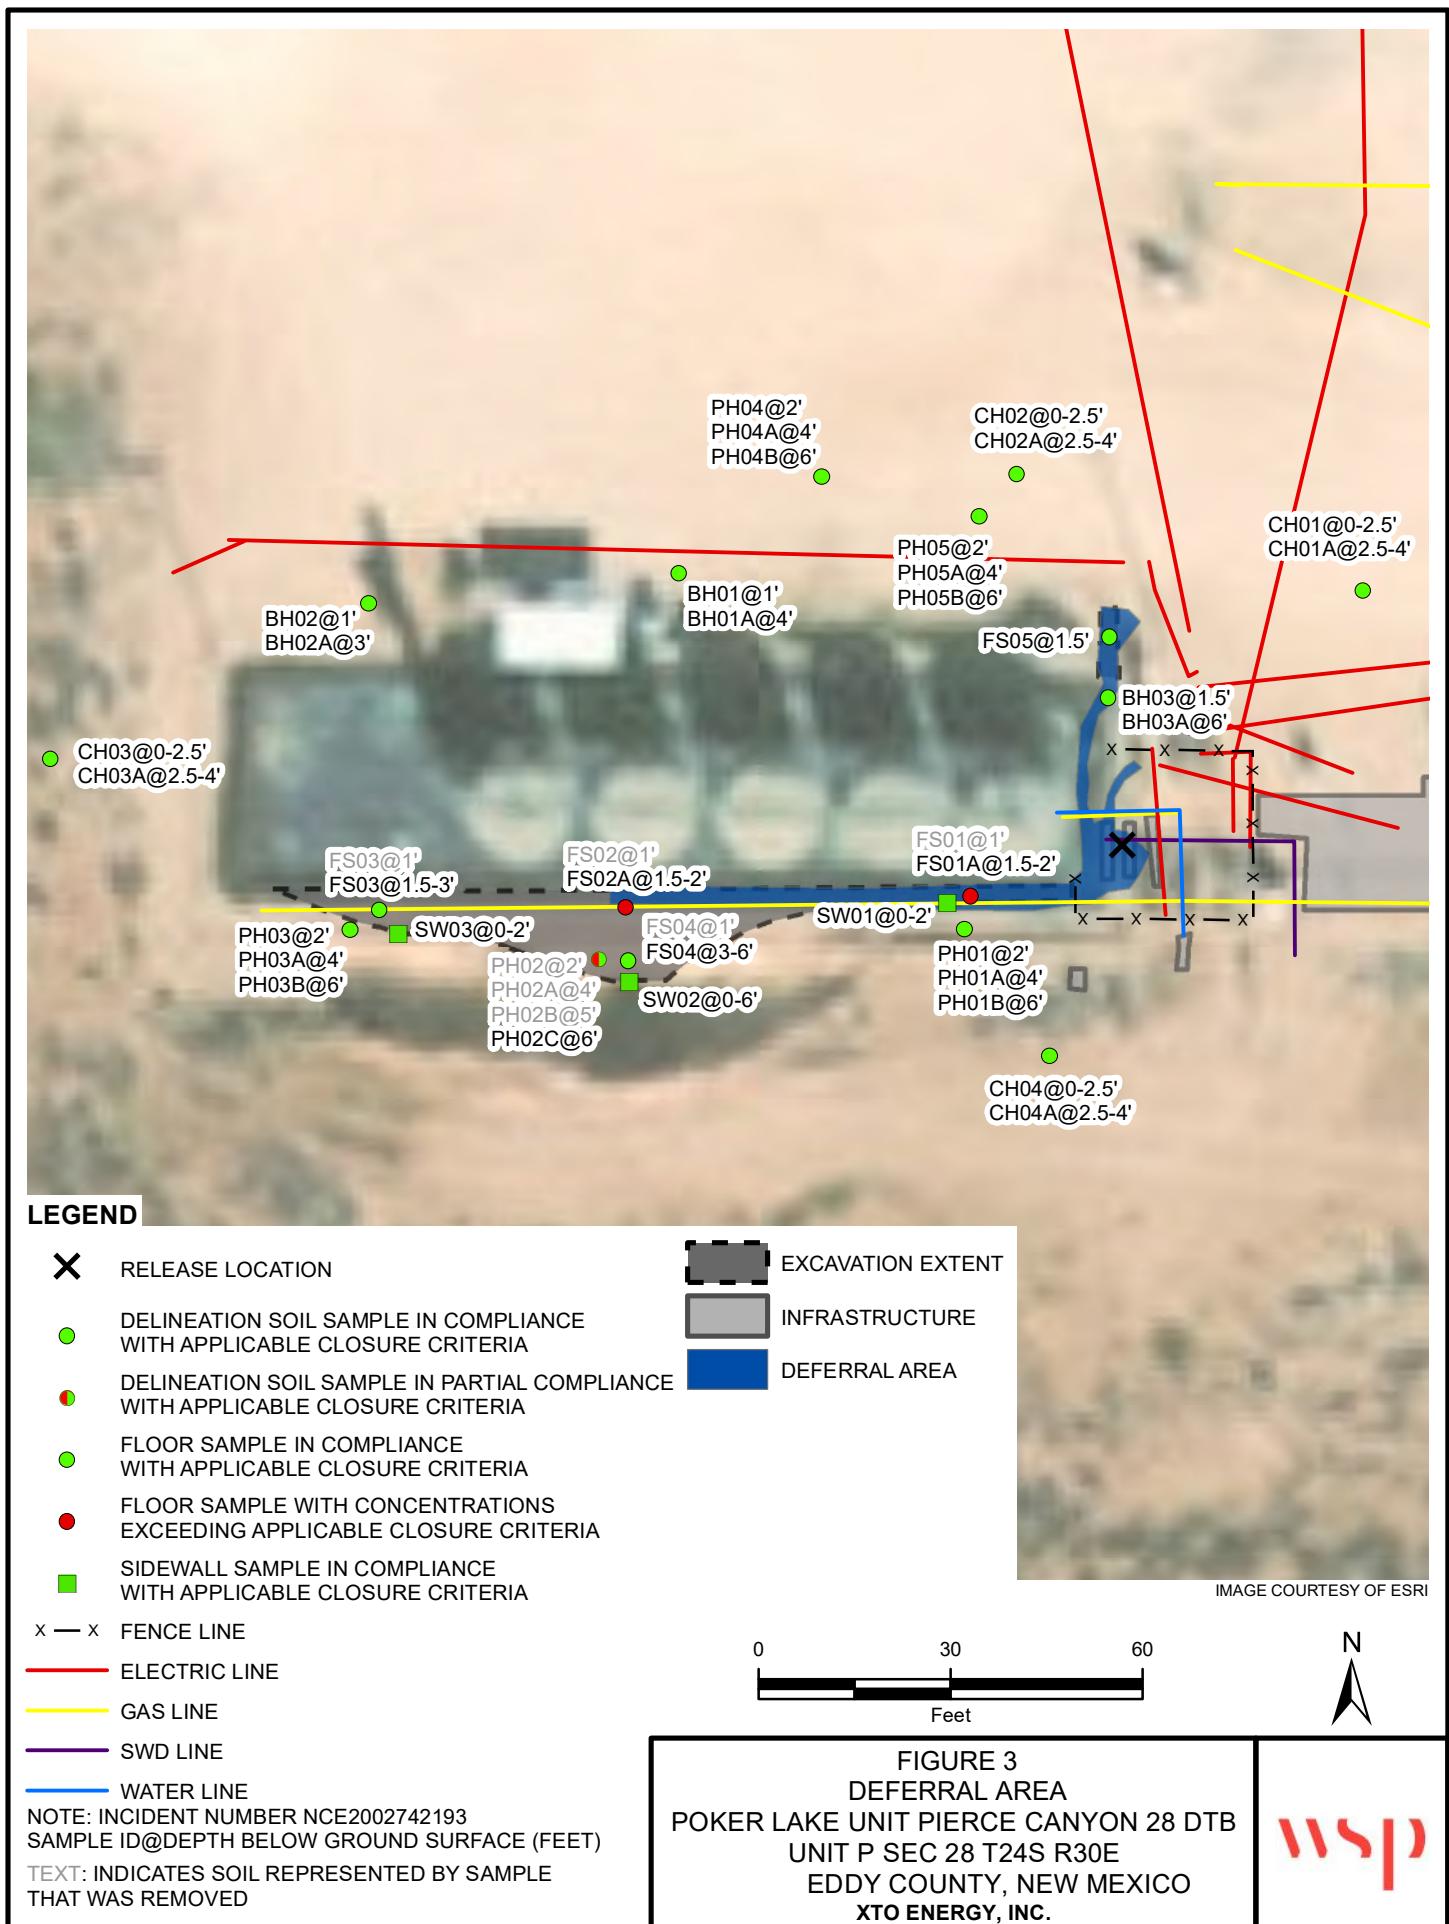
Laboratory analytical results from coreholes CH01 through CH04 provide the additional lateral delineation of impacted soil for deferral as outlined in the approved Remediation Work Plan. The deferral area is shown on Figure 3. Laboratory analytical results for soil sample FS05@1.5' confirmed that impacted soil does not extend deeper than 1-foot bgs at the original FS05 location, which fulfills NMOCD's condition of approval.
