May 25, 2021

Vertex Project #: 21E-00087-007

Spill Closure Report: Coleman North Facility
Unit H, Section 14, Township 23 South, Range 27 East
County: Eddy
Tracking Number: nAPP2105529838

Prepared For: Matador Production Company
5400 Lyndon B Johnson Freeway
Suite 1500
Dallas, Texas 75240

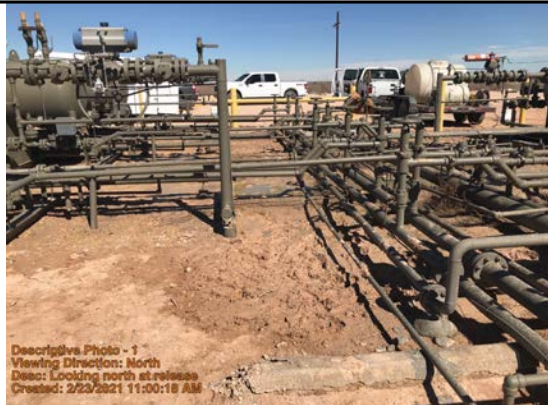
Viewing Direction: North

Looking north at release

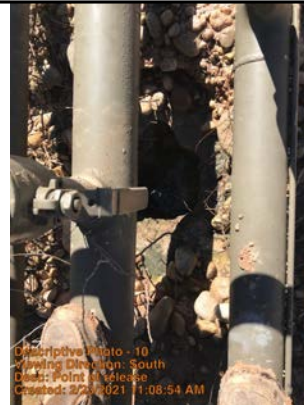
Viewing Direction: South

Point of release

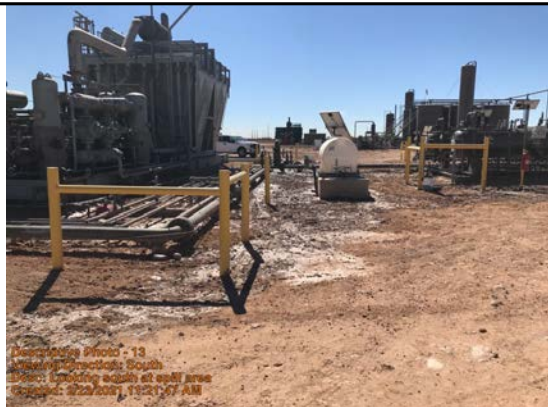
Viewing Direction: South

Looking south at spill area

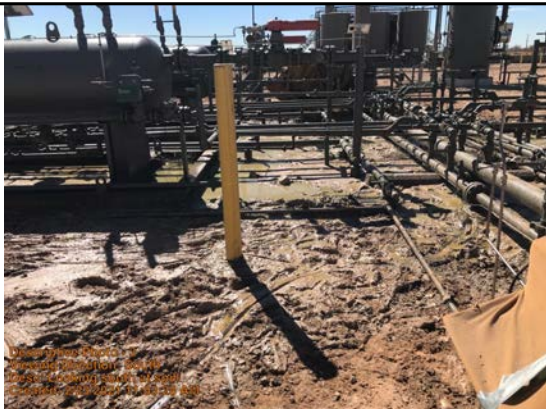
Viewing Direction: South

Looking south at spill

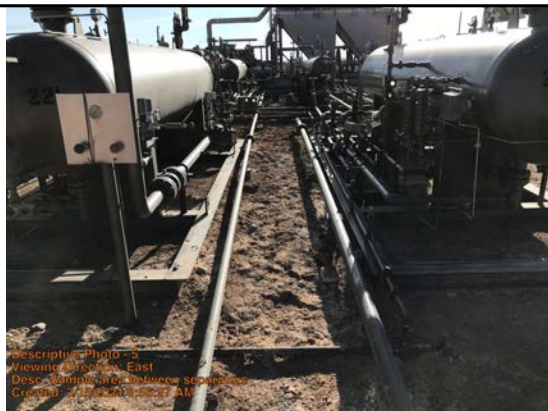
Viewing Direction: East

Sample area between separators

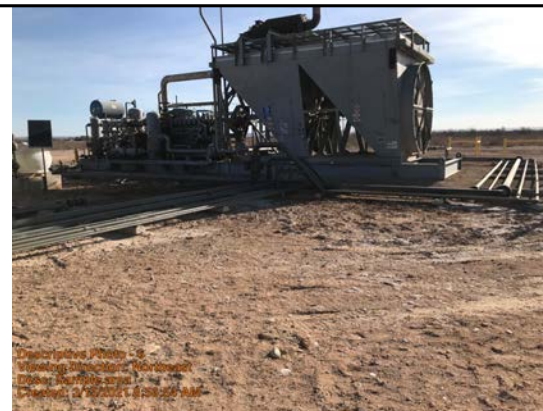
Viewing Direction: Northeast

Sample area

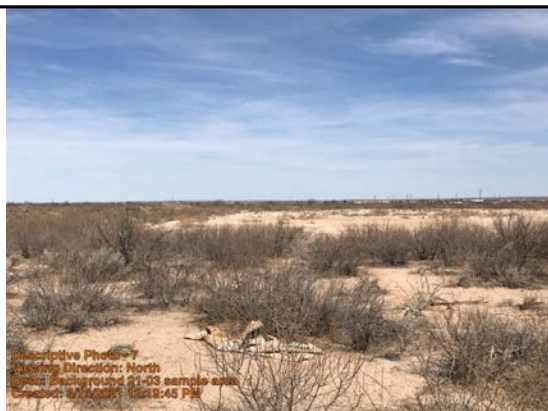
Viewing Direction: North

Background 21-03 sample area

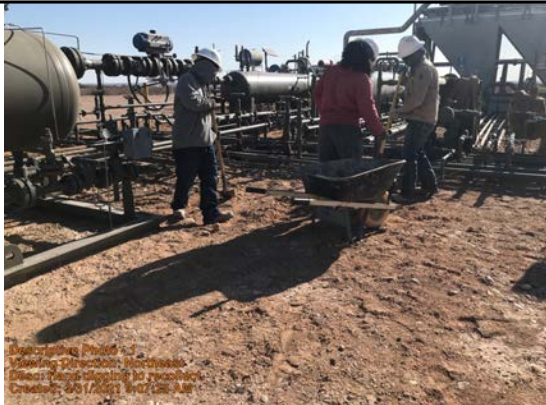
Viewing Direction: Northeast

Hand digging to recollect.

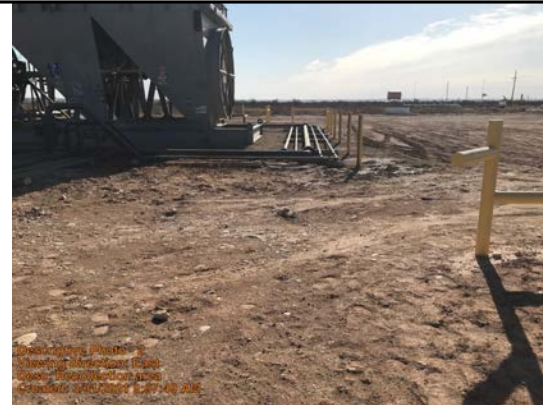
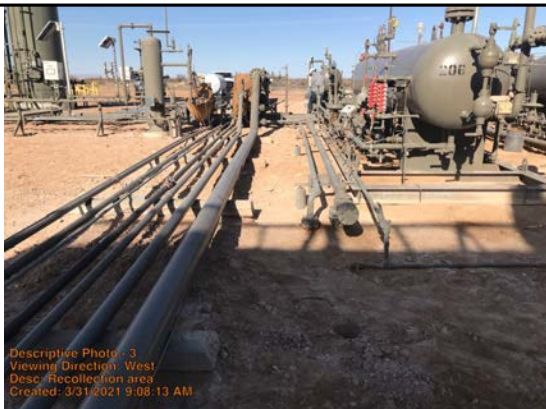
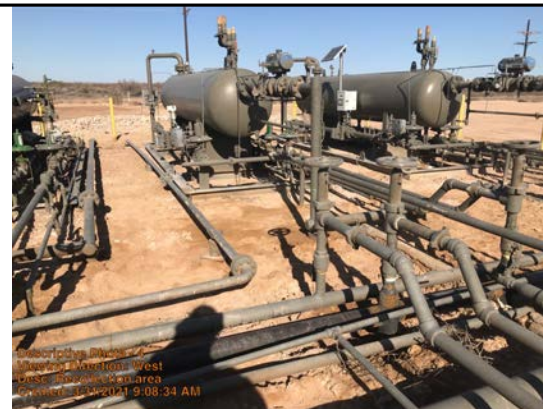
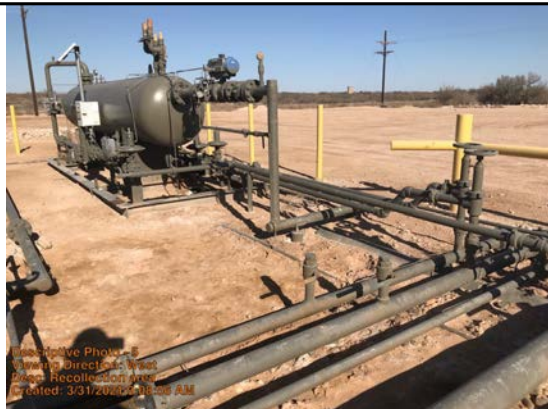
Recollection area
