**APACHE CORPORATION
NEDU INJECTION LINE
REQUEST FOR BACKFILL AND CLOSURE OF SITE**

**RELEASE DATE: 06/04/2020 and 9/17/2020
CASE NO. NRM201754777 and NRM2026942891
U/L C, SECTION 10, TOWNSHIP 21S, RANGE 37E LEA
COUNTY, NEW MEXICO**

**RE: NEDU Injection Line – Request for Backfill and Closure
Case No. NRM2017547777 and NRM2026942891**

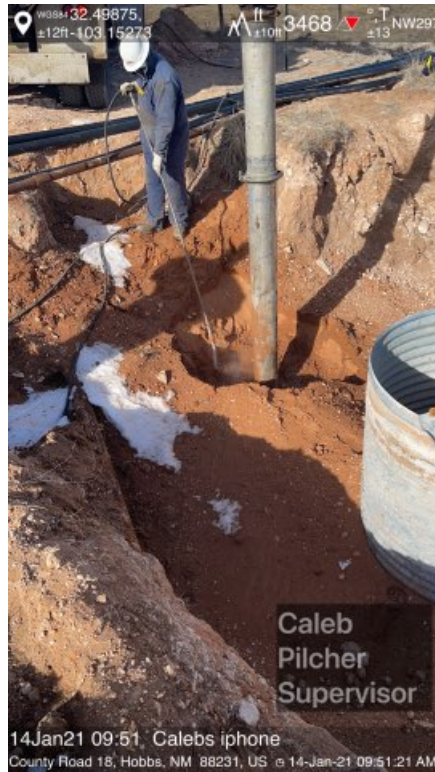
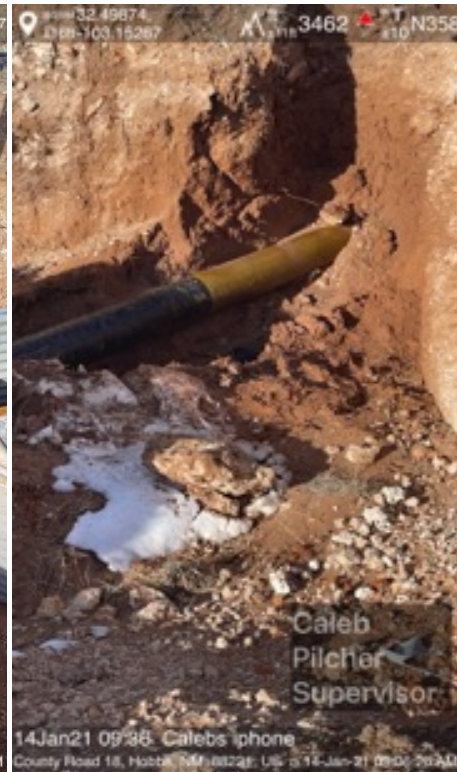
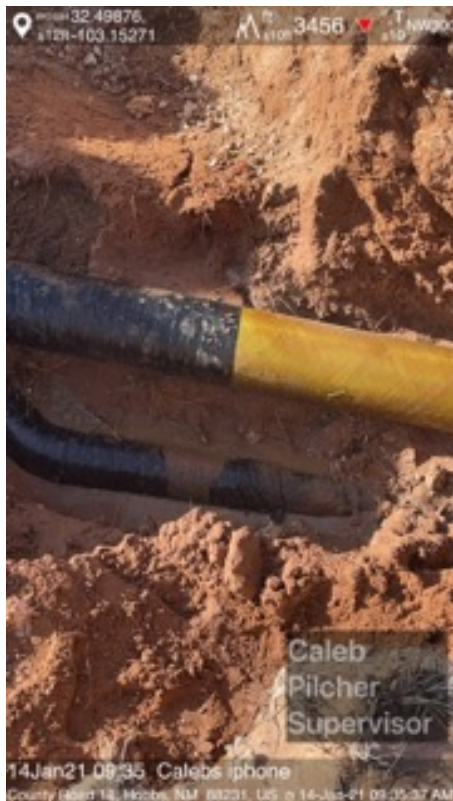
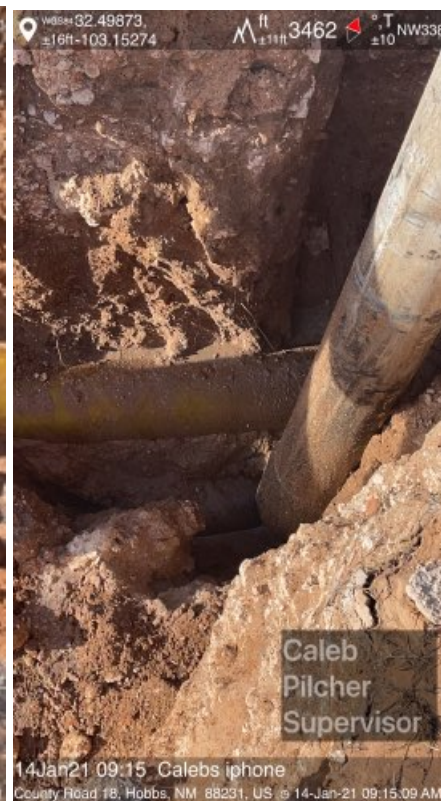
NEDU INJECTION LINE SITE PHOTOS

Upon beginning the remediation as approved by the OCD, ESS determined that several buried lines were in the proposed excavation area. At this time, a hydro-vac was dispatched to the site to spot any and all lines in the area of excavation. Upon doing so seven lines were found at the center point of the release. This includes a 2" and 6" fiberglass injection line, 4" steel production line, 6" emulsion poly line, 6" water transfer line belonging to Apache Corporation, a 4" gas line belonging to Energy Transfer and a 12" gas line belonging to Targa. Please find the attached buried line map.

The hydro-vac was then used to install a trench to spot where each line entered the impacted area and where it exited. The line depths were determined and several variations were found, which can cause unwanted line strikes. We then began to hydro-vac out the soil in the area of impact and we encountered unstable ground causing the walls to cave in on-top of the lines.

This then made it unsafe to continue to hydro-vac safely for the remediation staff and for the integrity of the fiberglass and high-pressure gas lines. This release is also 35' from the highway, which causes a danger of a potential release that could occur during excavation, this could cause a release to lines that go under the highway and will cause unsafe driving conditions if released over the highway.

A total of 62 cubic yards of impacted soil was hauled to Sundance Disposal. Please see the attached approved workplan dated September 4, 2020 and site photos from the attempted excavation procedure. At this time on behalf of Apache Corporation, we would like to request a deferral on this active ROW due to Safety and Environmental Hazards that have been presented in this case which restricts site ample reclamation and remediation. The site will be backfilled with clean imported topsoil and final remediation will be conducted when lines have been removed safely from this area.

On behalf of Apache Corporation, ESS would like to request approval to backfill the NEDU Injection Line release and the NEDU High Pressure Injection Line. If you have any questions or concerns, please contact myself or Bruce Baker at larry.baker@apachecorp.com.
