**Cameron
State Q #004**

Work Plan

**U/L F, Section 30, T16S, R37E
Lea County, New Mexico**

NRM2034533903

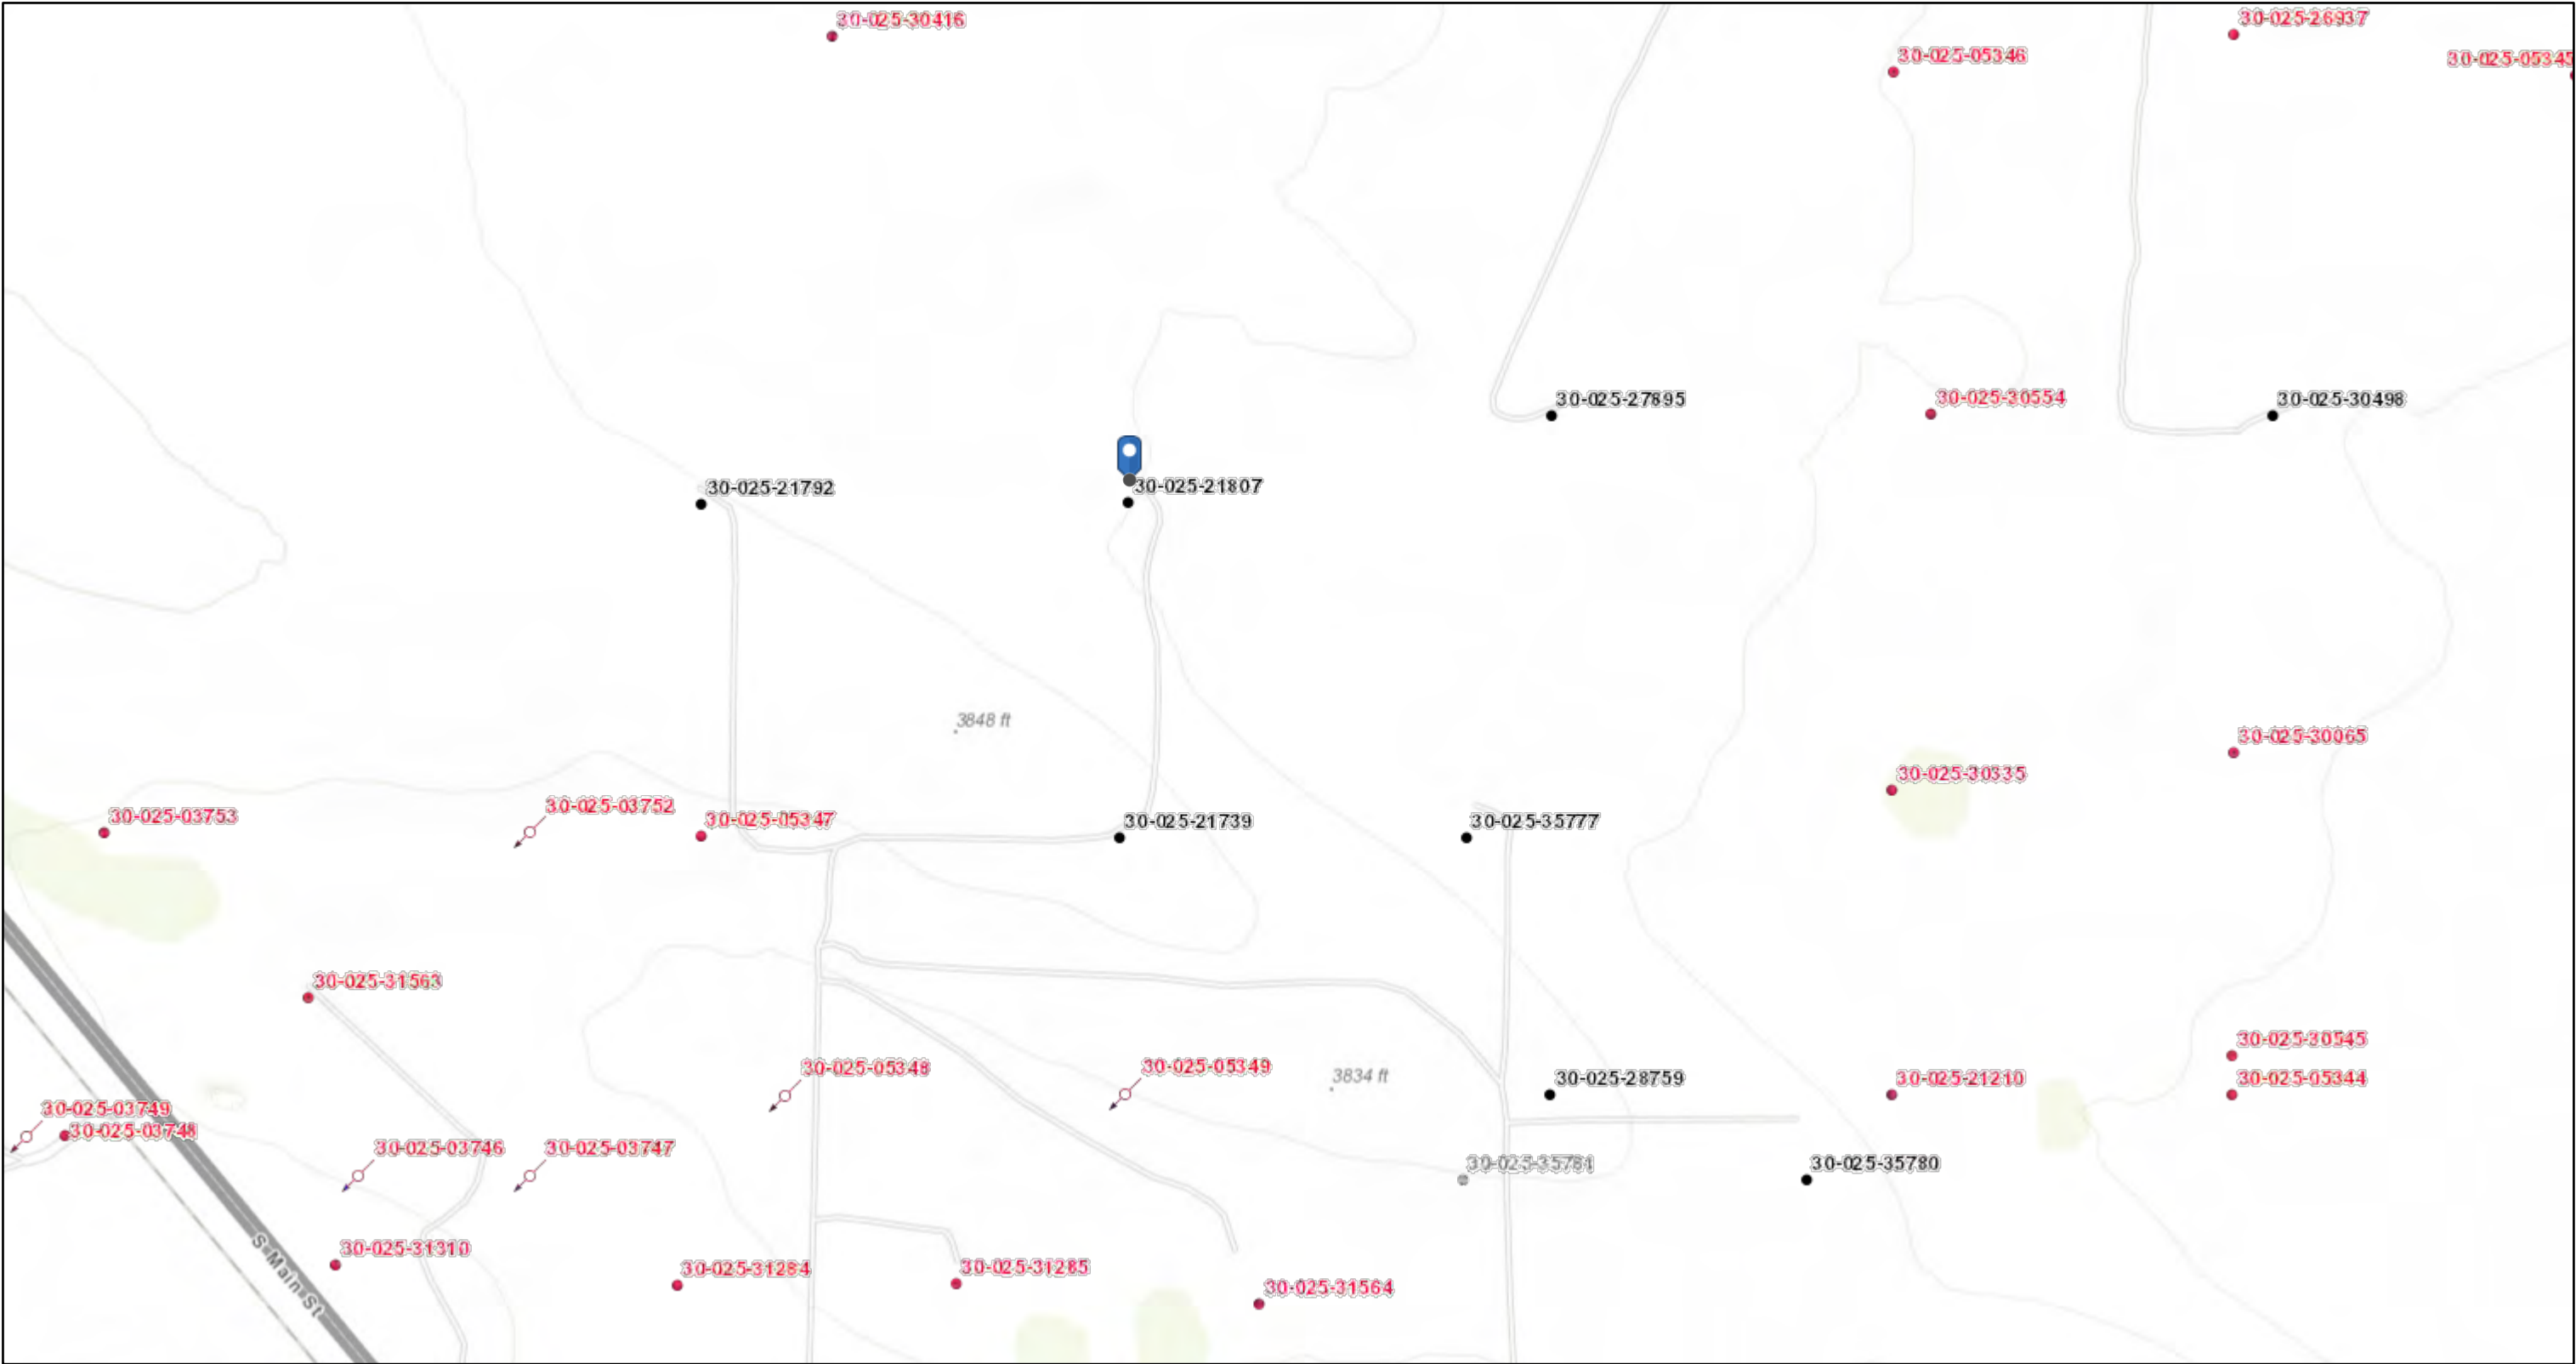
Cameron Oil & Gas, State Q #004

Safety and Environmental Solutions, Inc., hereinafter referred to as (SESI) was contracted by Cameron Oil & Gas to assess a spill at the State Q #4 location. This site is situated in U/L F, Section 30, Township 16S and Range 37E, in Lea County New Mexico.

According to the C-141 for incident NRM2034533903, a routine inspection revealed a long term release around the well head. No fluids were recovered as this appears to be a historical leak. The inspection ID# for this incident is IEZB2029046321.

In April of 2021, SESI personnel, along with a subcontractor, collected samples at the well spill area. This spill area is very small but the ground at this location is extremely difficult to penetrate as it is all very hard rock and boulders. Furthermore, the well is very old (1960s) and potentially frail. Six sample points were advanced, including two vertical samples and four horizontal samples, properly packaged and preserved, and sent to Hall Environmental laboratories to be analyzed. The results of the analyzation are captured in the table below:

For the area around the well, SESI proposes to only perform a cosmetic clean up of this area. Vertical extent of this area is simply not achievable. After a detailed discussion during a teleconference with Mike Bratcher of NMOCD, it was determined that extensive cleanup of this area is not realistic nor feasible. Due to the potentially fragile condition of the well (which was drilled in the 1960s), combined with the extreme hardness of the ground, excavation poses a dangerous safety threat. The only way to properly excavate the surface level rock would be to use a jack hammer or hammer hoe. The vibrations from these machines would potentially cause extensive damage to the well bore/casing. Therefore, it is strongly recommended by Mr. Bratcher and Bob Allen of SESI to only perform a cosmetic cleanup until this well is plugged.

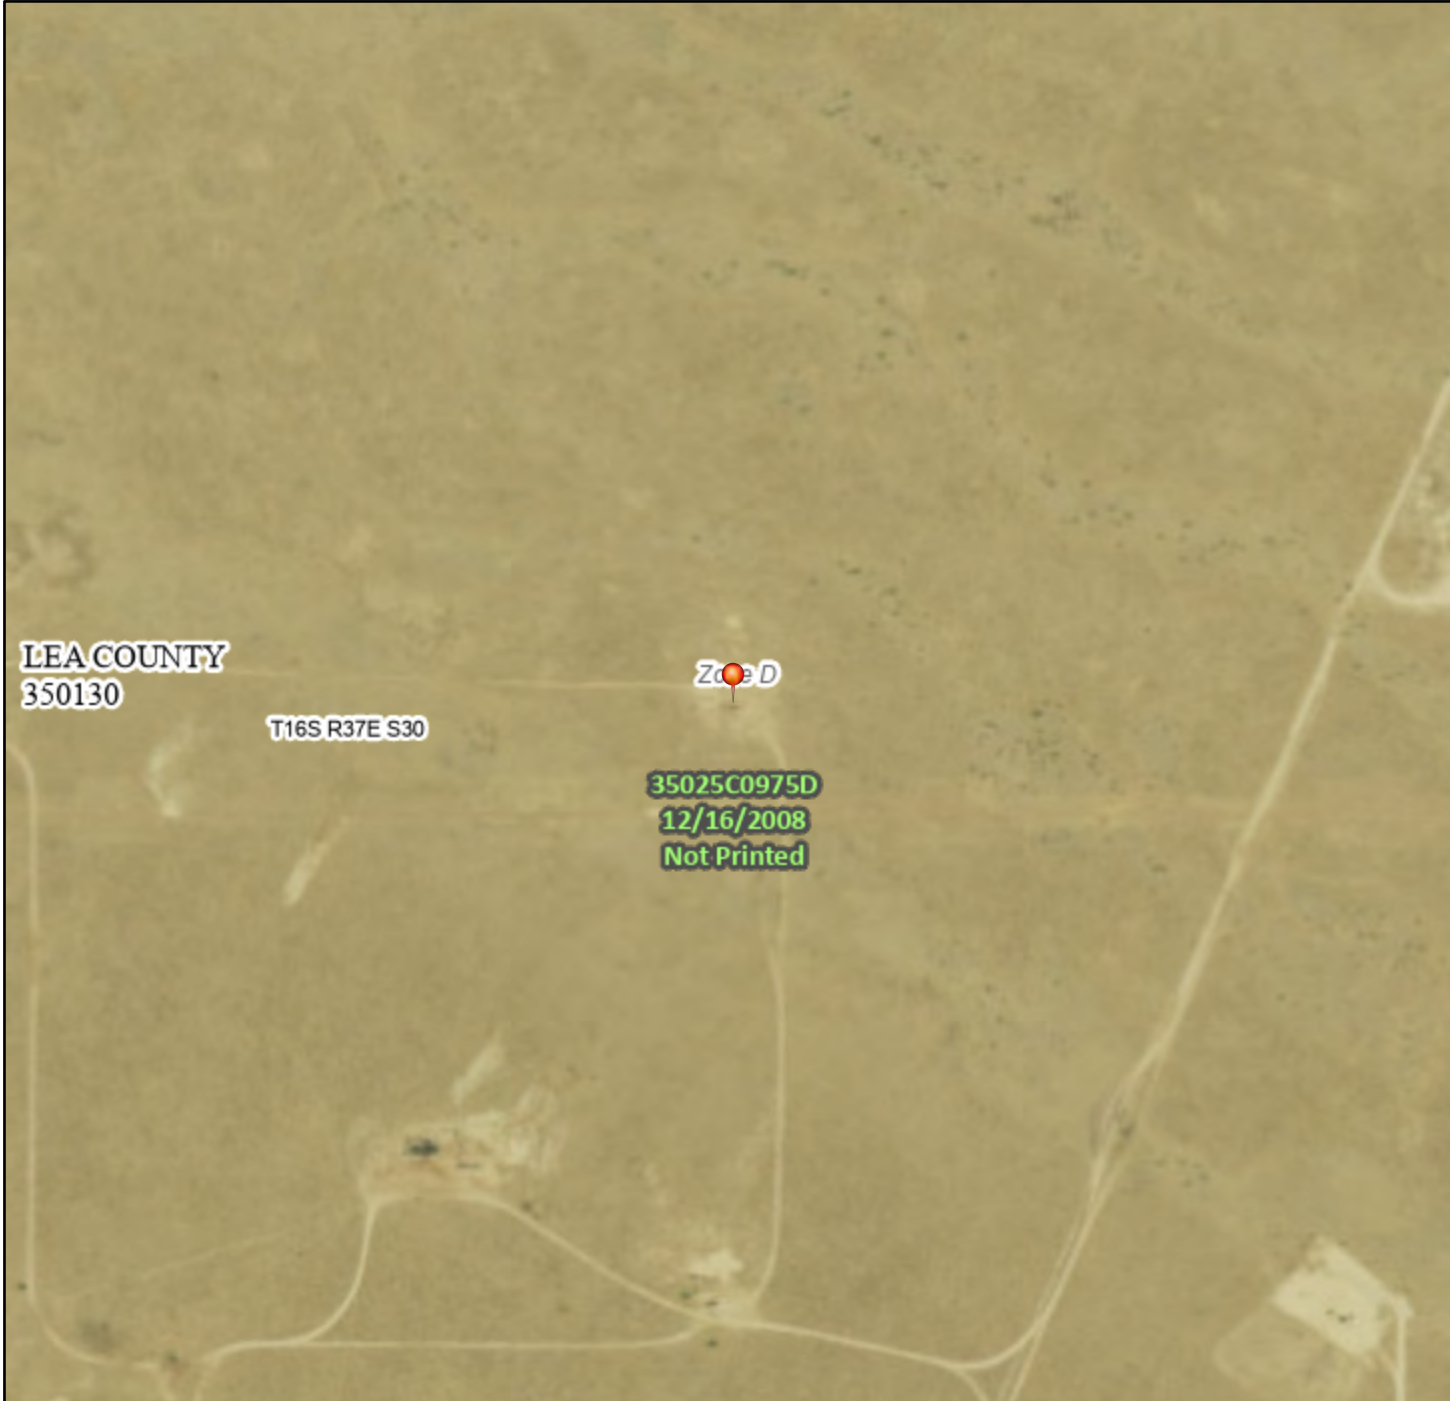
National Flood Hazard Layer FIRMMette

The flood hazard information is derived directly from the authoritative NFHL web services provided by FEMA. This map was exported on 4/19/2021 at 6:49 PM and does not reflect changes or amendments subsequent to this date and time. The NFHL and effective information may change or become superseded by new data over time.

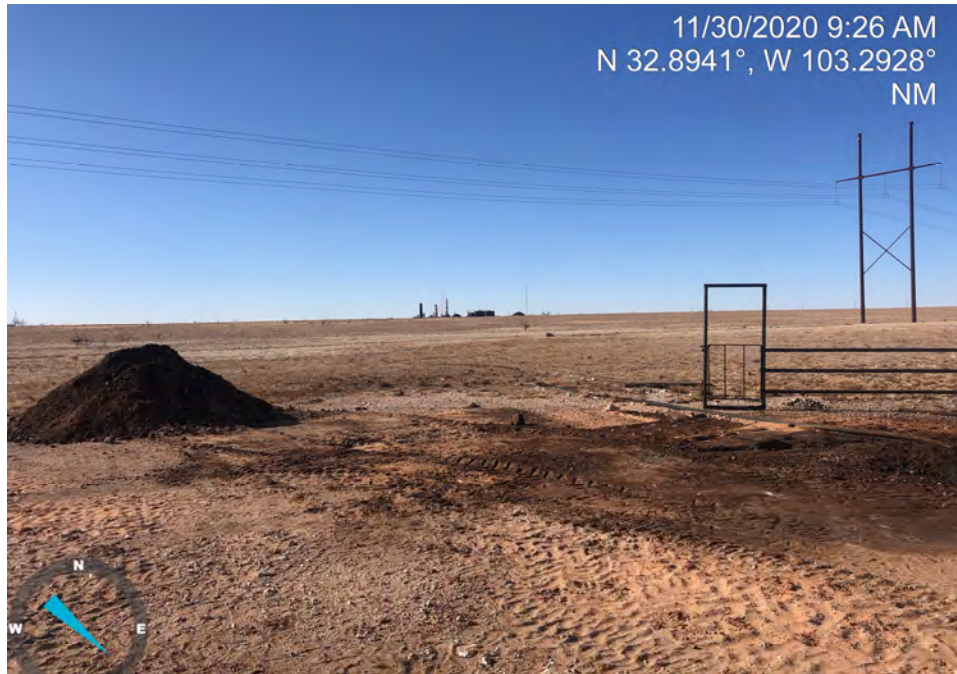
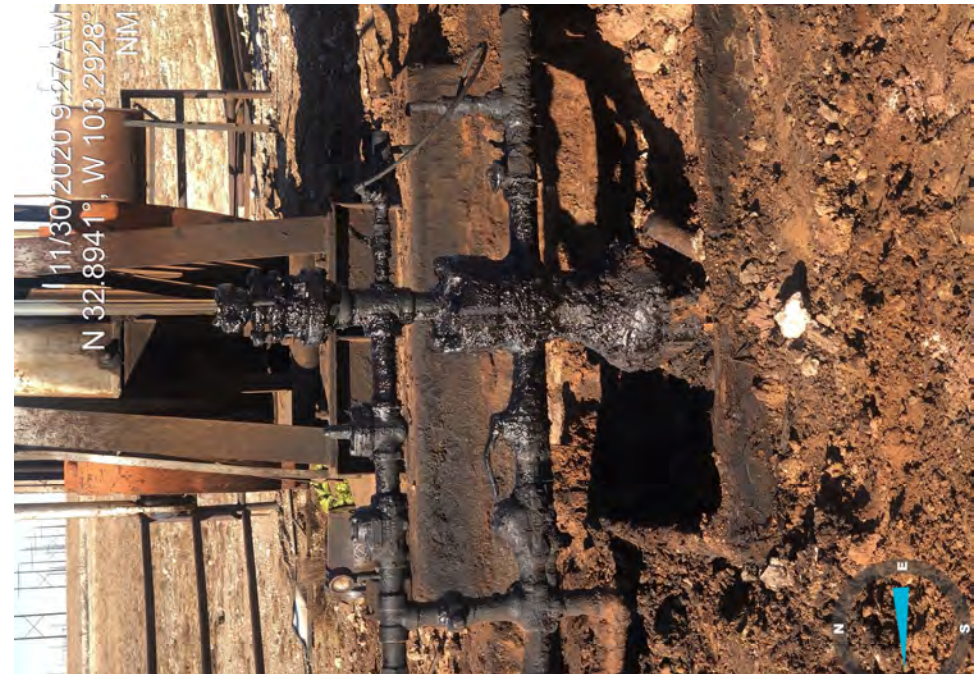
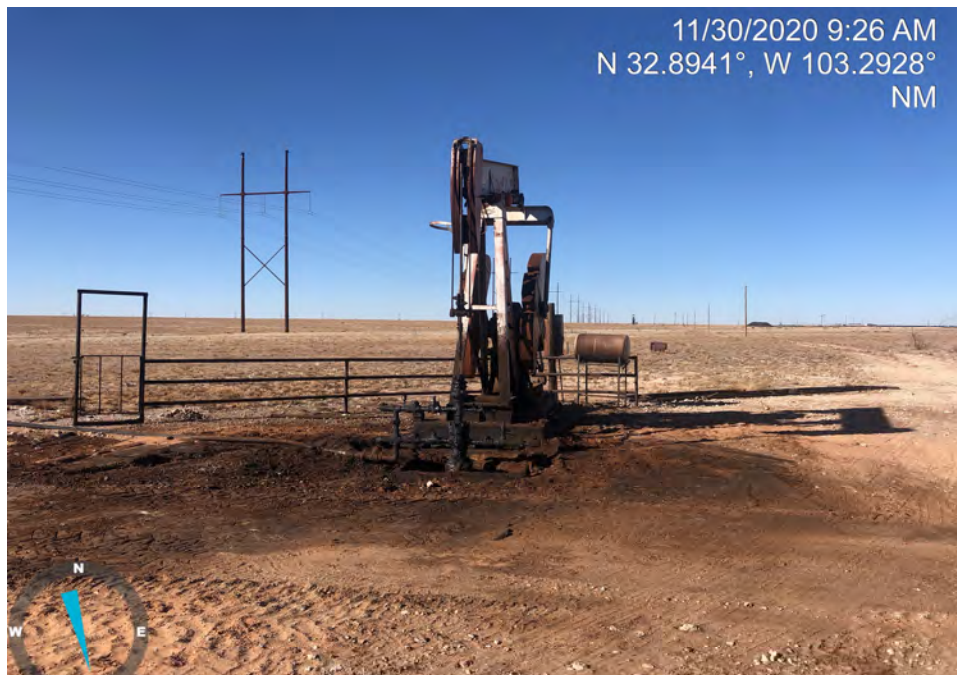
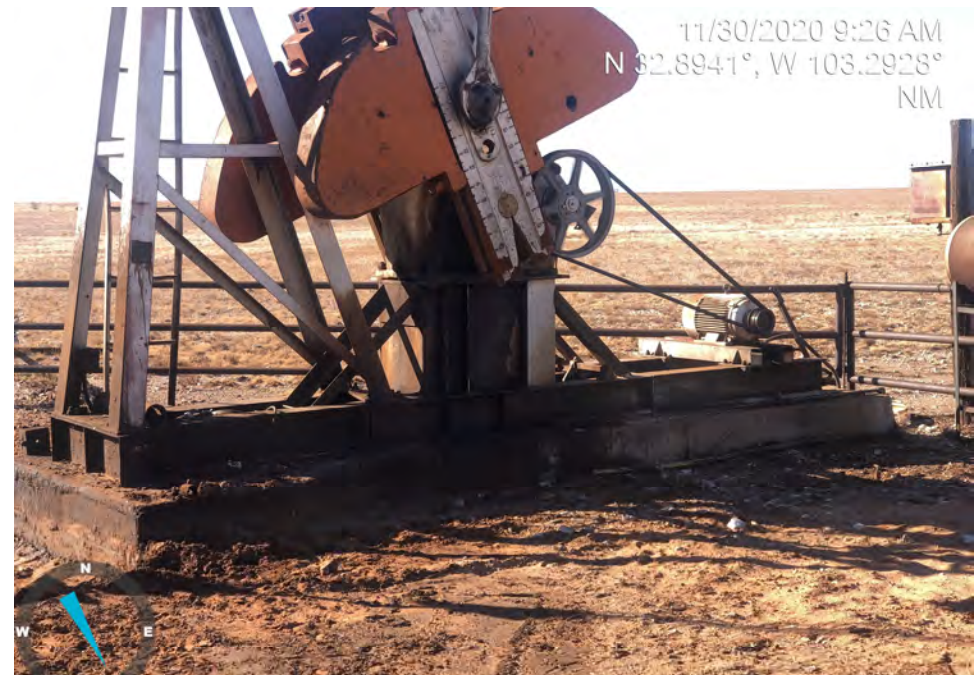
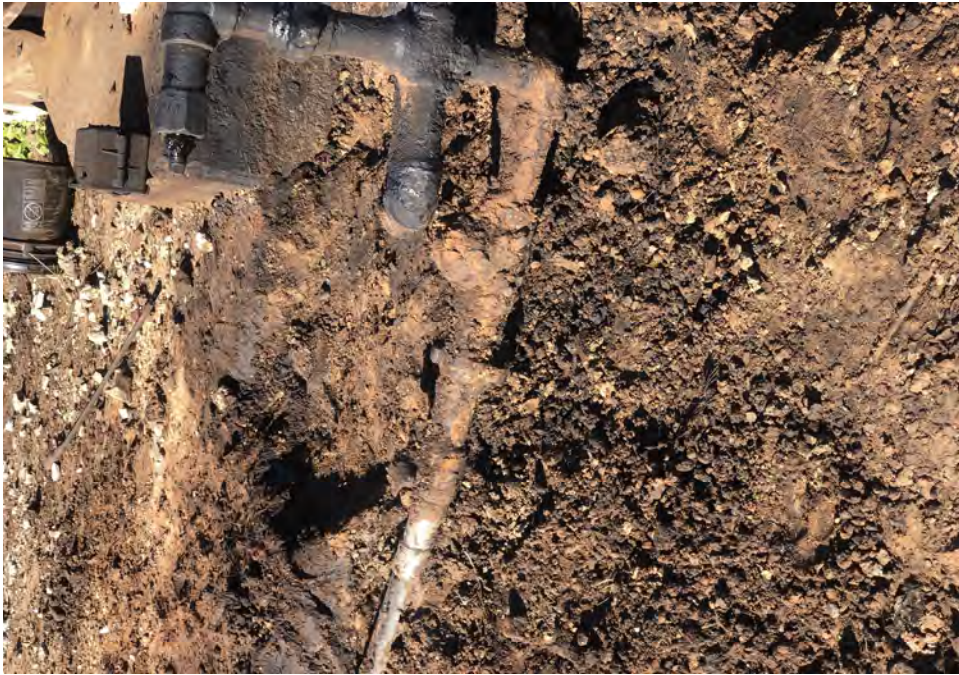
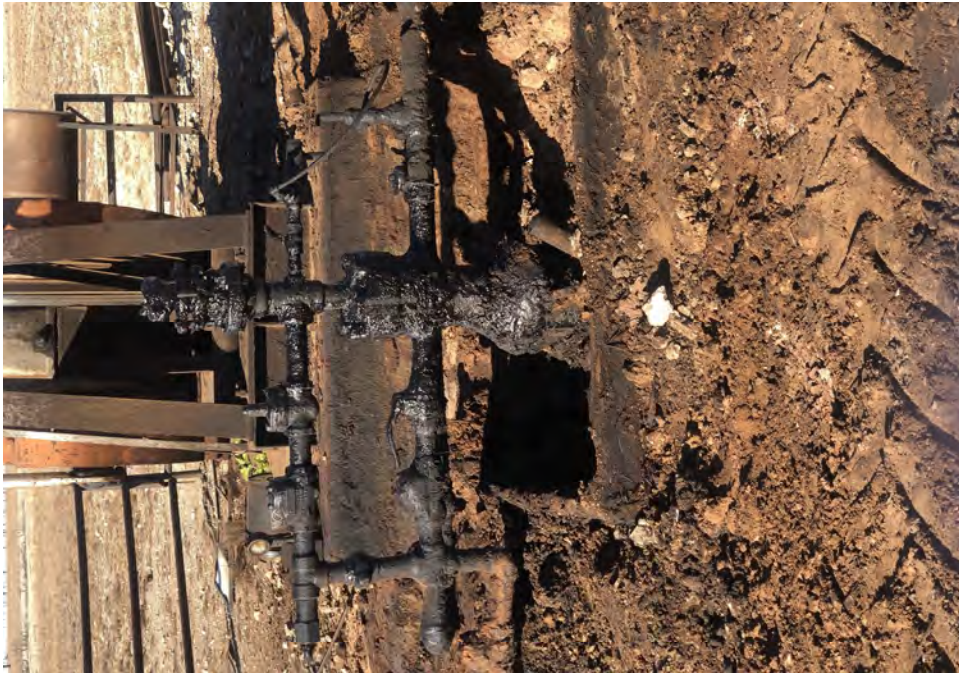
- Evidence Document 1: Map of Spill area
- Evidence Document 2: NMOCD Oil and Gas Topo map detailing area water features
- Evidence Document 3: BLM Cave Karst map showing location in low potential area
- Evidence Document 4: FEMA demonstrating minimal flood hazards for this area
- Evidence Document 5: Lab analysis
- Evidence Document 6: C-141, pgs. 3-5 for NRM2034533903
- Evidence Document 9: Photos depicting age of well with evidence of rocky surface
