Re: Remediation Plan
Prima Exploration, Inc. McElvain #5
Incident ID: nAPP2107740815

RXSoil, Inc. is pleased to submit the remediation plan for the on-site remediation of impacted soil for the above release in Lea County, New Mexico.

On behalf of Prima Exploration, Inc., RXSoil, Inc. ("RXSoil") has prepared this work plan that describes remediation of the release crude oil.

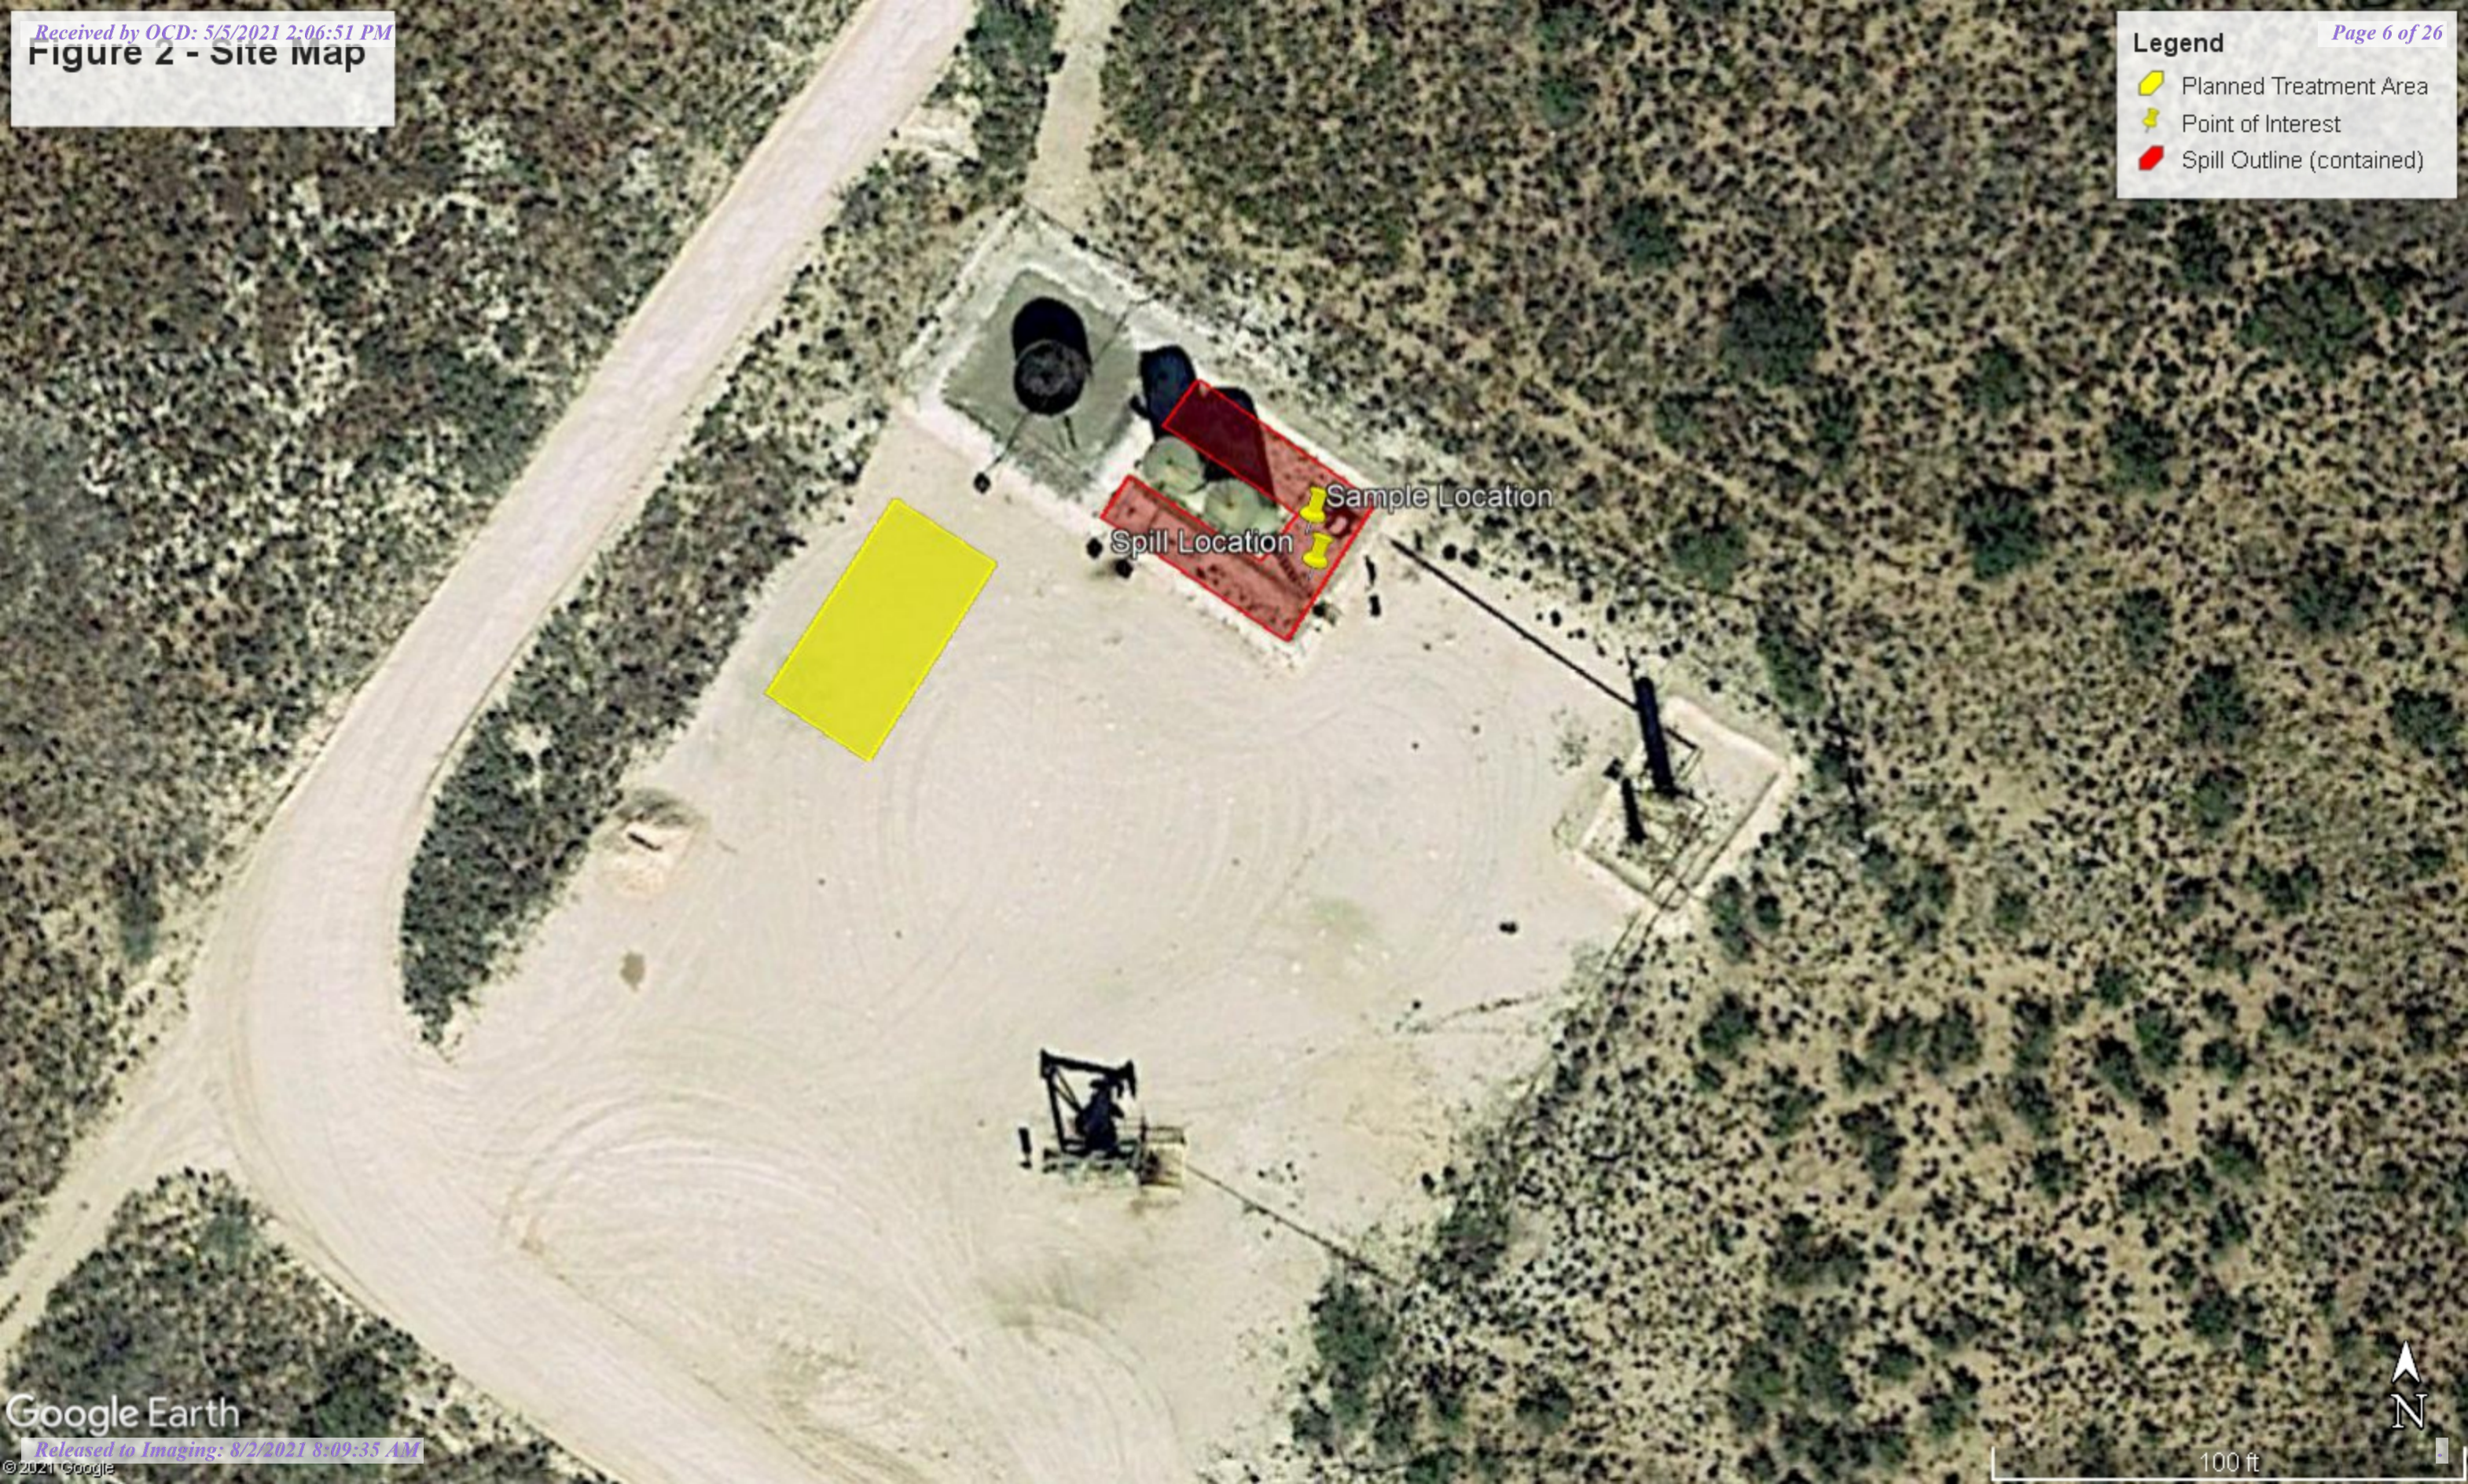
Figure 2 - Site Map

1. **Site Map** – See *Figure 2*
2. **Depth to ground water** – USGS 324317103354401 is the nearest water well (listed in *Appendix B*) and has a reported depth to water of 42.62'. This well is approximately 1.6 miles from the spill area. Remediation standards will follow the strictest thresholds stated in Table I, ≤ 50 feet.

RXSoil will construct an above-ground treatment cell adjacent to the contaminated area (see *Figure 2* for projected placement). Berms will be constructed around the perimeter of the cell area. A 20-mil reinforced poly liner will be placed on the surface and up the sides of the berms to contain treatment. A proprietary drainage and collection system will be installed prior to filling the cells. Based on

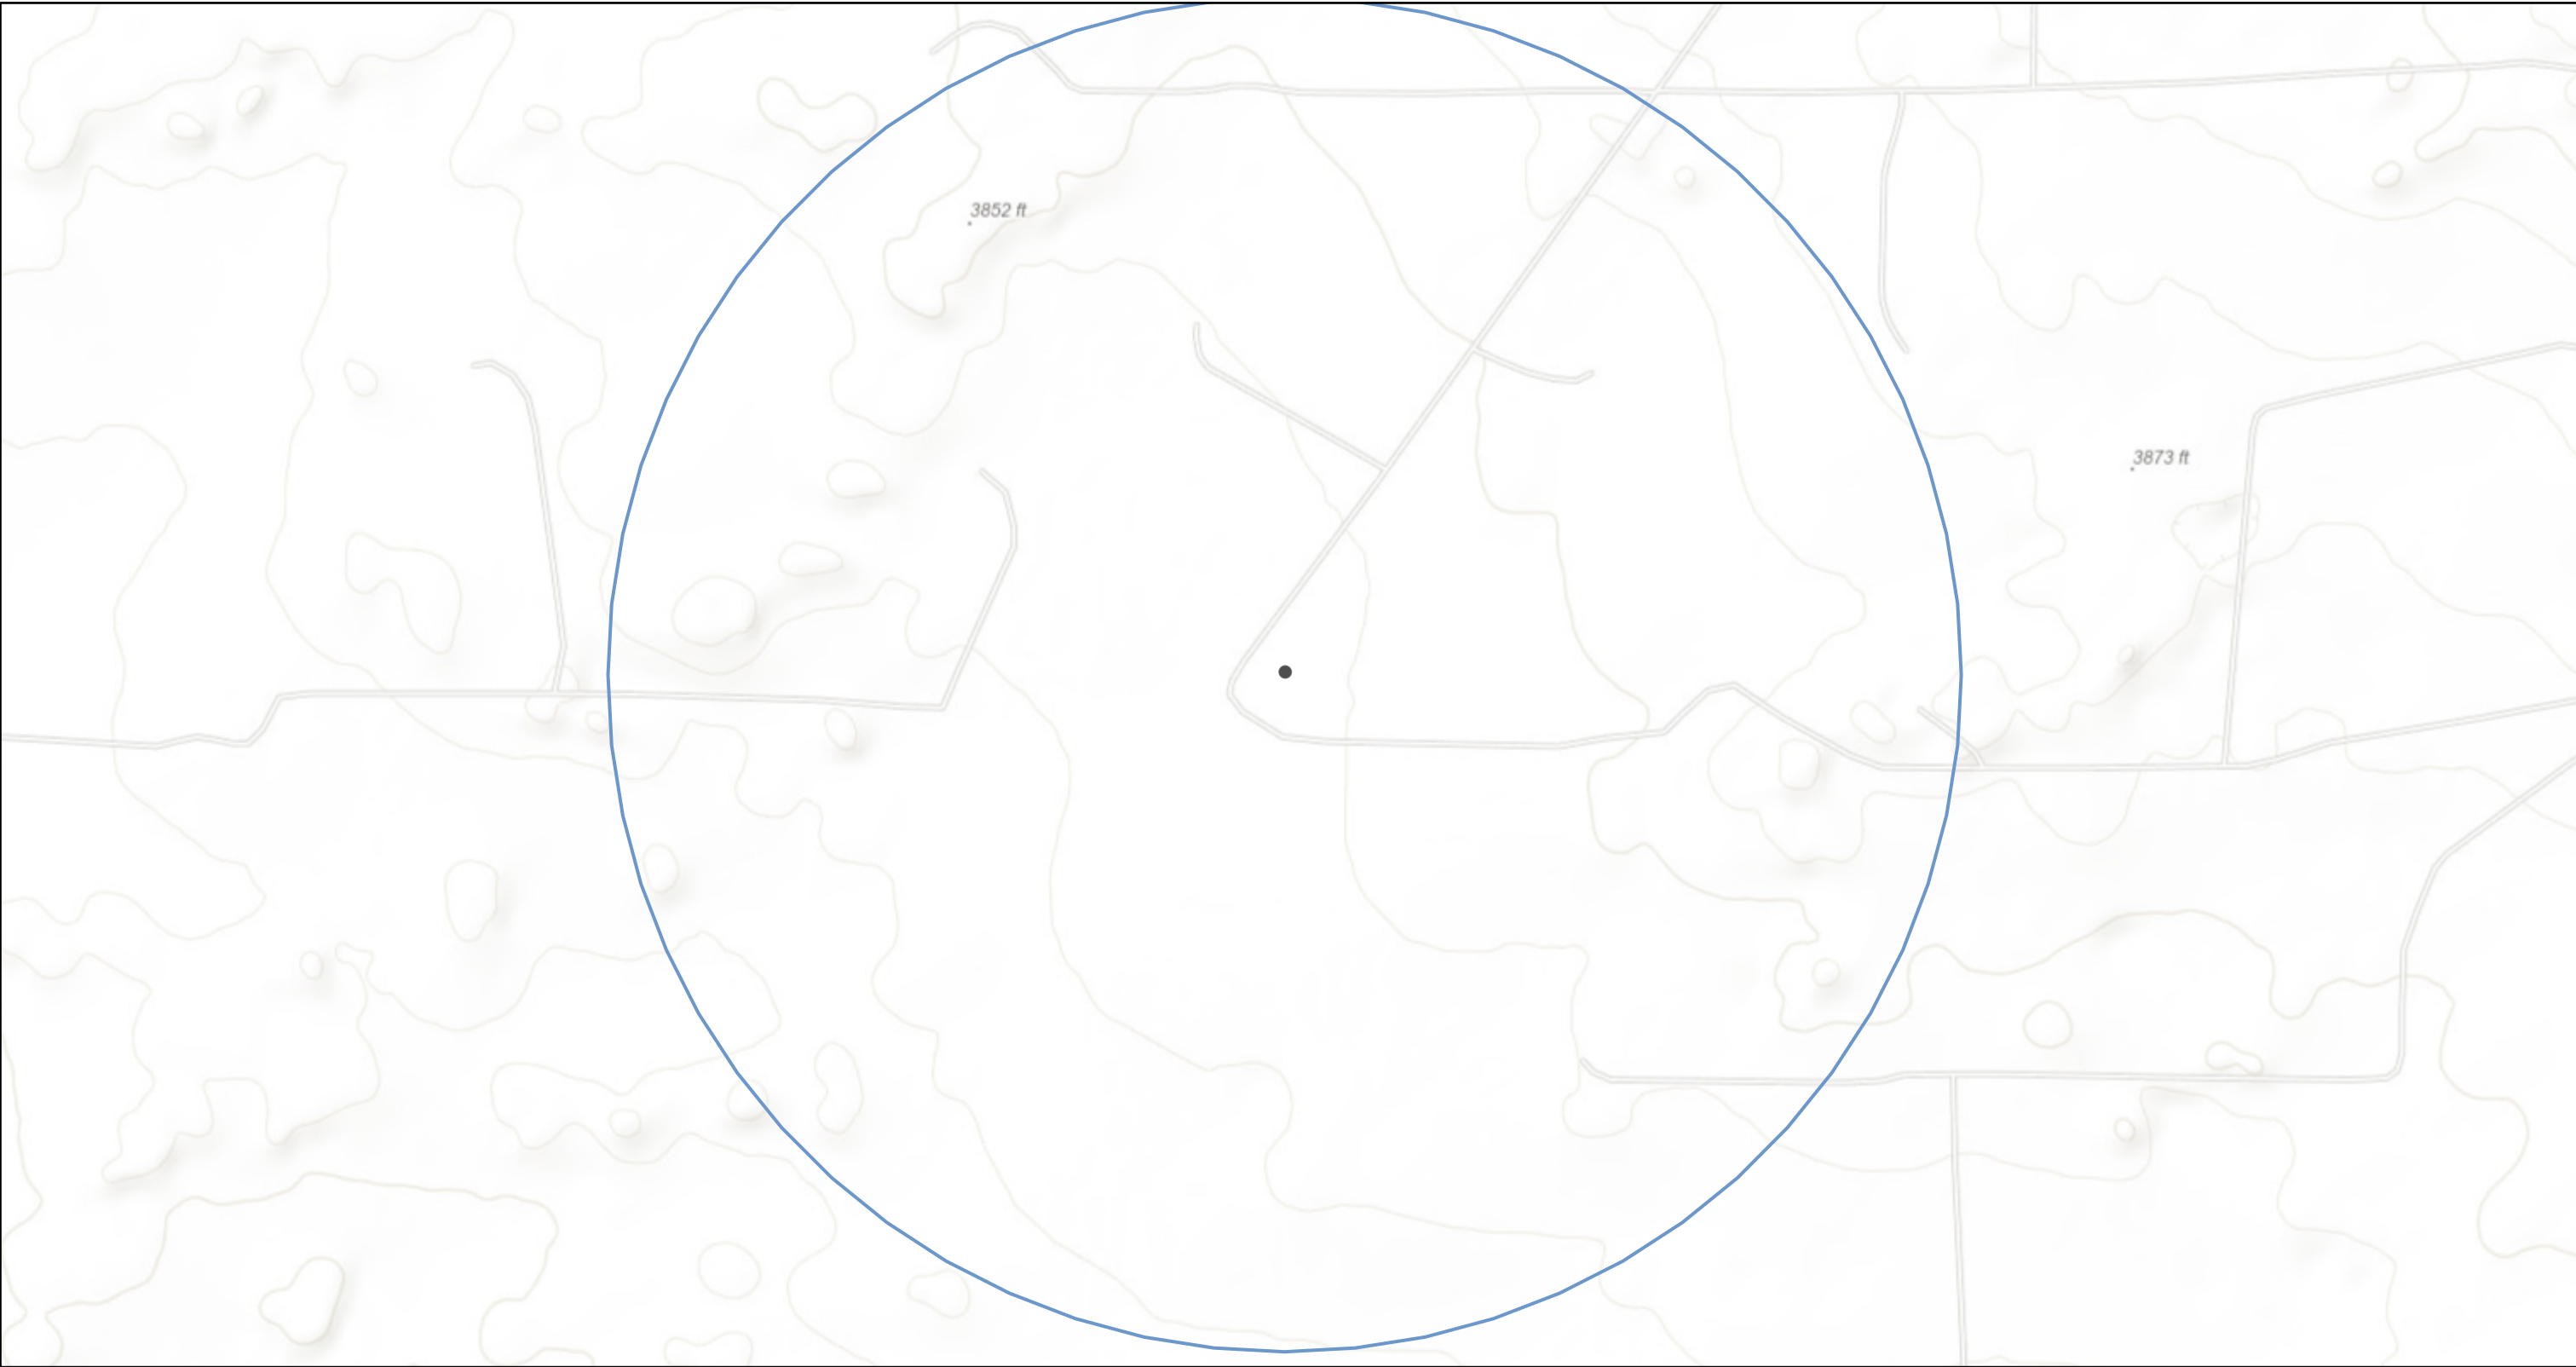
Figure 3 - Hydrology Map

3. **Wellhead protection area** – There are no known water sources within a half mile of the release (see *Figure 3*).
4. **Distance to nearest significant watercourse** – There are no known watercourses within a half mile of the release.

5. **Soil/waste characteristics** – An initial delineation was completed on 4/13/2021. Sample points are shown in *Figure 3* with results summarized in *Appendix C*. Lab data is displayed in *Appendix D*. Horizontal excavation will consist of sampling sidewalls (composites representing <200 square feet) to verify each wall is below thresholds listed in NMAC 19.15.29.13.D.1 (600 mg/kg chloride) and Table I (100 mg/kg TPH, 50 mg/kg BTEX, 10 mg/kg benzene). Vertical delineation will continue throughout the spill area to clean material per Table I. Excavation will be guided by field data and confirmed via third-party laboratory.

The delineation points can be seen in *Figure 3* with results in *Appendix C*. As stated in **Section II**, further delineation will be conducted throughout excavation to strictest thresholds in Table I with samples representing no more than 200 square feet or 100 cubic yards.
