State of New Mexico
Oil Conservation Division

Incident ID	nCH1903363086
District RP	
Facility ID	
Application ID

Remediation Summary & Soil Closure Request

Goodnight Midstream Permian, LLC Penroc State E & Piper SWD Fire

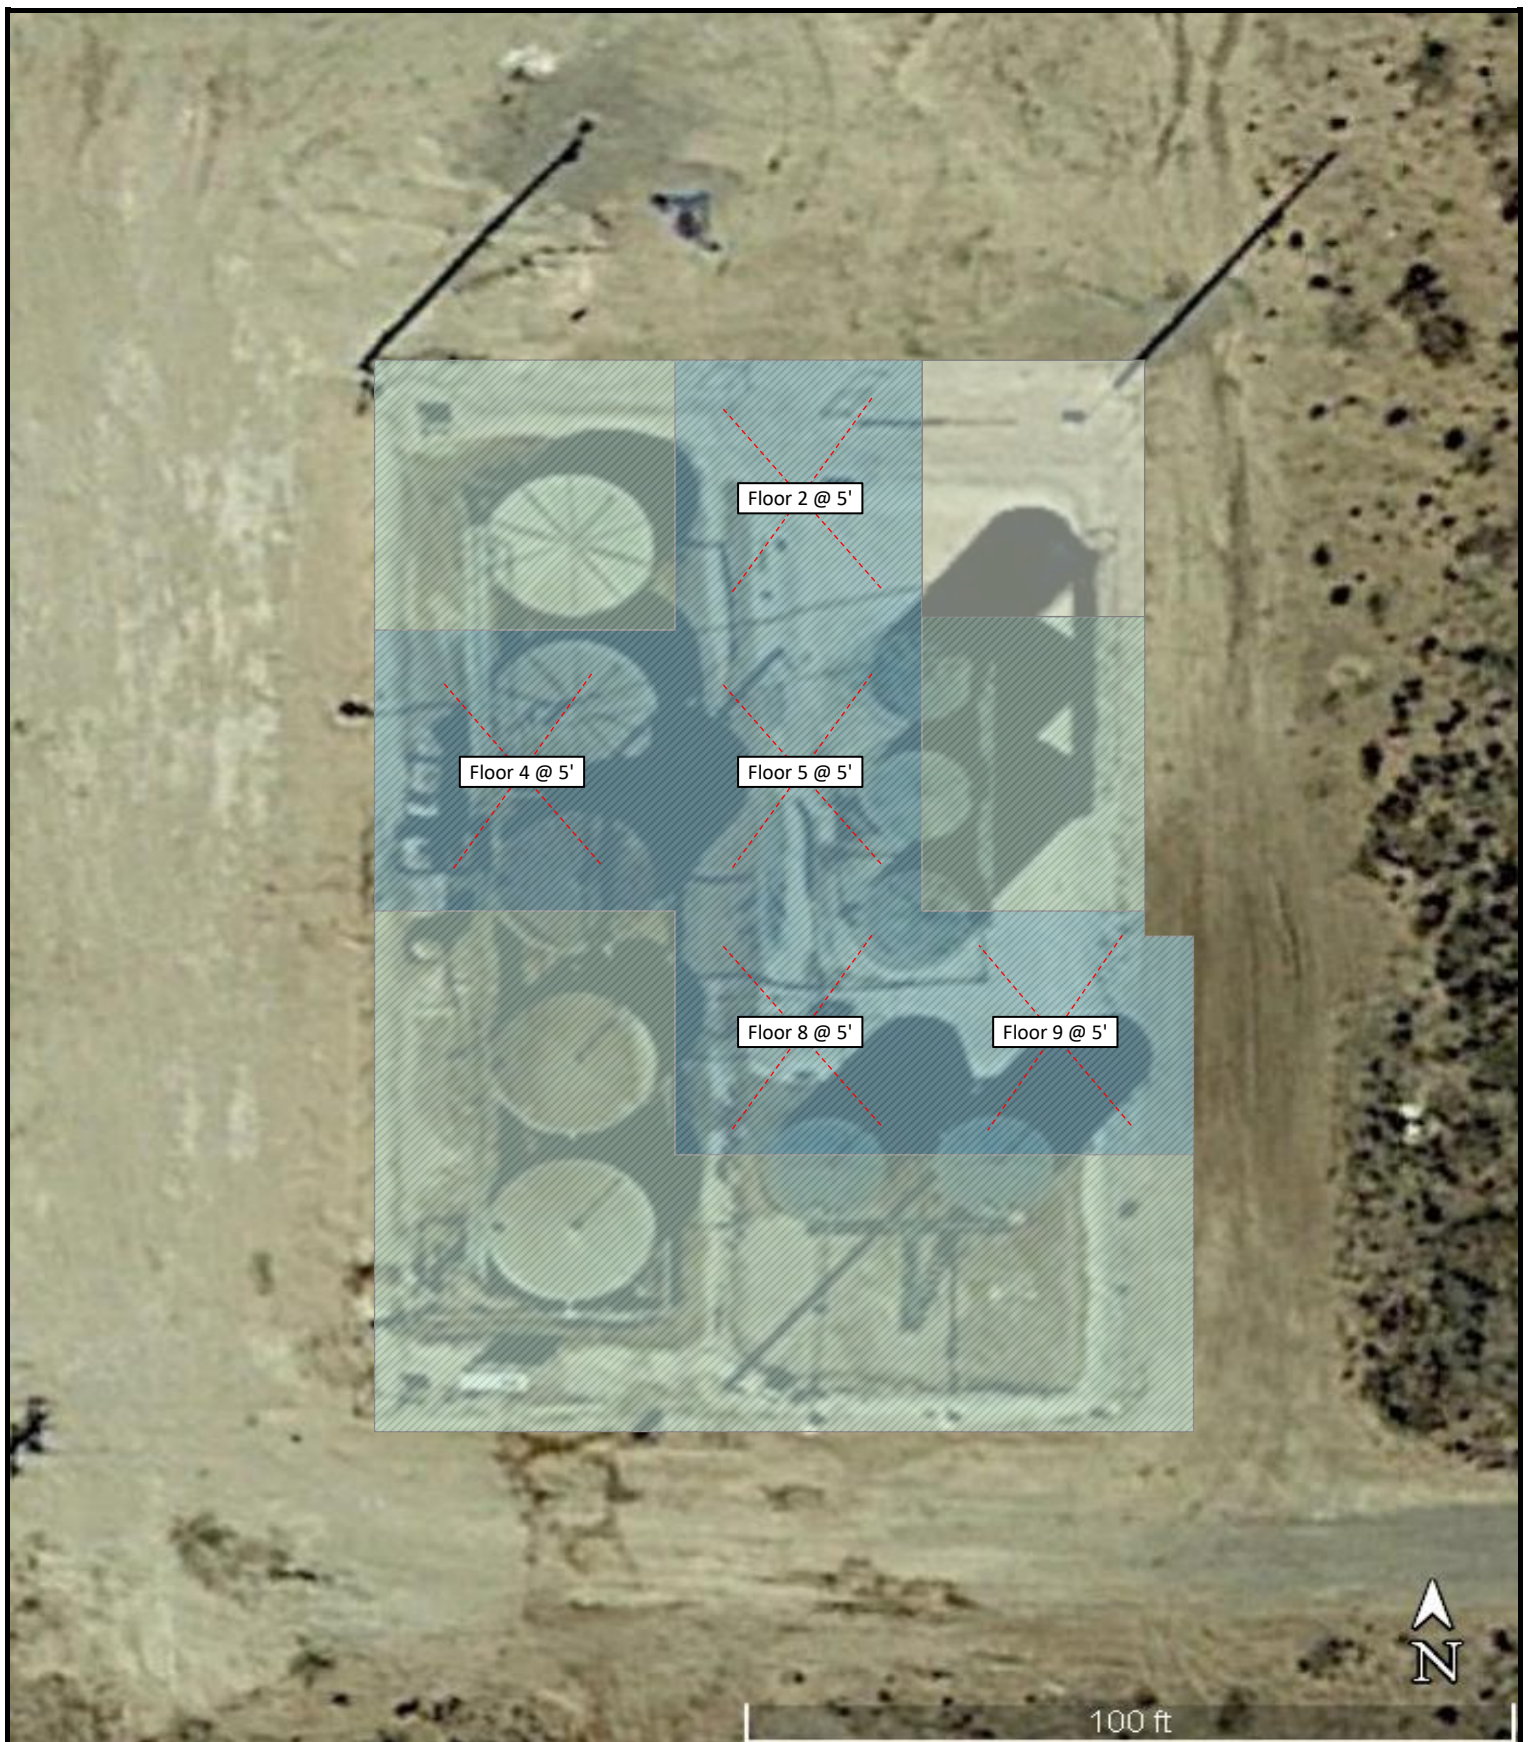
Figure 3

Site & Sample Location Map

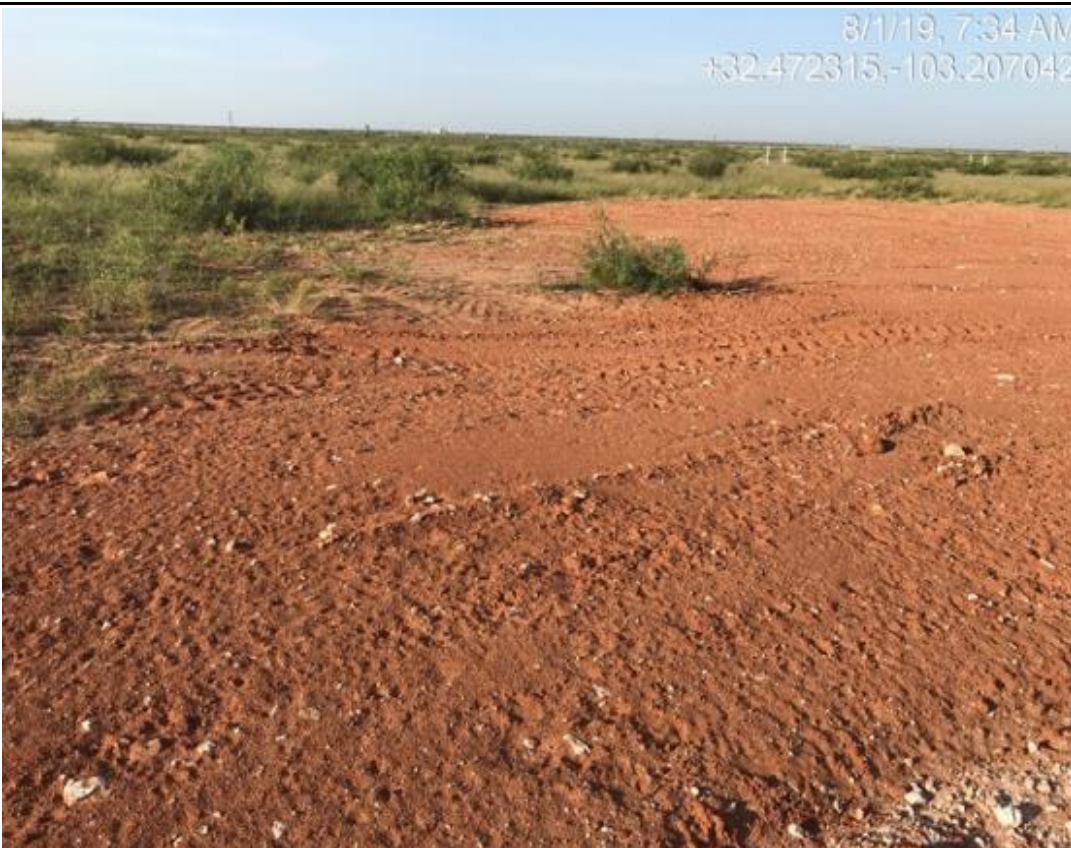
Photo Number: 9

Photo Direction: South	
Photo Description: View of remediated area south of the former SWD after backfill & regrading

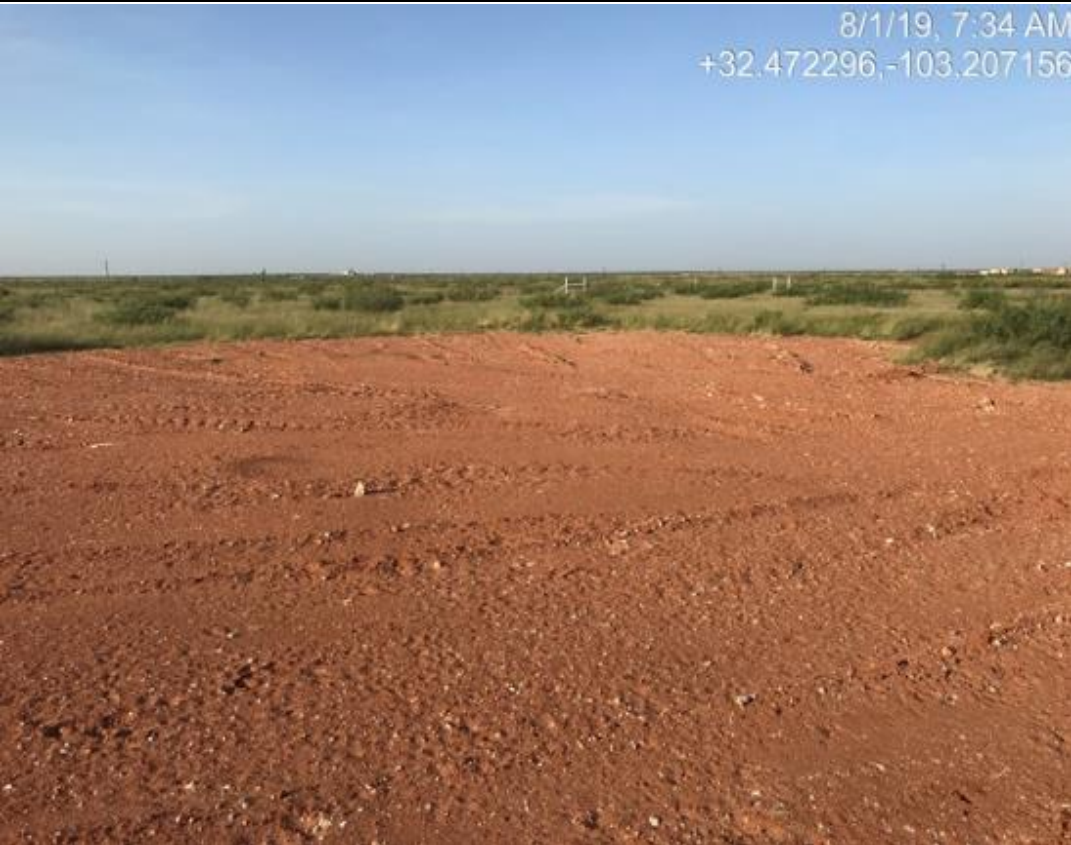
Photo Number: 10

Photo Direction: South	
Photo Description: View of remediated area south of the former SWD after backfill & regrading

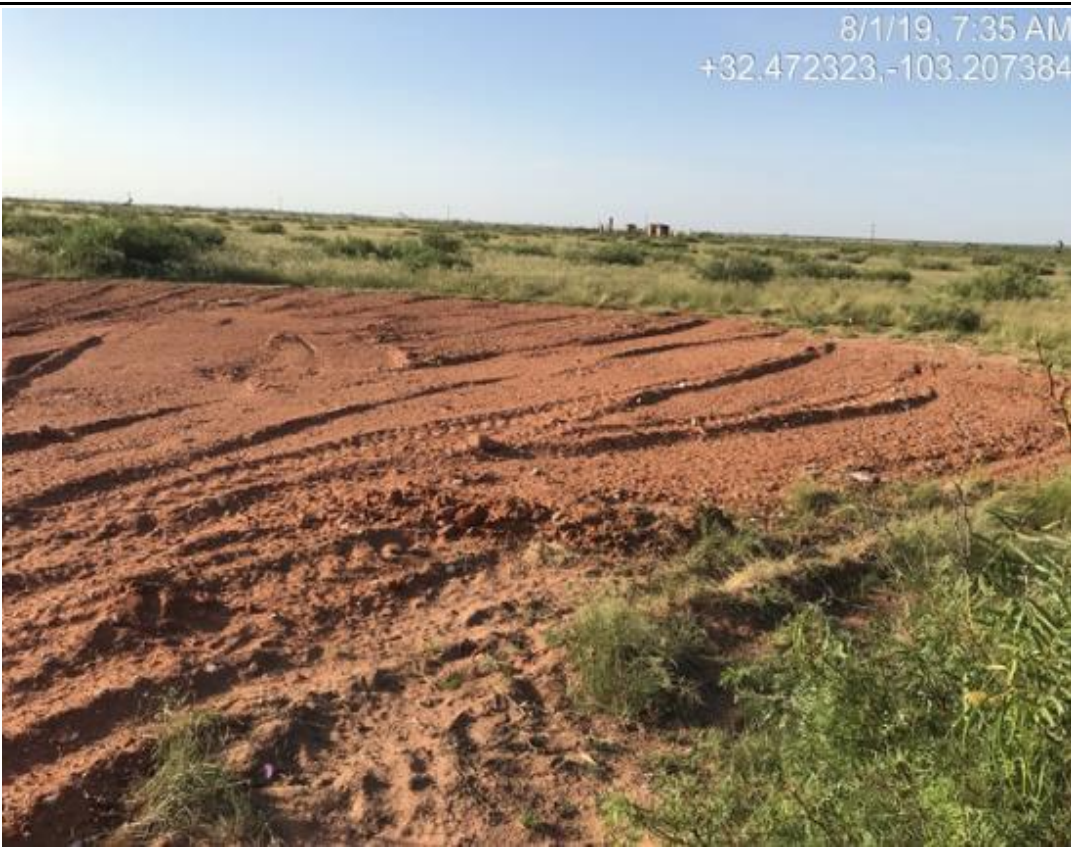
Photo Number: 11

<p>8/1/19, 7:35 AM +32.472323,-103.207384</p>
Photo Direction: South	
Photo Description: View of remediated area south of the former SWD after backfill & regrading

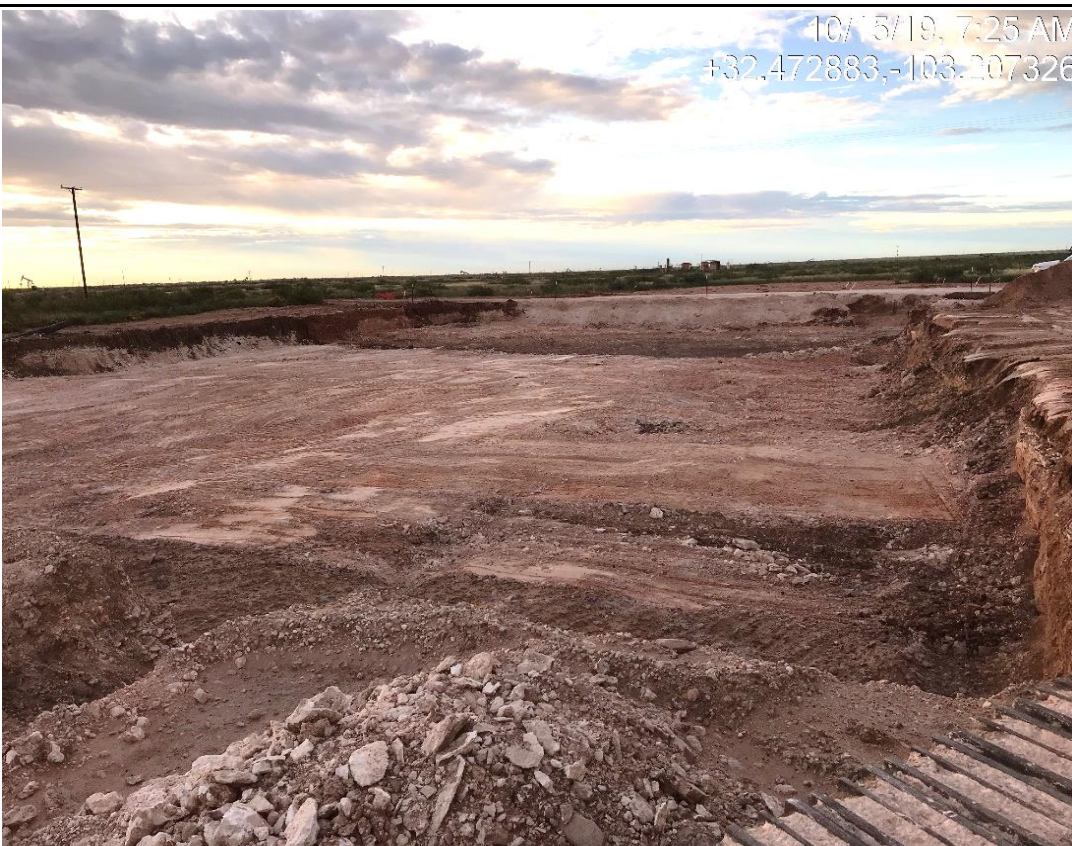
Photo Number: 13

Photo Direction: South	
Photo Description: View of a portion of the excavation under the former SWD containment area

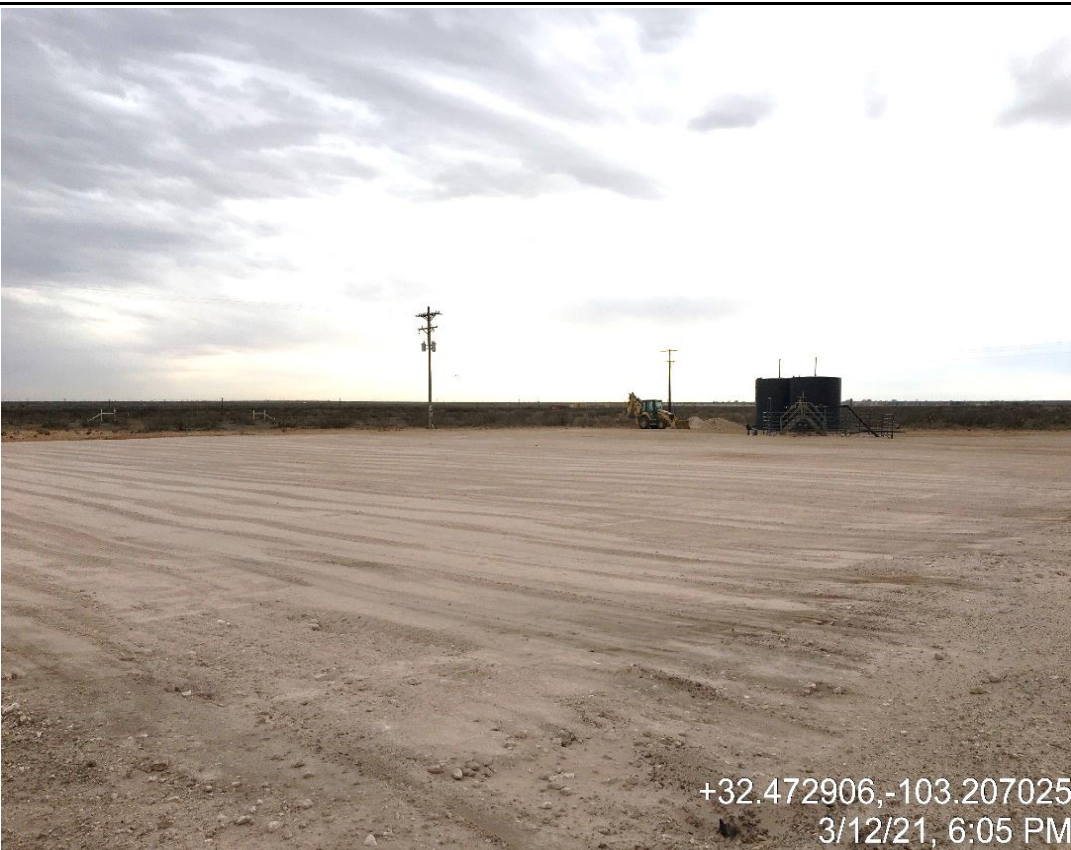
Photo Number: 19

Photo Direction: Southwest	
Photo Description: View of remediated area after backfill and regrading

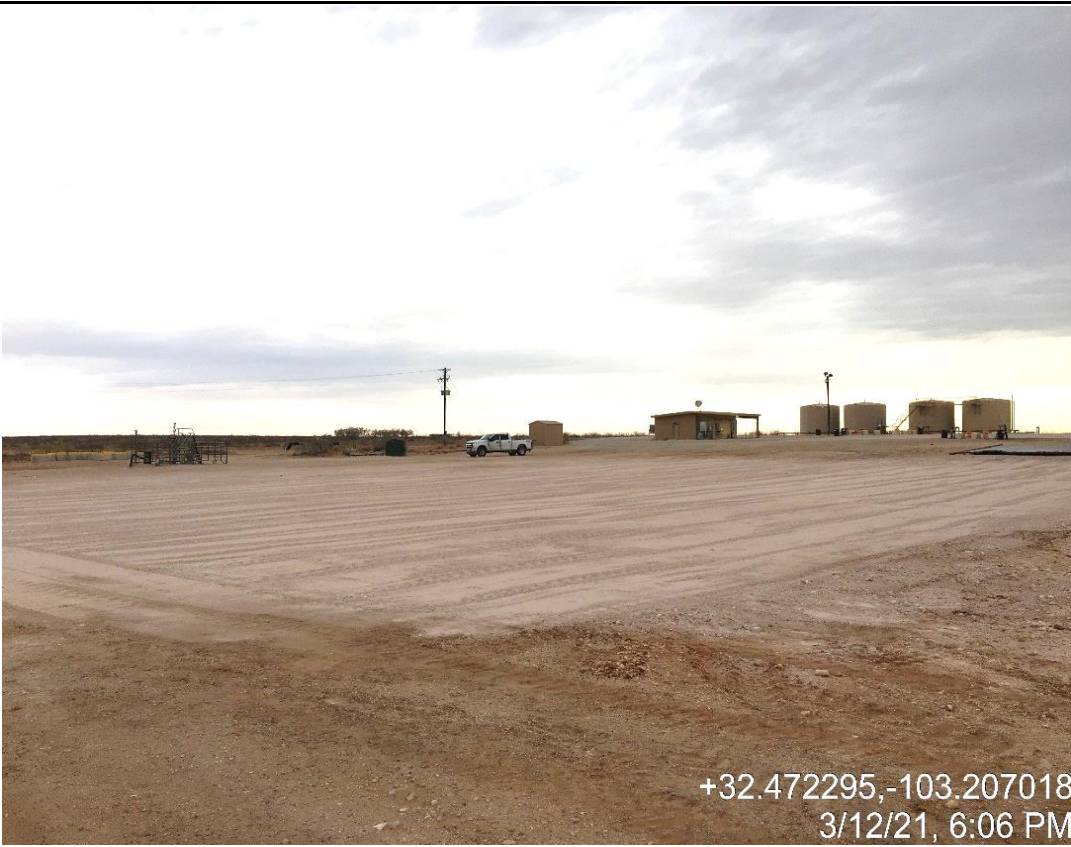
Photo Number: 20

Photo Direction: Northwest	
Photo Description: View of remediated area after backfill and regrading
