Release Notification

Site Name: Rojo 20 21 Tank Battery	Site Type: Tank Battery
Date Release Discovered: 8/23/2021	API# (if applicable) Nearest well: Rojo 7811 34 27 Fed #020H API #30-025-47460

Daily Progress Report

Client Name	BTA
Project Name	Rojo 20-21
Type of Form	Progress Reports
RXSoil Personnel	Jace Caraway
Date/Time	Aug 26, 2021 8:10:00 AM MDT
Task	Site assessment and grab stockpile sample
Percentage Complete	100
Picture 1

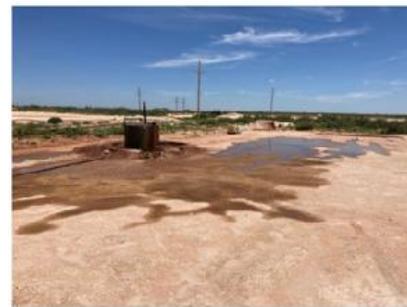
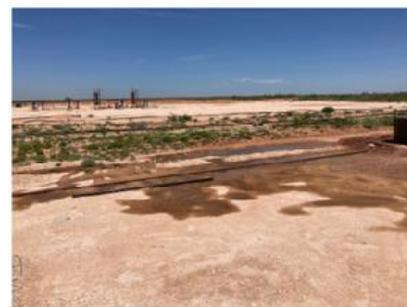
Rojo 20-21 scrape looks very good. Few wet spots in some areas. Scrape zone measures 50x90. Stock pile is 17x12 and close to 4ft high. Took a composite sample from stock pile and will be taking to lab.
