**SITE CHARACTERIZATION, ASSESSMENT, AND CLOSURE
REPORT**

**TRES CANAL BAL STATE #1
1RP-4865
UNIT K, SECTION 26, TOWNSHIP 8S, RANGE 33E
CHAVES COUNTY, NEW MEXICO
33.589816, -103.538924
RANGER REFERENCE NO. 5375**

JULY 19, 2021

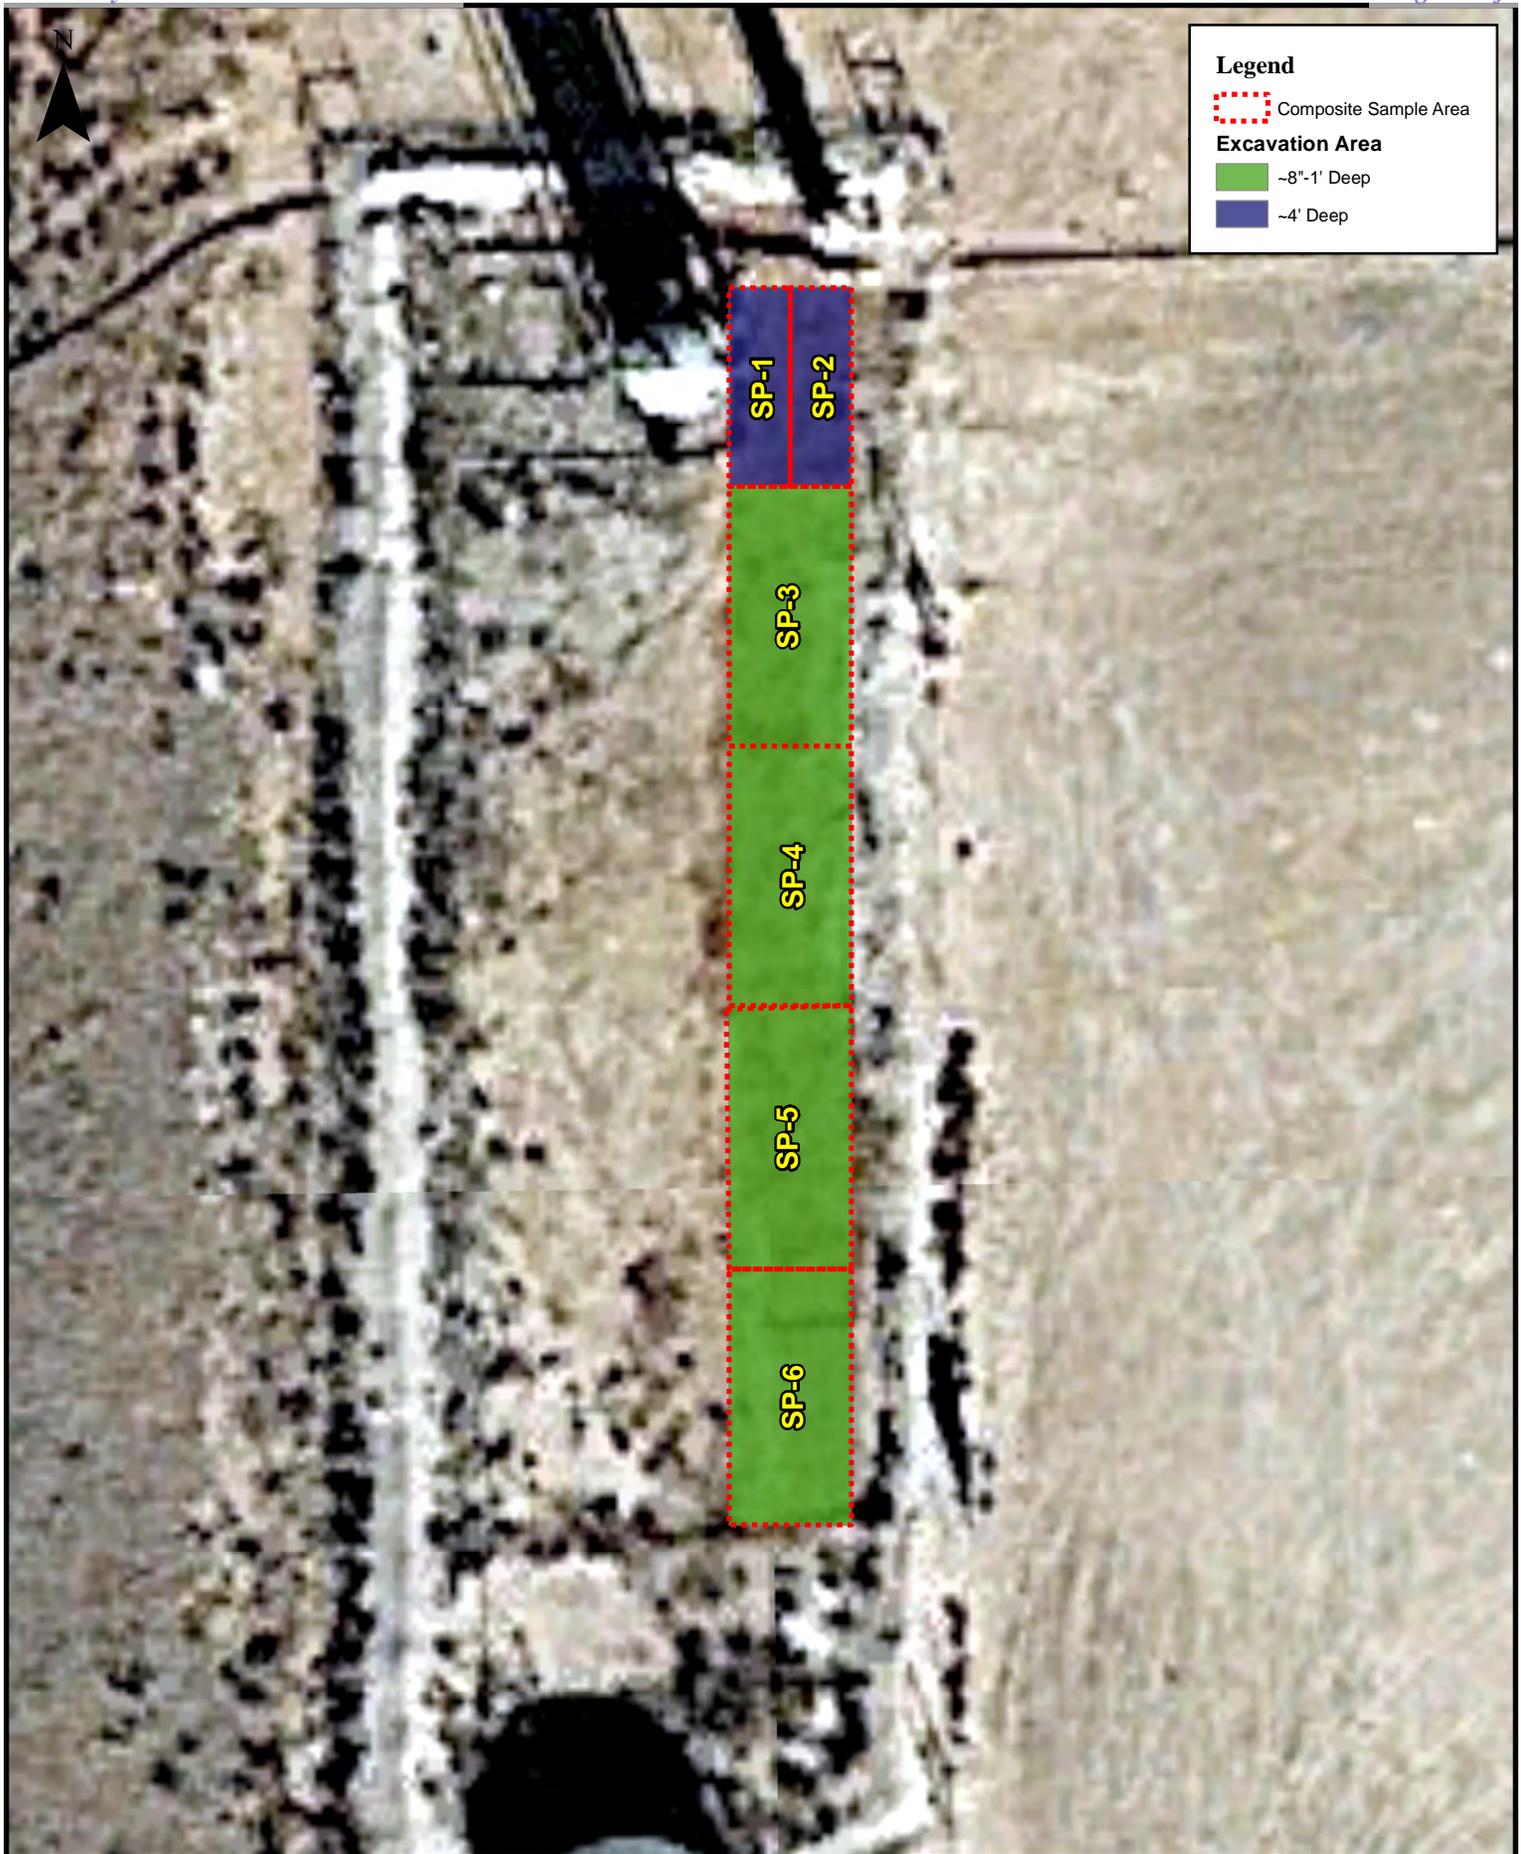
Site Map
Tres Canal BAL State #1
EOG Resources, Inc.

Upon inspection, the excavated area was noted to have maximum dimensions of approximately 81 feet long by eight (8) feet wide. In the northern portion of the excavation, in the vicinity of the release location, an area measuring approximately 13 feet long by eight (8) feet wide was observed to have been excavated to a depth of approximately four (4) feet below ground surface (bgs). The southern portion of the excavated area, measuring approximately 68 feet long by eight feet wide, was observed to have been excavated to varying depths ranging from approximately eight inches to one foot bgs. A Site Map depicting the excavated area is attached.

A Site Map depicting the excavated area and soil sample locations is attached. The soil sample analytical results are summarized in the analytical table included in the Tables section of this report. Copies of the laboratory analytical reports are also attached.

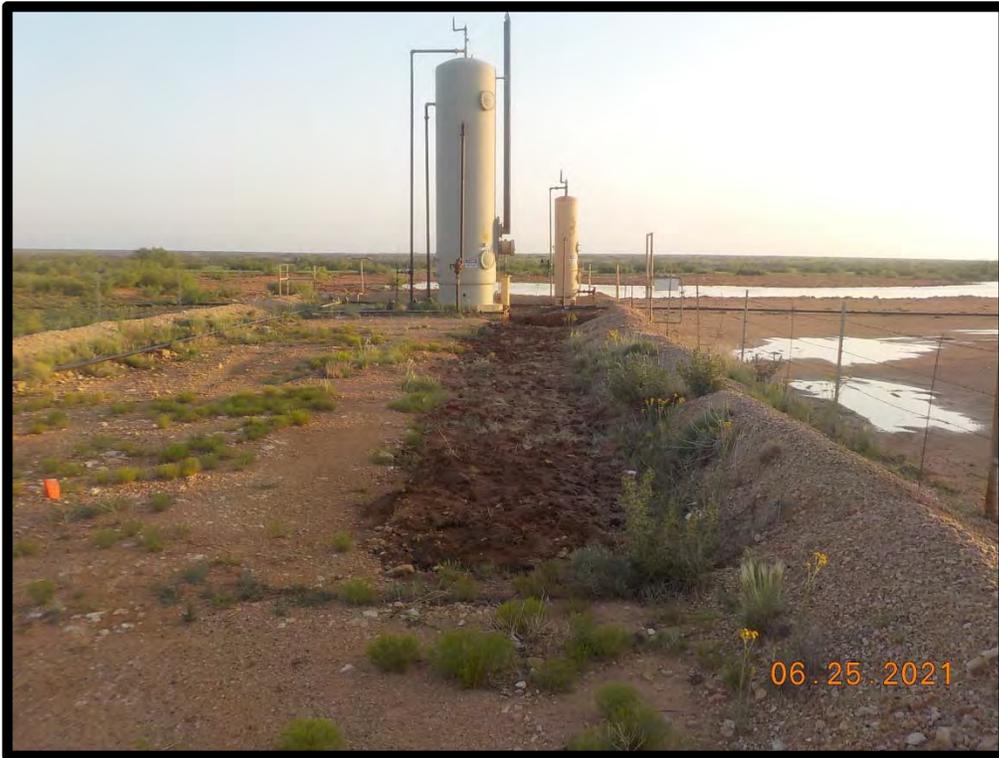
PHOTOGRAPH NO. 1 – A view from the southern extent of the impact/excavation area on June 25, 2021. The view is to the north.
(Approximate GPS Coordinates: 33.589598, -103.538929)

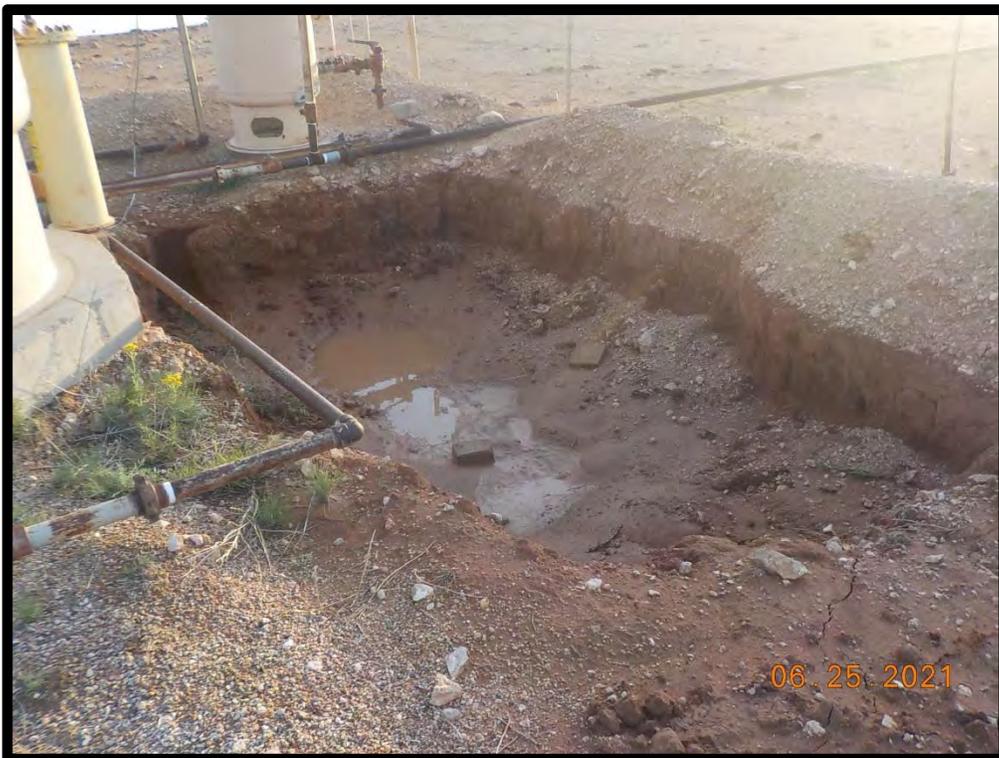
PHOTOGRAPH NO. 2 – A view of the four foot deep excavation area in the vicinity of the release location. The view is towards the northwest.
(Approximate GPS Coordinates: 33.589785, -103.538951)

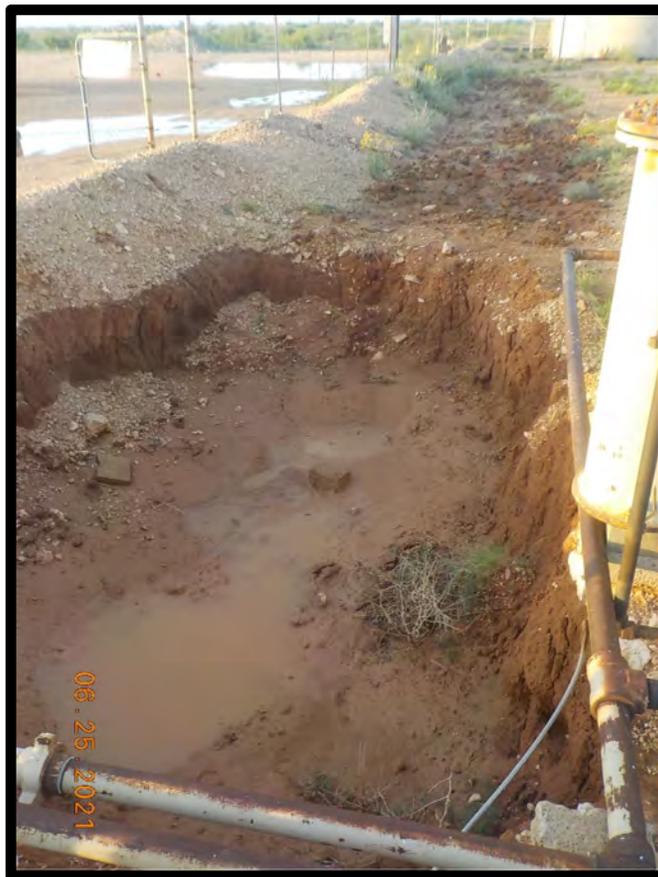
PHOTOGRAPH NO. 3 – An additional view collected of the excavation from the vicinity of the release location. The view is towards the south.

(Approximate GPS Coordinates: 33.589844, -103.538921)
