Re: Dayton Water Line (Gushwa DX #1)  
30-015-21703  
Section 21, T18S-R26E  
Eddy County, New Mexico  
2RP-2824

Dayton Water Line (Gushwa DX #1)  
Closure Report  
2RP-2824

**EOG Y Resources, Inc.**  
**Dayton Water Line (Gushwa DX #1)**  
**Closure Report**  
**Section 21, T18S-R26E**  
**Eddy County, New Mexico**  
**March 1, 2018**  
**2RP-2824**

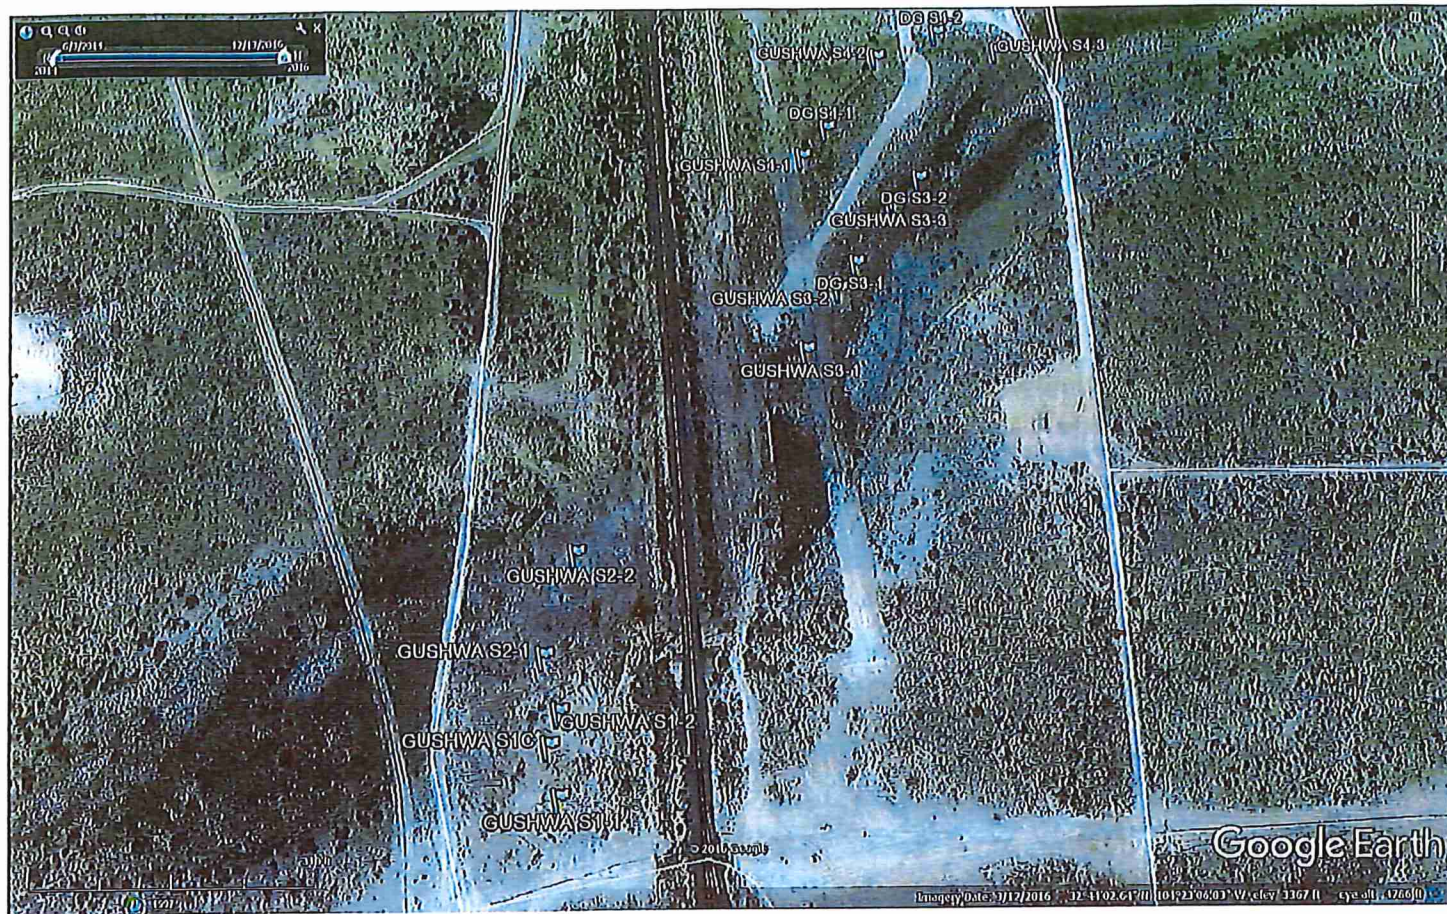
# Figure 1

## Site Map with Sample Points

W. side of tracks- 1000'X230' (at widest point), E. side of tracks- 705'X90' along tracks, S. Finger- 395'X50', N. Finger- 595'X75'

Based on the analytical results, the depth to groundwater (140'), and a decrease in chlorides, EOG Y Resources, Inc. excavated four (4) feet of impacted soil within the S2 release area, hauling this excavated soil to a NMOCD approved facility. EOG also excavated four (4) feet in the S1 release area, hauling the excavated soil to a NMOCD approved facility. EOG then installed a 20 ml synthetic liner within the excavated release area and backfilled with the entire excavation with similar topsoil sourced within a half mile. After the excavated area was backfilled, it was revegetated according to the private surface owner's desired objectives.

Due to the vegetative growth in the S3 and S4 sample areas, and approval by NMOCD, no work was conducted. This area has recovered in regards to vegetation and has a tremendous population of native grass that is thriving compared to the surrounding area.
