**Re: Release Characterization and Closure Request  
ConocoPhillips  
VGEU 10-03 Tubing Release  
Unit Letter H, Section 28, Township 17 South, Range 35 East  
Lea County, New Mexico  
Incident ID: nAPP2116770257**

Release Characterization and Closure Request  
September 13, 2021

**VGEU 10-03 TUBING RELEASE  
SITE LOCATION MAP**

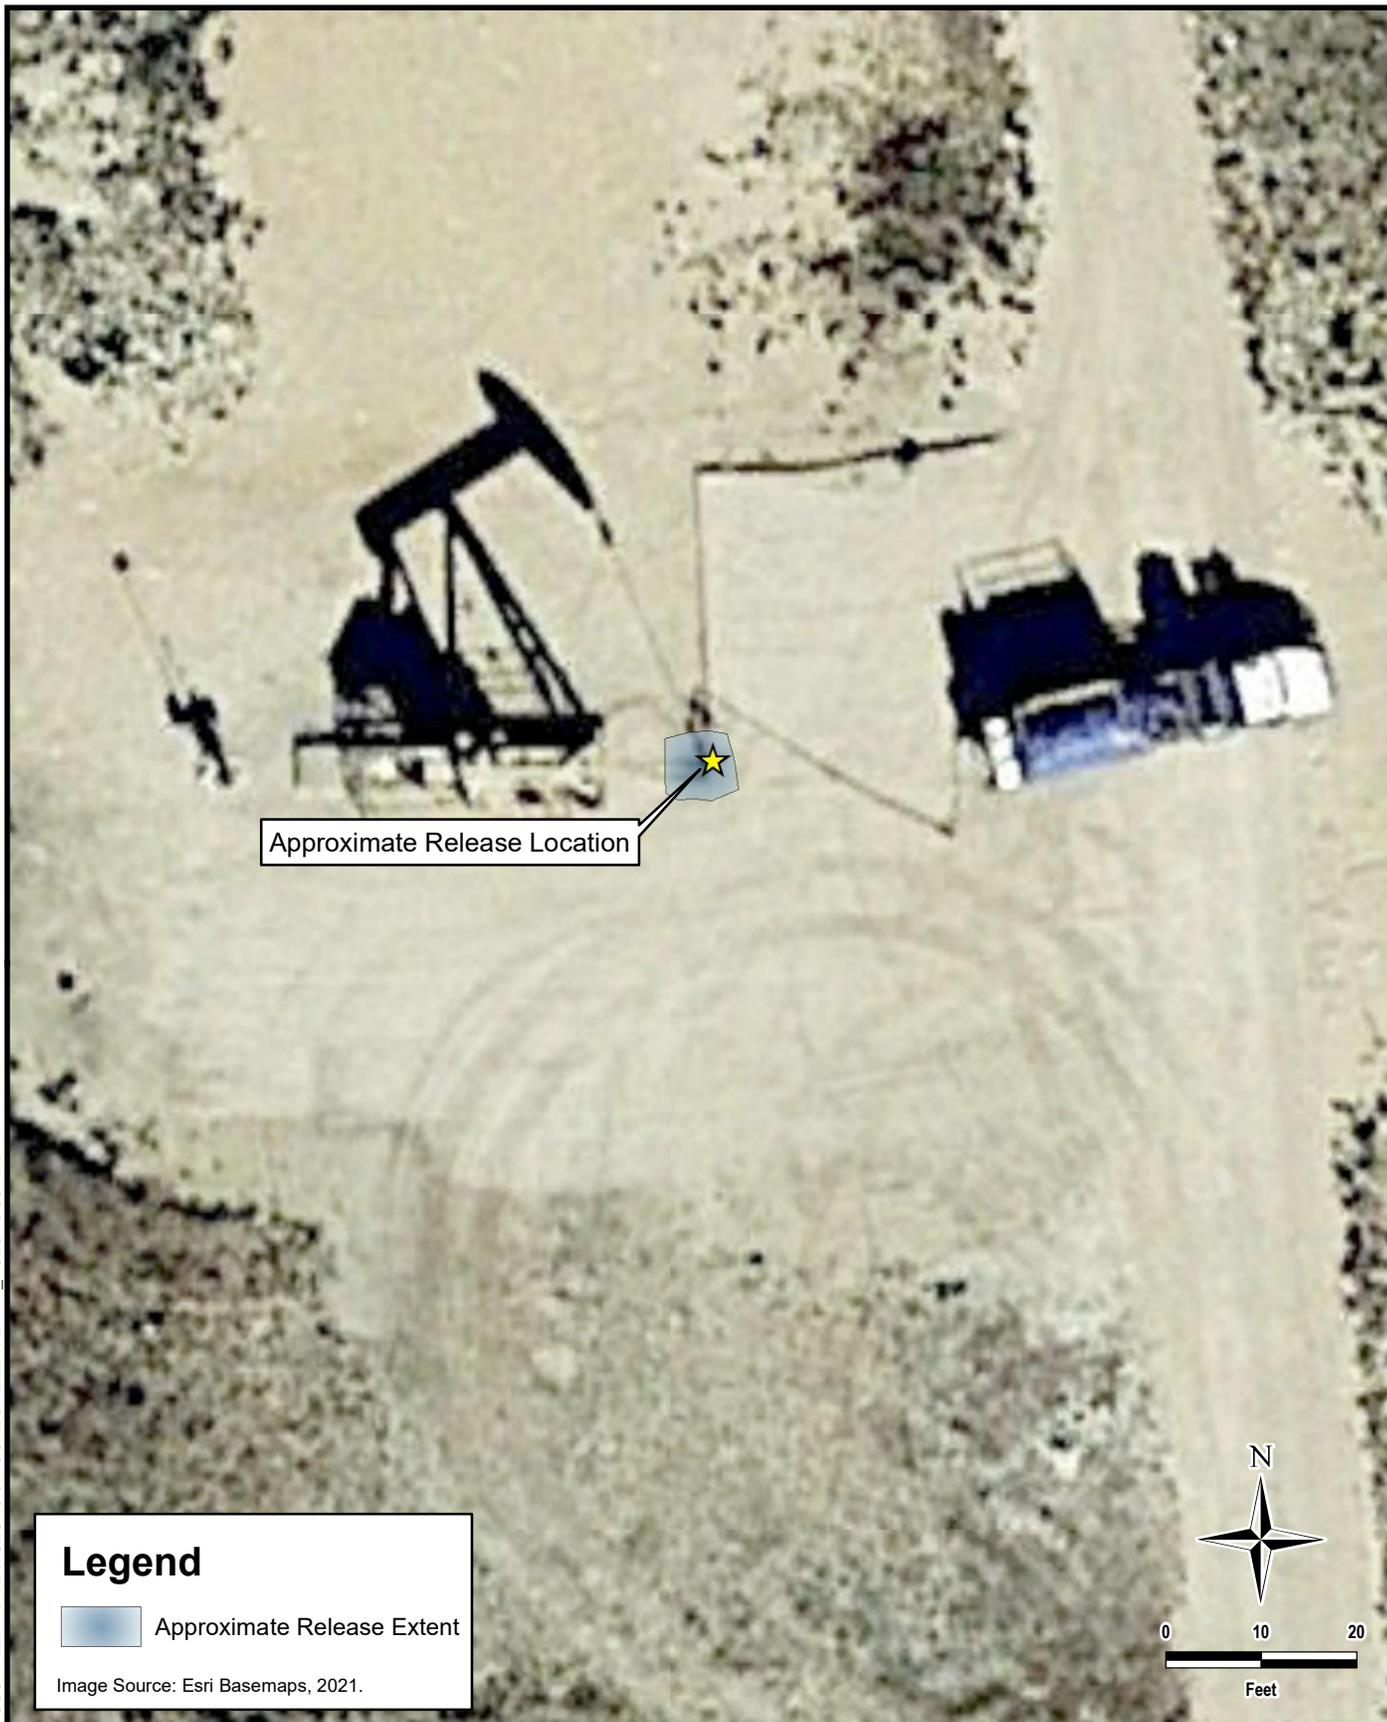
Figure No.

Approximate Release Location

Approximate Release Extent

### VGEU 10-03 TUBING RELEASE APPROXIMATE RELEASE EXTENT

The approximate release footprint is shown in Figure 3. The C-141 report form for the release was submitted to the New Mexico Oil Conservation District (NMOCD) on June 17, 2021. The NMOCD assigned this release Incident ID nAPP2116770257.

The approximate release extent is shown in Figure 3. In accordance with 19.15.29.8.B.(4) NMAC that states "the responsible party may commence remediation immediately after discovery of a release", COP elected to begin remediation of the impacted area in August 2021.

Due to the well control incident which caused the release, the pumping unit was removed from location. The release footprint in the immediate vicinity of the well tubing (as shown in Figure 3) was then excavated to approximately 18 feet bgs to access the well tubing, as well as remove the impacted soils in the vicinity. For safety of the onsite workers, the excavation was benched down to the floor at 18' bgs. Approximately 150 cubic yards of impacted material were transported to the R360 facility in Hobbs, New Mexico.

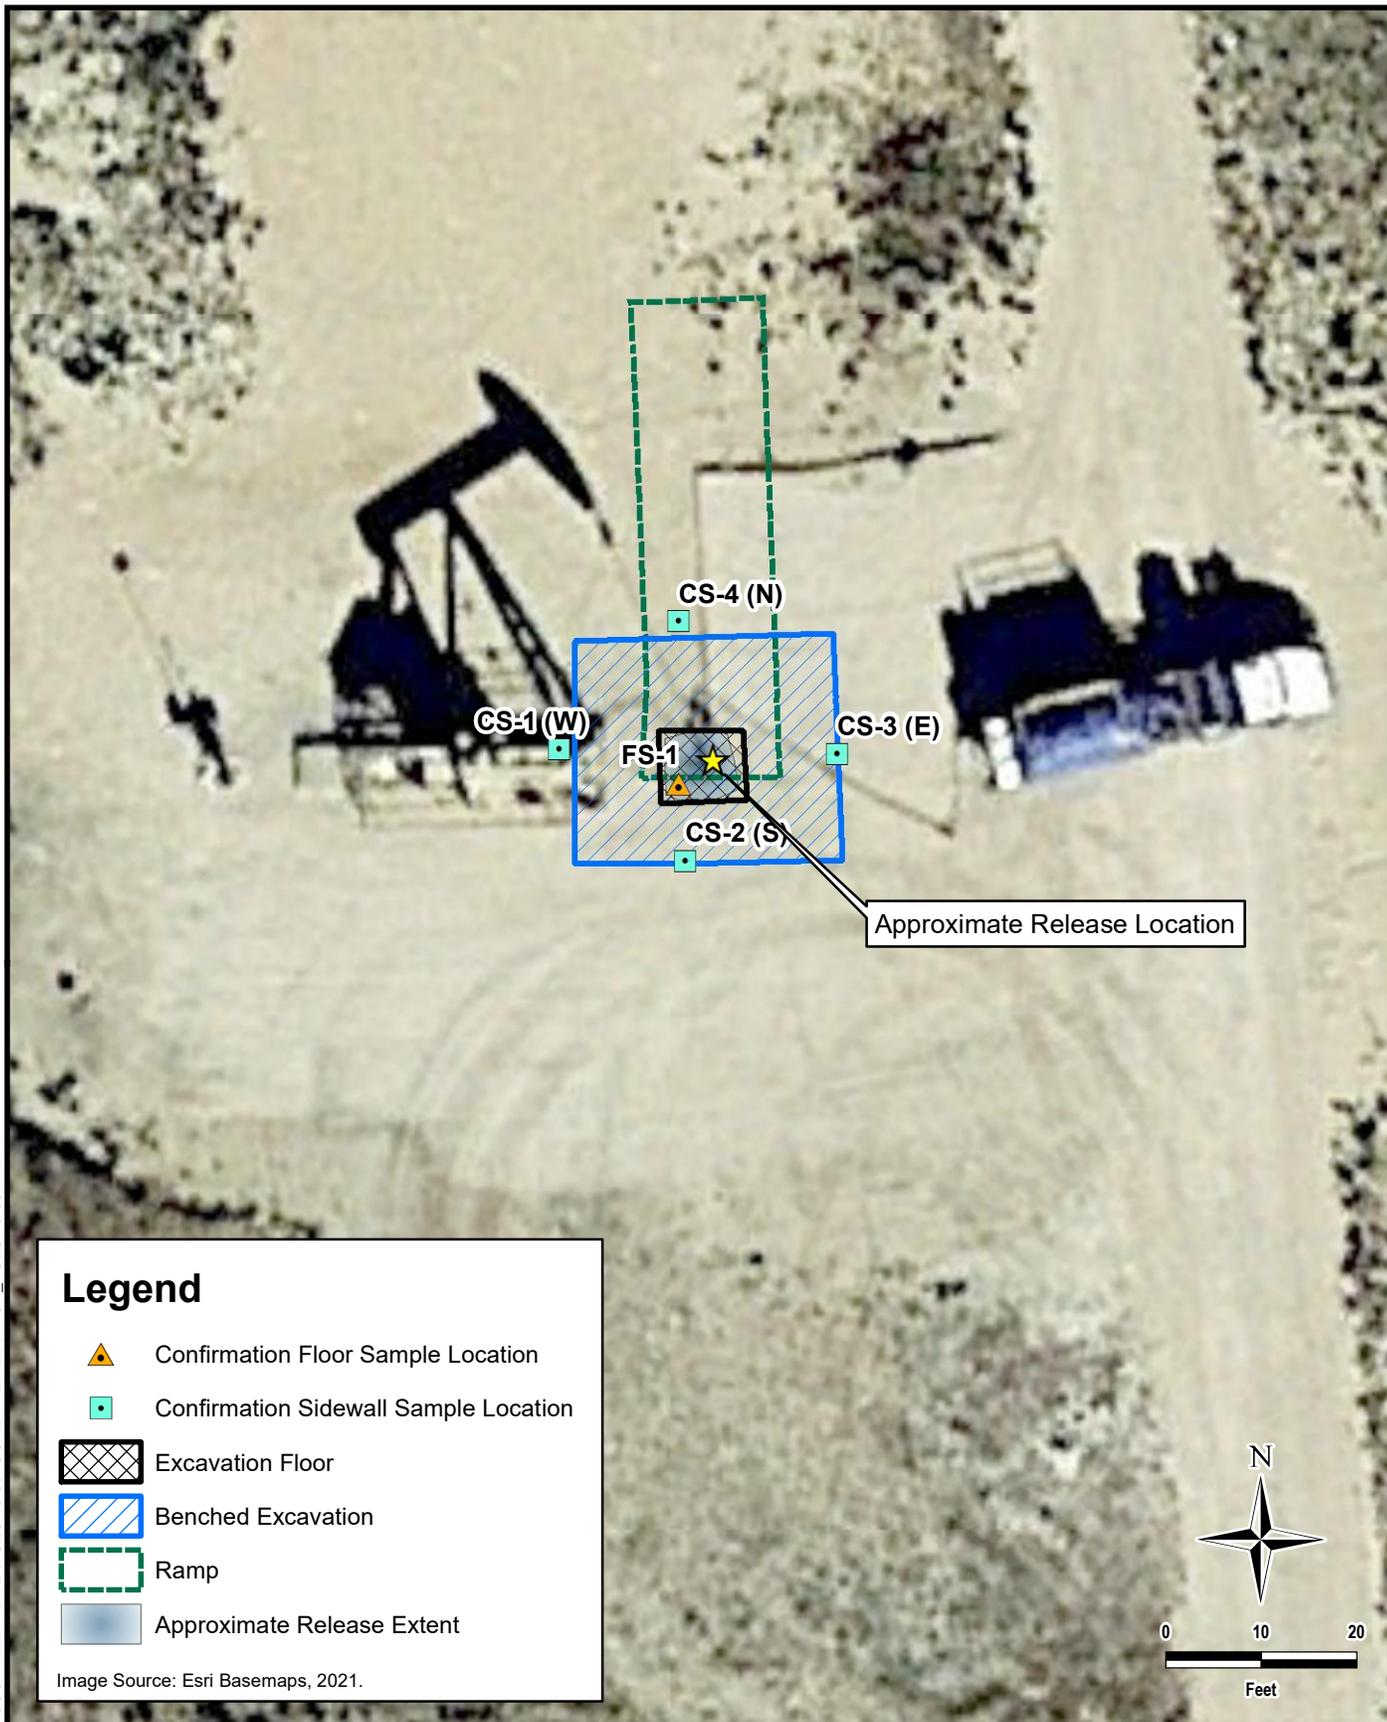
- Confirmation Floor Sample Location
- Confirmation Sidewall Sample Location
- Excavation Floor
- Benched Excavation
- Ramp
- Approximate Release Extent

For the health and safety of onsite workers, after confirmation sampling, the open excavation was backfilled with clean material to surface grade. The total remediated area encompassed a surface area of approximately 650 square feet. Each confirmation sample laboratory analytical result was directly compared to the proposed RRALs to demonstrate compliance. All final confirmation soil samples (floor and sidewall) were below the respective remediation RRALs for BTEX, TPH and chlorides.

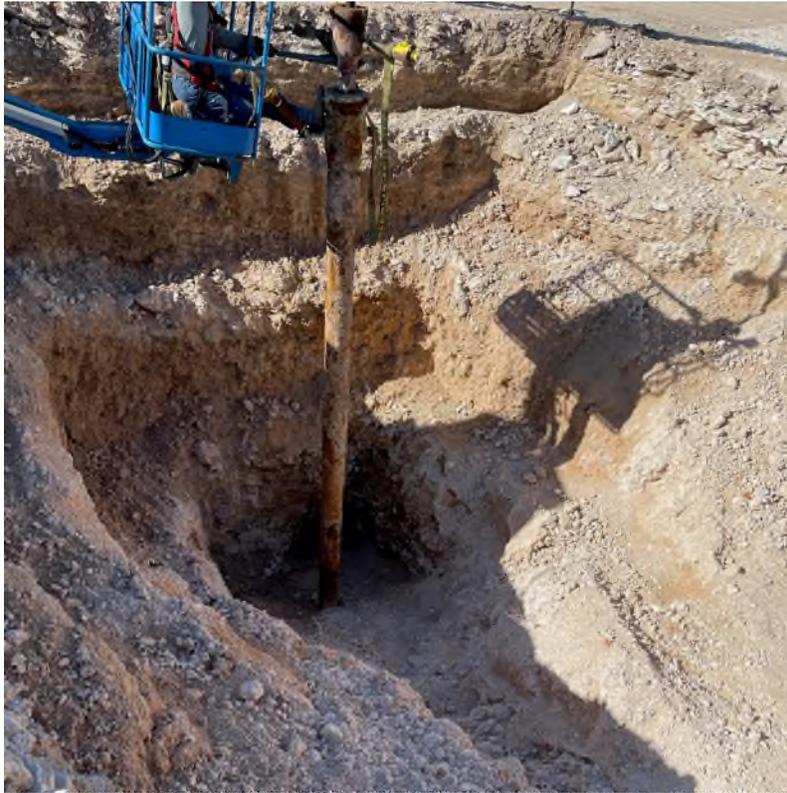
TETRA TECH, INC. PROJECT NO. 212C-MD-02377	DESCRIPTION	View of the release point and excavated area.	1
	SITE NAME	VGEU 10-03 Tubing Release	8/23/2021

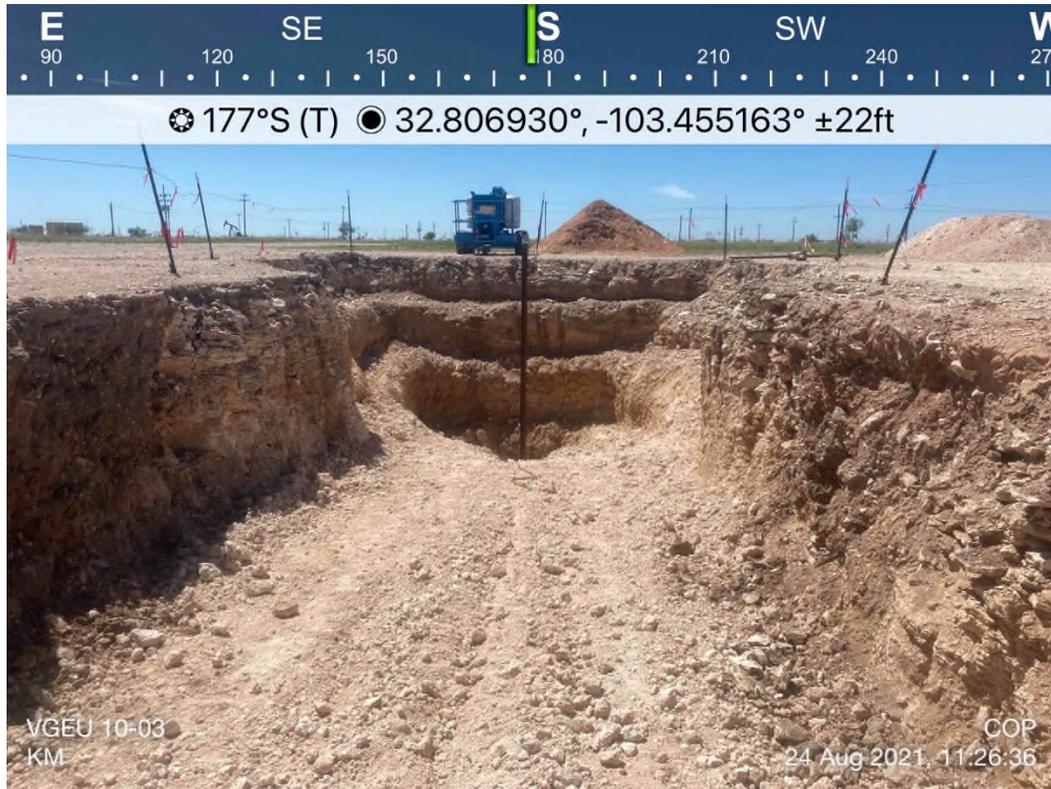
TETRA TECH, INC. PROJECT NO. 212C-MD-02377	DESCRIPTION	View south of the release point and excavated area.	2
	SITE NAME	VGEU 10-03 Tubing Release	8/24/2021

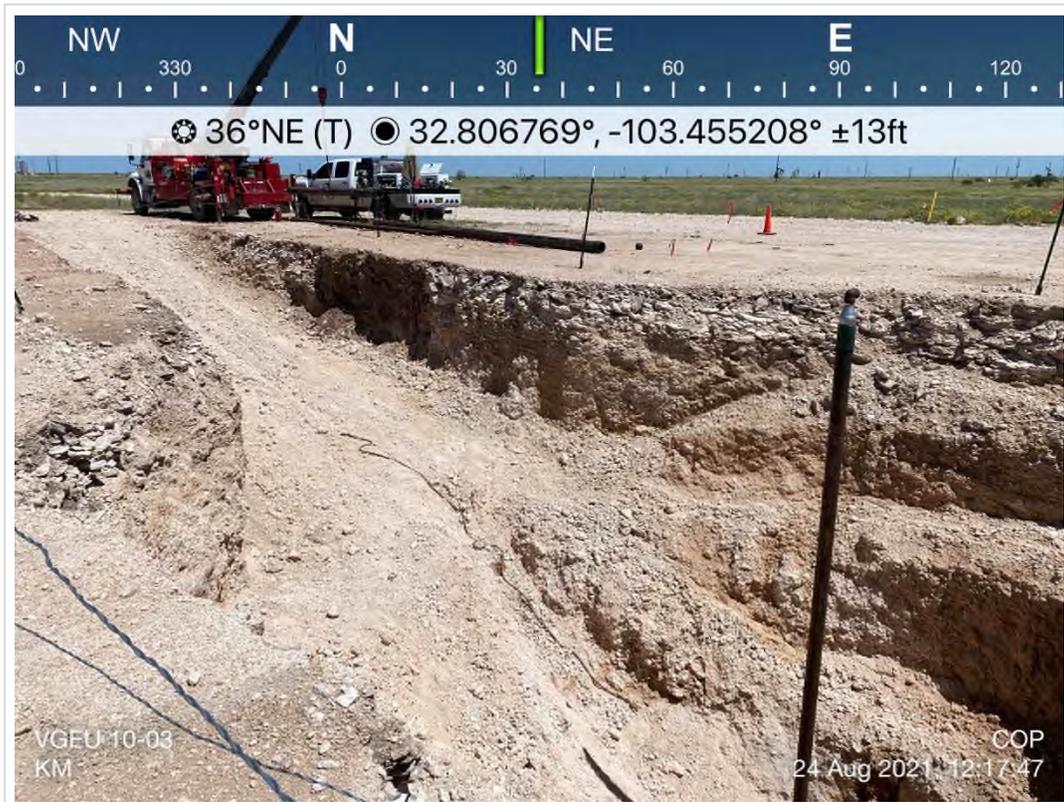
TETRA TECH, INC. PROJECT NO. 212C-MD-02377	DESCRIPTION	View northeast of the release area, excavated area and access ramp.	3
	SITE NAME	VGEU 10-03 Tubing Release	8/24/2021

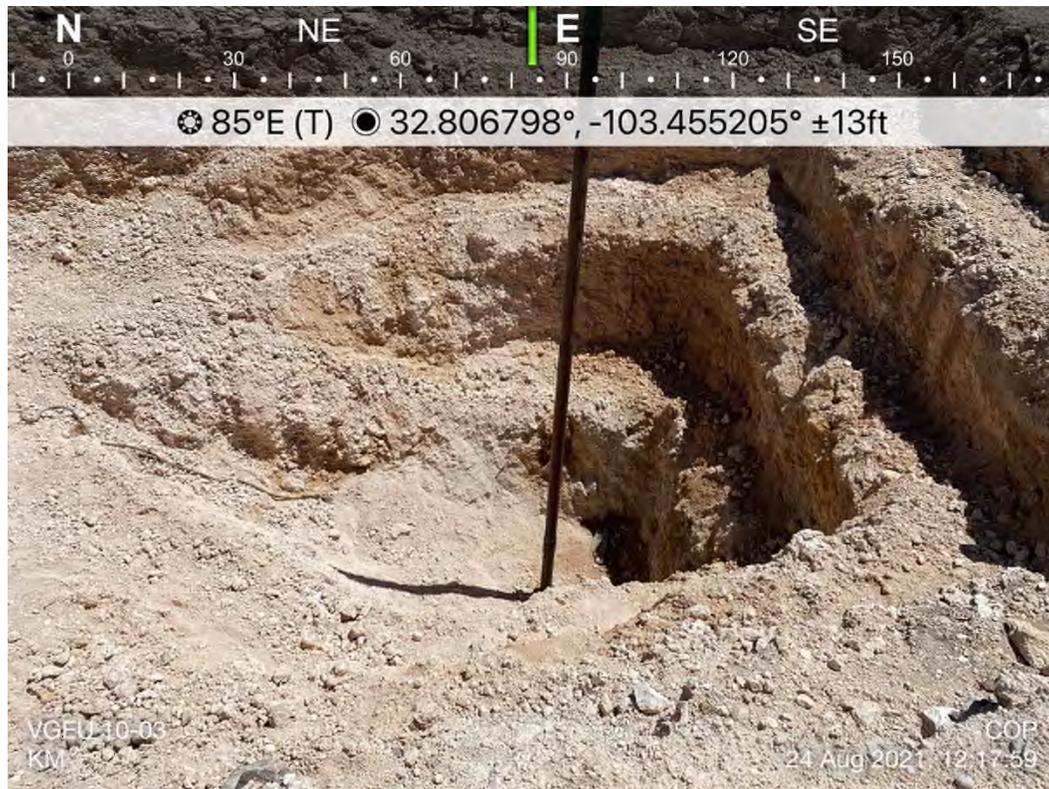
TETRA TECH, INC. PROJECT NO. 212C-MD-02377	DESCRIPTION	View of excavated area and benching.	4
	SITE NAME	VGEU 10-03 Tubing Release	8/24/2021

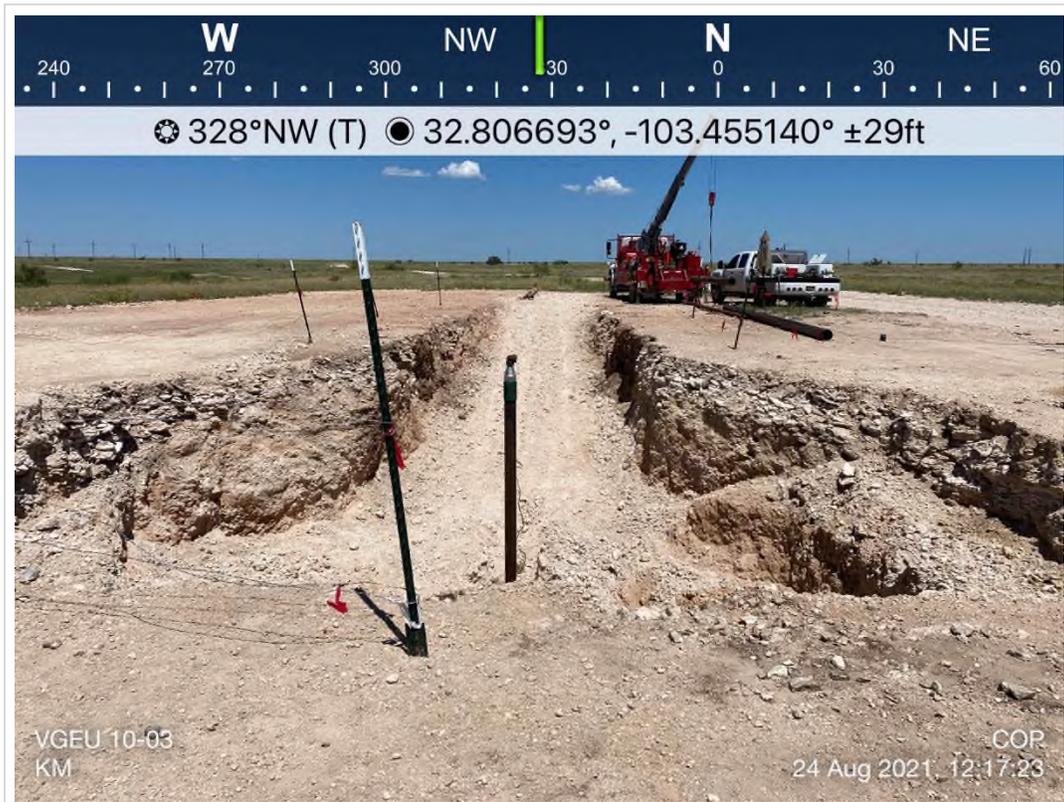
TETRA TECH, INC. PROJECT NO. 212C-MD-02377	DESCRIPTION	View northwest of the release area, tubing and access ramp.	5
	SITE NAME	VGEU 10-03 Tubing Release	8/24/2021
