Site Name: Canyonlands 2 State Com	Site Type: Battery
Date Release Discovered: 7/1/2021	API# (if applicable)

## **CLOSURE REQUEST AND REMEDIATION SUMMARY REPORT**

**Cimarex Energy Co.  
Canyonlands 2 State COM  
Lea County, New Mexico  
Unit Letter "O", Section 2, Township 24 South, Range 34 East  
Latitude 32.241925° North, Longitude 103.437931° West  
NMOCD Reference #: nAPP2119226446**

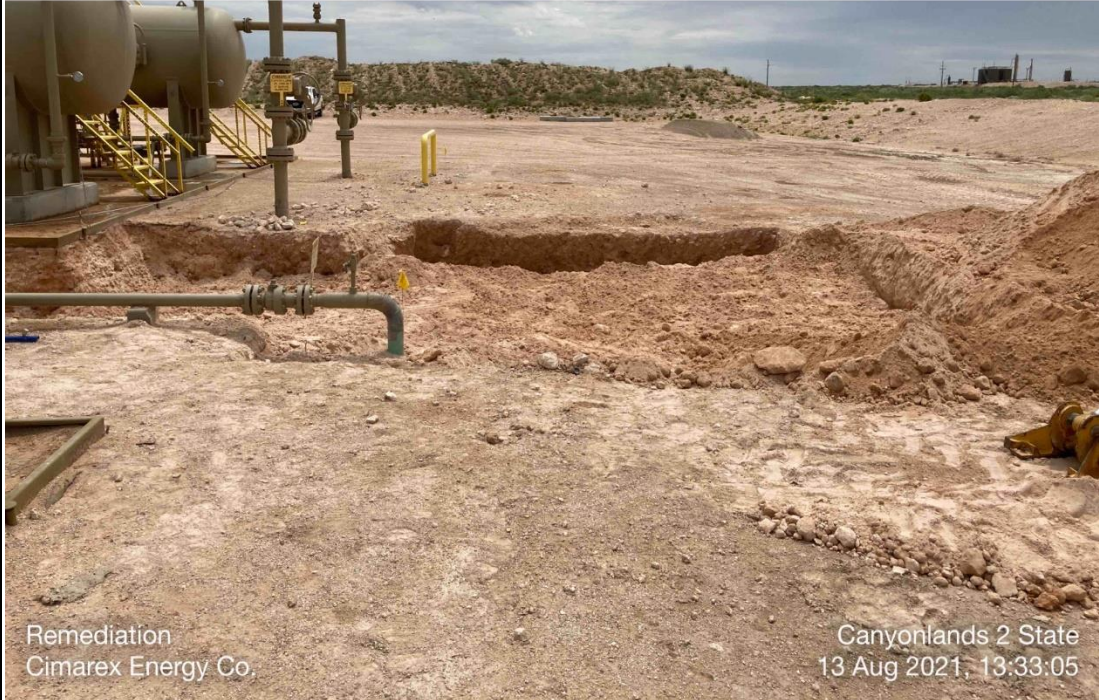
<b>Photo No:</b> <b>7.</b>

<b>Direction Taken:</b>  South	<p>☀ 185°S (T) ● 32.242057°, -103.437879° ±13ft ▲ 3446ft</p>

<b>Description:</b>  View of the excavated area.	<p>Remediation Cimarex Energy Co.</p> <p>Canyonlands 2 State 13 Aug 2021, 13:33:05</p>
